**KOP 25
Ruby Lake Road**

Figure 3.9-26

Falcon to Gonder Project EIS

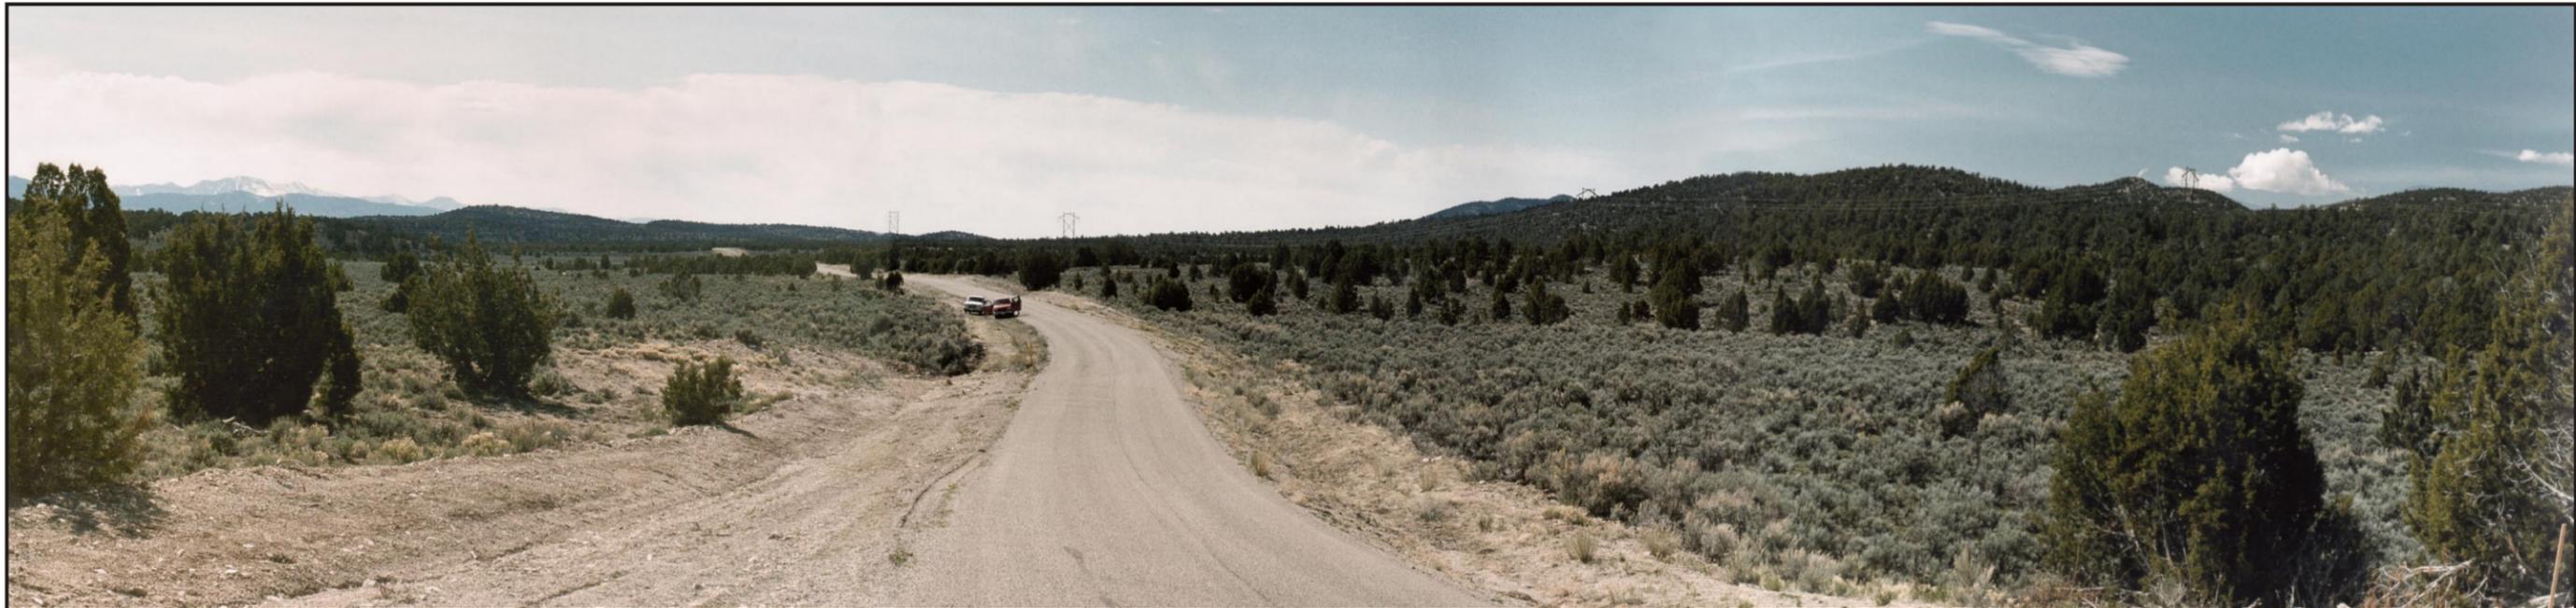
Existing Conditions

Existing Modifications: An existing wood pole transmission line

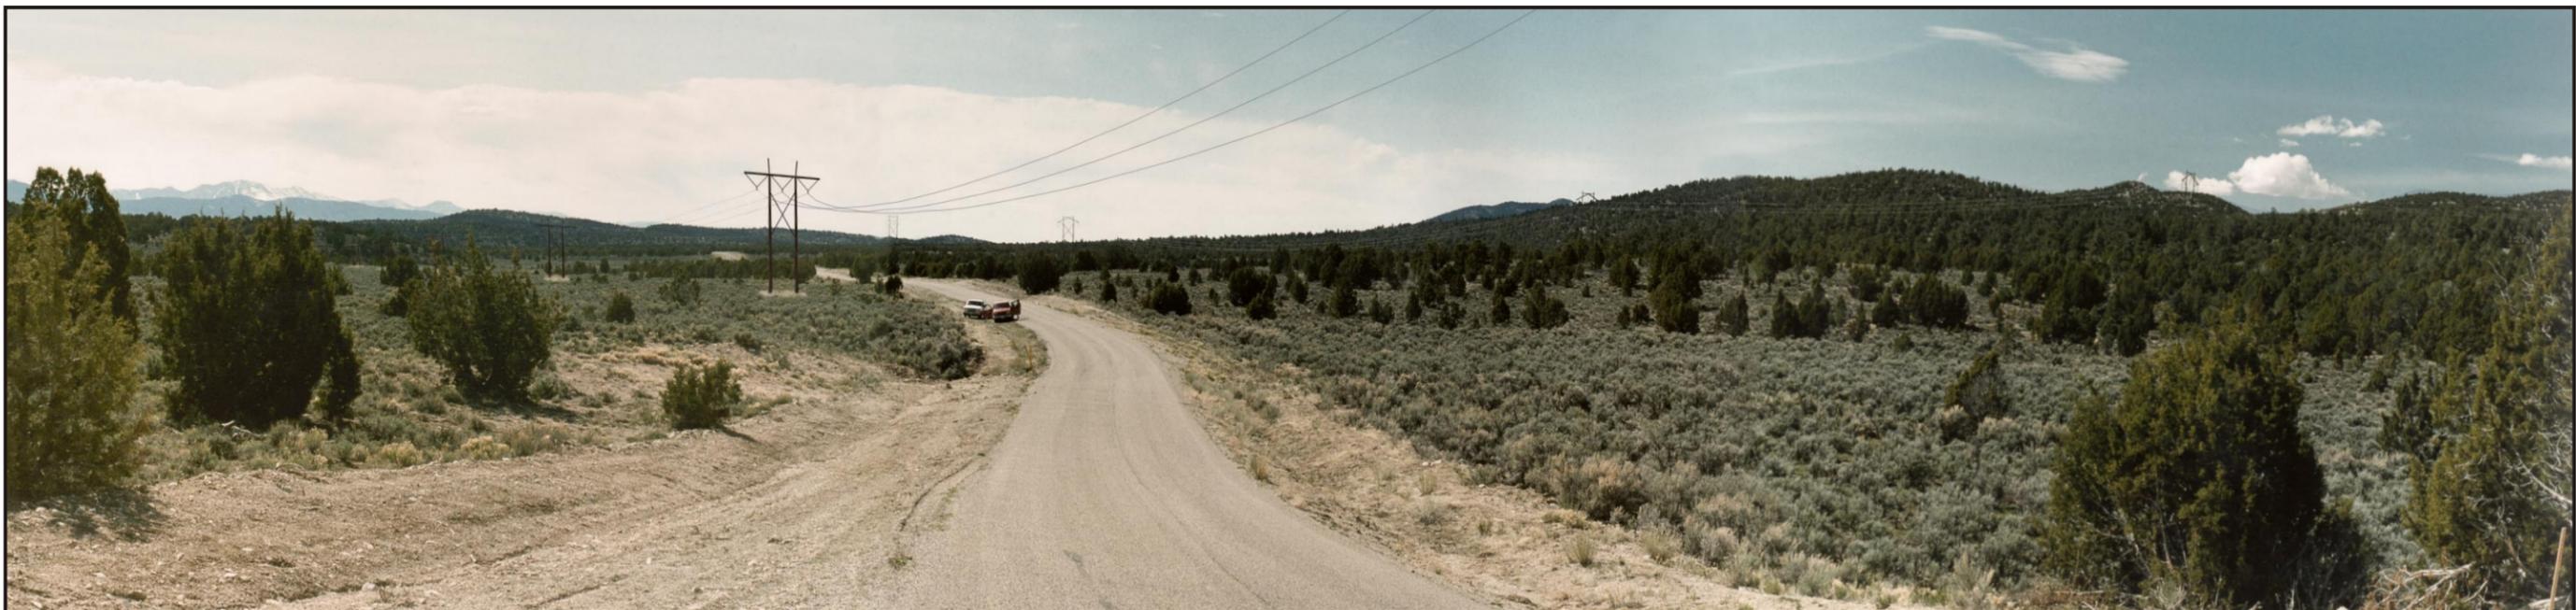
Future Conditions

Summary of Visual Changes

T/L Distance from Viewer: Background to foreground crossing views

T/L Prominence in Landscape: Moderate - generally backdropped except for near distance skylining

Contrast Rating: Moderate

VRM Class: III (Interim)

Visual Impact Rating: Medium
