**KOP 13
 Highway 278**

Figure 3.9-14

Falcon to Gonder Project EIS

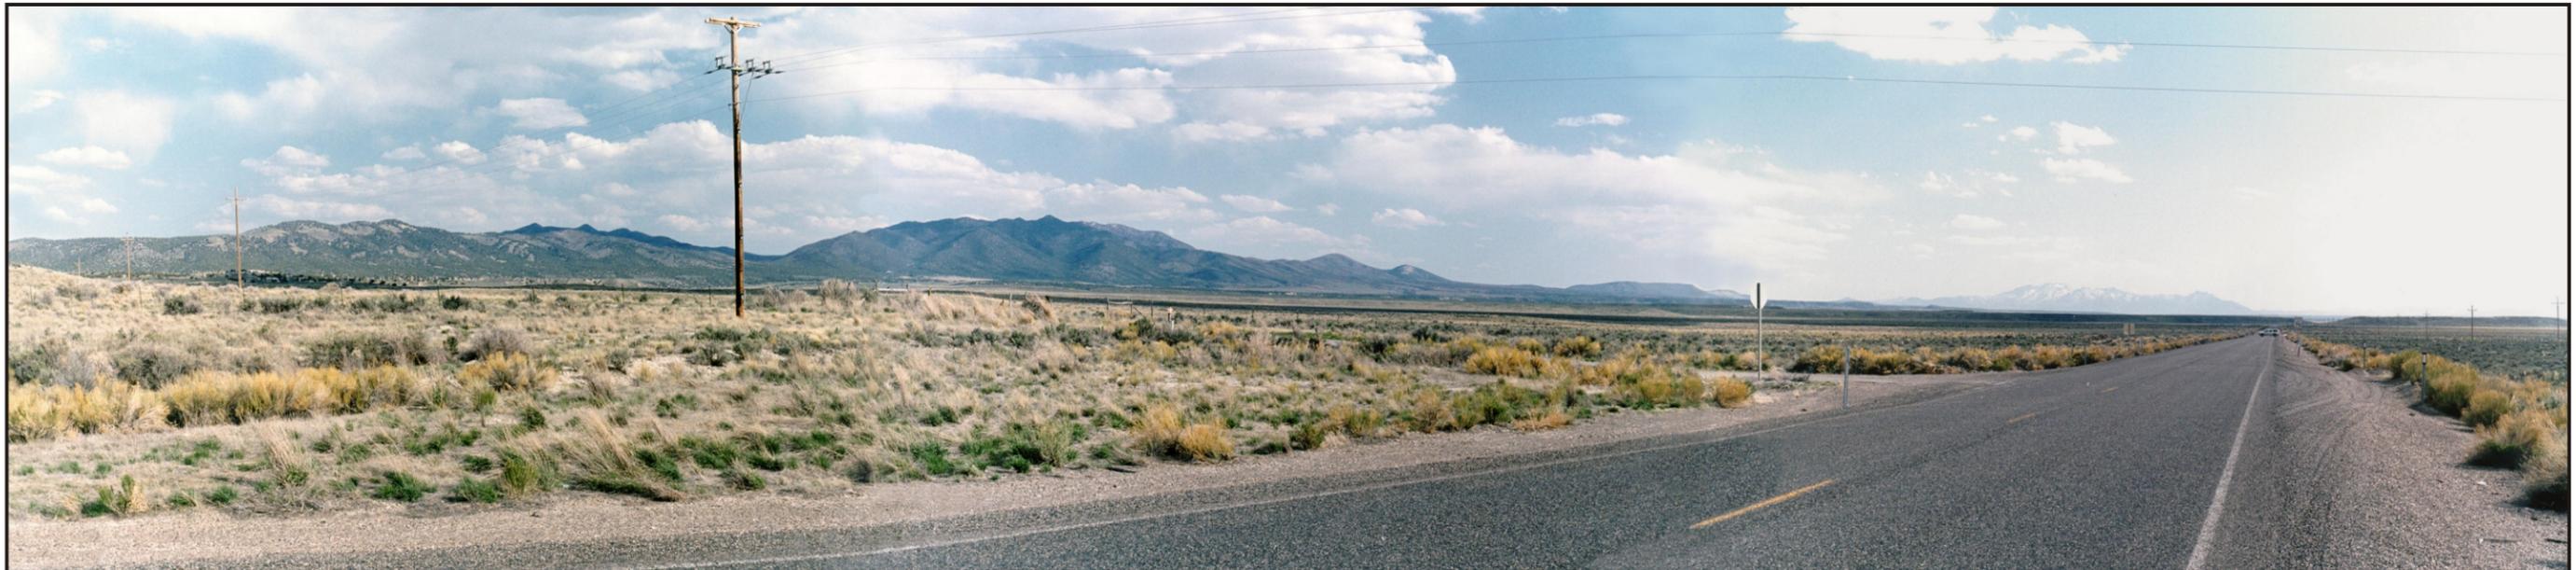
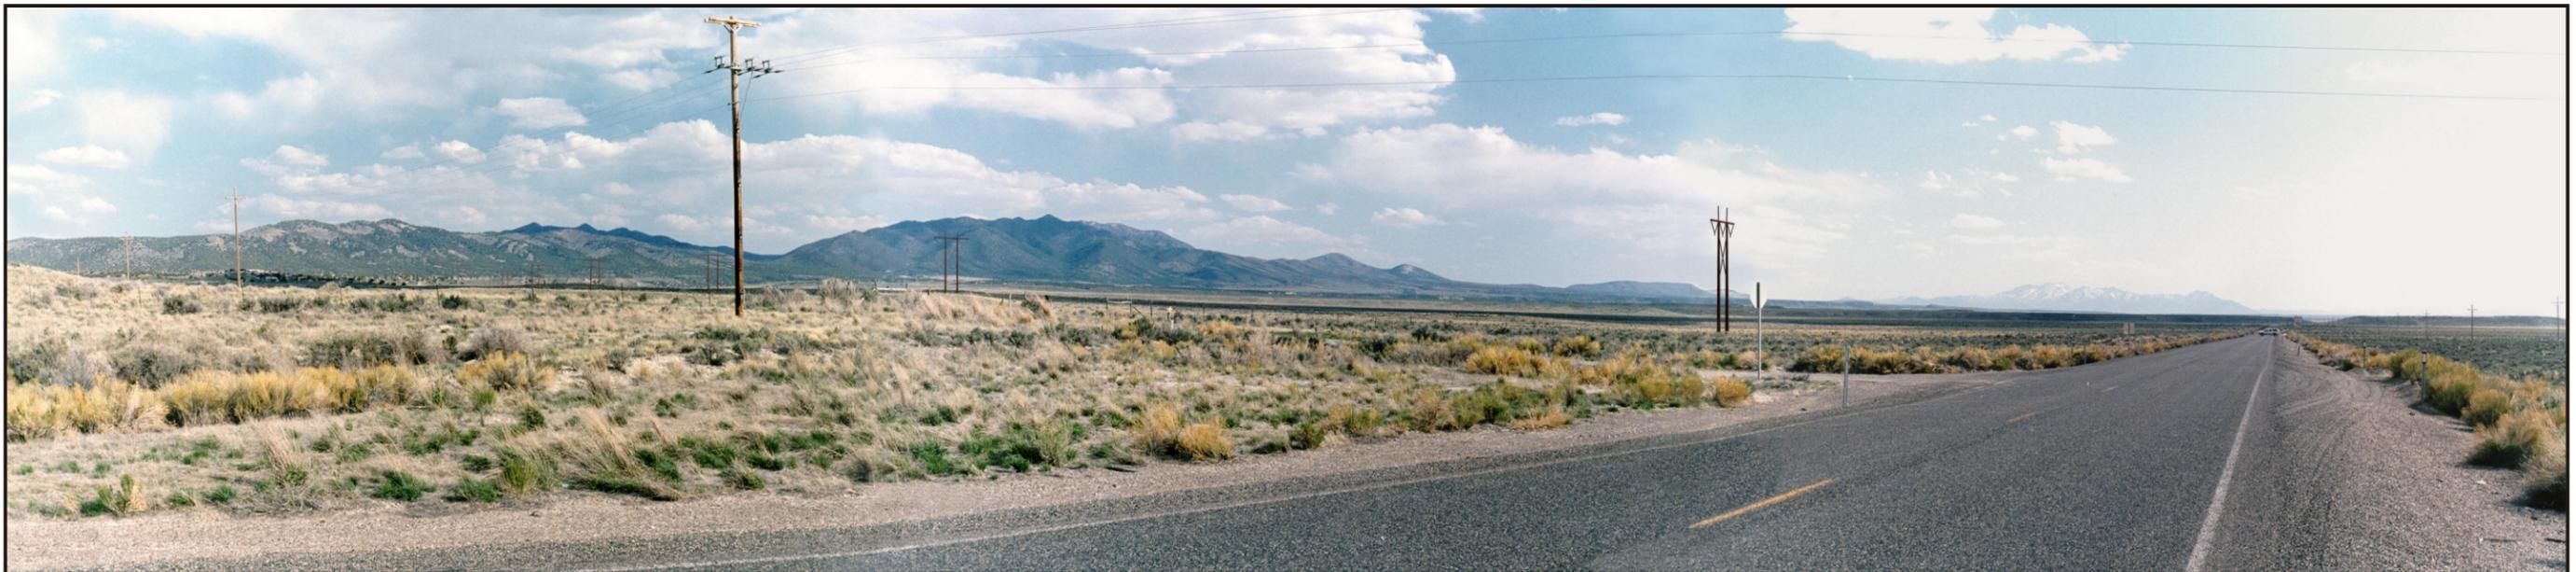
Existing Conditions

Future Conditions

Summary of Visual Changes

Type/Sensitivity of Users: Primarily local highway travelers with moderate sensitivity to visual quality
 Volume of Users: Moderate
 T/L Distance from Viewer: From background views to the foreground crossing
 T/L Prominence in Landscape: Moderate - seen primarily against distant backdrops but against the sky near the crossing
 Existing Modifications: Existing wood pole distribution line and some limited ground disturbance

Contrast Rating: Strong
 VRM Class: IV
 Visual Impact Rating: Medium
