FEDERAL ENERGY REGULATORY COMMISSION FIELD INSPECTION REPORT

Dates of Inspection June 25-27, 2013

Project Ruby Pipeline, L.L.C.
Ruby Pipeline Project
Wyoming, Utah, Nevada, and Oregon
Docket No.: CP09-54-000
Authority: Section 7(c)

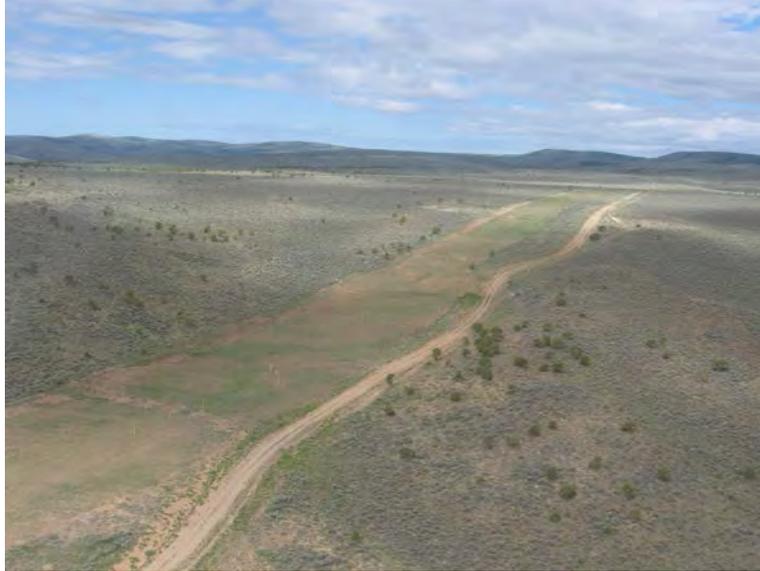
5) MP 30.5

5-8) Western Wyoming exhibits more greening of ROW in higher elevations, though patchiness is common

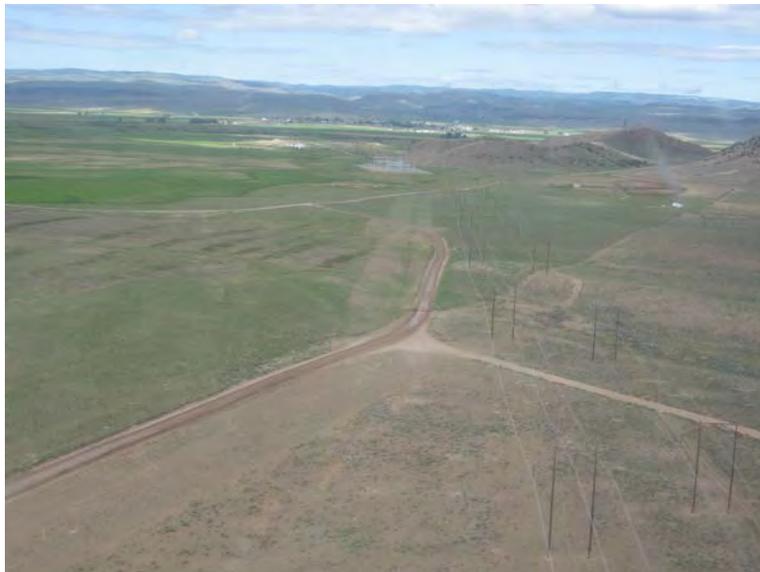
10) MP 50

The right-of-way showed good revegetation in some areas, particularly in the east and in the higher elevations (**photos 10-13**) but bare areas and patches were common in many areas, and predominant in the westernmost portion of the state (**photos 14-25**). Side slopes appeared stable (**photos 26 and 27**). An area reported for subsidence last year (MP 75.1) was still exhibiting a problem (**photo 28**). Some new areas of subsidence and sinkholes were noted as well at MPs 59 and 62 (not pictured) and MPs 149.5 and 157.9 (**photos 29-30**). The State property in the Bear River Valley looked good (**photos 31-32**) as did some of the nearby slopes (**photos 33-35**).

10-13) Some areas in the eastern part of the state show good revegetation.

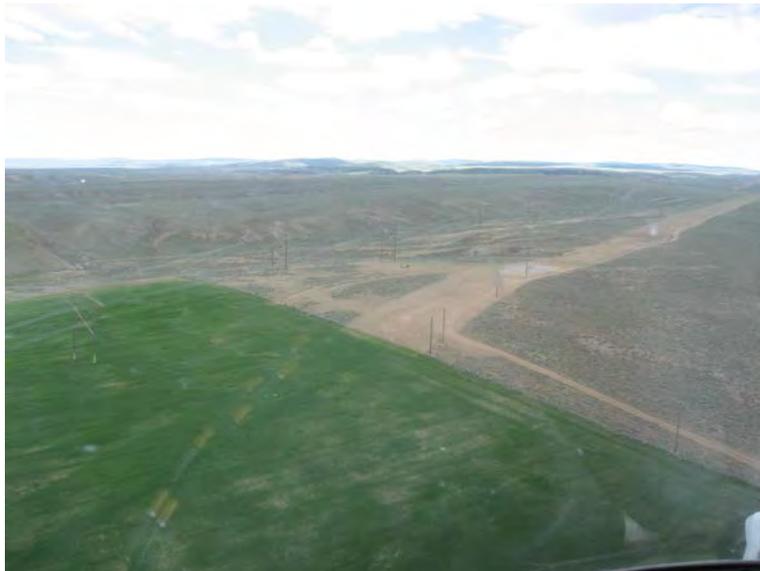
14-25) Some of the Utah route exhibited patchy revegetation or bare areas. The further West, the more chance for bare right-of-way.

14) MP 55.5; transition between irrigated agricultural area and bare right-of-way

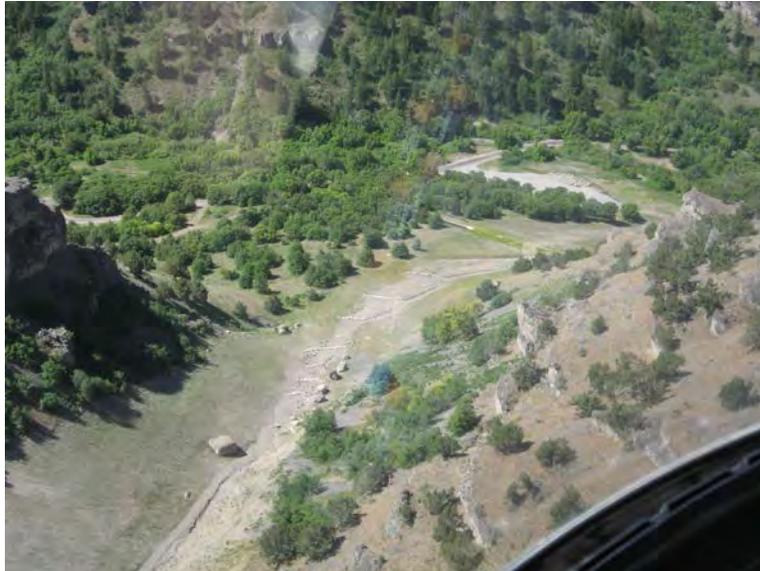
31) MP 92; Lime Kiln Spring

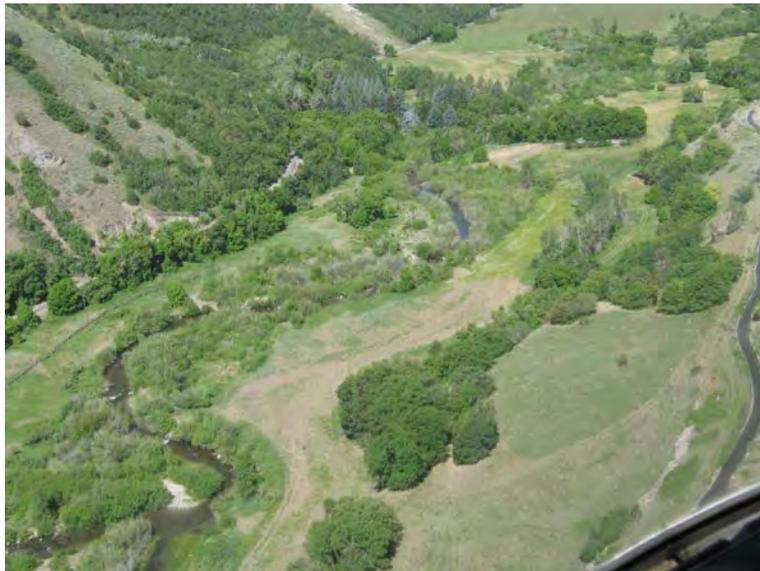
32) MP 92.5

31-32) State of Utah property in the Bear River Valley

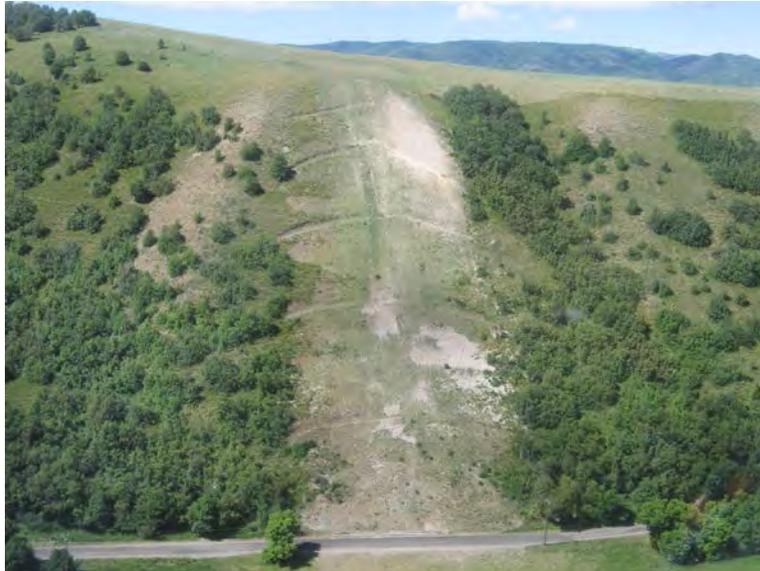
33) MP 93.5; La Plata Hill

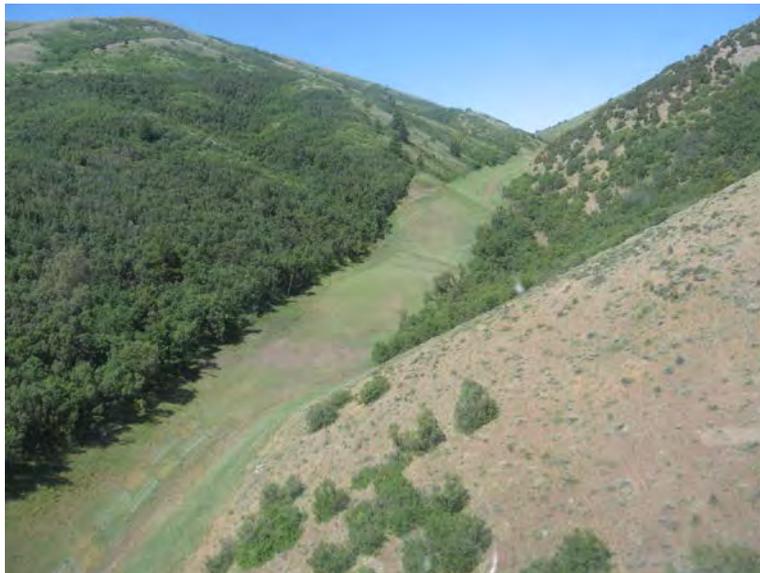
34) MP 99.5

33-35) Various slopes and waterbodies in the general area north of Brigham City

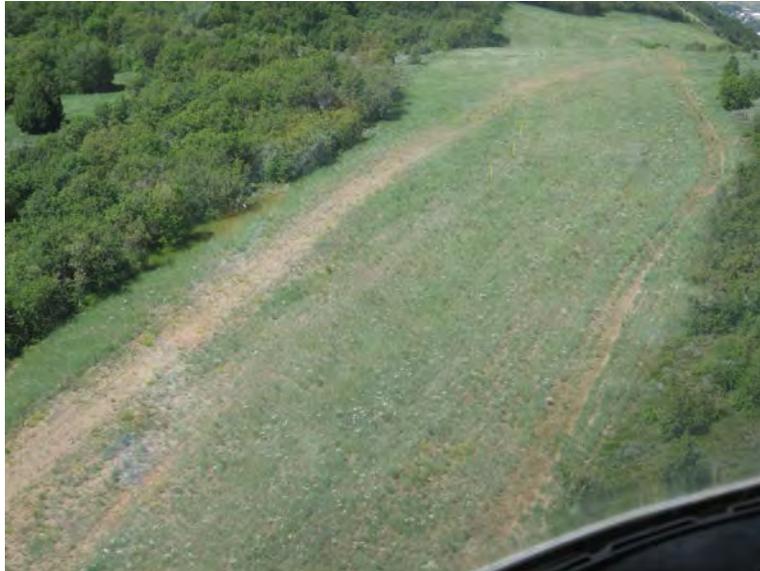
37) MP 104.5

37-38) yarrow (?)

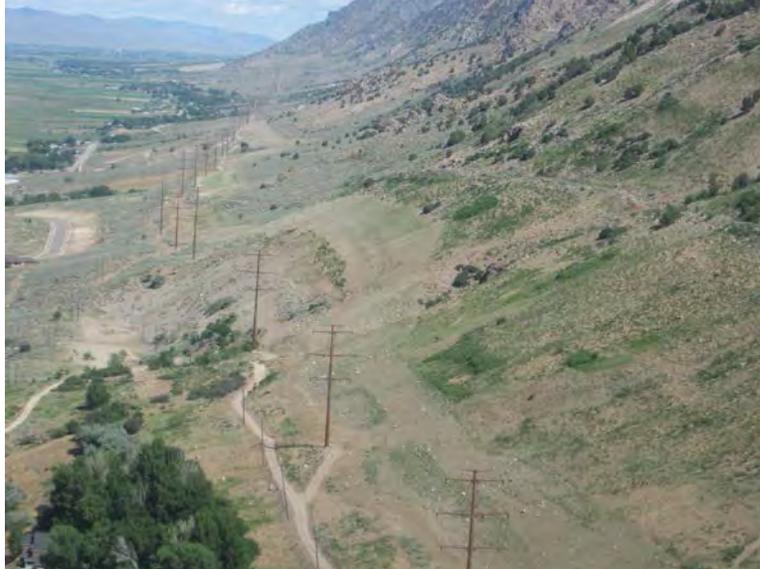
39) MP 106

39-41) Brigham City Bench

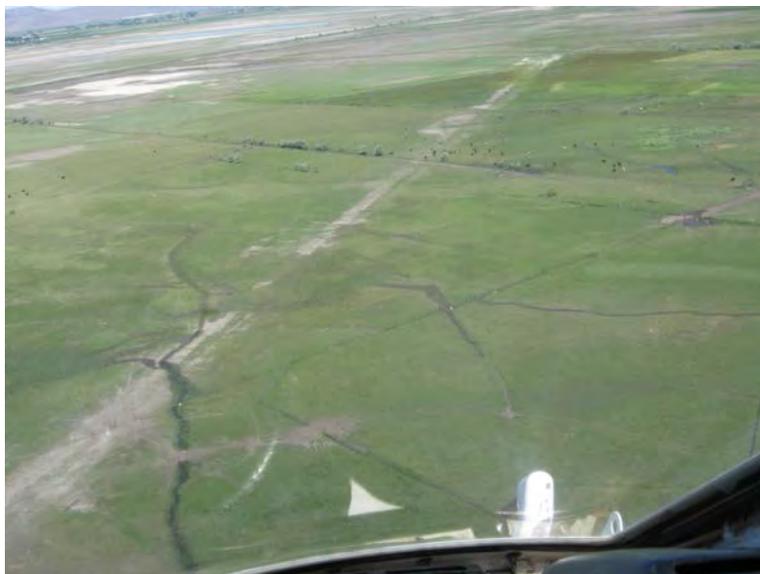
42) MP 109

The nuisance weed Dyer's woad was present at various locations on the right-of-way (**photo 36**), but not nearly as much as seen in the 2012 inspection. This species is also present in off right-of-way areas. Ruby reports that it is continuing eradication/control strategies, which appear to be mostly effective. Another species, tentatively identified as yarrow, was also noted (**photos 37 and 38**). This plant was not obviously present off right-of-way, but it is known as an early colonizer of disturbed areas. Ruby will monitor and consider eradication strategies if succession does not result in natural transition to other species. The Brigham City Bench (MPs 106-109; **photos 39-41**) and the nearby large wetland flat area (MPs 110-115; **photos 42-45**) looked good stability-wise, although portions still showed bare spots.

42-45) large wetland flat area west of the Bench

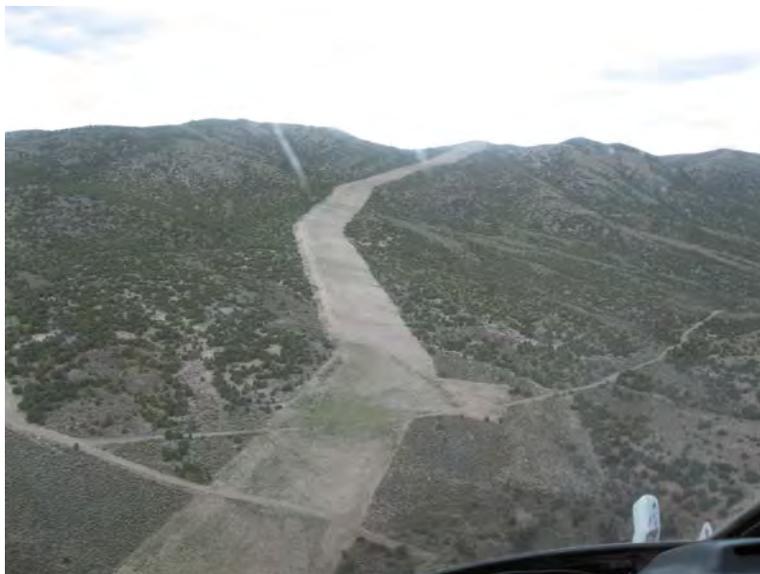
46) MP 234

Photos 46-61 depict typical restoration and include examples of upland, wetland, and channel/waterbody crossings. The major Problem Area for Nevada was the lack of revegetation in many areas, especially Washoe County in the western portion of the state (**photos 62-65**). Cheatgrass was seen sporadically, especially between MPs 394-409 and certain specific locations west (**photos 66-67**). Several areas of sinkholes and subsidence were observed, especially in about a 4-mile stretch east of the Weiland Flat Compressor Station (between about MPs 329-333 [no photos]). There was little evidence that sagebrush plantings had resulted in reestablishing sagebrush on the right-of-way.

46-61) Typical examples of the right-of-way across Nevada

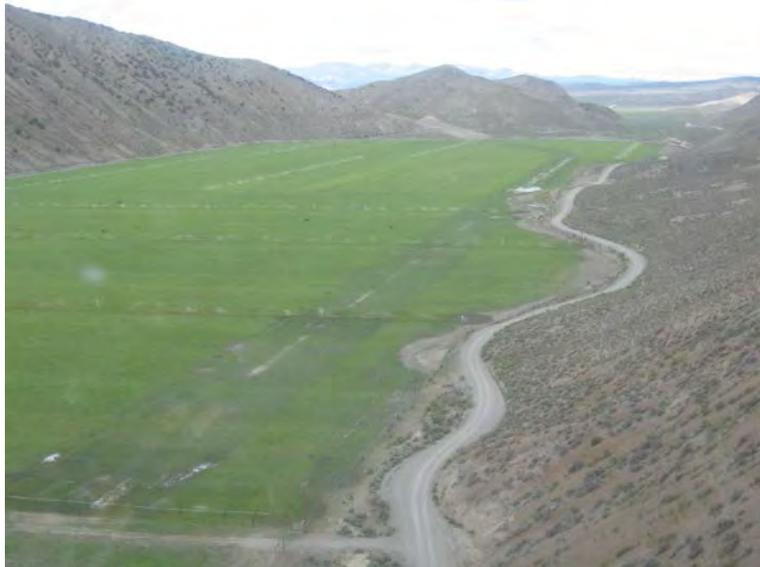
47) MP 243; one of the few Nevada tracts in active agriculture

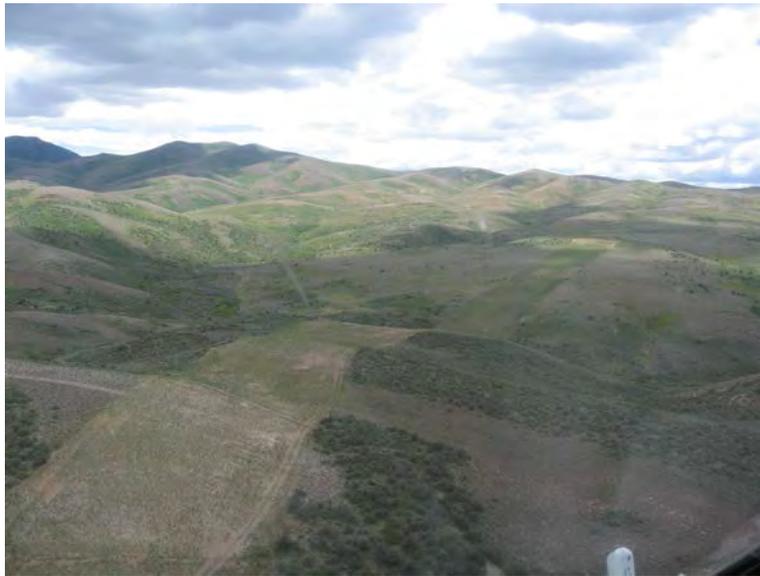
49) MP 283.5; more revegetation here

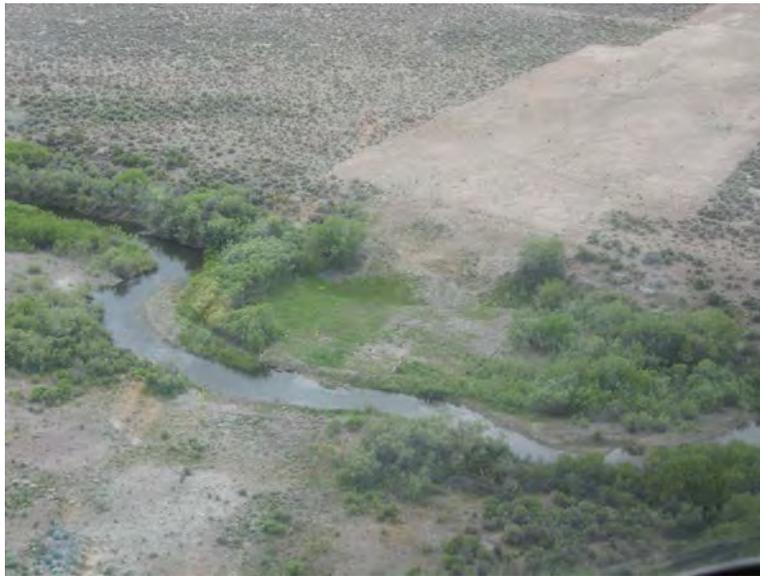
51) MP 303; Marys River

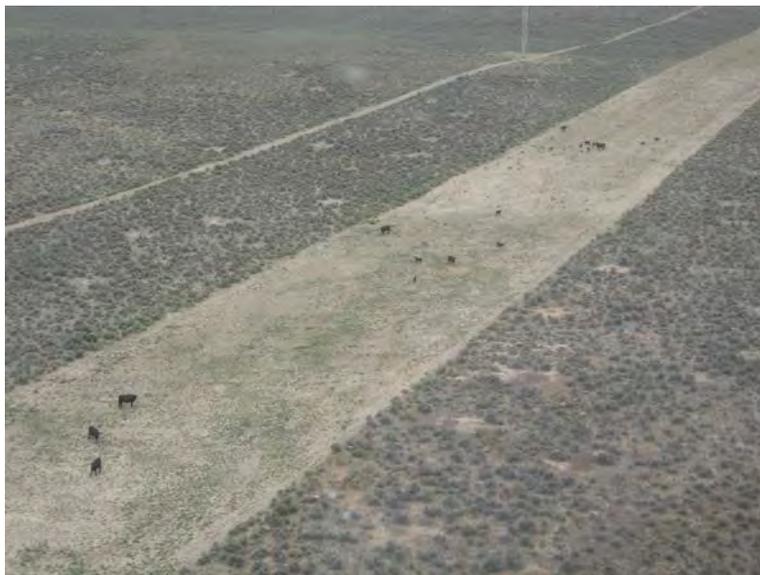
52) MP 313; grazing

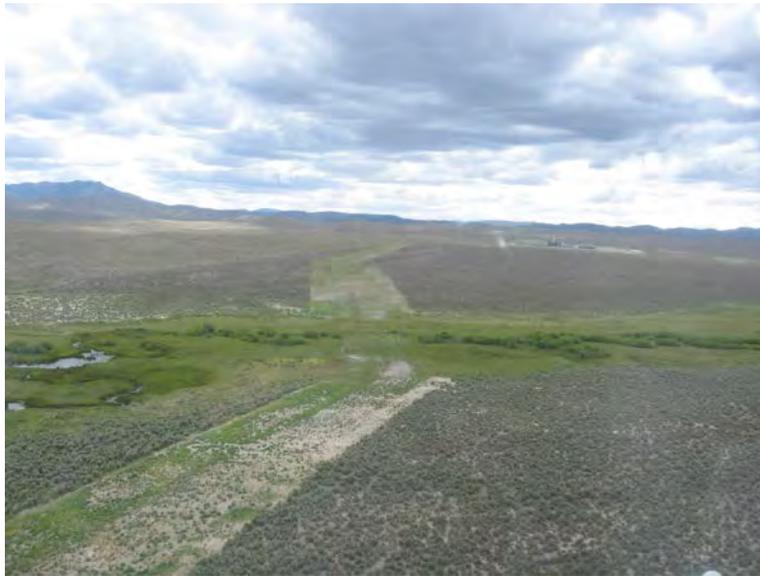
53) MP 332; wetland

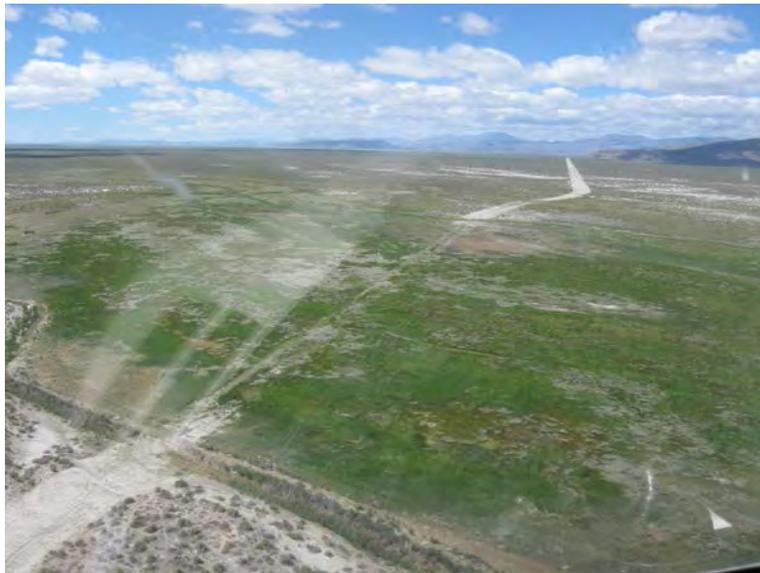
60) MP 494.5; transition from bare to green

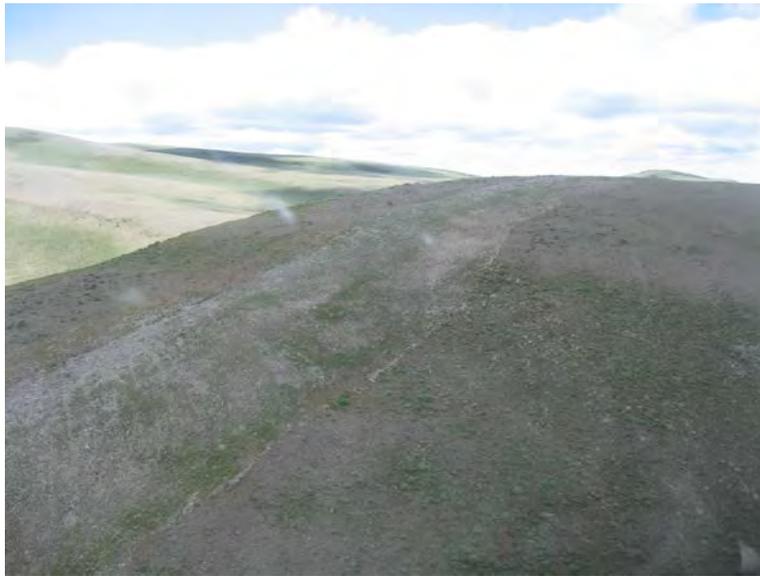
61) MP 519.7; revegetation on ridgetop

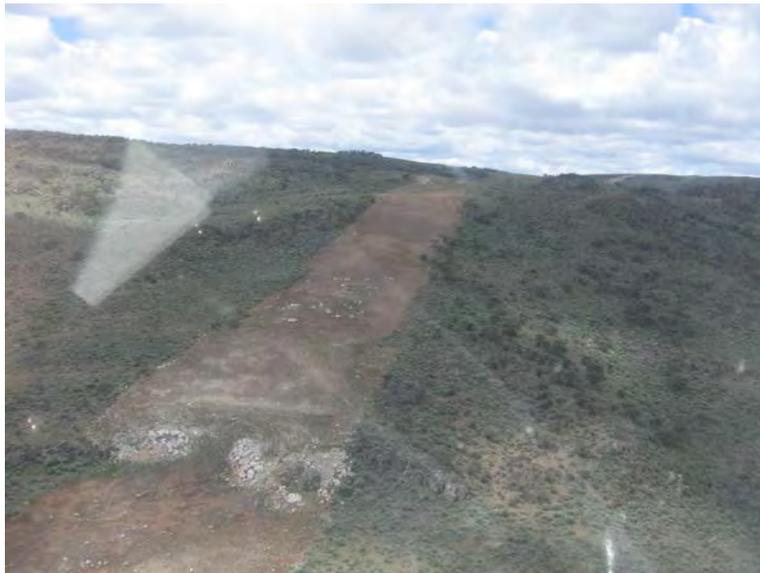
62) MP 534

62-65) lack of sufficient revegetation in Washoe County, NV

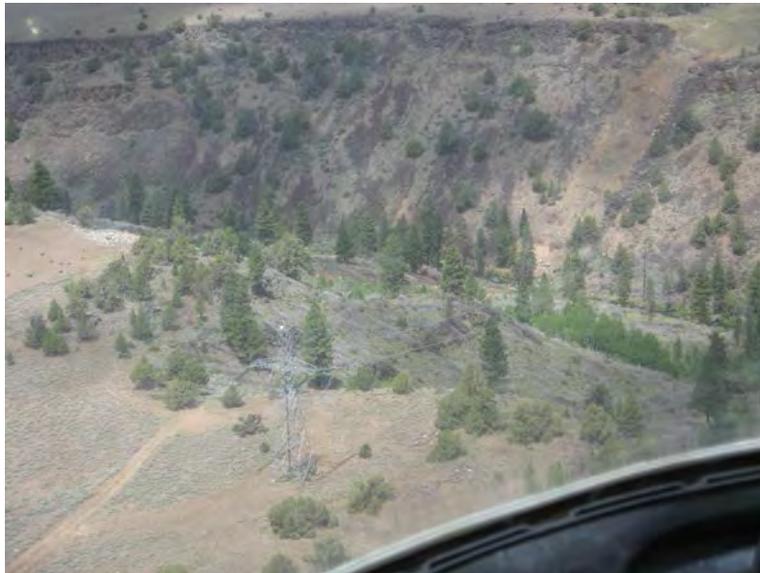
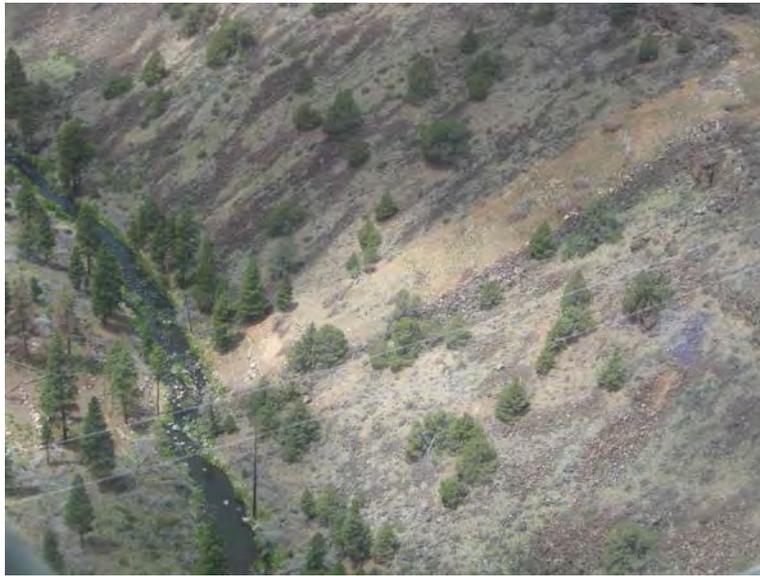
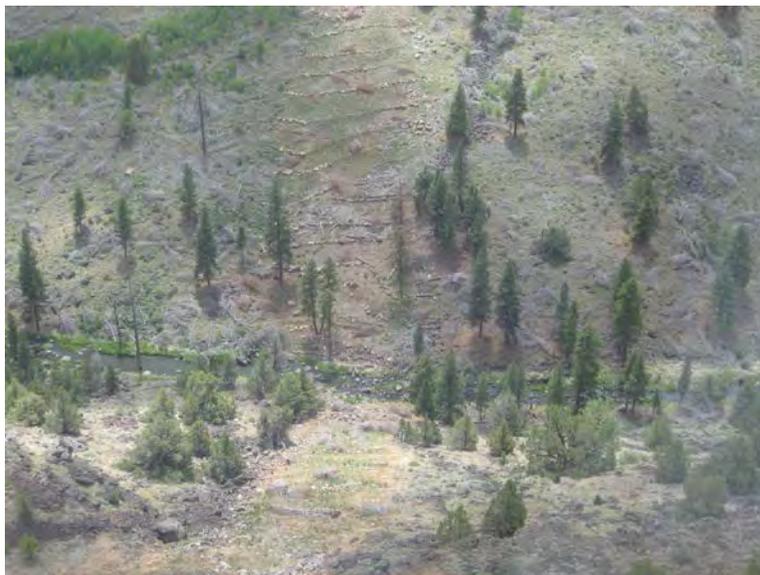
68-70) MP 595; Twelve-Mile Creek; slopes remain stabilized

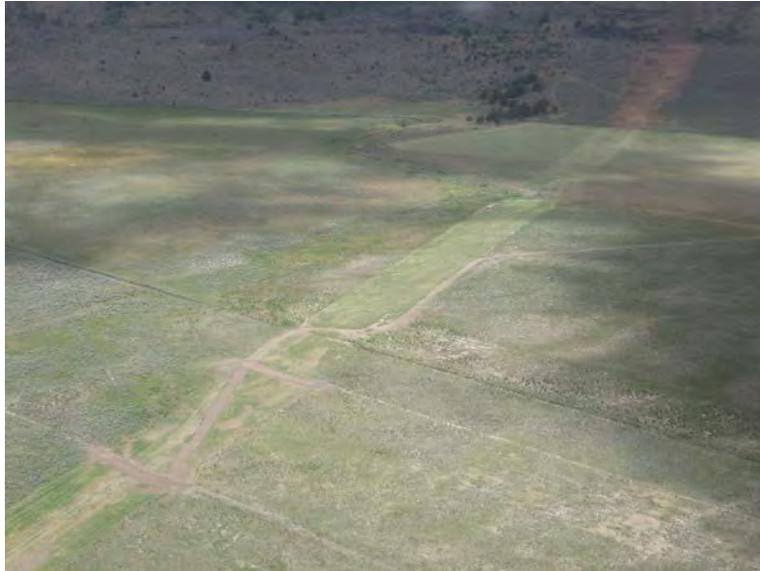
71) vegetation prevalent across the flat part of the tract

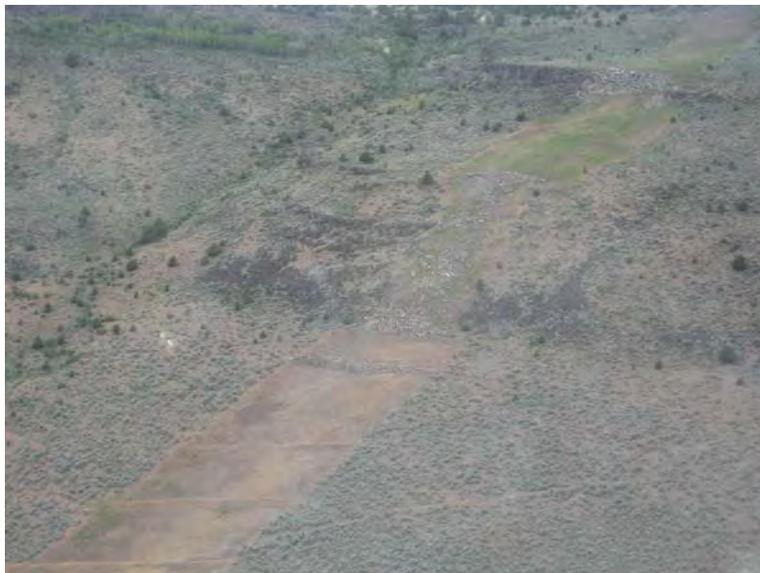
72) lower slope stabilized; better revegetation on upper portion

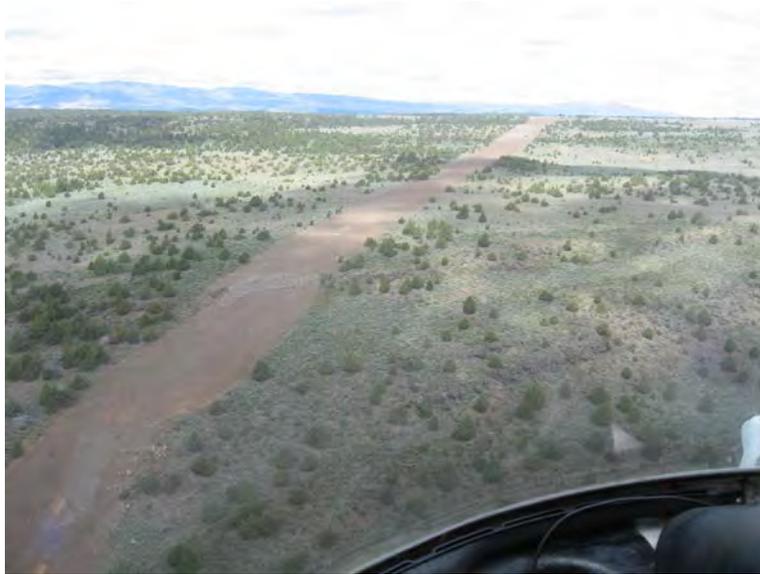
73) flat portion above slope

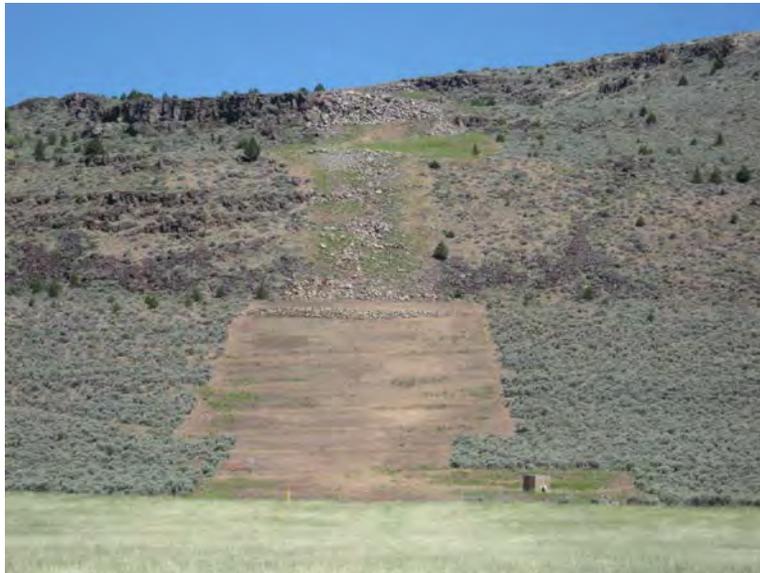
74) lower slope stabilized; better revegetation on upper portion

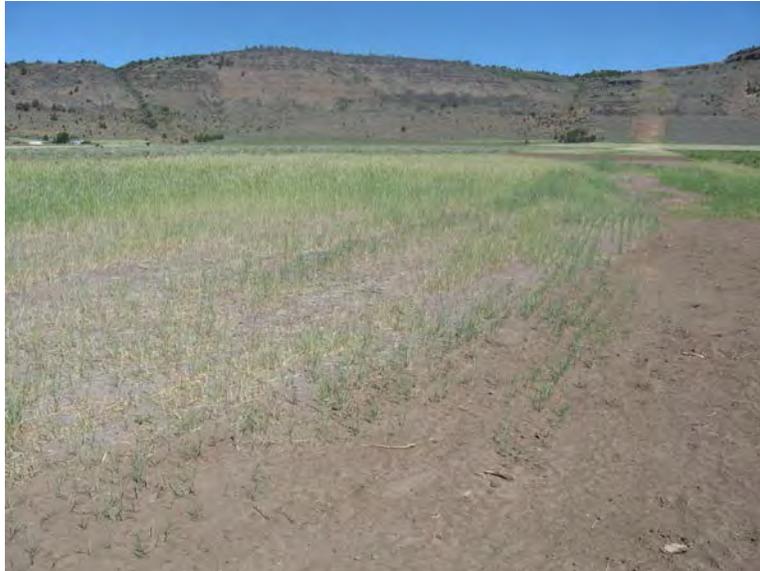
75) seeded area revegetating

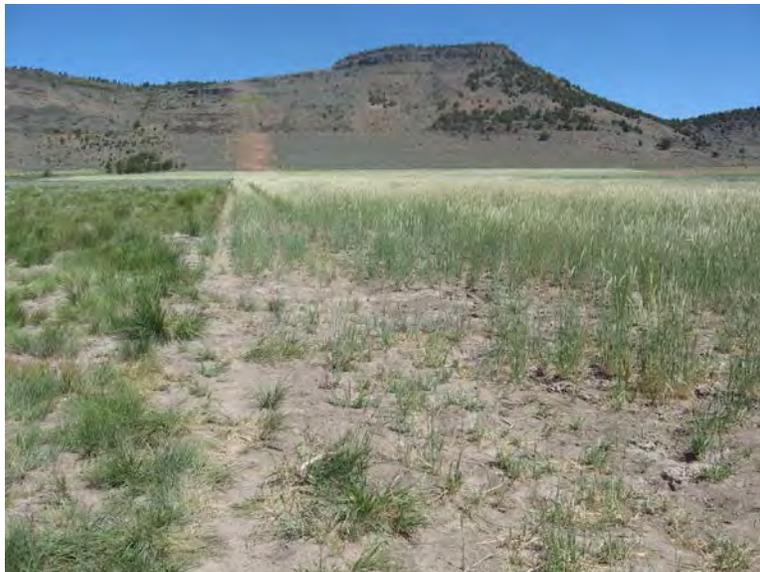
76) seeded area revegetating

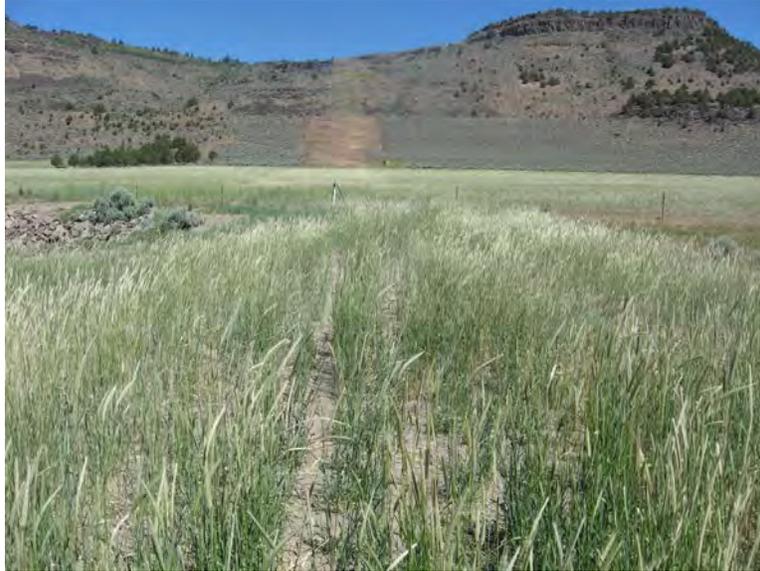
77) seeded area revegetating

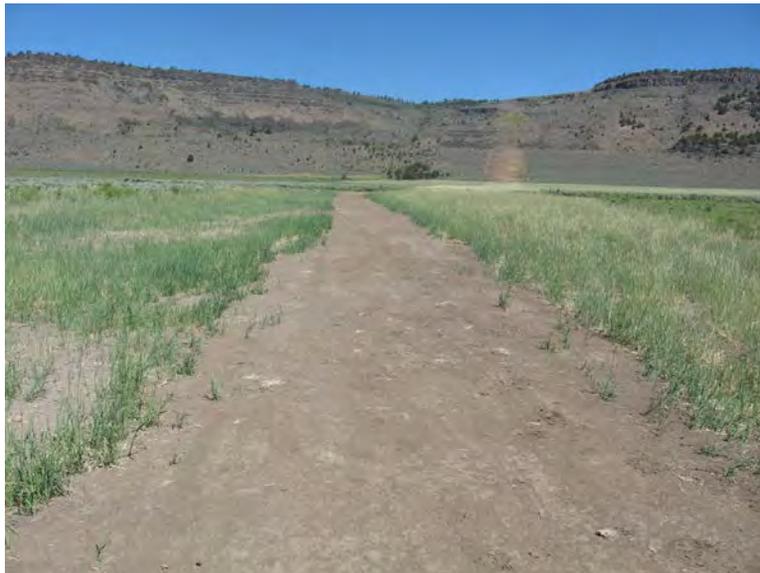
80) recent fill in of ditch

Ruby states that it has brought in numerous trucks of topsoil in an effort to replace lost soil and fill in low spots. Ruby reports it will reseed these locations. This appears satisfactory. However, I have instructed Ruby to compare topsoil and compaction readings on and off right-of-way to ensure soil conditions are comparable to the surrounding area.

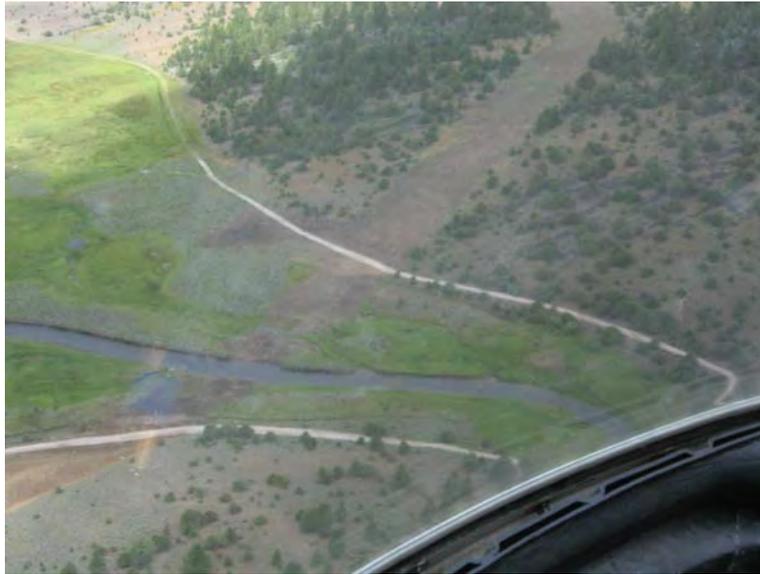
89) MP 607.7; Deep Creek

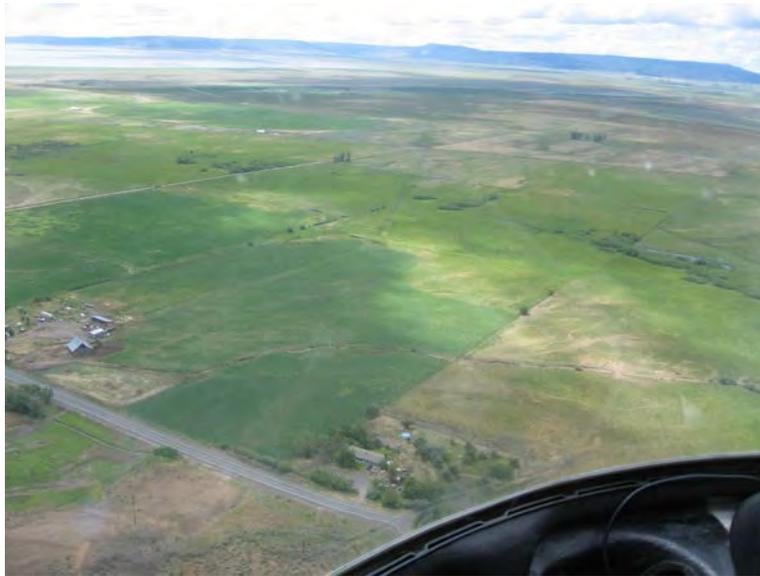
93) MP 620; agricultural area approaching Goose Lake

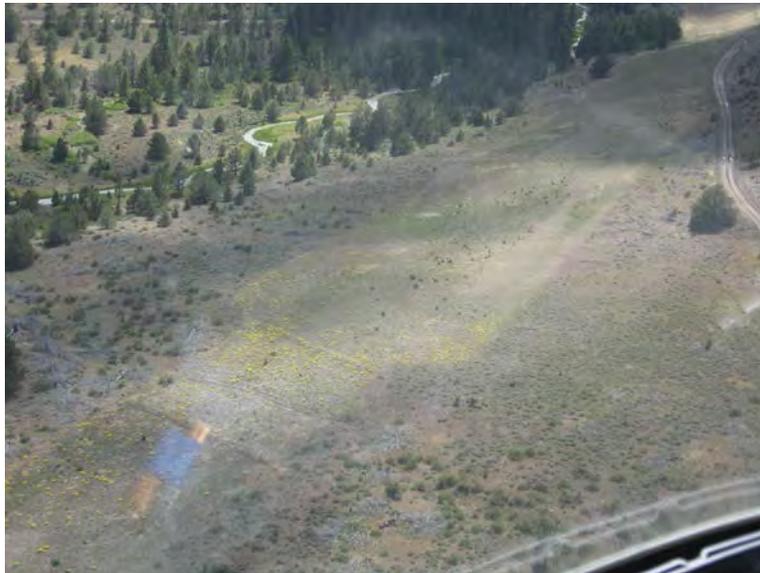
98) MP 637.2; Oregon sunshine (desirable native)

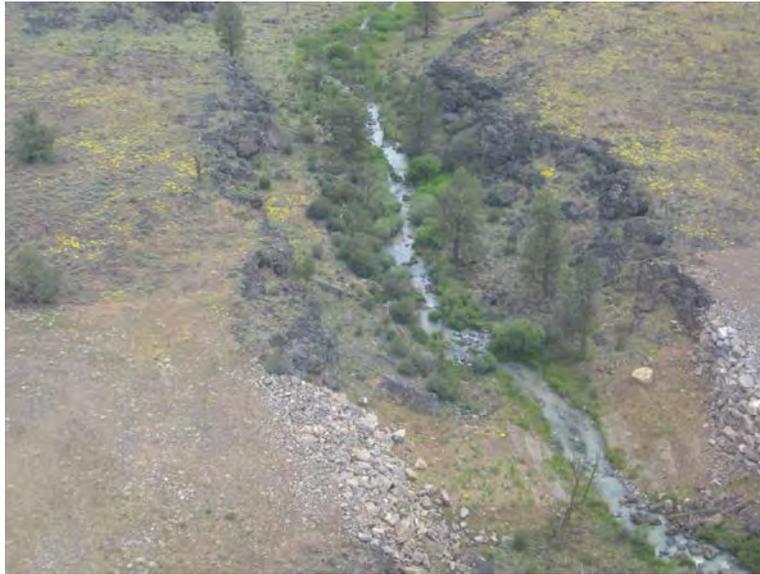
101) MP 667; rock walls at creek crossing

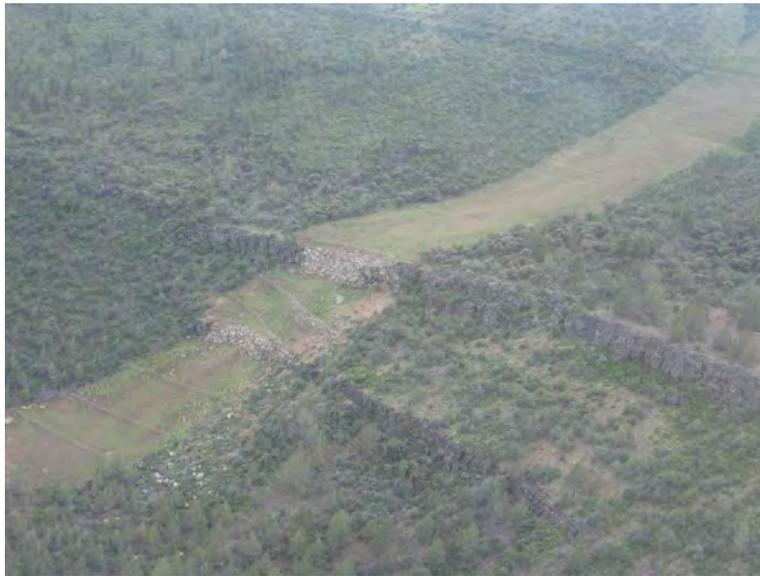
103) MP 673.5; rock walls on slope

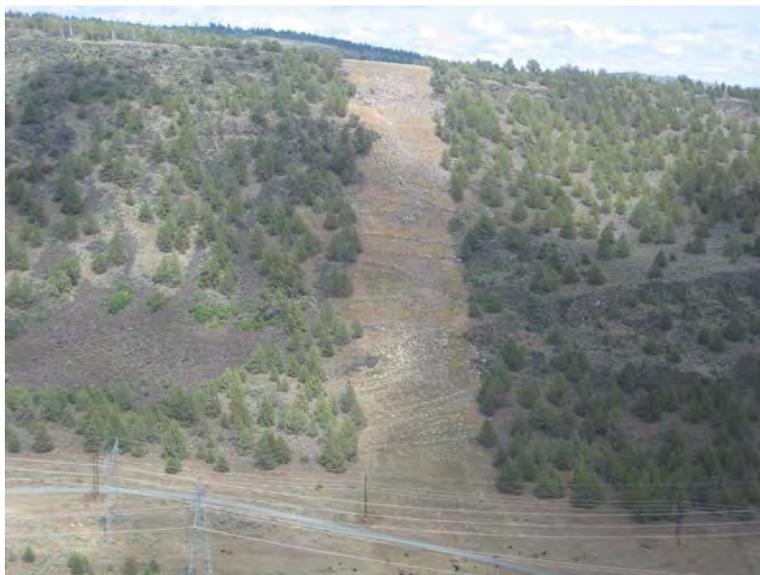
104) MP 678.2; steep slope
