**BLM Unit Identification:** Adobe Town WY-030-401 and WY-040-408

**Description** Adobe Town is proposed by the conservation community for wilderness designation. The area proposed for wilderness includes all of the Adobe Town Wilderness Study Area, plus additional lands of wilderness quality in The Haystacks, along Willow Creek and the Willow Creek Rim, and south of the WSA to the Powder Rim and just beyond it. All of these areas possess the full complement of required characteristics for wilderness in abundance: outstanding opportunities for both solitude *and* primitive and unconfined recreation, wilderness-quality naturalness, size (at over 180,000 acres, the citizens proposed Adobe Town wilderness is well above the 5,000-acre minimum), and in addition has outstanding supplemental values such as abundant wildlife, wild horse herds, unique geology, and abundant archaeological and paleontological resources.

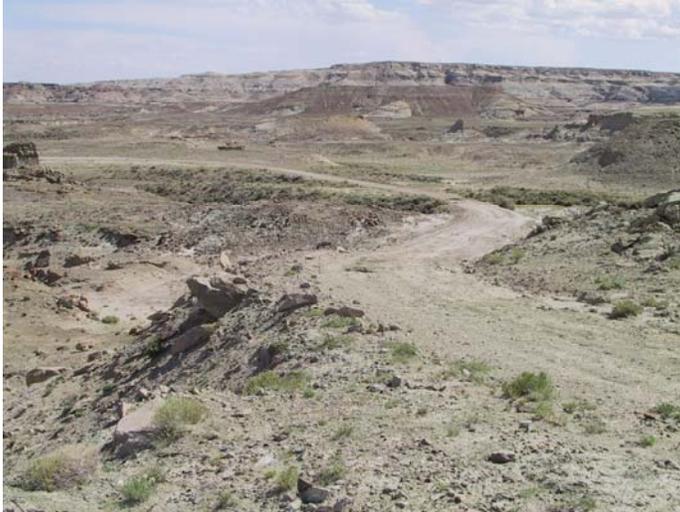
Figure 1

Route AT-1, also known as BLM 4412 and Route “B” in BLM’s Wilderness Intensive Inventory. This route was upgraded in 1978 for access to the Koch Adobe Town #1 well. It shows signs of intensive construction, but is classed a “temporary intrusion.”

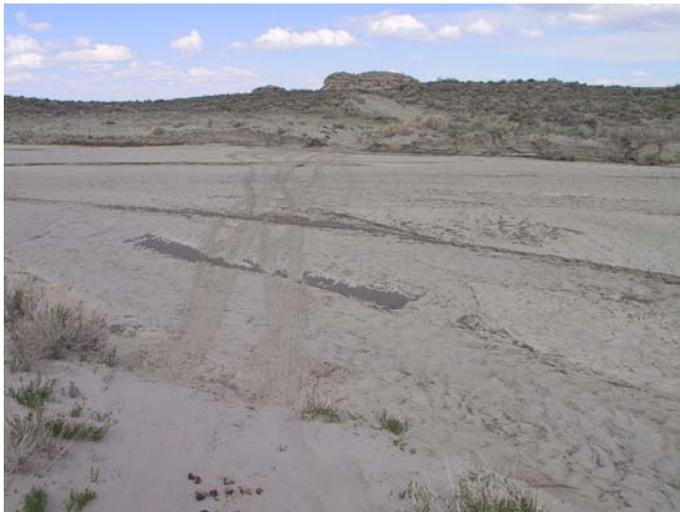
Figure 2

View of AT-1 crossing Sand Creek wash. Two-foot banks on either side make this crossing possible only with high-clearance 4 wheel drive. This constitutes a lack of regular maintenance and illustrates the route’s degradation.

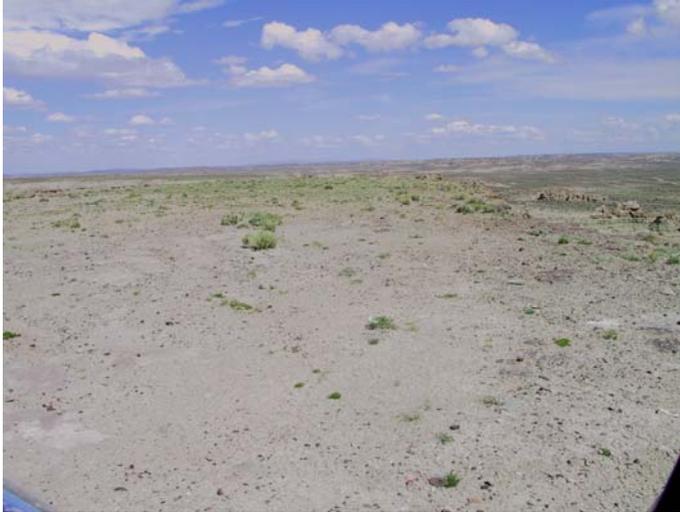
Figure 4

Route AT-2. Although shown on the USGS Monument Valley quad, there is no evidence of this route on the ground.

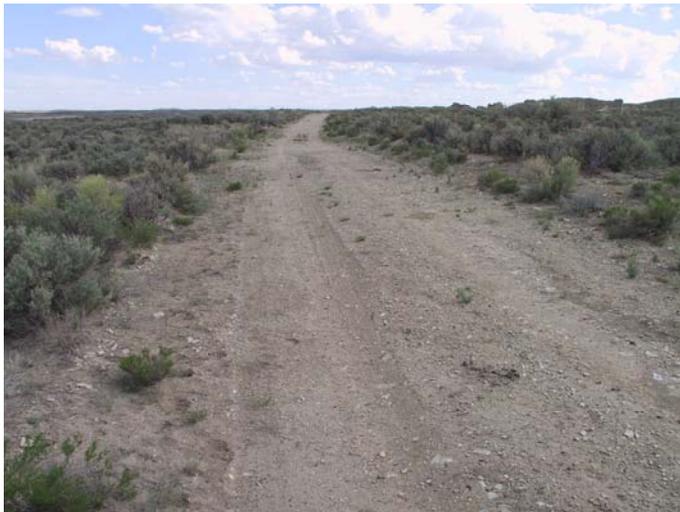
Figure 5

View of AT-3 (BLM Route "F") in typical condition. This route was constructed but is not maintained. Although probably qualifying as a "road," BLM classed it a "temporary intrusion" due to its post-FLPMA construction. Note the shrubs growing on road margins. Photo #EMM37-89

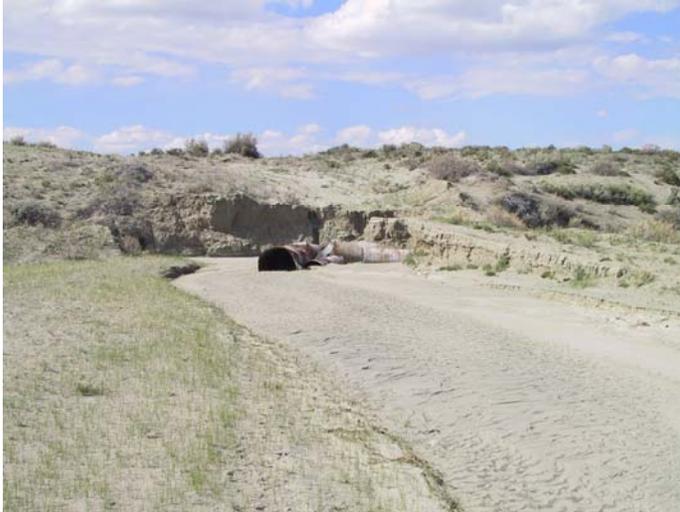
Figure 7

Impasse on Route AT-3 near well site. This washout renders the route impassable to vehicles of any kind at this point.

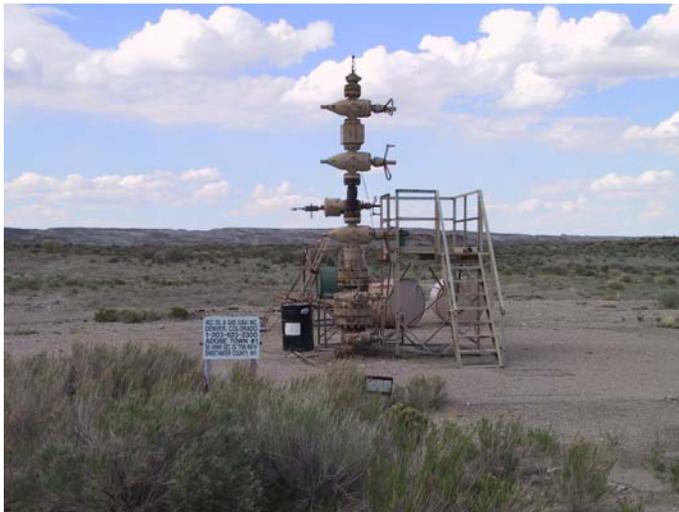
Figure 8

Well tree at AEC (Formerly Koch Exploration) Adobe Town #1. This well has been temporarily abandoned, although the deteriorating equipment remains on the site. There is no evidence of recent extraction activity at this site.

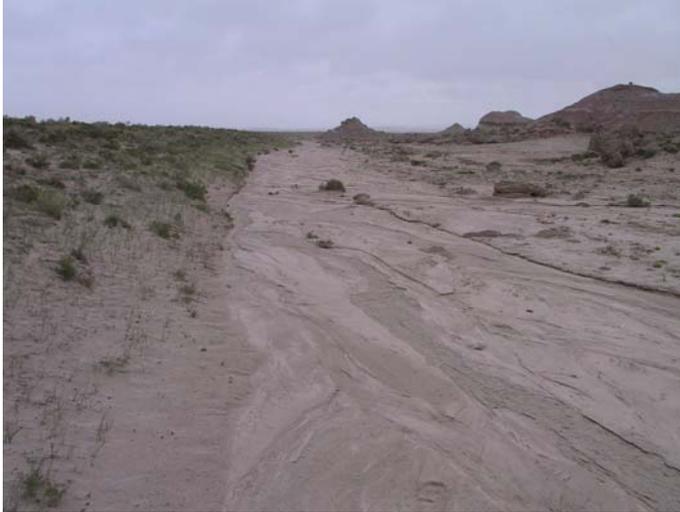
Figure10

One of several wash crossings along AT-4 where the route is completely invisible and drivers must navigate by dead reckoning.

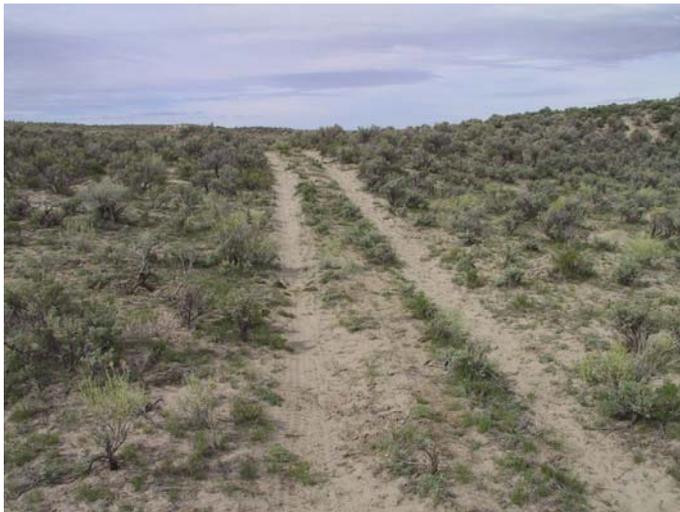
Figure11

Route AT-5 (part of the old “Monument Valley route”) in its most well-worn condition. Although some blading has reportedly occurred on this route, no evidence remains of it.

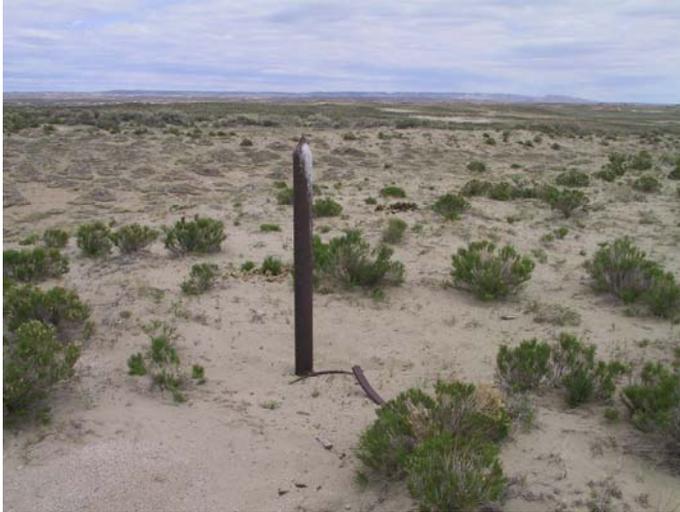
Figure13

The plugged and abandoned Husky well along AT-5. Although this site was viewed as a reclamation failure 20 years ago, greasewood and saltbush have invaded and now the site is returning to a natural state.

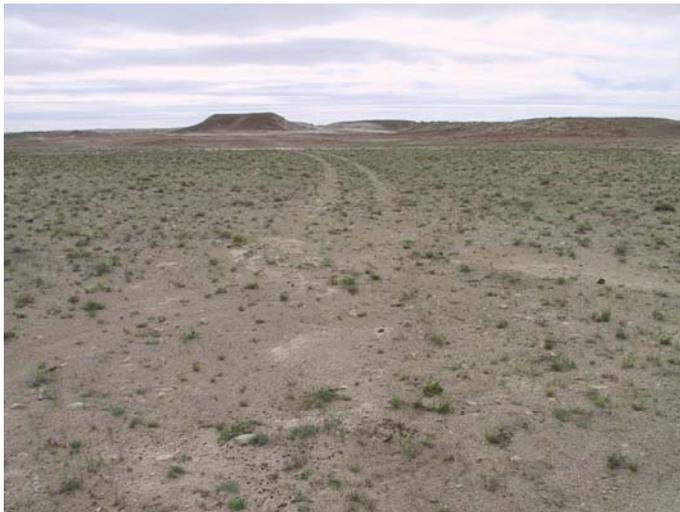
Figure14

Route AT-6 (BLM Route "H") came into being as a cutoff to the Monument Valley route when that route became impassable. Itself abandoned, this route was never constructed or maintained. This view is typical of the route.

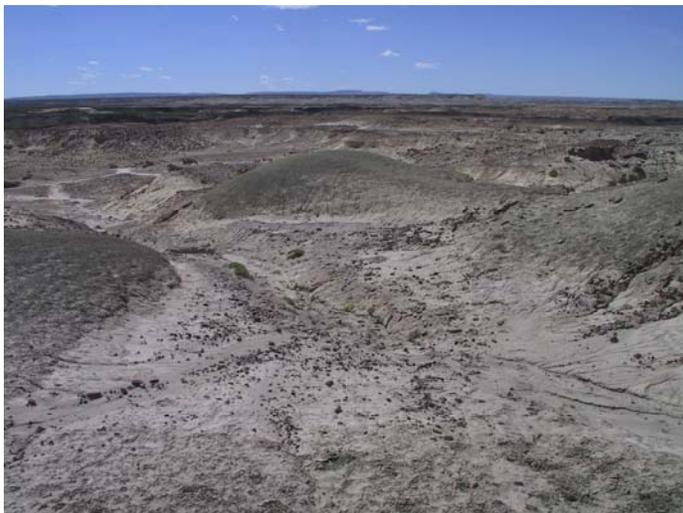
Figure 15

Impasse along the central part of AT-6. This route through clay badlands has completely disappeared in places.

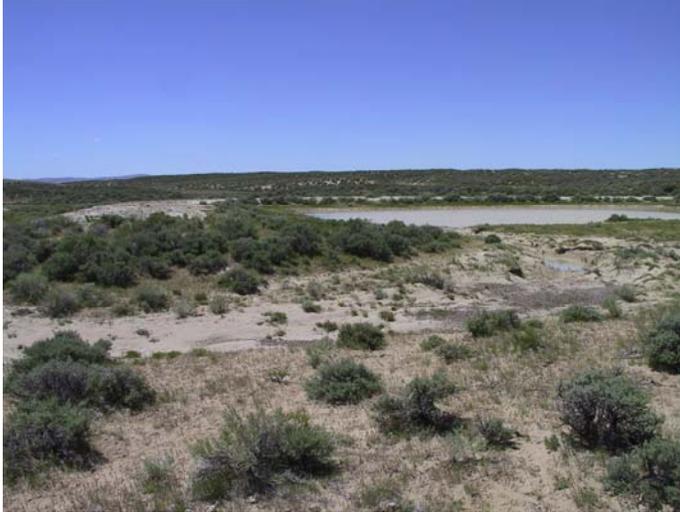
Figure 19

Windy Reservoir, along AT-8. Note the shrub vegetation that is taking over its dam and provides it some camouflage.

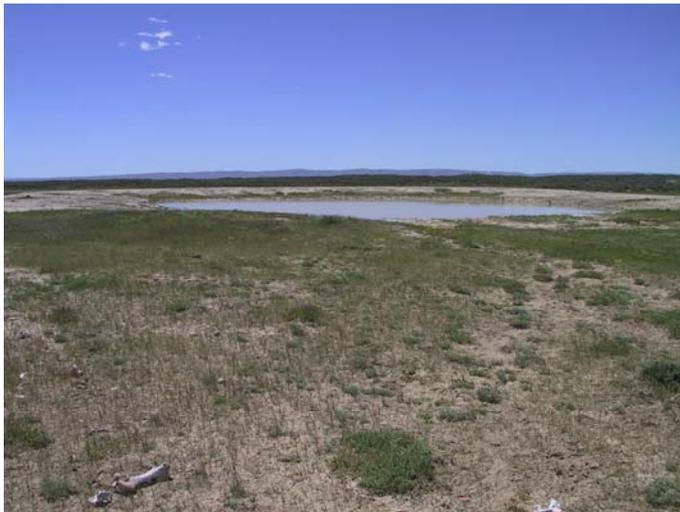
Figure 20

Upper Draw Reservoir along AT-8. This reservoir has yet to return to a natural state.

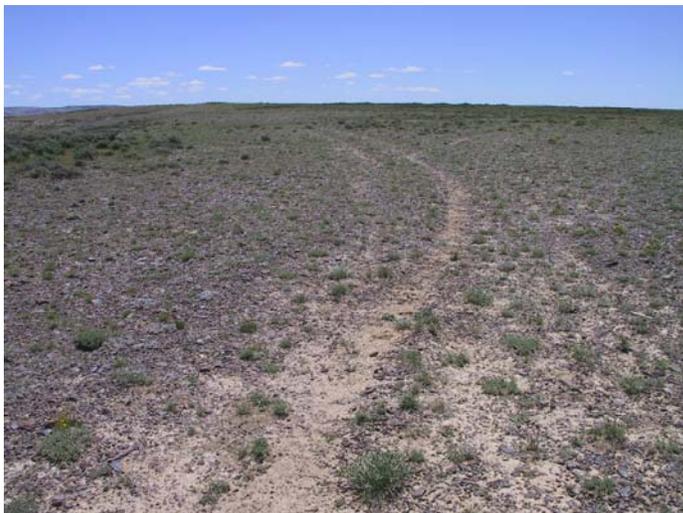
Figure 21

Route AT-8A atop its rise. This dead-end way exhibits no construction or maintenance, and is not used regularly

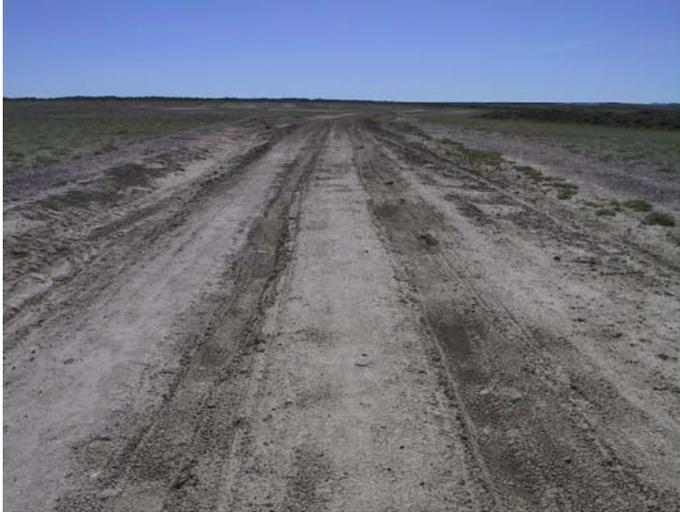
Figure 22

Route AT-9, which is constructed and receives some maintenance. This route was excluded from the proposed Adobe Town WSA expansion.

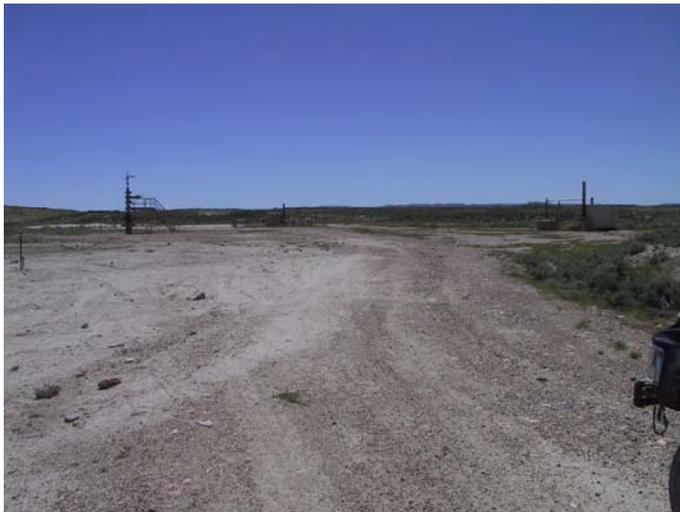
Figure 23

Inactive well pad at the end of AT-9.

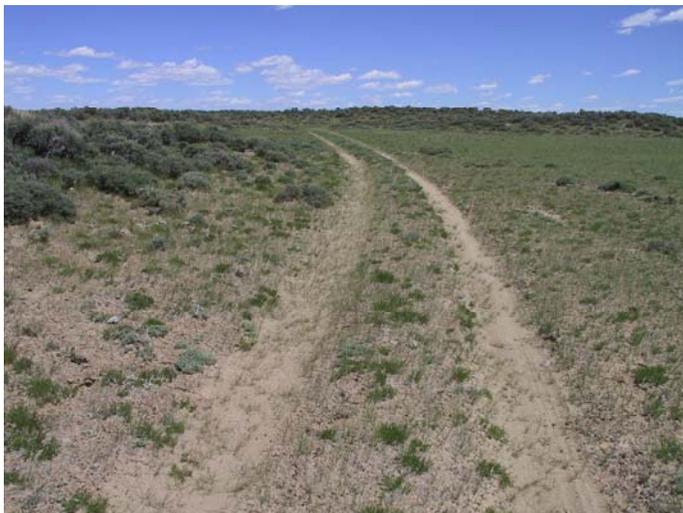
Figure 24

Typical view of Route AT-10. This "way" falls entirely within Adobe Town WSA.

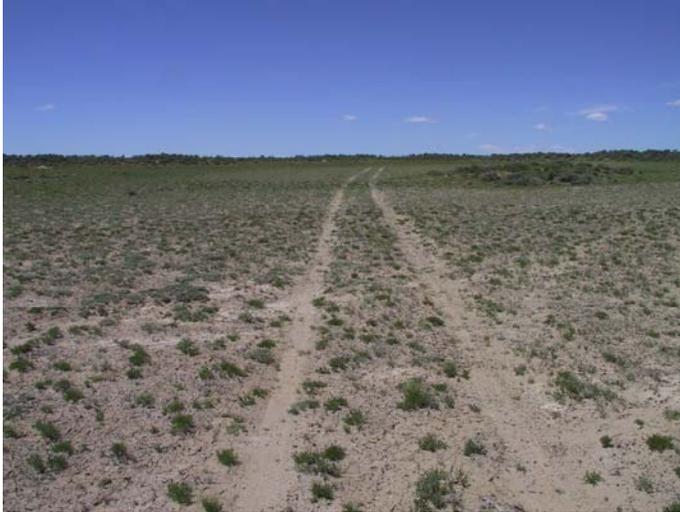
Figure 25

Route AT-11 in its best condition. This short, dead-end spur accesses a small reservoir, and falls entirely within Adobe Town WSA.

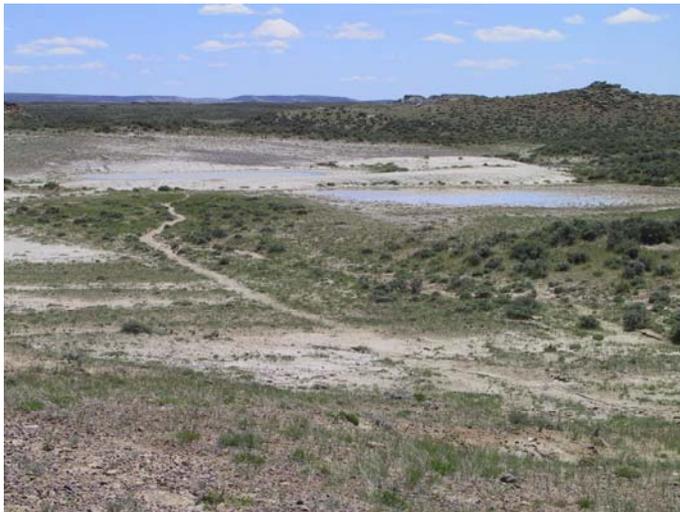
Figure 26

Reservoir at the end of AT-11. It appears that a dam was built in the center of a natural depression that collected water without additional help. It is unclear whether this dam actually retains any additional water over and above what naturally occurs in this pocket.

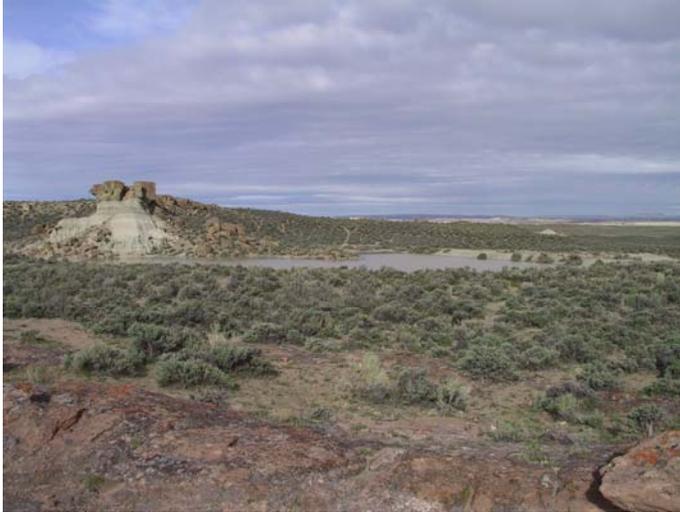
Figure 28

No Name Reservoir along Route AT-12. This reservoir is still functional. Its dam is partially camouflaged by desert shrub vegetation.

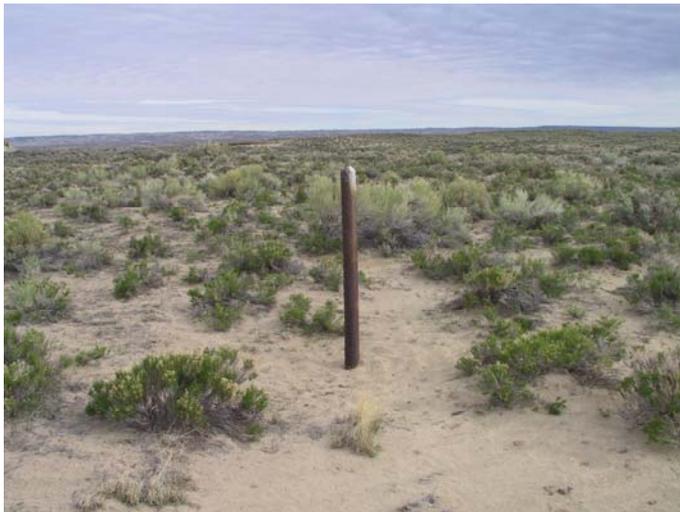
Figure 29

Husky well site along AT-12. This site has achieved a relatively natural condition.

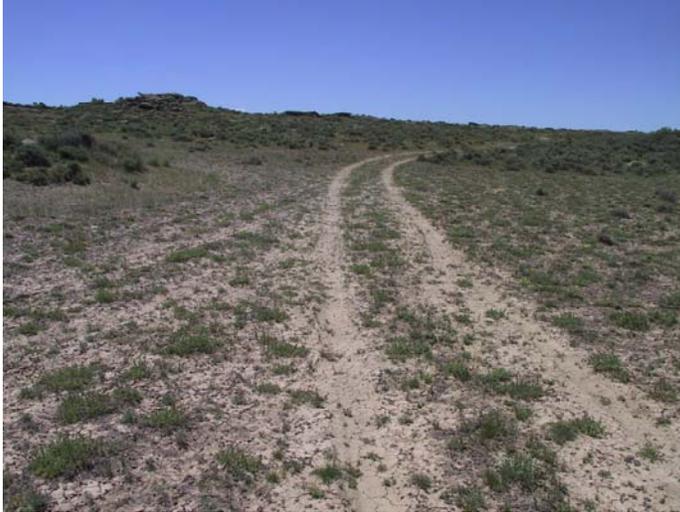
Figure 31

View of Route AT-14 that is also representative of conditions on AT-14A. This two track way is within Adobe Town WSA, but was not identified in BLM's Wilderness Intensive Inventory. It may be of more recent origins.

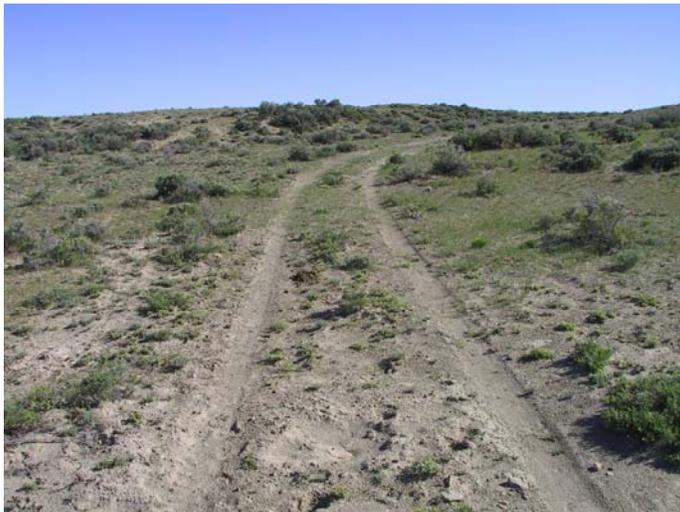
Figure 32

Route AT-15 in its best condition. It exhibits no evidence of construction or maintenance, being maintained solely by the passage of vehicles.

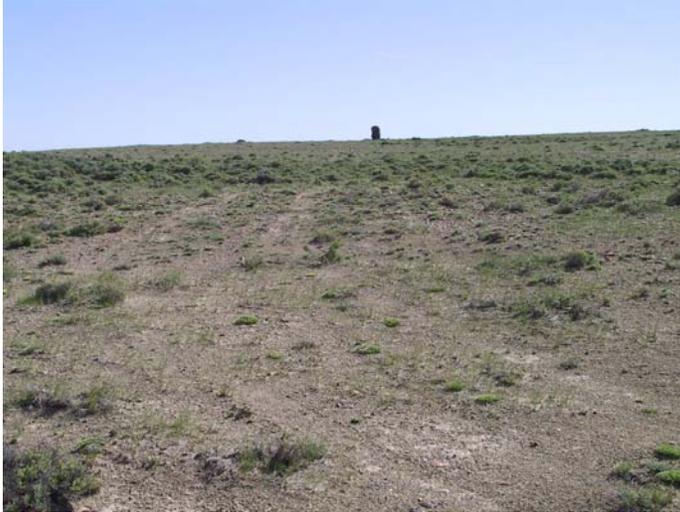
Figure 34

View of Route AT-15A, a short spur from AT-15 that visits a hill-top overlook. It is not even well-worn enough to constitute a “way.”

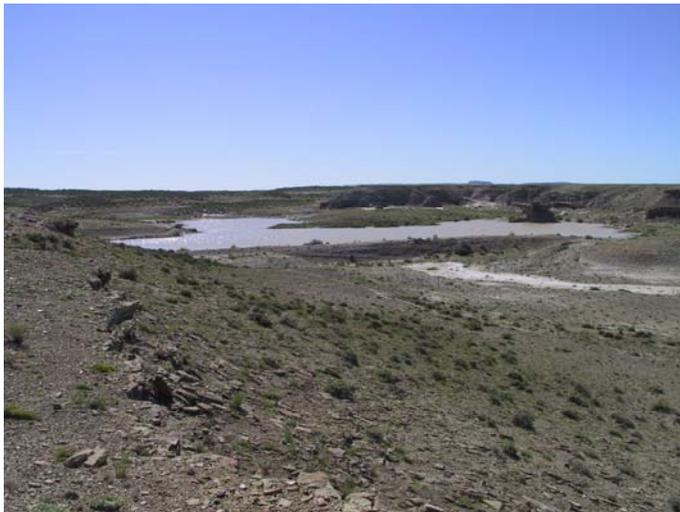
Figure 35

No Name Reservoir (south), off of Route AT-15A. It has no access route of its own. It is sound and holds water, with little vegetation on its dam. It lies entirely within Adobe Town WSA.

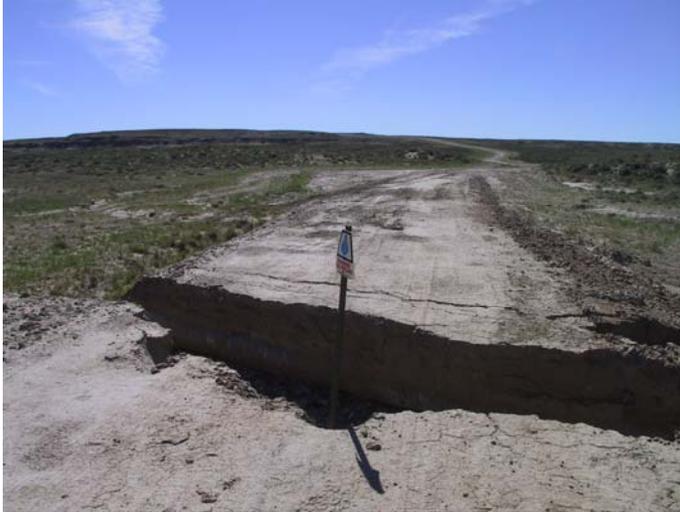
Figure 37

One of several impassable rifts across Route AT-16 that render it impassable to passenger vehicles. Four wheel drives can bypass these obstacles by descending into the neighboring ditch.

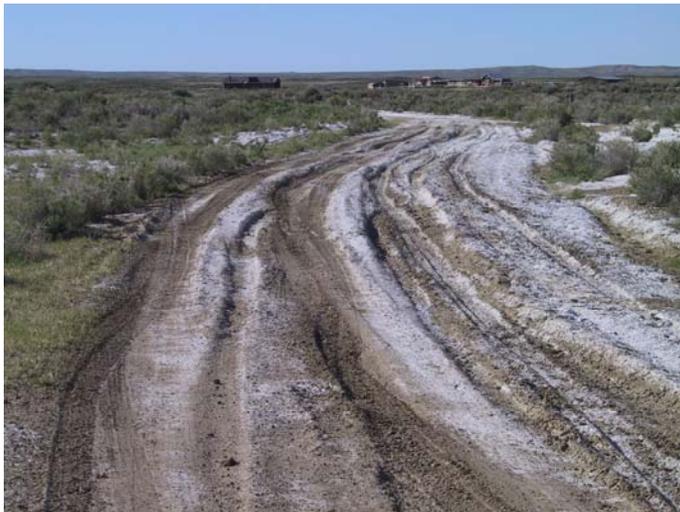
Figure 38

Boggy conditions like this are prevalent where AT-16 crosses alkali marshes.

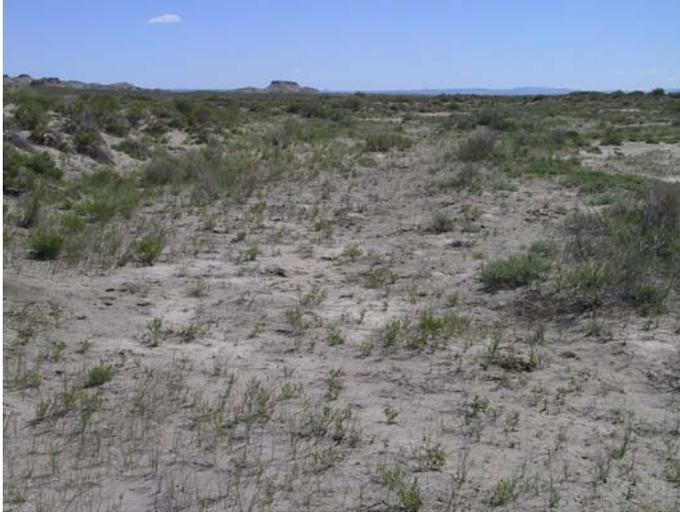
Figure 40

The majority of Route AT-17 no longer exists. This is a view along the former route near the site of Adobe Draw Reservoir.

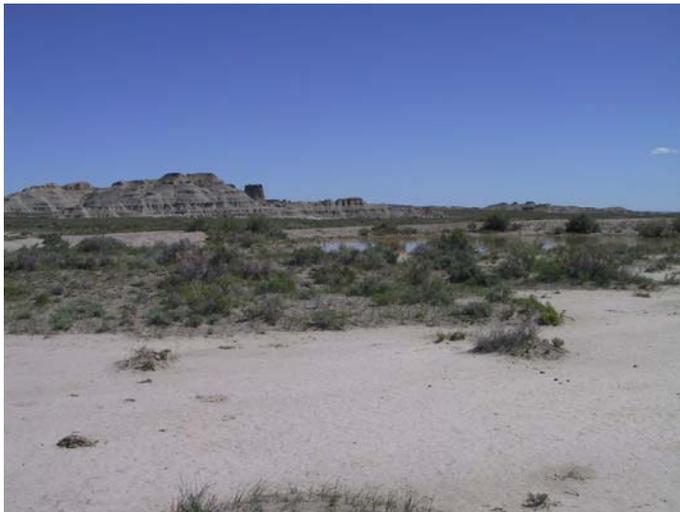
Figure 41

Adobe Draw Reservoir, along AT-17. This reservoir still holds a little water, but the main wash that once fed it has bypassed the dam. The dam itself is partially camouflaged with vegetation.

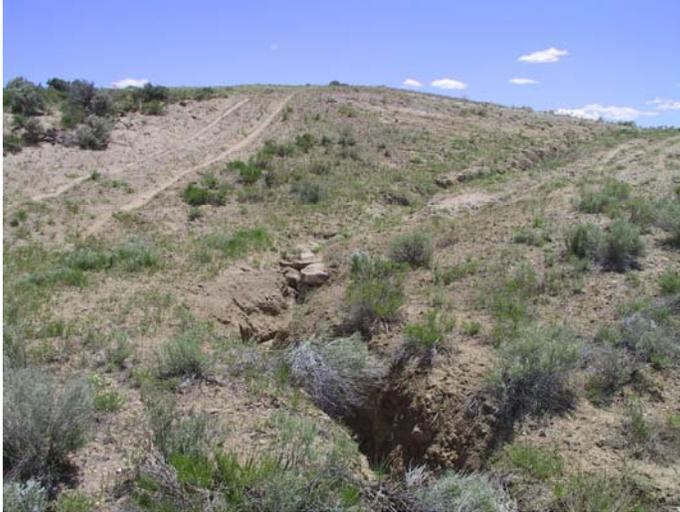
Figure 43

An impasse along AT-18 (visible at right). At left is an ad hoc drive-around to avoid the obstacle. This is one of several impasses that demonstrates the route's lack of maintenance or regular use.

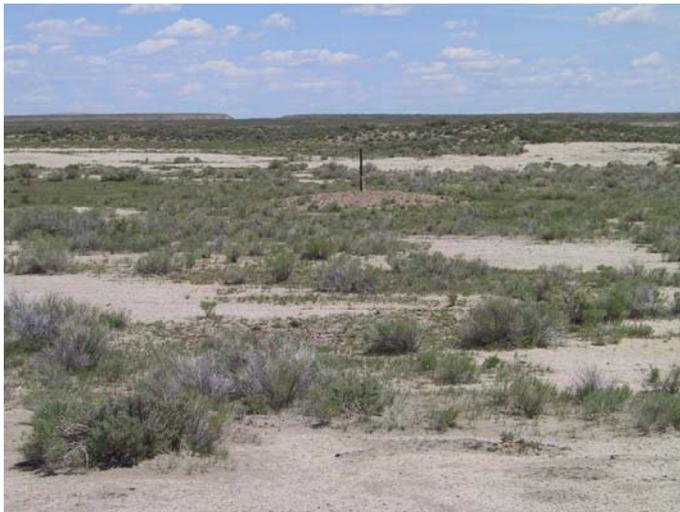
Figure 44

Coastal Haystack #4 well site at the end of Route AT-18. The well site is overgrown with native vegetation and has achieved a natural condition.

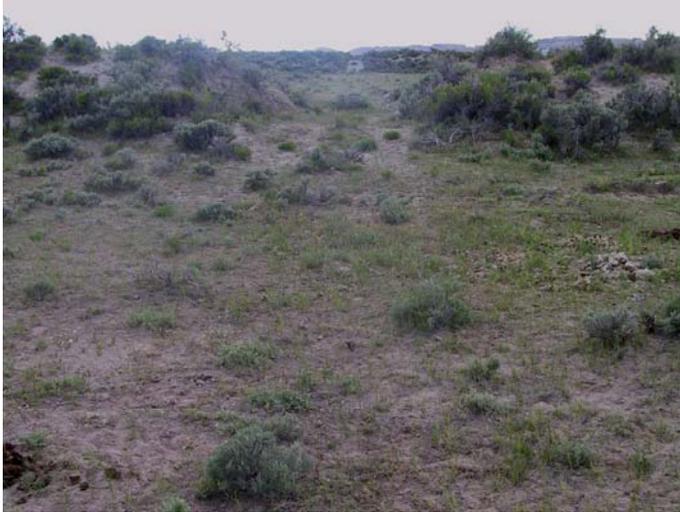
Figure 46

Typical view of AT-19, from its junction with AT-20 (it is accessible to vehicles here).

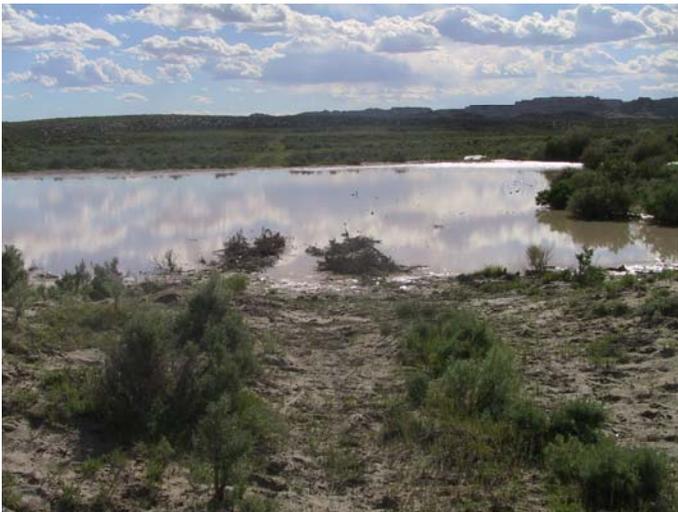
Figure 47

Impassable pond or bog that prevents vehicle access to AT-19 from the northeast. The unused and reclaimed route can be seen running southwest on the far shore of the pond.

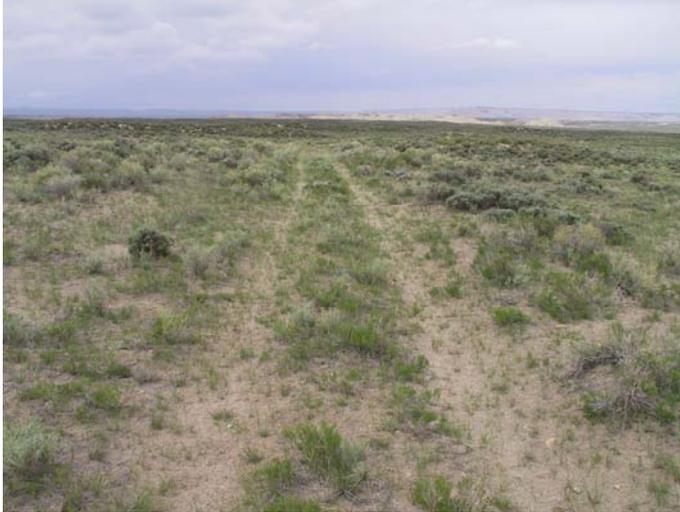
Figure 49

Typical view of AT-21. This way is revegetating nicely. It way used as a boundary for Adobe Town WSA despite the fact that many more impacted ways were found suitable for inclusion within the WSA.

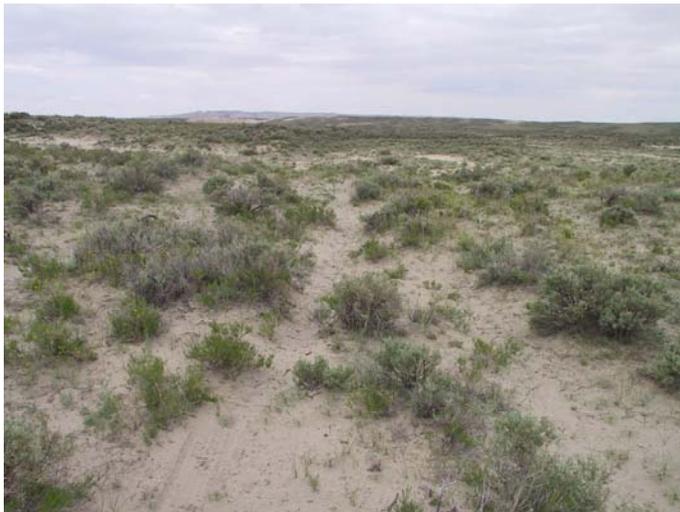
Figure 50

At this point, AT-21 ceases to be even an old vehicle way and becomes a “slight intrusion.” Despite the fact that it is difficult even to find, it is used as a boundary for the WSA.

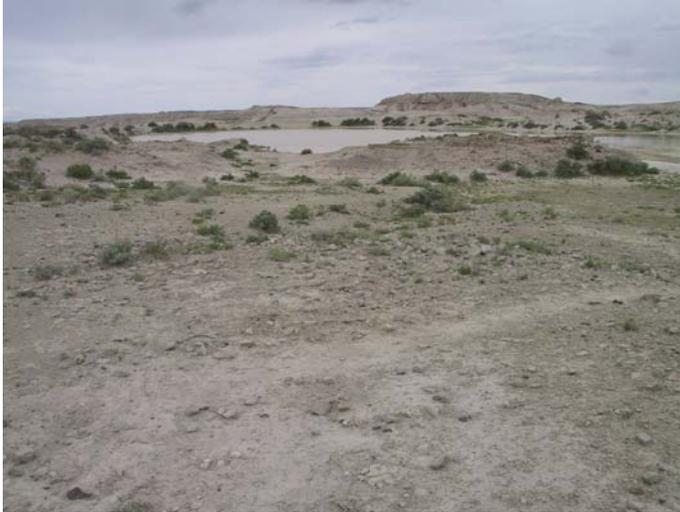
Figure 52

Blank Reservoir, at the end of route AT-22. This reservoir is sound and holds water. Although its dam is not well-revegetated, it blends in with the surrounding clay badlands. It lies within Adobe Town WSA.

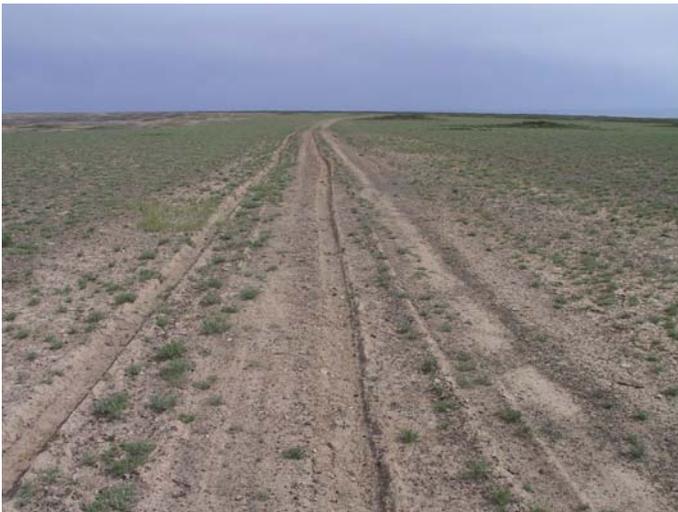
Figure 53

Typical view of Route AT-23. This route is recorded as having been bladed originally and receiving regular use. It appears that the original route was mechanically obliterated and reseeded. There is no evidence of maintenance.

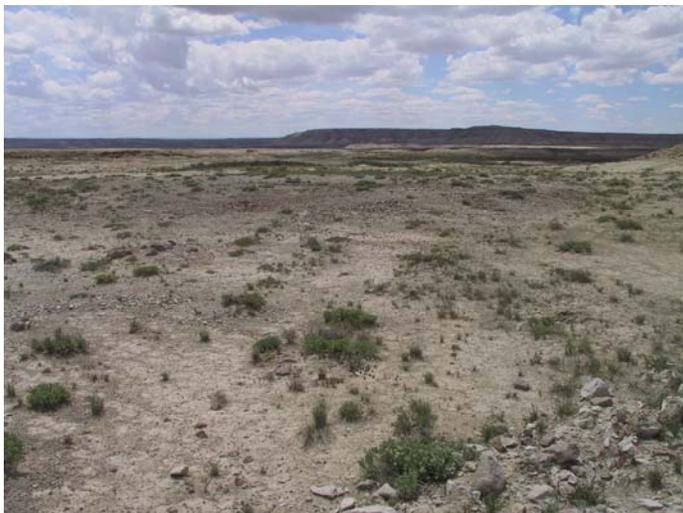
Figure 54

Route AT-24, shown on several maps. No sign of it exists on the ground. This is not even an “impact.”

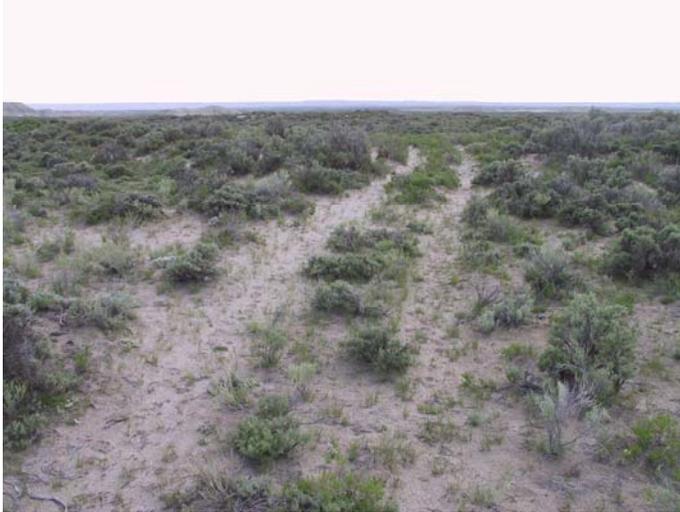
Figure 55

Route AT-25, part of BLM route "I," originated as a reservoir access route. This way is no longer used and is being reclaimed by the forces of natural degradation. This view is typical of the route.

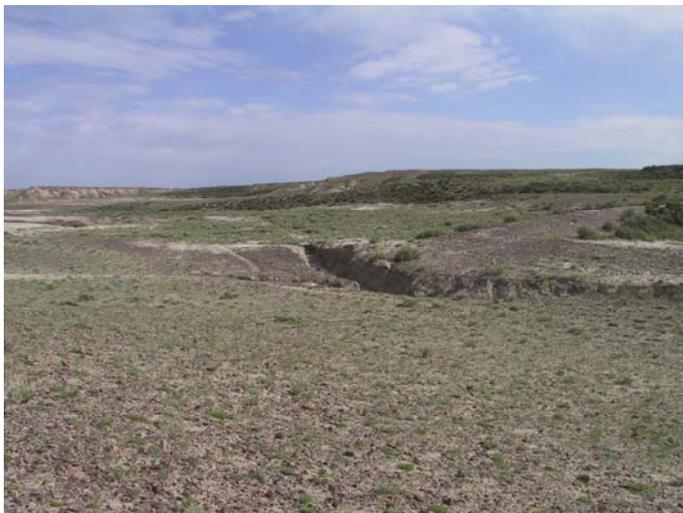
Figure 57

Route AT-25 is more of a "slight impact" than a "way" at this point. The route does not exist as mapped, crossing the wash, but rather ends near this point.

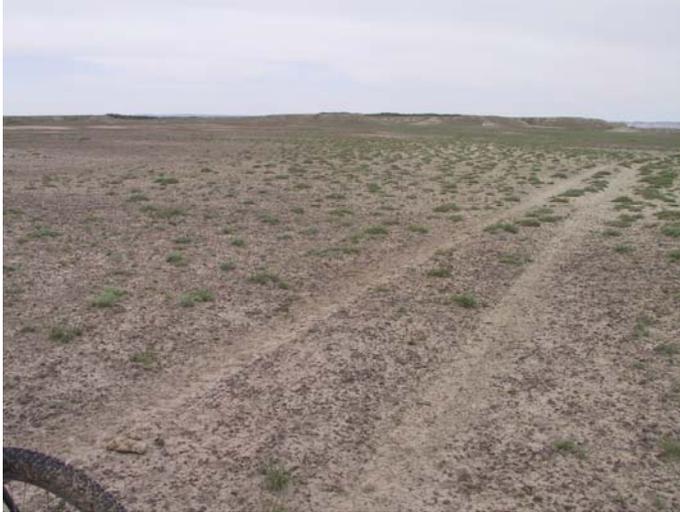
Figure 58

Abandoned reservoir at the end of former Route AT-25. The reservoir is breached in its center and no longer holds water.

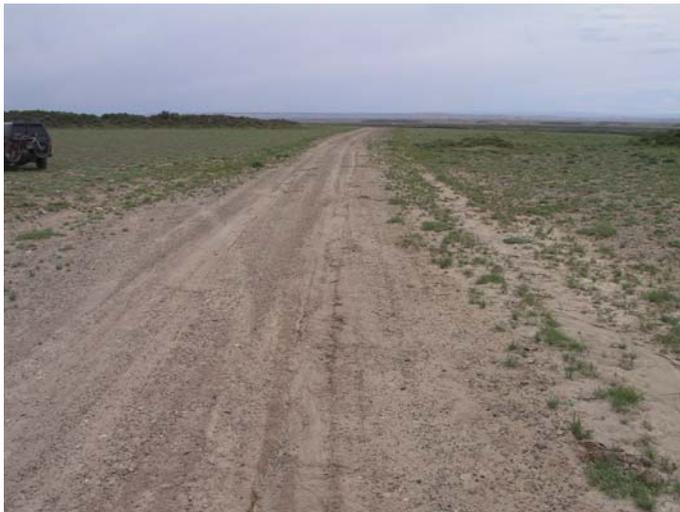
Figure 59

Typical view of AT-26. This two-track way receives very little use, and is becoming reclaimed through natural processes. The actual route occupies the draw bottom to the east of the map route that BLM inventoried as Route "I."

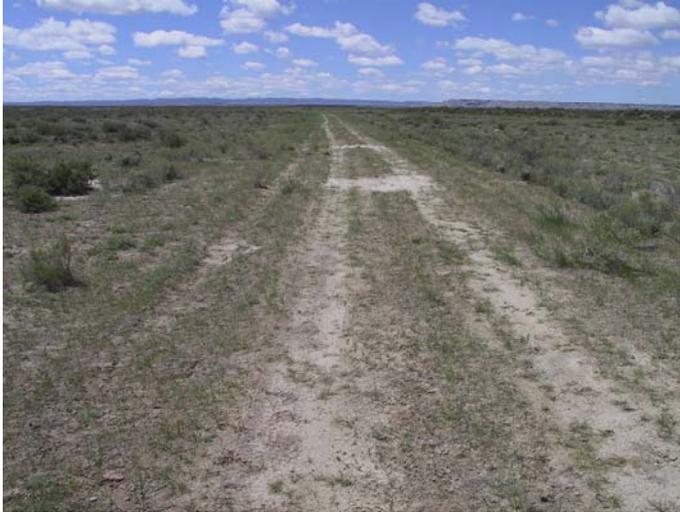
Figure 61

Unreclaimed portion of AT-27 at its most primitive. The original constructed route has washed out here, and a two-track detour carries all traffic.

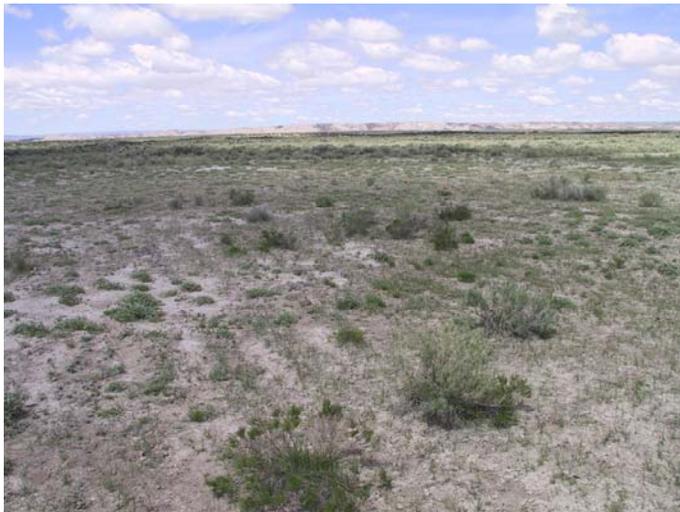
Figure 62

Typical view of southern leg of AT-27. This part of the route falls entirely within Adobe Town WSA and has been obliterated mechanically and reseeded. Use continues along the old route, making this an unimproved “way” superimposed over a revegetated strip.

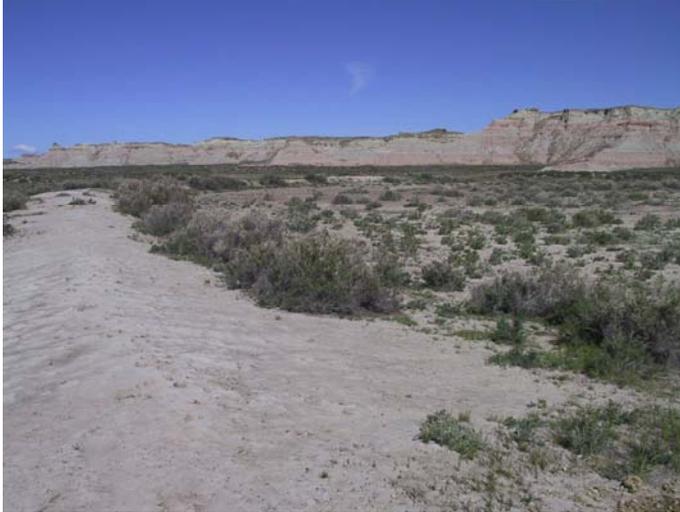
Figure 64

Route AT-28, the former access route to Sand Branch Reservoir. It has been completely obliterated by natural degradation, and now does not even qualify as a “slight intrusion.”

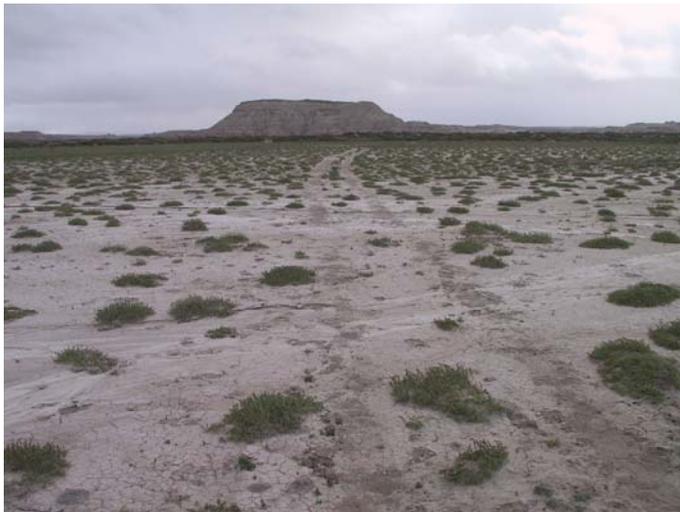
Figure 65

Dam of Sand Branch Reservoir, at the end of Route AT-28. The dam is breached at its west end. The reservoir bed is revegetated, but the dam itself has not yet returned to a fully natural condition.

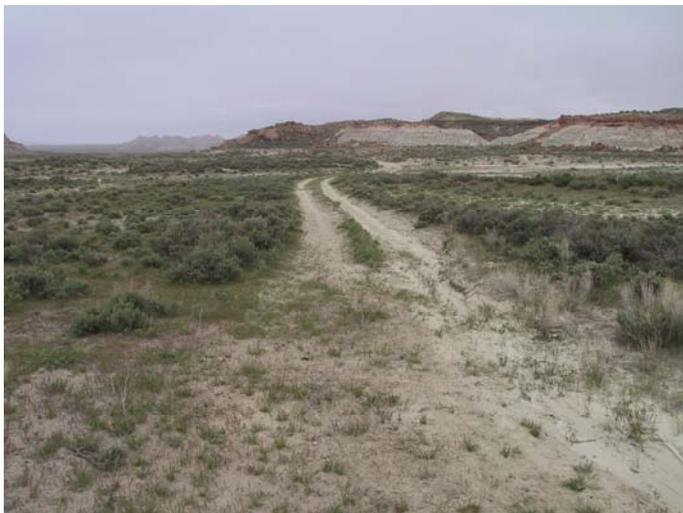
Figure 66

Typical view of AT-29. This way was not inventoried in BLM's Wilderness Intensive Inventory. It shows no signs of construction or maintenance, and does not receive regular use.

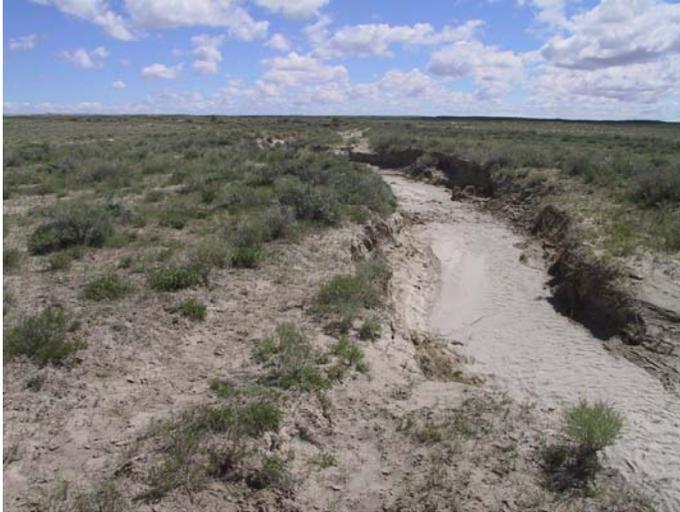
Figure 67

Route AT-30, the Manuel Gap route, at its most road-like. Although BLM formerly asserted that this route was constructed and maintained, it no longer shows evidence of either.

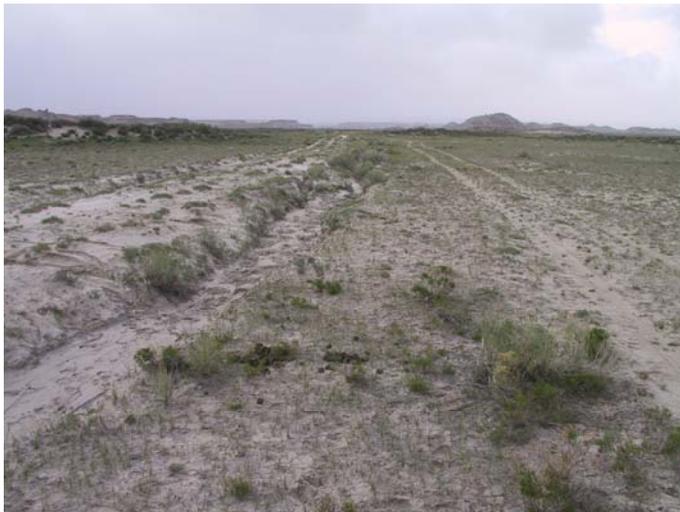
Figure 68

View of AT-30 (lower right) reaching one of many impasses that indicate its lack of maintenance. The route can be seen ahead in the center distance.

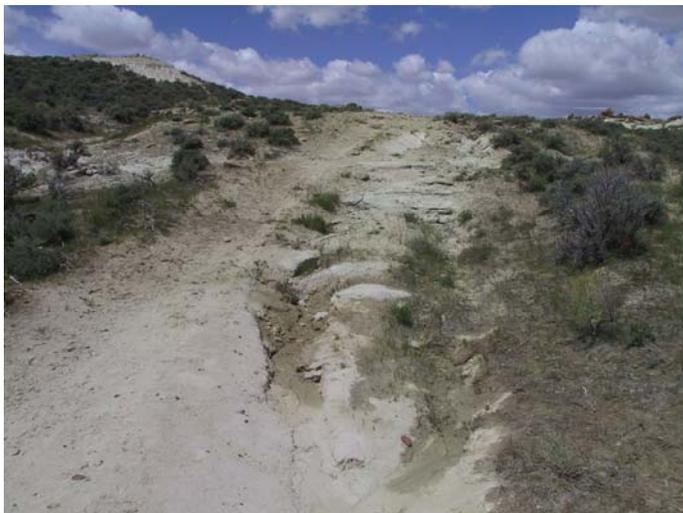
Figure 69

Original route of AT-30 (at left) displays deep erosion and multiple trailing that is characteristic of AT-30 on the Archer Plain.

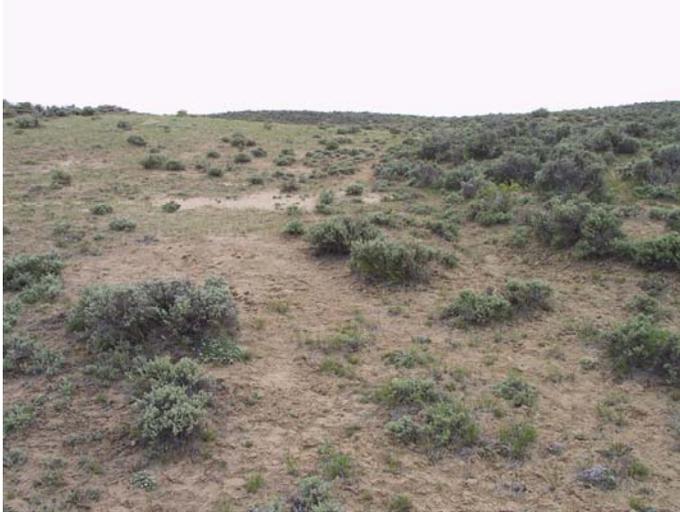
Figure 73

Near Manuel Gap, AT-30 is passable only to four-wheel drive vehicles. Much of it is very rocky in this stretch.

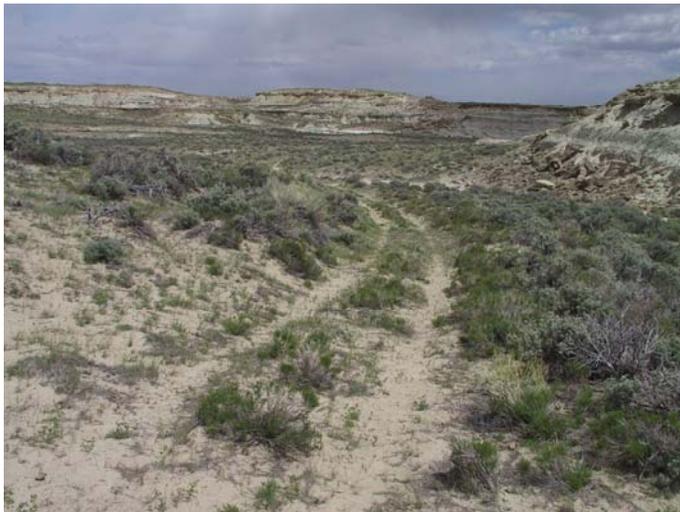
Figure 74

View of the beginning of Route AT-31A, a dead-end offshoot from Rout AT-31 that exists on the map but not on the ground.

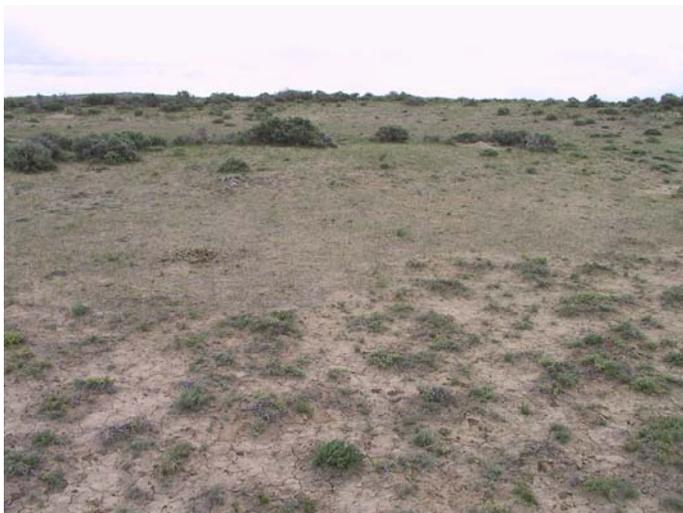
Figure 75

Typical view of AT-31 (BLM route "U"). This former seimograph trail was classified a "way" by BLM. It no longer receives any use.

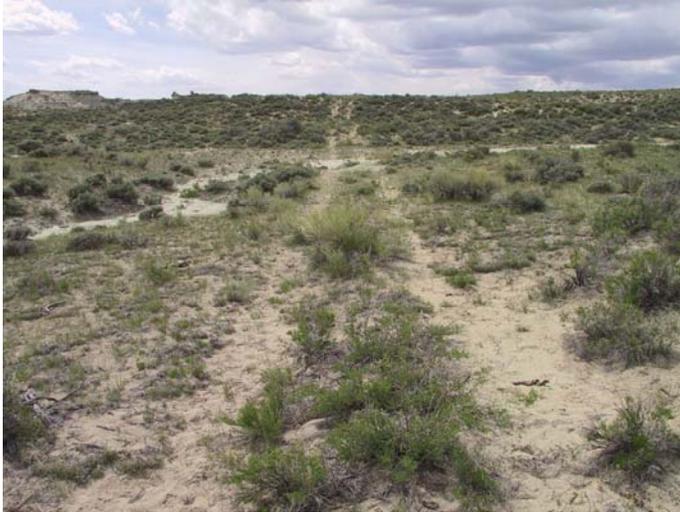
Figure 76

Beginning of Route AT-32A, a dead-end spur off AT-32. This route is shown on the map but does not exist on the ground.

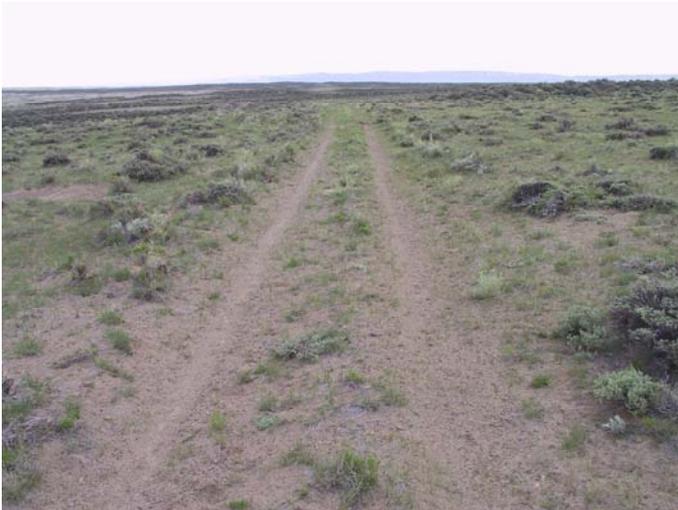
Figure 77

Typical view of AT-33, a dead-end spur off of AT-32. This former seismograph trail is now an abandoned “way.”

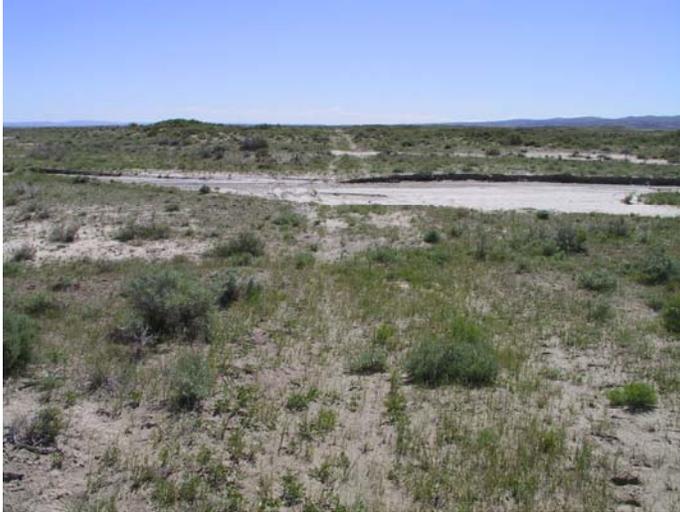
Figure 82

Typical view of AT-37, a dead-end way with no signs of construction, maintenance, or regular use.

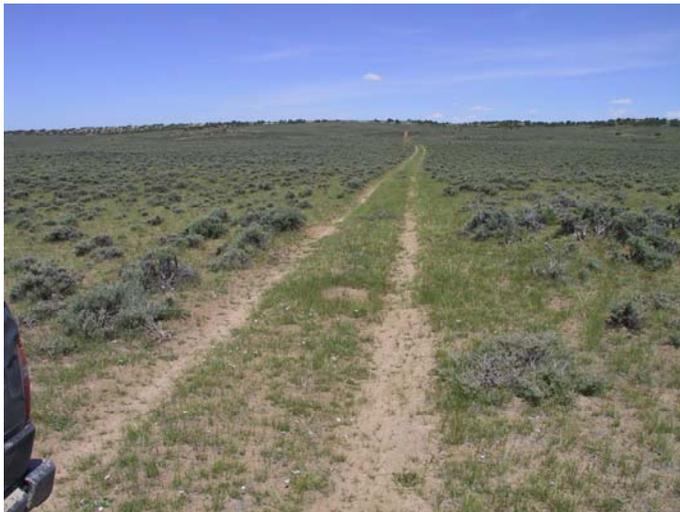
Figure 86

Typical view of AT-40, an abandoned way that now constitutes only a “minor intrusion.” It was never constructed or maintained and receives no use.
