**BLM Unit Identification:** Adobe Town WY-030-401 and WY-040-408

**Description** Adobe Town is proposed by the conservation community for wilderness designation. The area proposed for wilderness includes all of the Adobe Town Wilderness Study Area, plus additional lands of wilderness quality in The Haystacks, along Willow Creek and the Willow Creek Rim, and south of the WSA to the Powder Rim and just beyond it. All of these areas possess the full complement of required characteristics for wilderness in abundance: outstanding opportunities for both solitude *and* primitive and unconfined recreation, wilderness-quality naturalness, size (at over 180,000 acres, the citizens proposed Adobe Town wilderness is well above the 5,000-acre minimum), and in addition has outstanding supplemental values such as abundant wildlife, wild horse herds, unique geology, and abundant archaeological and paleontological resources.

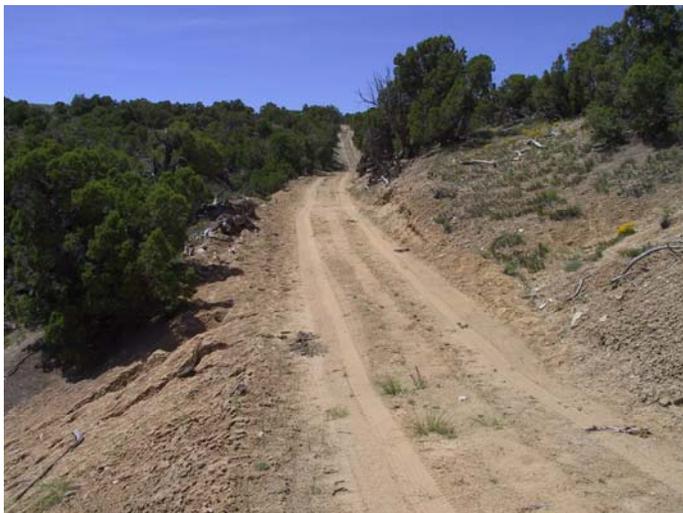
Figure 87

View typical of AT-41, an old seismograph trail. Most of this route shows no evidence of construction or maintenance, and is becoming revegetated.

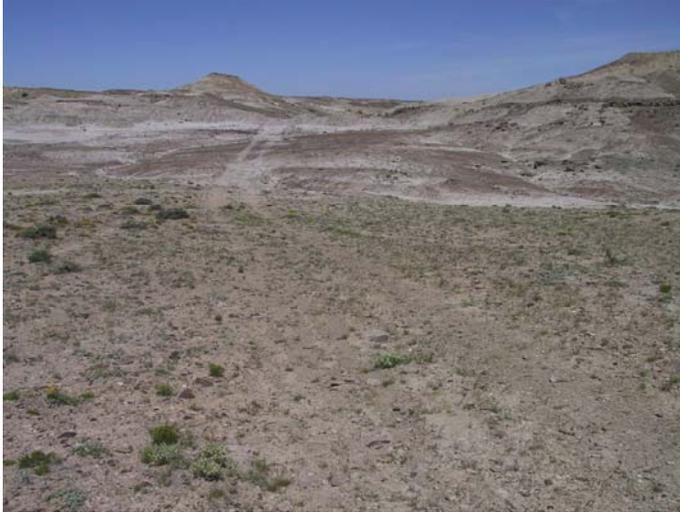
Figure 88

Evidence of blading on AT-41. This is likely the result of recent seismograph exploration.

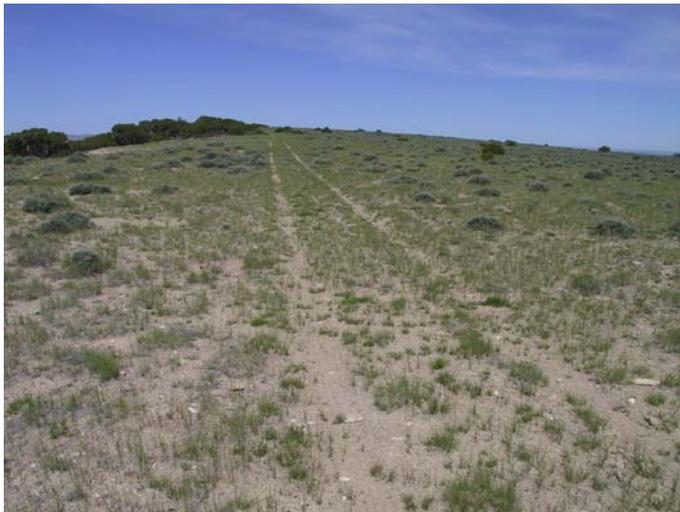
Figure 89

Route AT-41 at its faintest as it approaches the badlands near the foot of the Powder Rim.

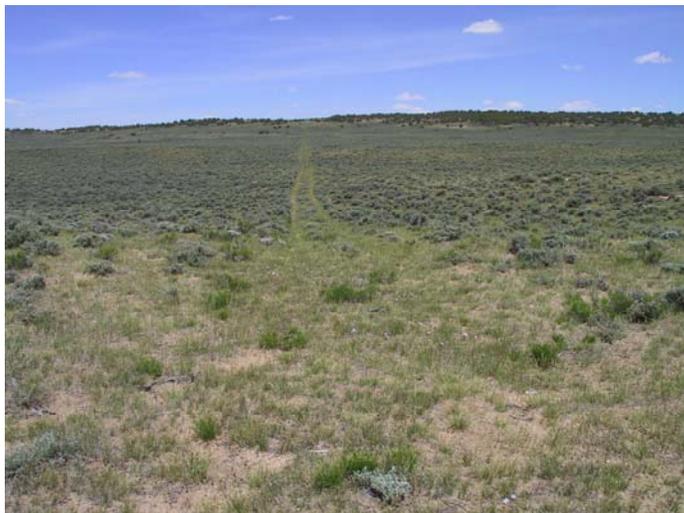
Figure 90

Typical view of AT-42, with no evidence of construction, maintenance, or regular use.

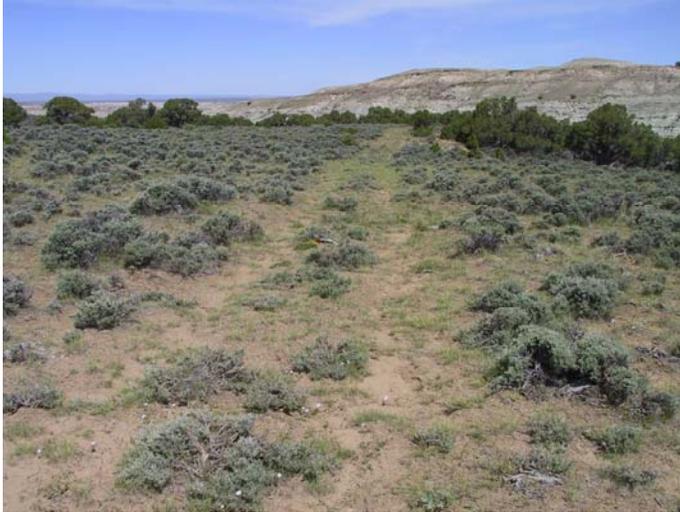
Figure 94

Typical view of AT-42A, an abandoned seismograph t rail. It has no evidence of construction, maintenance, or recent use.

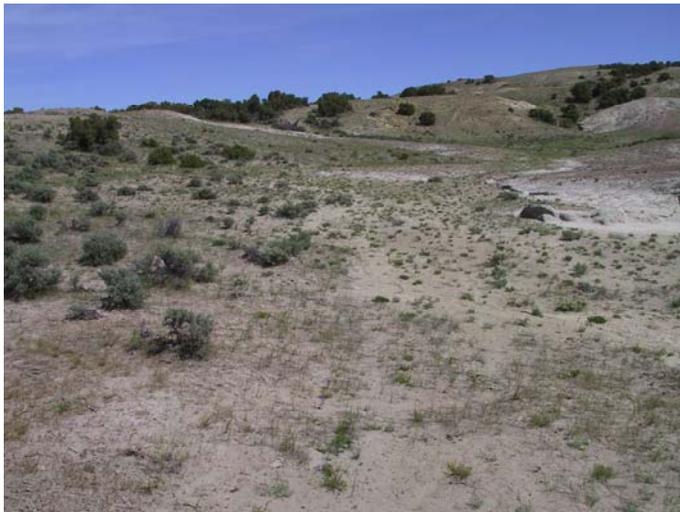
Figure 95

Typical view of Route AT-45. Neither constructed nor maintained, this old seismograph trail has been completely abandoned and now represents more of a minimal impact than a “way.”

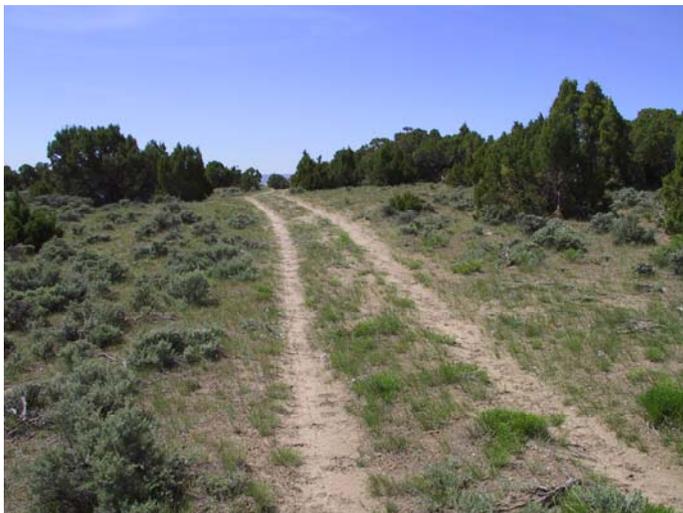
Figure 96

No trace of AT-45 exists beyond this point.

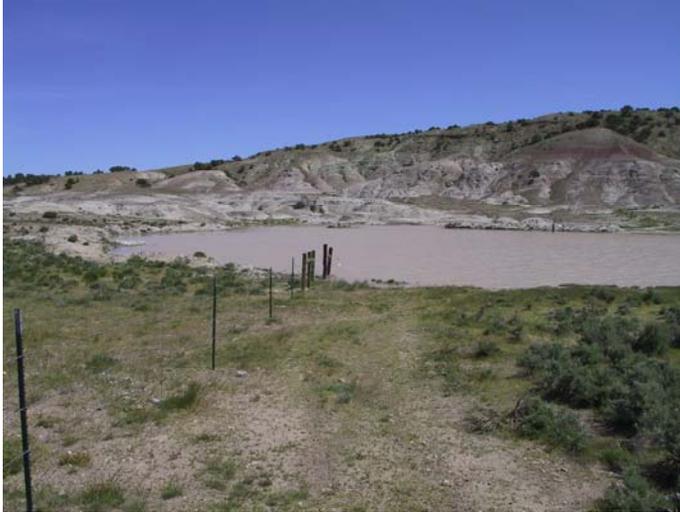
Figure 97

Typical view of AT-46, an access route to Adobe Reservoir. This route shows no evidence of construction, and is maintained solely by the passage of vehicles. It has none of the attributes of a “road.”

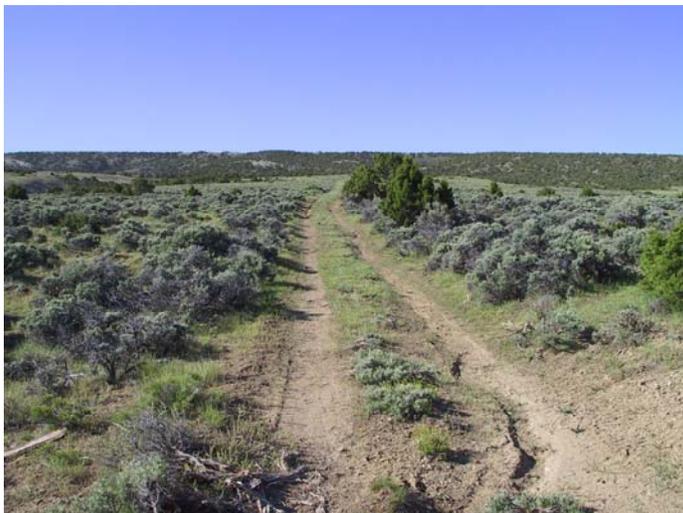
Figure 99

Typical view of AT-47 at its beginning, a dead-end jeep way that climbs to the top of the Powder Rim. It shows no evidence of construction or maintenance.

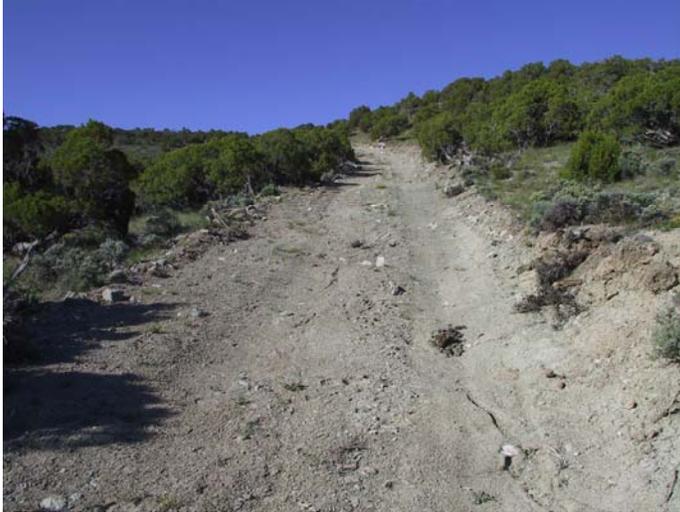
Figure 100

Typical view of AT-48. Most of this seismograph trail was never constructed and is maintained solely by the passage of vehicles.

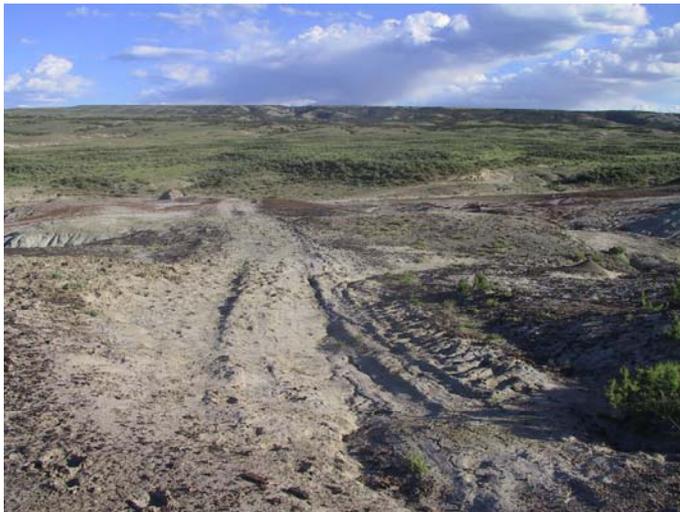
Figure 101

Signs of recent blading on a short, steep stretch of AT-48. This recent maintenance is likely associated with a one-time use for seismograph testing.

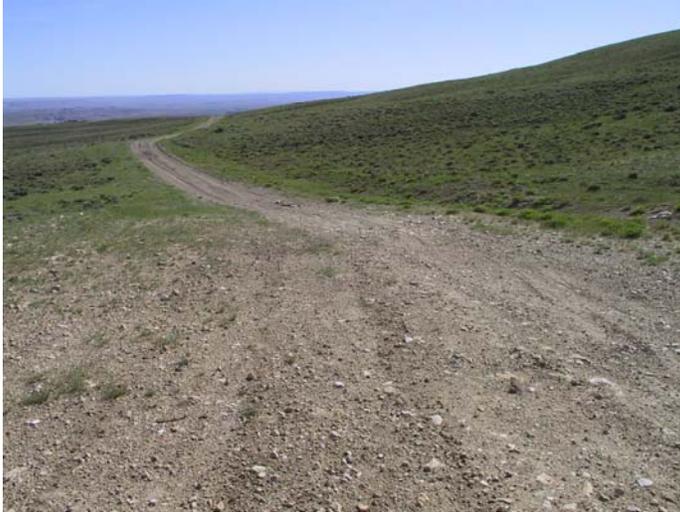
Figure 103

Typical view of AT-49. This route shows no evidence of construction, maintenance, or regular use.

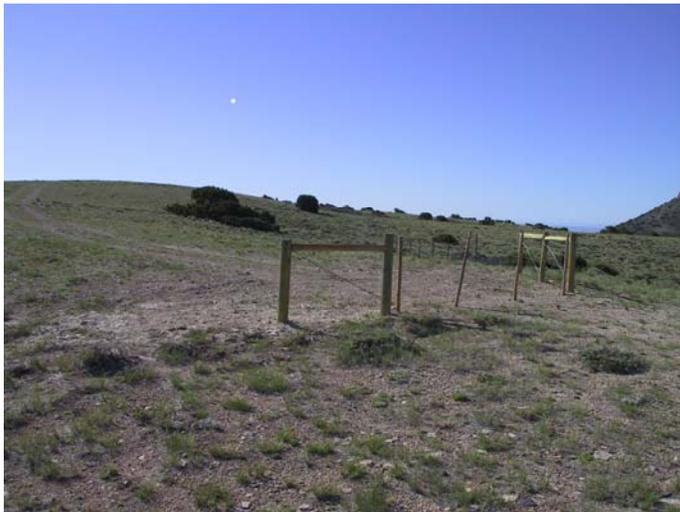
Figure 104

Typical view of Route AT-50, the Cherokee Trail Road. This route is constructed, maintained, and receives regular use. We classify it as a “road” and exclude it from the proposed Adobe Town WSA expansion.

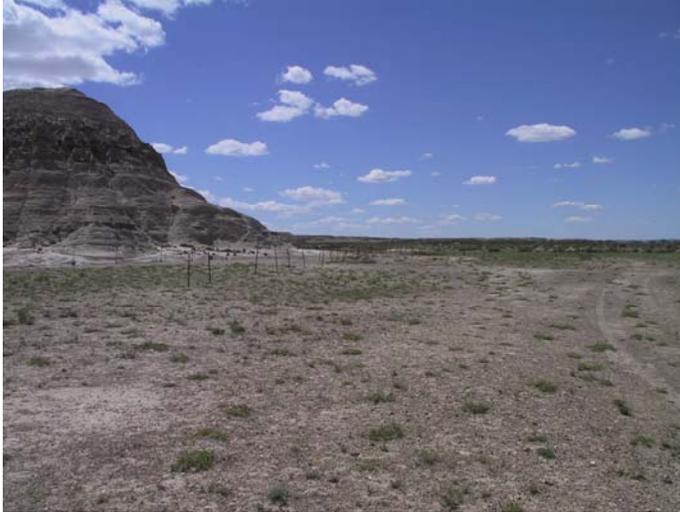
Figure 154

Old wild horse trap (at left) beside AT-83 (visible at right). The route is in its best condition here, qualifying as a “way.” The horse trap qualifies as a “minor intrusion” and is comparable to wild horse traps within the WSA.

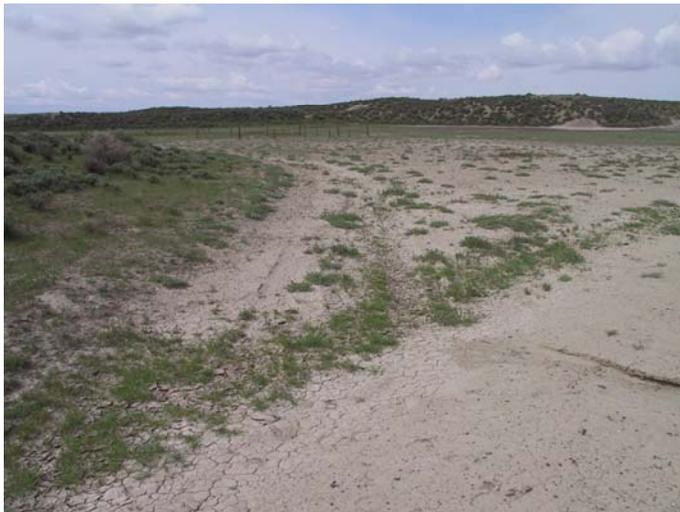
Figure 155

Beginning of AT-84 (left center). This route was not constructed or maintained, and does not even receive sufficient use to kill the vegetation in the wheel tracks. It is a “way.” Note the corral ruins in the background, a “minor intrusion.”

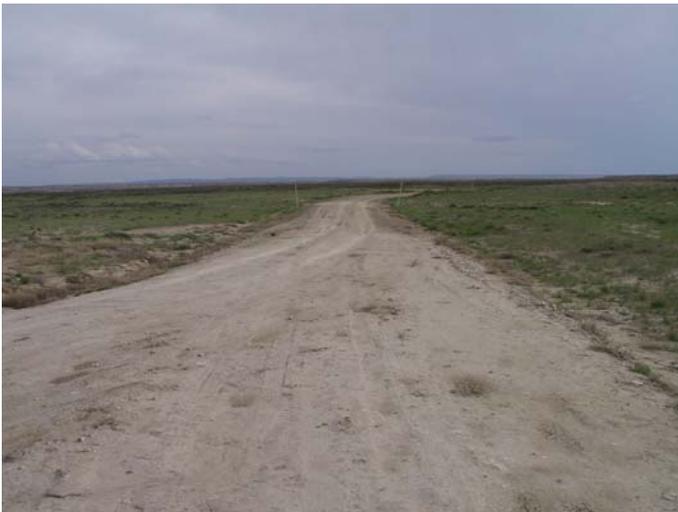
Figure 159

Typical view of AT-86A. This former improved road has been obliterated and reseeded, and now is a "minor intrusion."

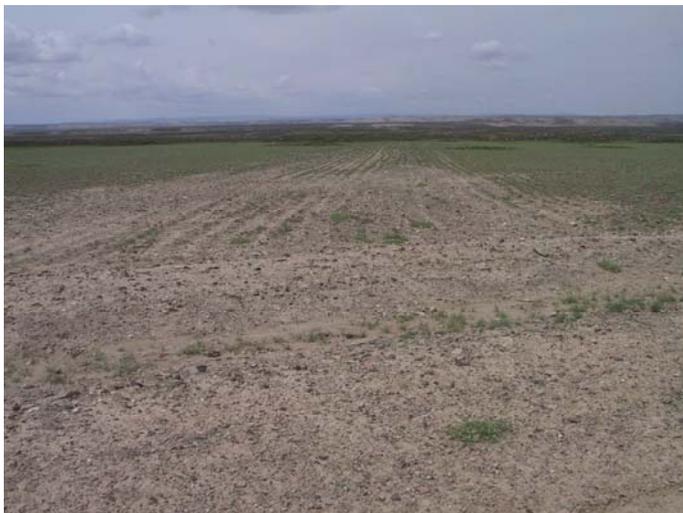
Figure 160

Abandoned well site at the end of AT-86A. It has been obliterated mechanically and reseeded, but has yet to return to a natural condition. Having only been 7 years since its abandonment, it can be expected to reclaim significantly in the coming years.

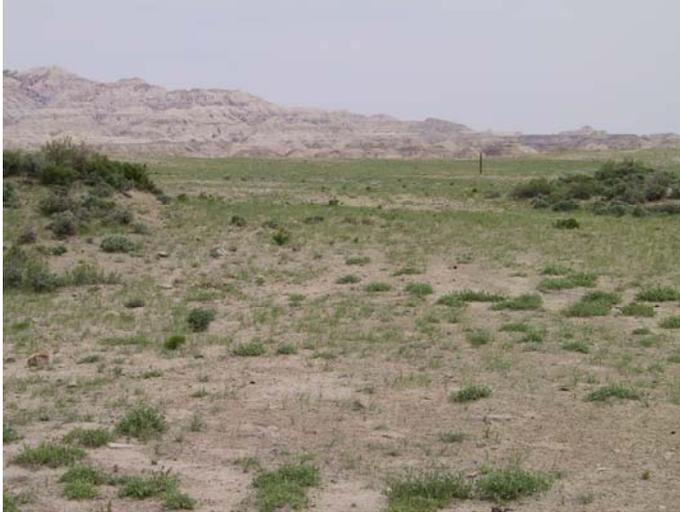
Figure 164

Route AT-87, the obliterated and reseeded segment of AT-86, in typical condition. This is a "minor intrusion" rather than a "way."

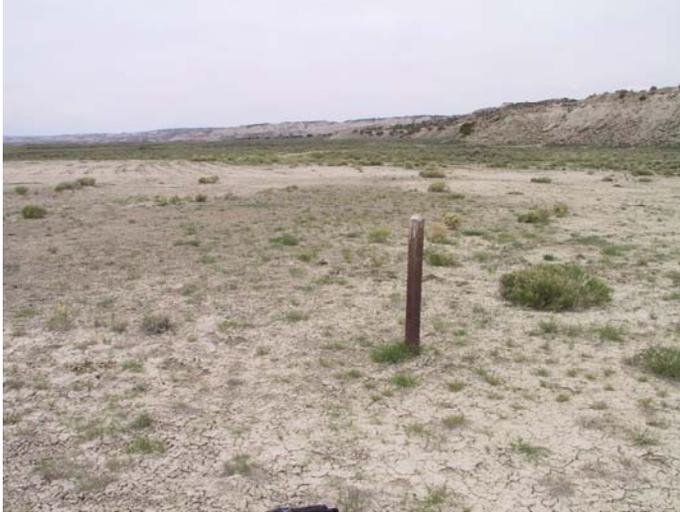
Figure 167

Typical view of AT-87A, a former jeep trail to a campsite that has since been abandoned and revegetated. It now is more of a "minor intrusion" than a "way."

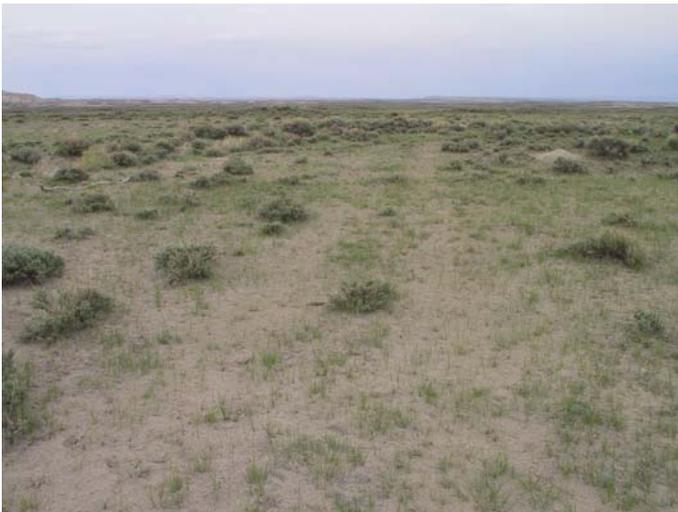
Figure 168

Route AT-88, a jeep trail shown on the USGS Haystack Flats quad, no longer exists even as a "minor intrusion."

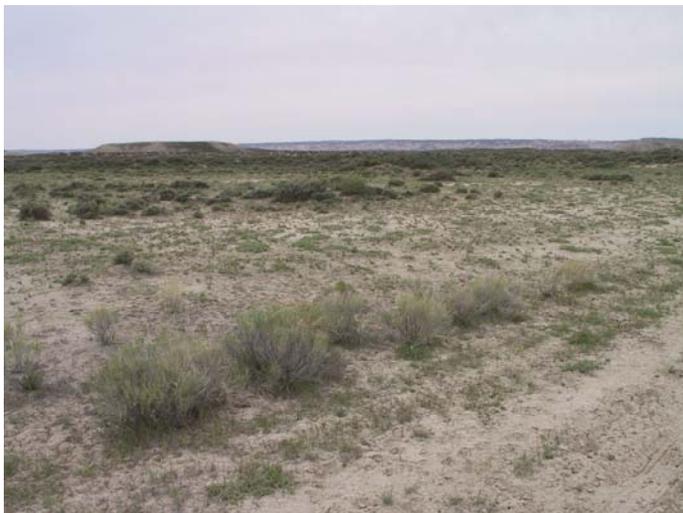
Figure 169

Route AT-87 is a jeep trail that receives neither construction, maintenance, nor regular use. It is maintained solely by the passage of vehicles, a classic “way.”

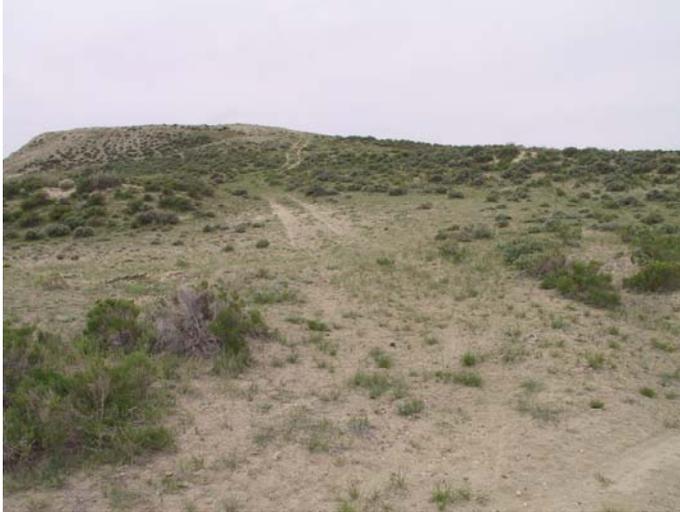
Figure 170

Typical view of AT-89B. This two-track was never constructed or maintained, and receives no use beyond N-T Reservoir. It is a “way” that is rapidly deteriorating.

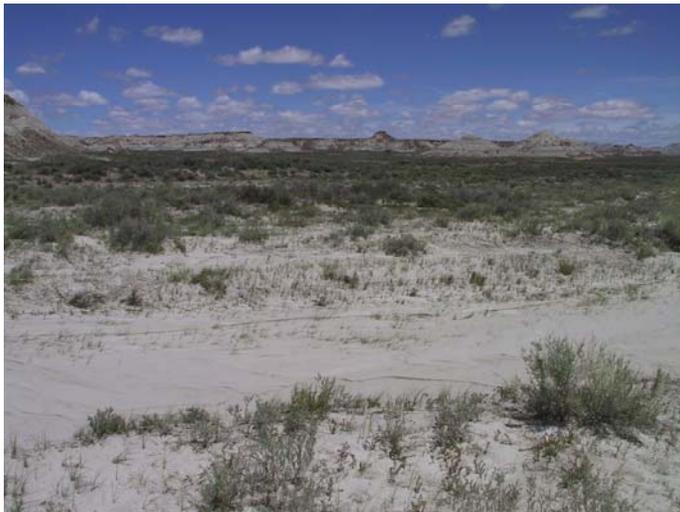
Figure 174

View of AT-90, obliterated and re-seeded. This former improved road is now a “minor intrusion.”

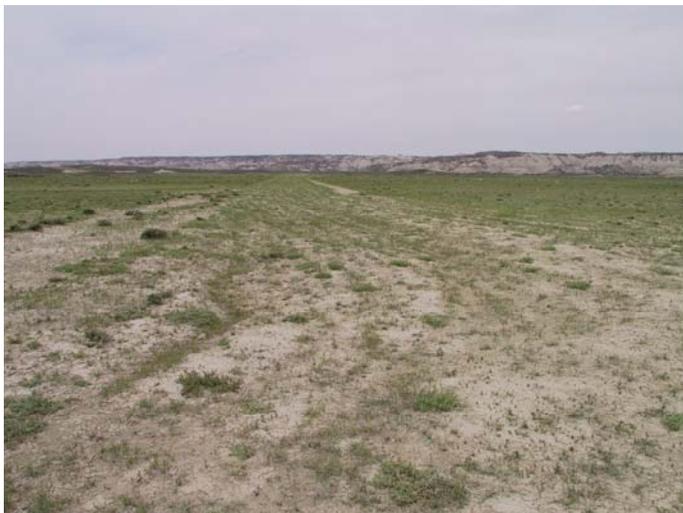
Figure 175

At the end of AT-90 is the Immigrant Trail #3 well site. It has been obliterated and re-seeded, but like the Trappers Trail #1 well which was included in Adobe Town WSA, it has not attained a natural state at the time of this inventory.

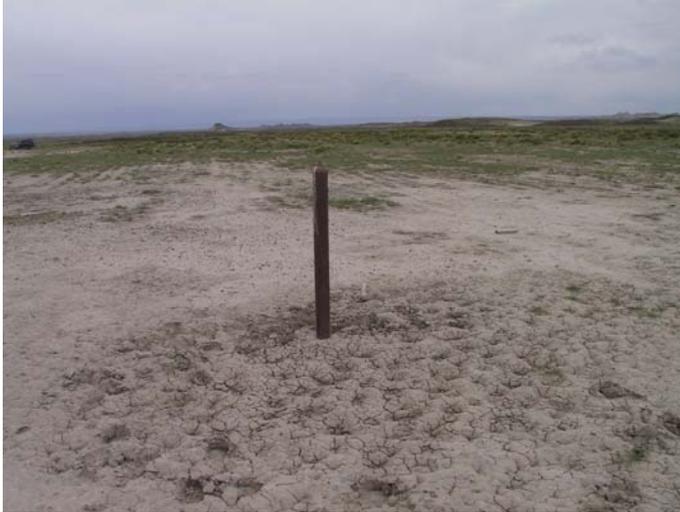
Figure 176

Abandoned and reclaimed drilling pad that was never drilled at the end of AT-91. This route is returning to a natural state, and constitutes a “minor intrusion.”

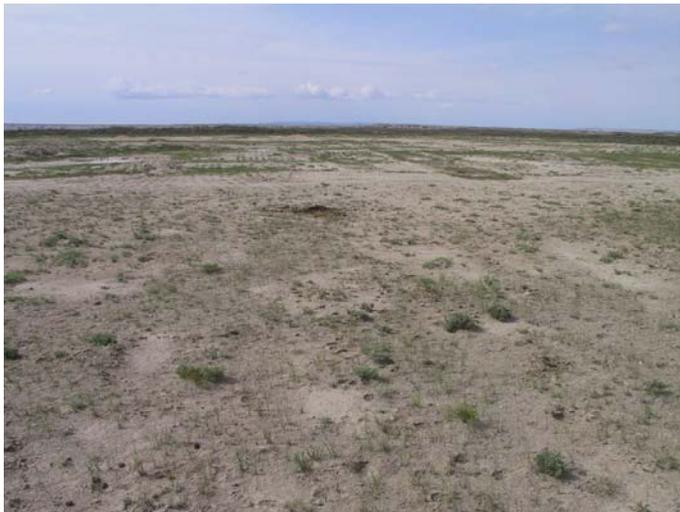
Figure 177

View of AT-92, which was obliterated but has not yet become revegetated. This impact will soon return to a natural state and become a “minor intrusion.” It has not yet had sufficient time to do so.

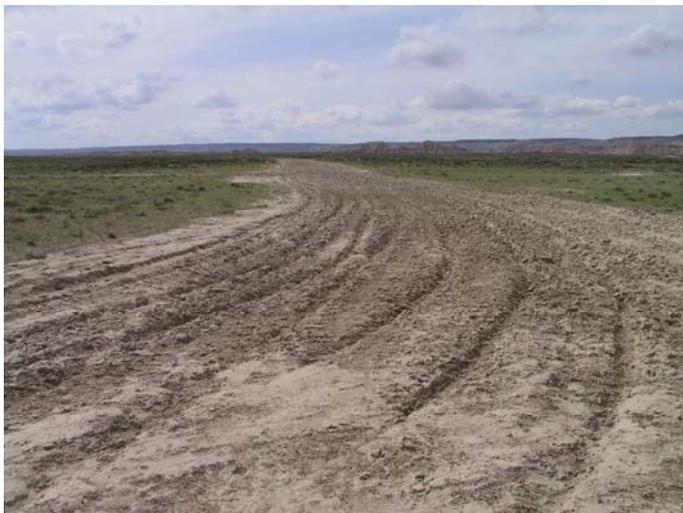
Figure 178

At the end of AT-92 is the abandoned Upper Willow Reservoir #12 well site. This site was abandoned only last autumn (2000), and has not yet had time to revegetate.

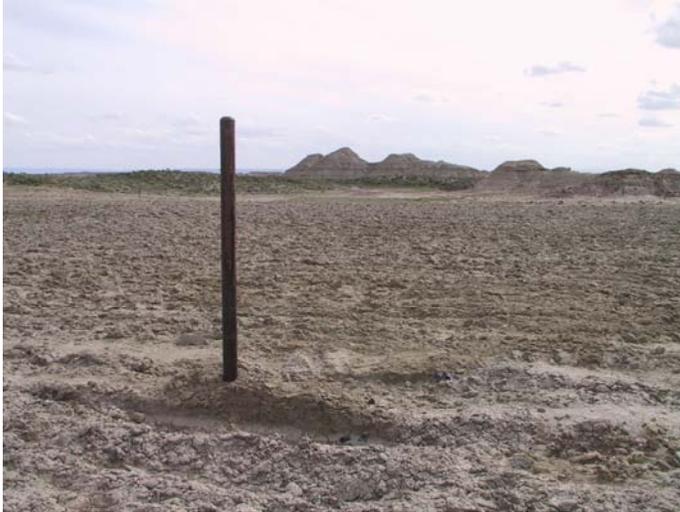
Figure 179

Abandoned and revegetated Rote AT-93, reclaimed in 1993. This former improved road is now a “minor intrusion” similar to AT-27 within Adobe Town WSA.

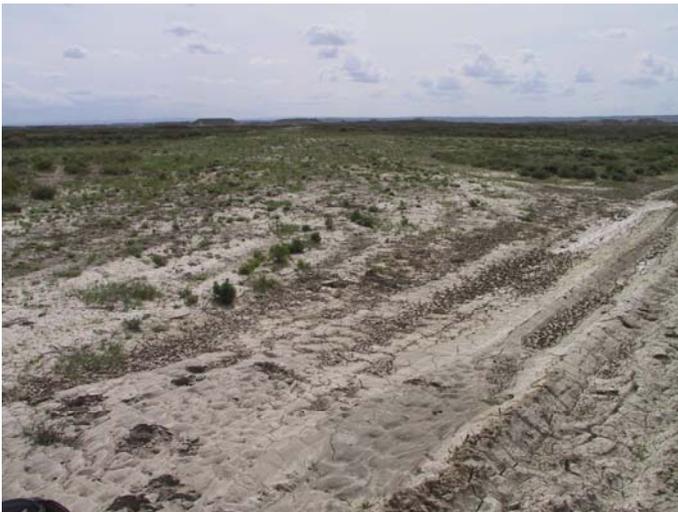
Figure 180

At the end of AT-93 is the revegetated pad of the Upper Willow Reservoir #11 well. This site is now proceeding toward a natural state.

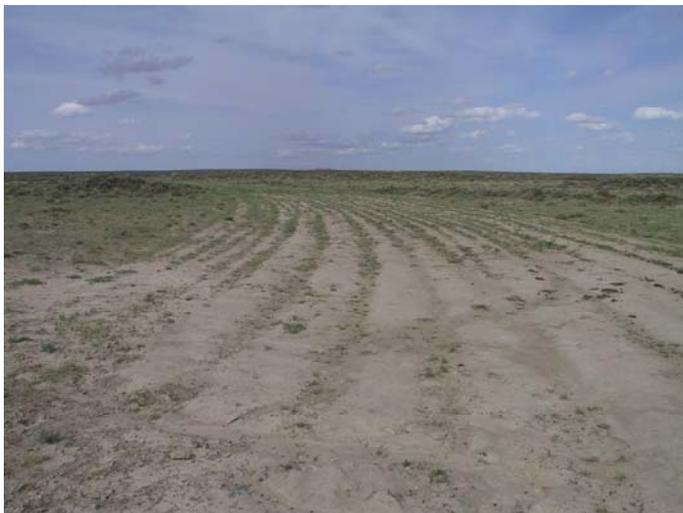
Figure 181

Typical view of abandoned jeep trail AT-94, which now does not even constitute a “minor intrusion.” It no longer exists.

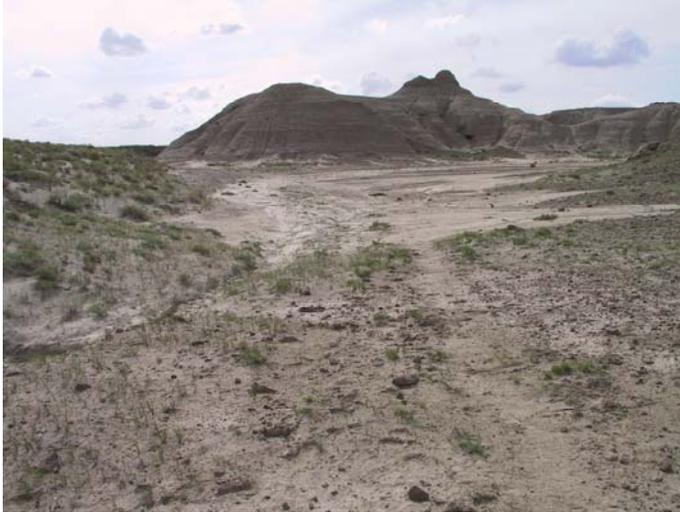
Figure 182

Jeep trail AT-95 paralleled by its natural gas pipeline. Although the vehicle route is a “way,” the pipeline is a significant intrusion and this route was excluded from the proposed WSA expansion, and forms part of its northeast boundary.

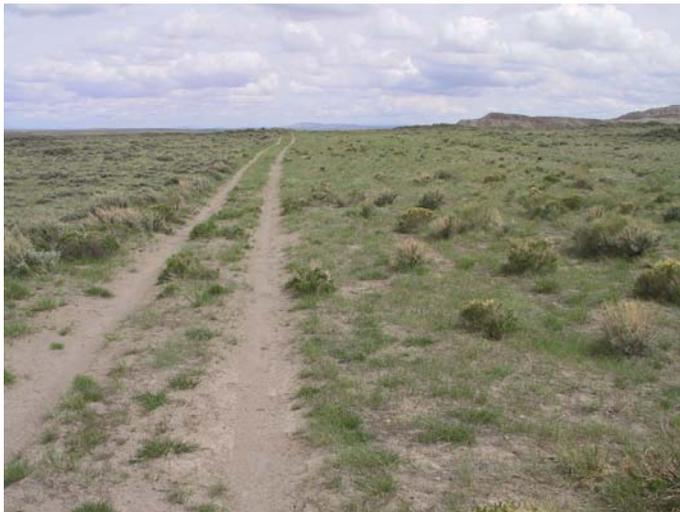
Figure 183

Route AT-95A, a short, dead end jeep trail of no purpose and which possesses none of the characteristics of a road.

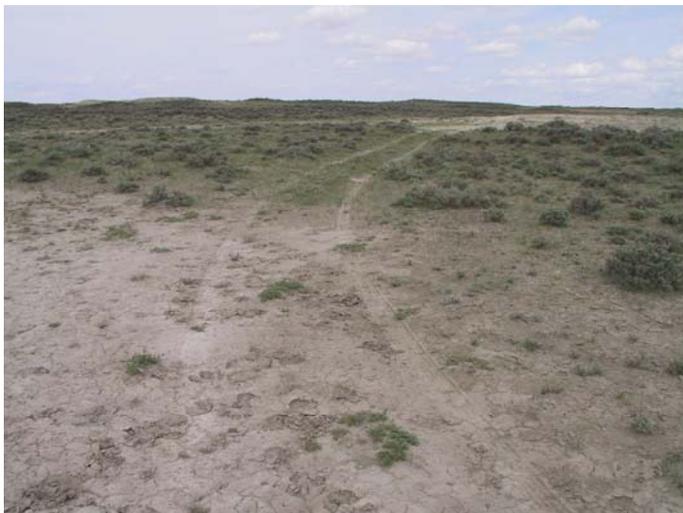
Figure 184

Typical view of abandoned jeep trail AT-94, which now does not even constitute a “minor intrusion.” It no longer exists.

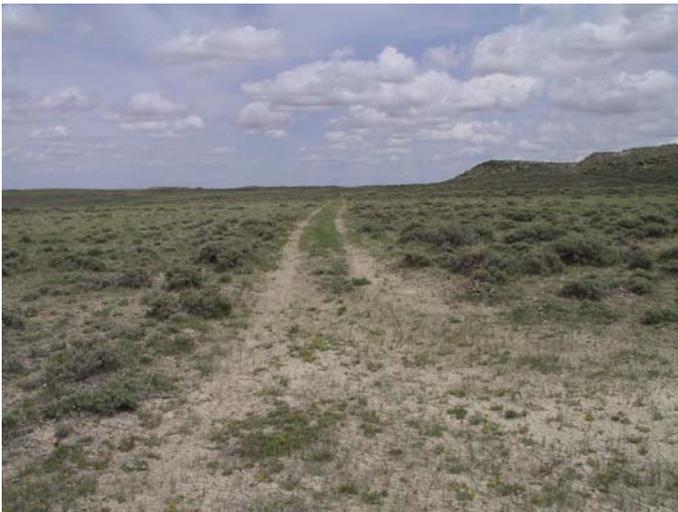
Figure 183

Route AT-95A, a short, dead end jeep trail of no purpose and which possesses none of the characteristics of a road.

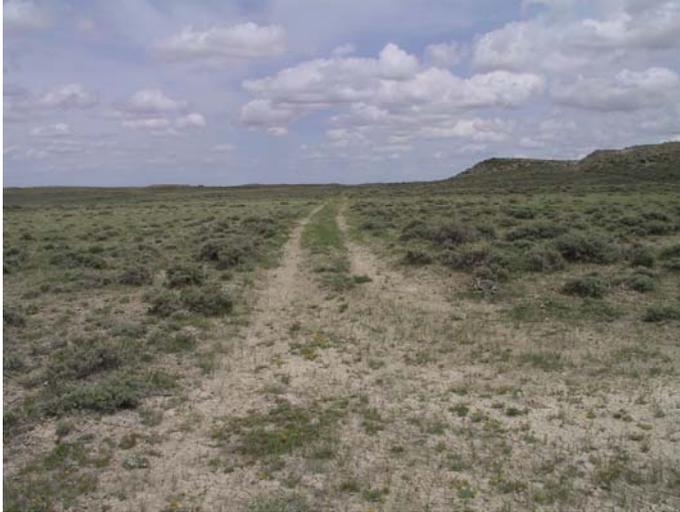
Figure 184

Typical view of Route At-96. It was never constructed or maintained, and the growth of vegetation in the wheel tracks indicates a lack of regular use. It is maintained solely by the passage of vehicles, a classic “way.”

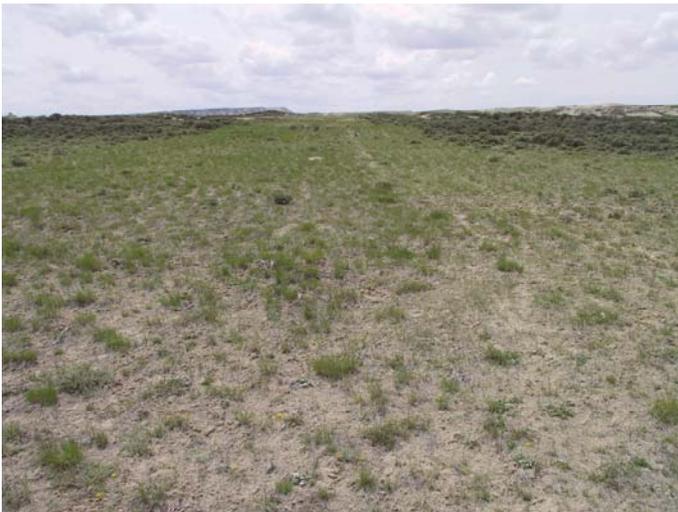
Figure 185

Pipeline AT-97. This feature is a significant intrusion due to its potential need for mechanical maintenance. It is excluded from the proposed WSA expansion, and serves as the north boundary.

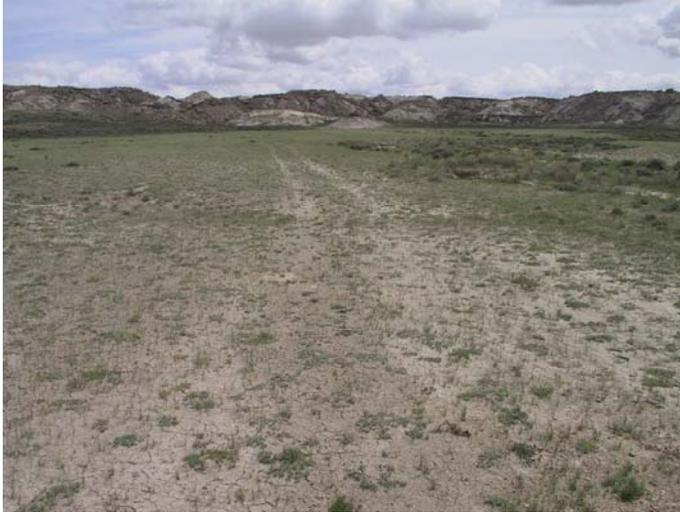
Figure 187

Typical view of Route AT-99, a little-used jeep trail. There is no evidence of construction or maintenance, and grass is taking over the route.

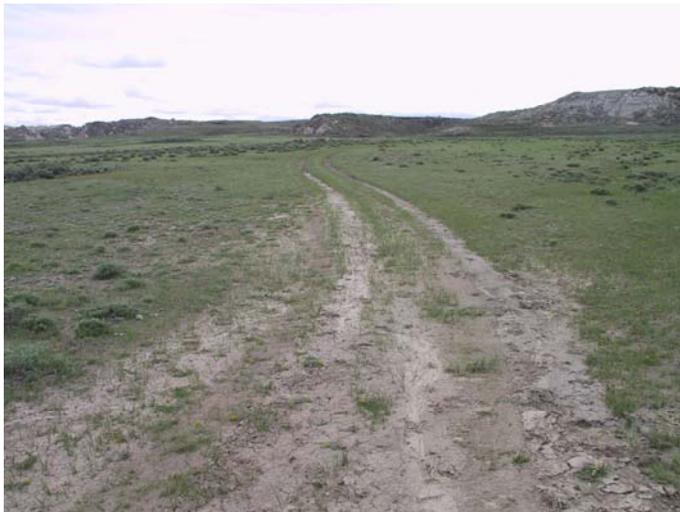
Figure 188

Typical view of AT-100. This route was never constructed and is maintained solely by the passage of vehicles, therefore necessitating its classification as a “way.”

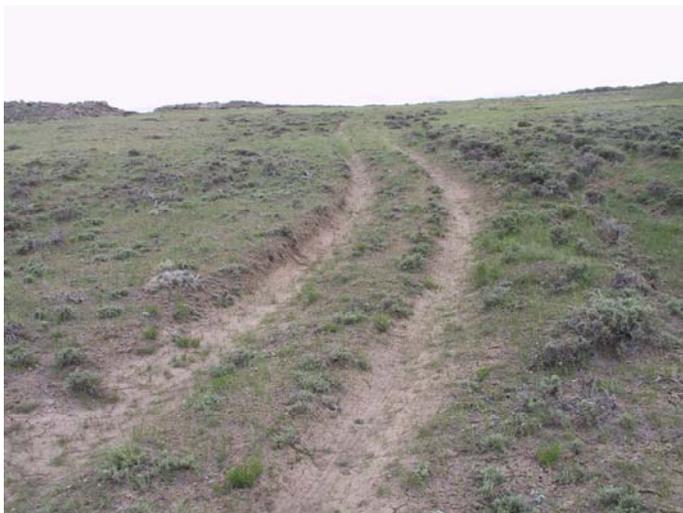
Figure 189

Route AT-101, an abandoned cut-off to AT-100, is no longer passable due to a washout at its north end. It is beginning to revegetate itself.

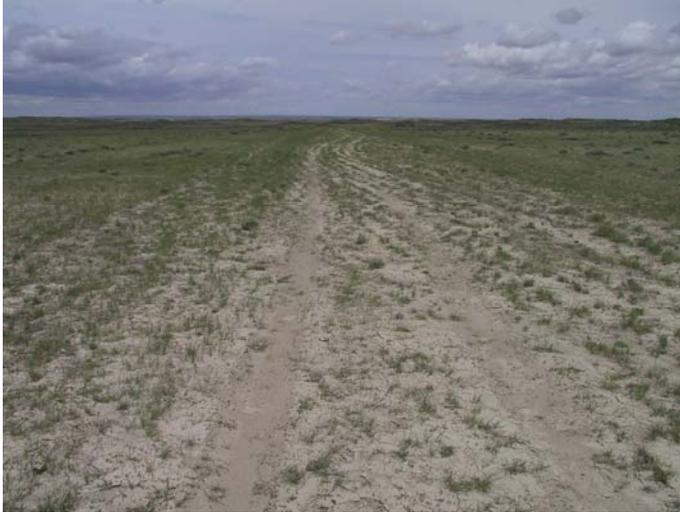
Figure 190

Route AT-102, formerly an improved road to an abandoned drilling pad. It was obliterated and re-seeded, by sporadic use has continued, wearing a two-track “way” into part of it.

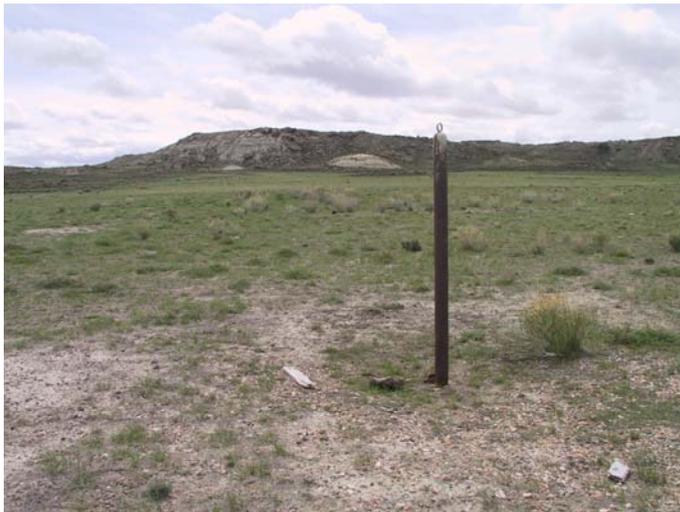
Figure 191

At the end of AT-102 is the abandoned drilling pad of the Amoco Emigrant Trail #2. This site has now returned to a relatively natural condition.

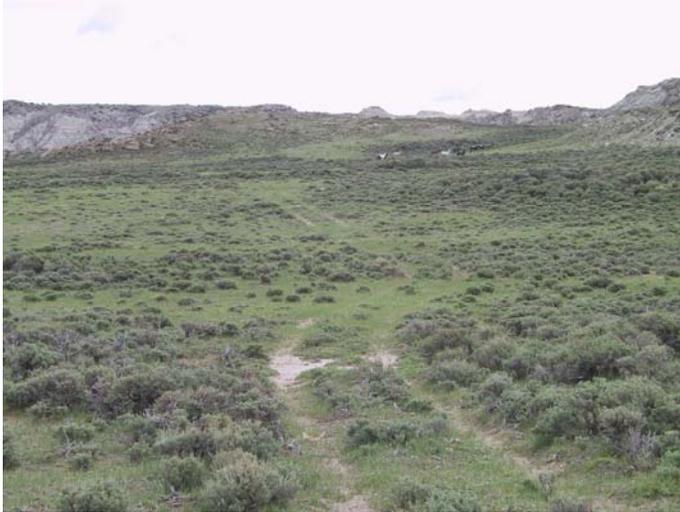
Figure 193

Route AT-104 in its best condition. This abandoned jeep trail is now a “minor intrusion” rather than a “way.”

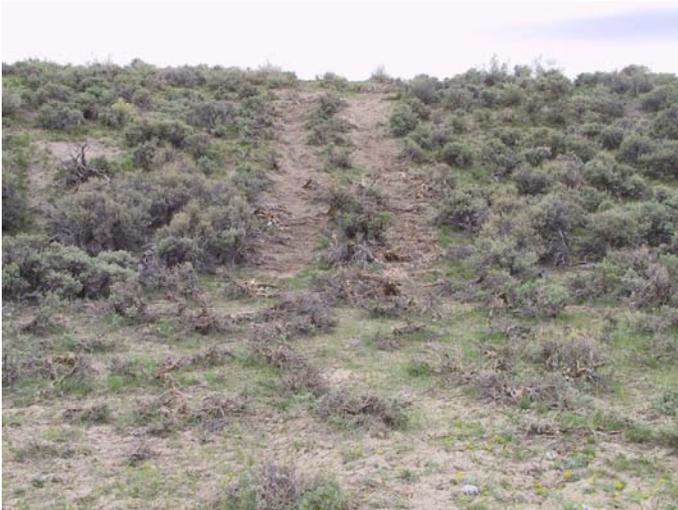
Figure 194

Route AT-105, off-trail damage by heavy equipment. This route is an “intrusion” rather than a “way” as it is impassable to vehicles.

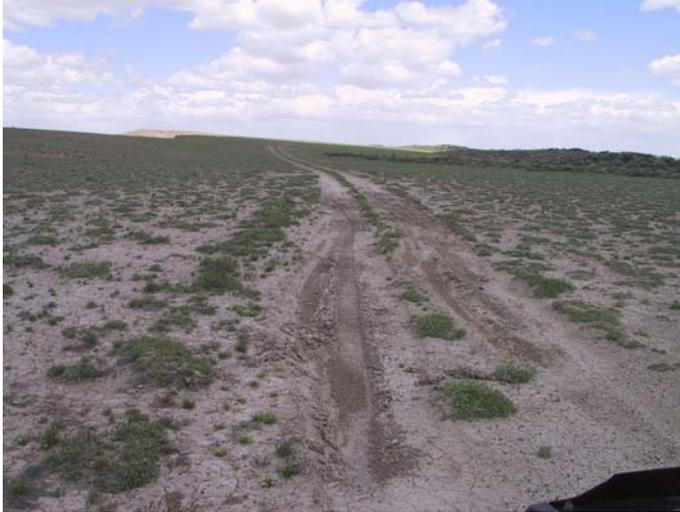
Figure 196

Route AT-107, a dead-end route that ends atop a ridgetop. This route was never constructed, and is maintained solely by the passage of vehicles.

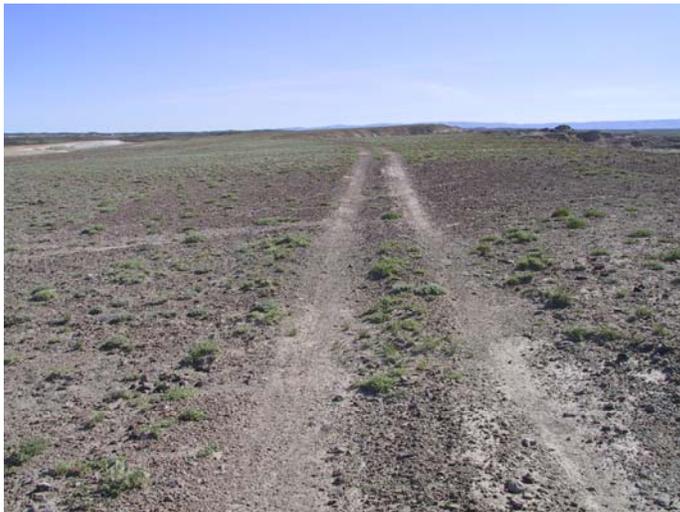
Figure 197

Route AT-108 in its best condition. Never constructed or maintained, this is a classic “way.”

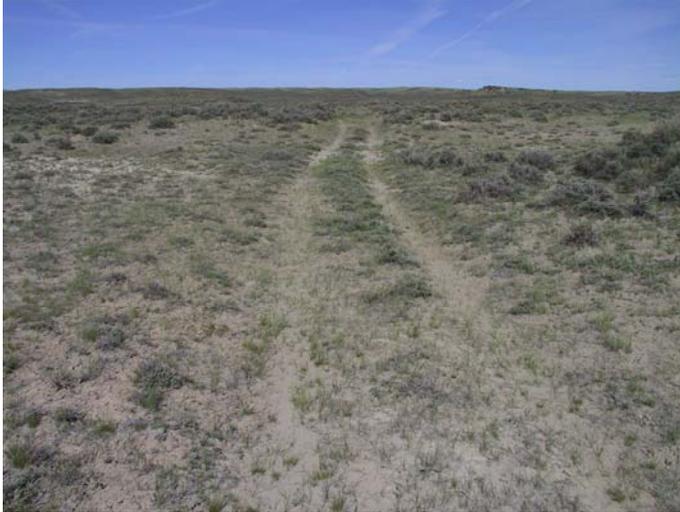
Figure 199

Typical view of AT-109 in its eastern stretch, which does receive some use. This portion qualifies as a “way.”

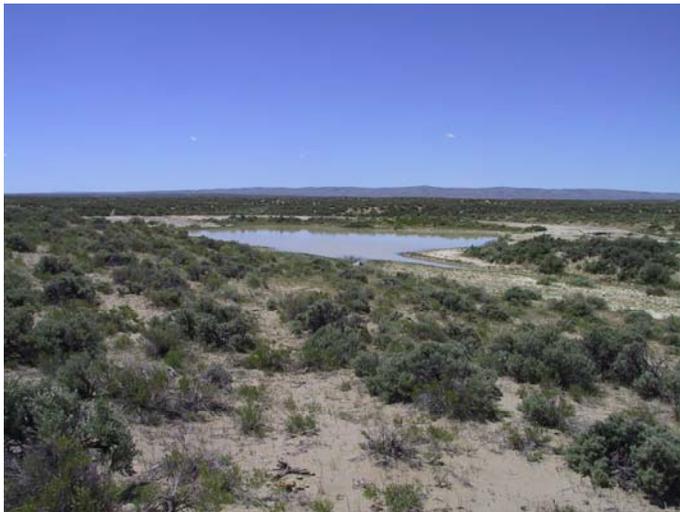
Figure 200

Sand Hill Reservoir, in the East Fork Point proposed expansion. This reservoir is sound and holds water, but its dam is camouflaged with vegetation. It is comparable to reservoirs within the WSA.

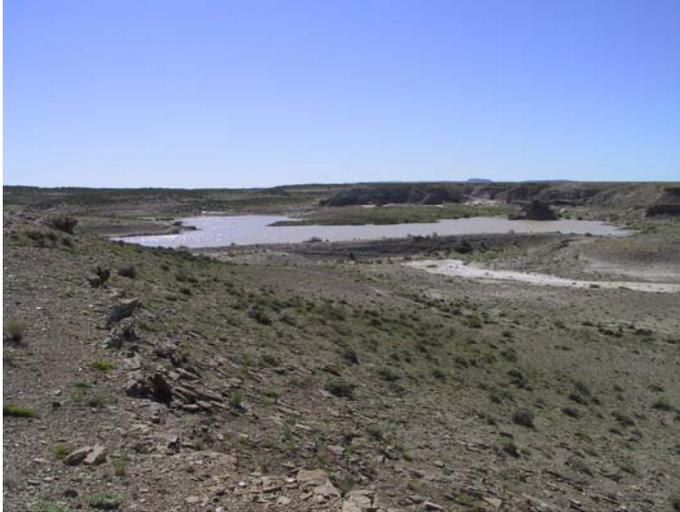
Photo #EMM45-22

East Cow Creek Reservoir, in the East Fork Point proposed expansion. Sound and holding water, this reservoir is tucked away in a pocket in the hills, and is impossible to see unless a visitor is standing at its edge. It is comparable to reservoirs inside the WSA

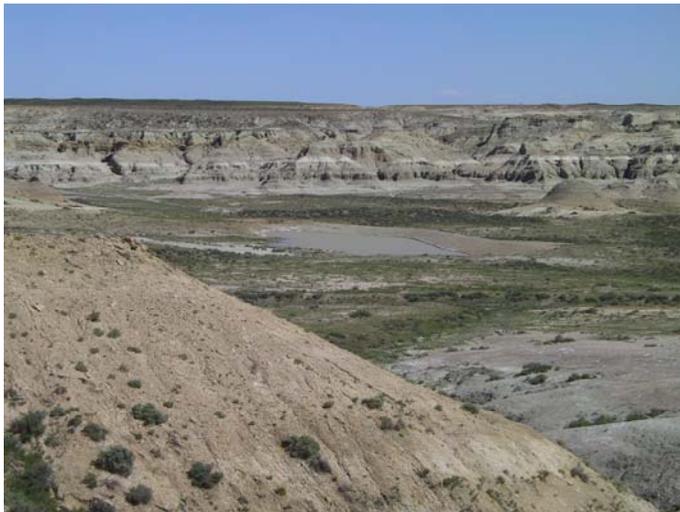
Photo #EMM46-9

No Name Reservoir (number AT-203) within Adobe Town WSA. It is sound and holds water.

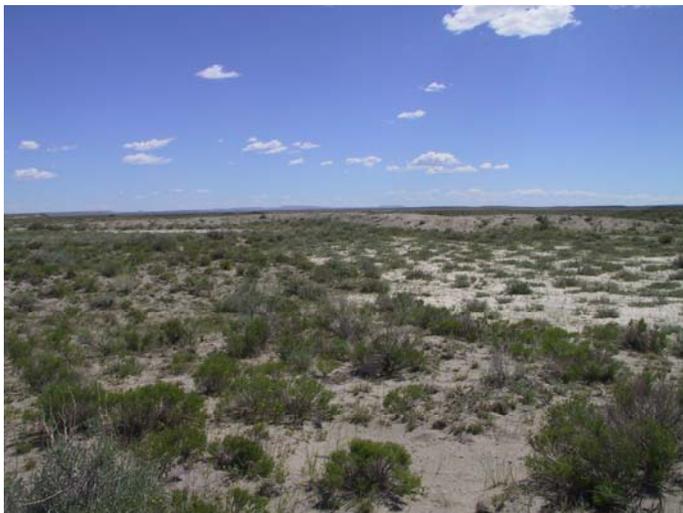
Photo #EMM46-15

Miserable Reservoir (AT-204) within Adobe Town WSA. It is sound and holds water. Its dam is not camouflaged by vegetation, and it is visible at a distance.

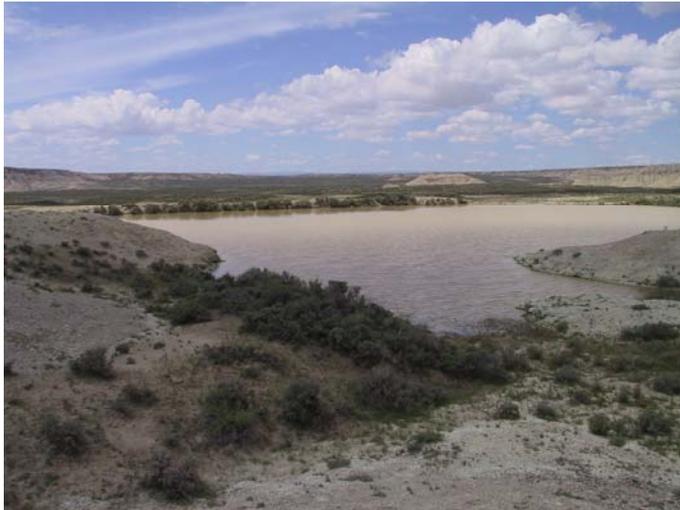
Photo #EMM56-10

Unnamed Reservoir (#AT-206) in the Powder Rim proposed expansion. It is sound and holds water, and blends in well with the surrounding clay badlands.

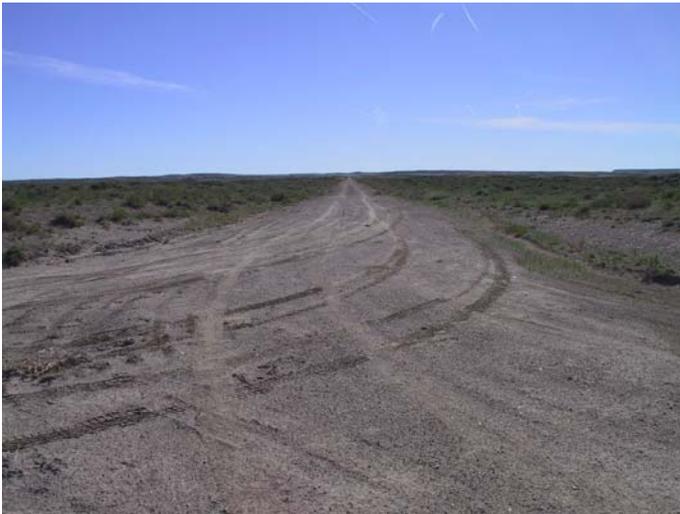
Photo #EMM45-4

Route departs from Route AT-16.  
Evidence of maintenance.

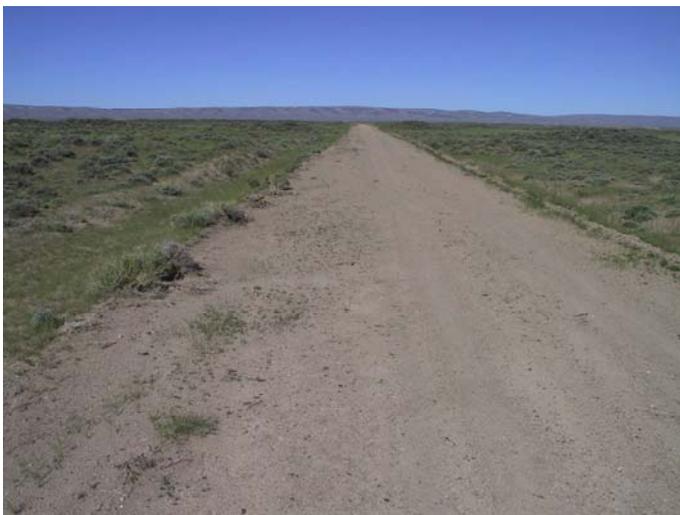
Photo #EMM45-2

Route in its best condition.

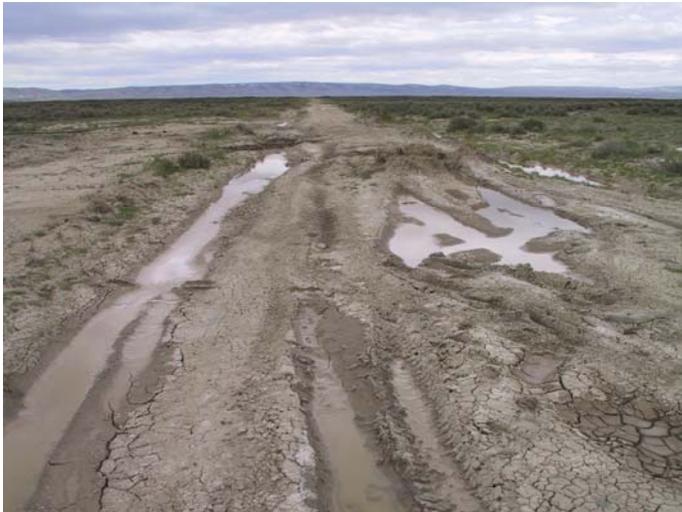
Photo #EMM38-23

Impasse with mud and water just west of junction with route AT-112. At the time this photo was taken, drive-arounds were impassable to all vehicles.

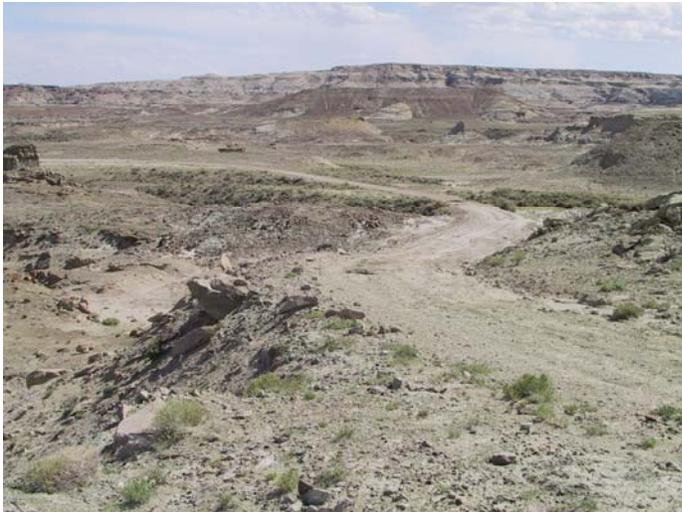
Photo #EMM37-75

Route just east of purported junction with route AT-3. Note cut-and-fill construction.

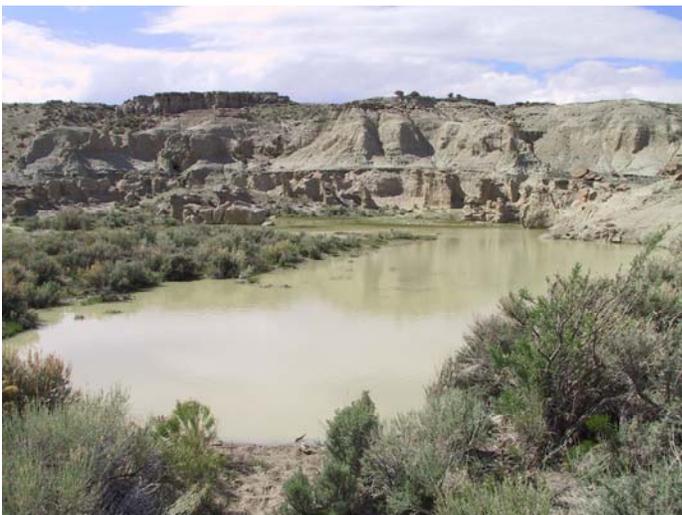
Photo #EMM37-77

Reservoir created by construction of route. No sign of maintenance.

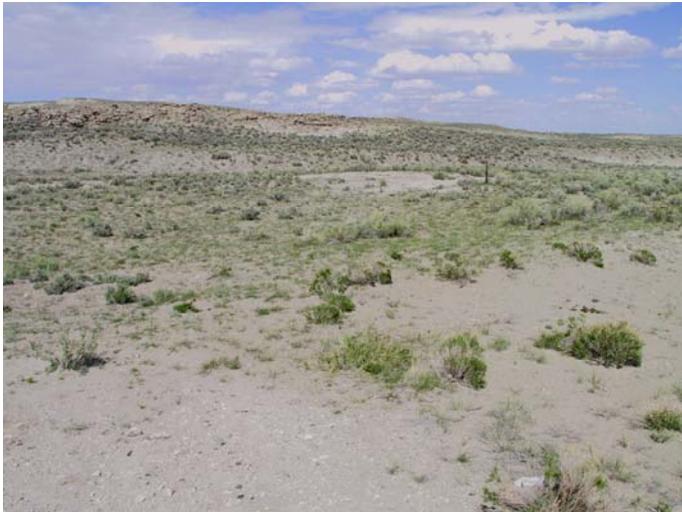
Photo #EMM37-79

Dry hole- Koch Exploration  
Adobetown #1-30. Well pad is  
still visible, but access route is  
reclaimed here.

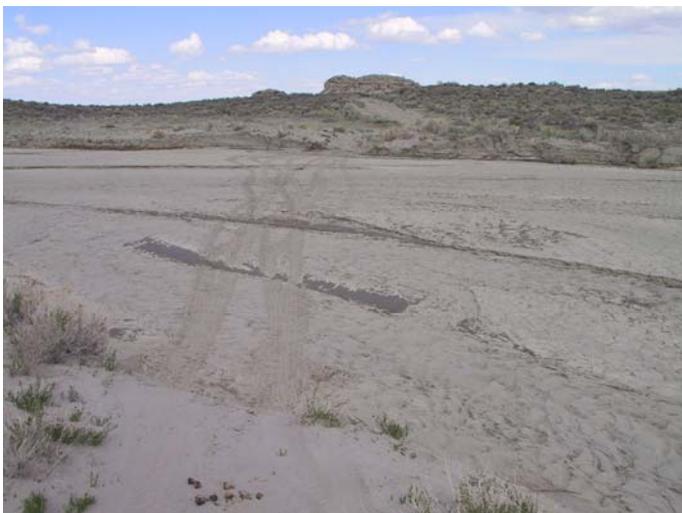
Photo #EMM37-83

Route crosses Sand Creek Wash.  
Evidence of ATV use only at this  
point. Wash has 2-foot banks at  
entrance and exit that are difficult  
to cross with a vehicle.
