**BLM Unit Identification:** Adobe Town WY-030-401 and WY-040-408

**Description** Adobe Town is proposed by the conservation community for wilderness designation. The area proposed for wilderness includes all of the Adobe Town Wilderness Study Area, plus additional lands of wilderness quality in The Haystacks, along Willow Creek and the Willow Creek Rim, and south of the WSA to the Powder Rim and just beyond it. All of these areas possess the full complement of required characteristics for wilderness in abundance: outstanding opportunities for both solitude *and* primitive and unconfined recreation, wilderness-quality naturalness, size (at over 180,000 acres, the citizens proposed Adobe Town wilderness is well above the 5,000-acre minimum), and in addition has outstanding supplemental values such as abundant wildlife, wild horse herds, unique geology, and abundant archaeological and paleontological resources.

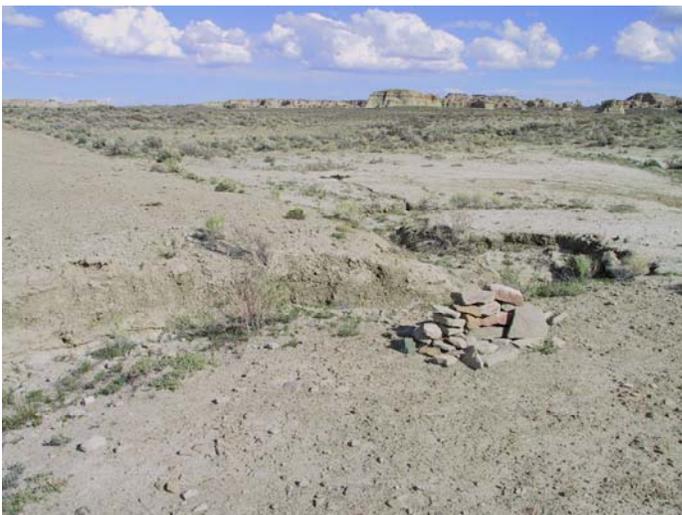
Photo #EMM37-90

Impasse at wash crossing; drive-around.

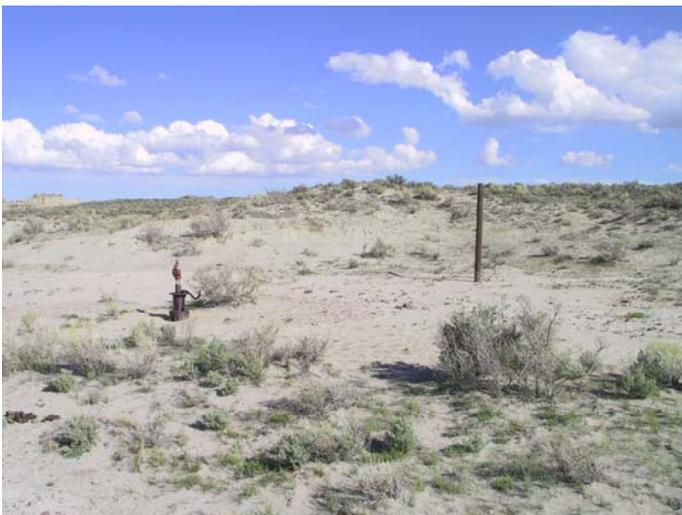
Photo #EMM37-92

Abandoned gas well pad associat-  
ed with Trappers Trail State Fed  
#1 well.

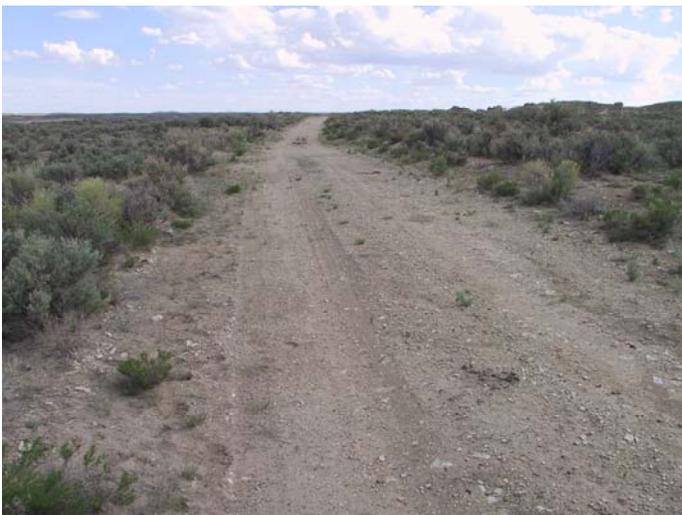
Photo #EMM37-89

Route AT-3 in average condition.  
Note shrubs moving in on route  
grade.

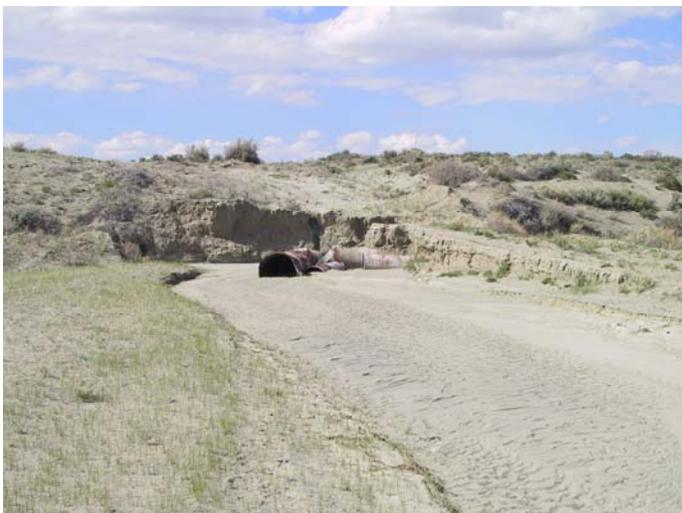
Photo #EMM37-85

Route washed out at wash cross-  
ing--impasse. Note destroyed cul-  
vert.

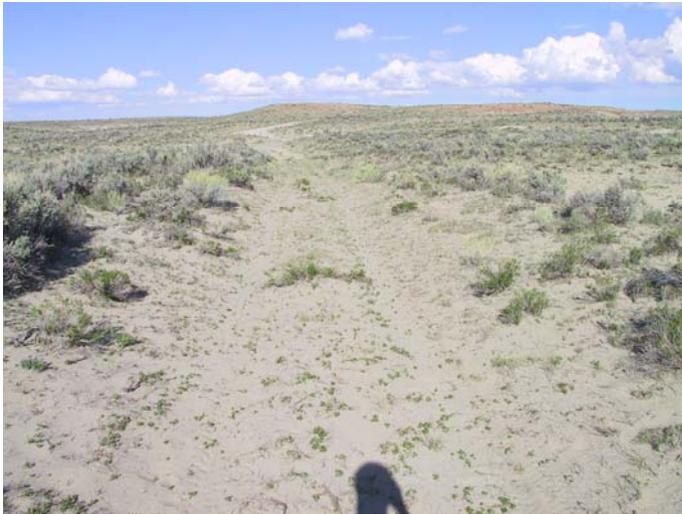
Photo #EMM37-97

Typical of route AT-4 crossing sandy country. Note plants recolonizing trail tread.

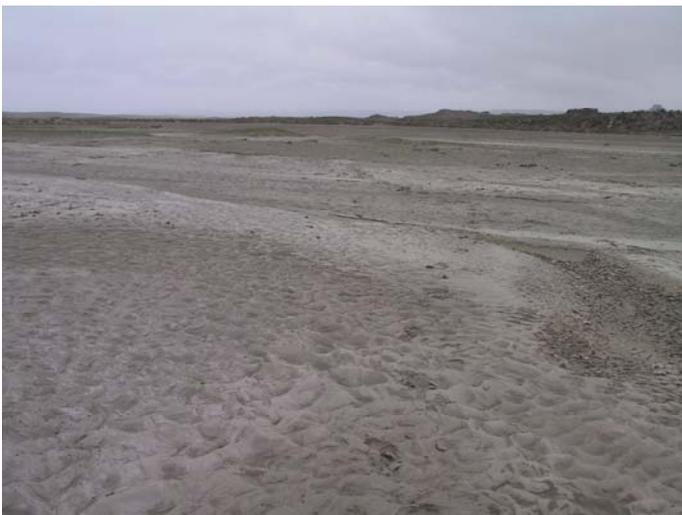
Photo #EMM43-54

Sand Creek Wash crossing--trail is invisible as it crosses wash bed 2-foot banks to negotiate on either side of crossing.

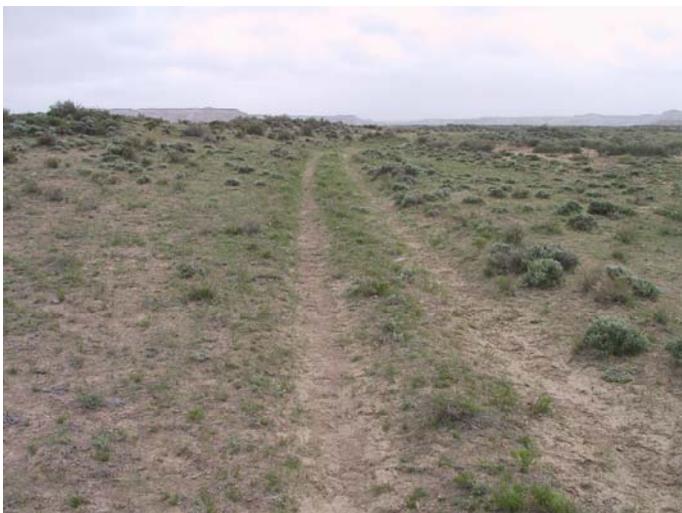
Photo #EMM43-53

Route is fairly well reclaimed here.

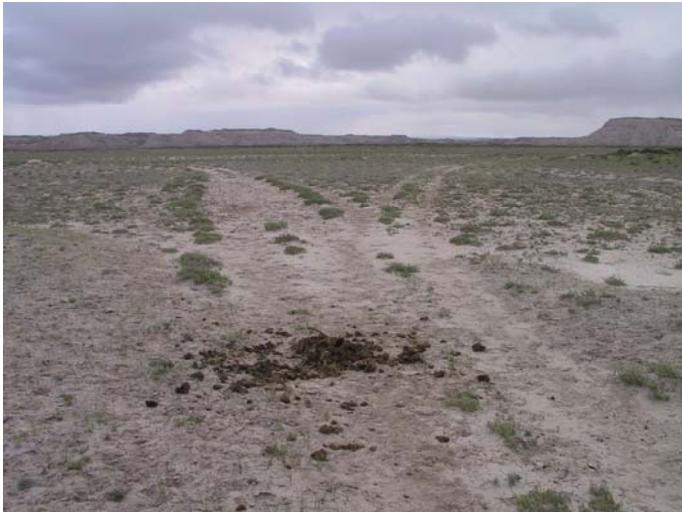
Photo #EMM43-50

Route AT-4 (at left) is joined by  
AT-29 (faint, at right).

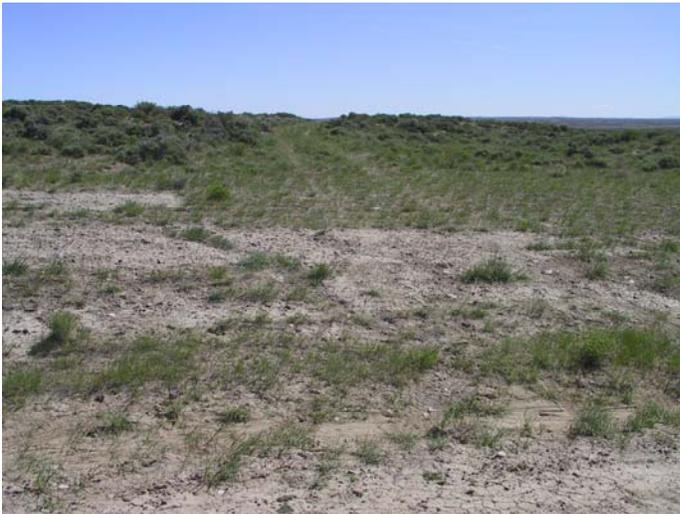
Photo #EMM45-12

Beginning of route, at its  
departure from route AT-16.

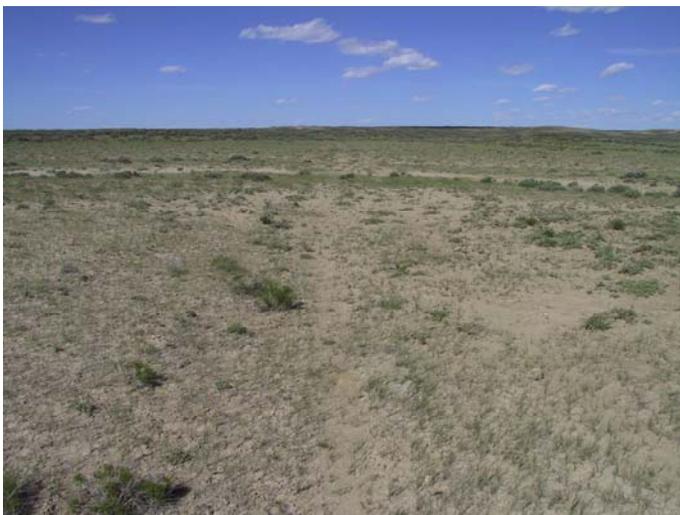
Photo #EMM45-84

Route faintest along the stretch.

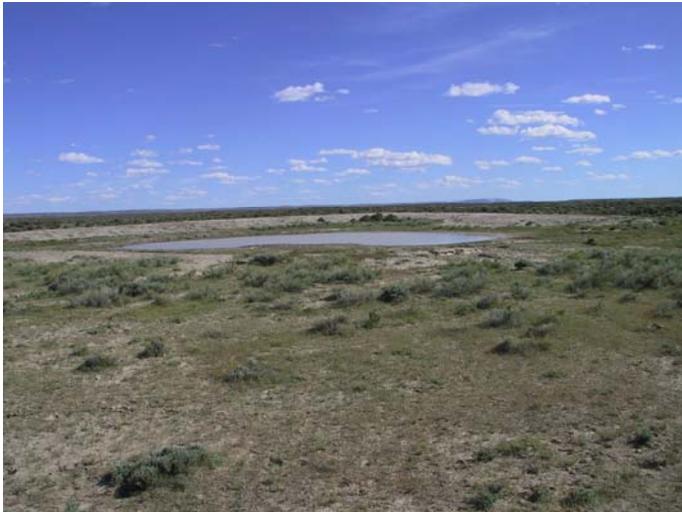
Photo #EMM45-85

Water Can Reservoir. This reservoir still holds some water, but is partially breached at its west end. It was constructed but never maintained.

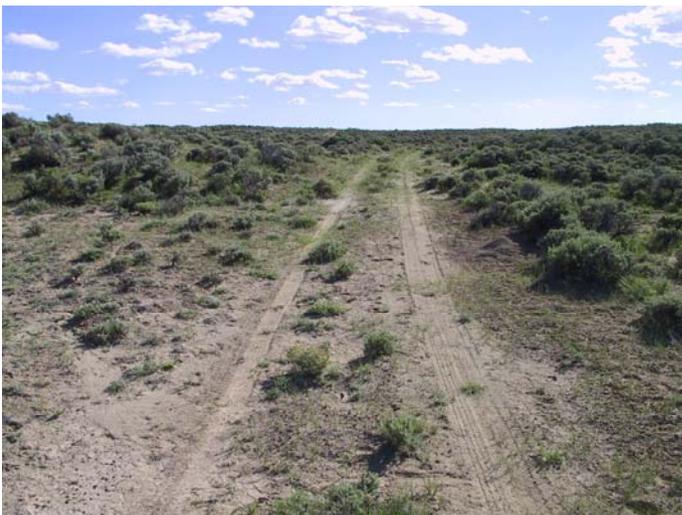
Photo #EMM45-92

Typical view of this route along this section.

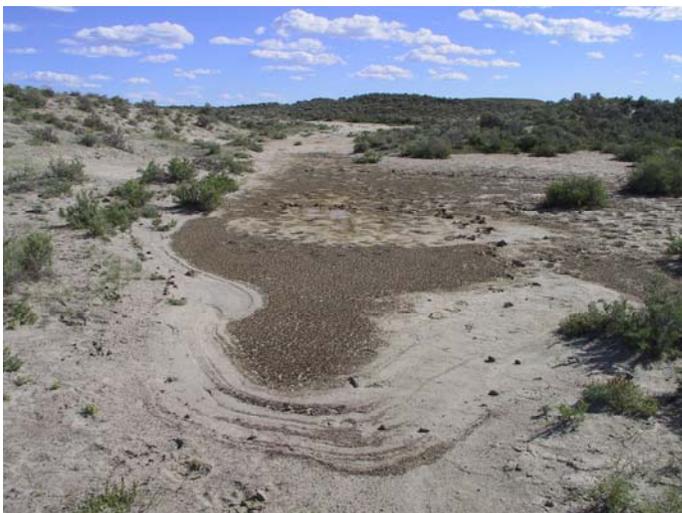
Photo #EMM45-90

Marshy spot in route--this is a seasonal impasse to all vehicular travel.

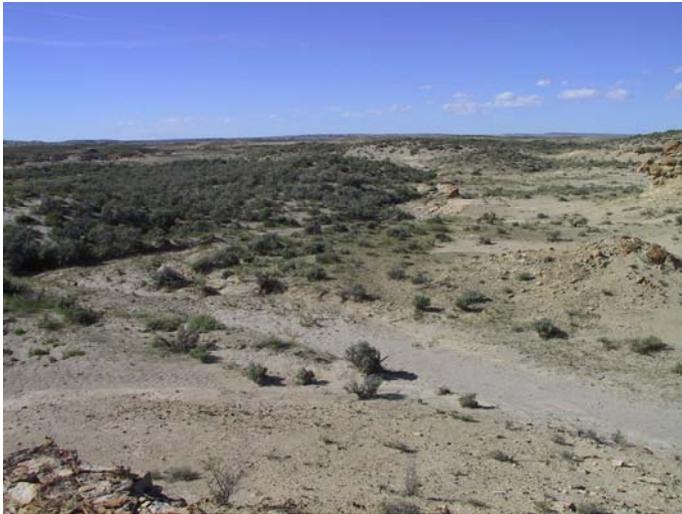
Photo #EMM45-91

Route disappears entirely in wash at this point. There is no evidence of vehicle use here.

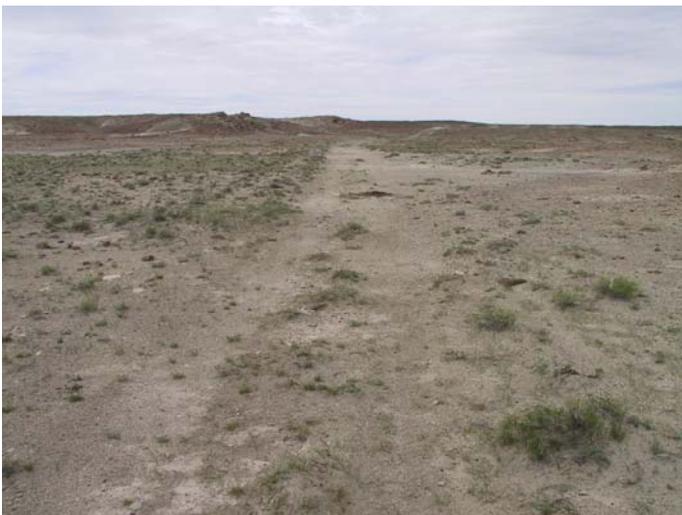
Photo #EMM38-21

View southwest along AT-5 from its junction with AT-6. Route is very faint with no evidence of use at this point.

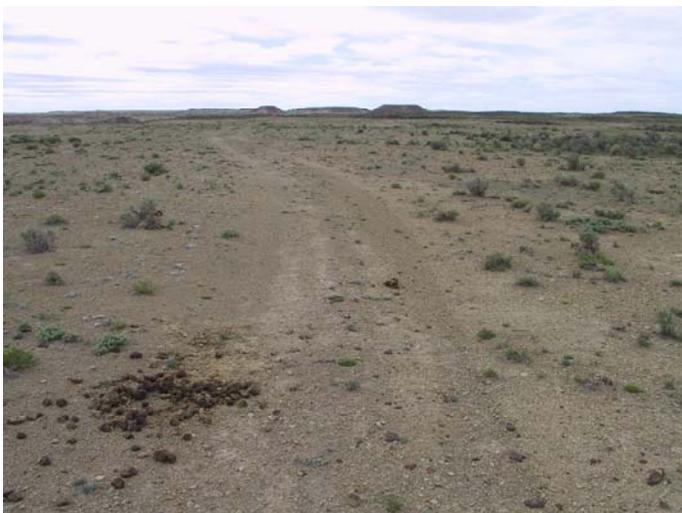
Photo #EMM38-19

Typical view of this stretch of route.

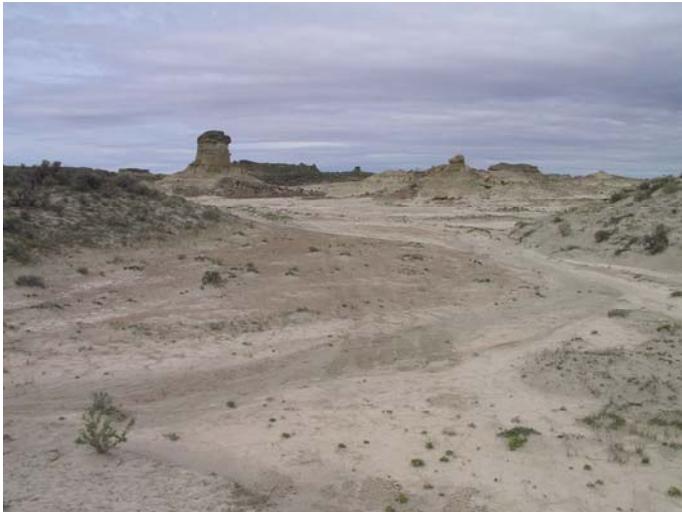
Photo #EMM38-18

Route almost disappears on clay  
beds here.

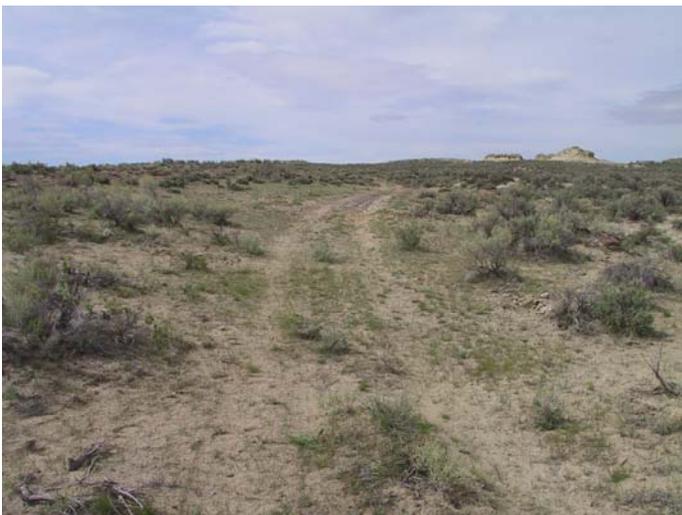
Photo #EMM38-17

Route is rather faint in this locale  
and is starting to become revege-  
tated.

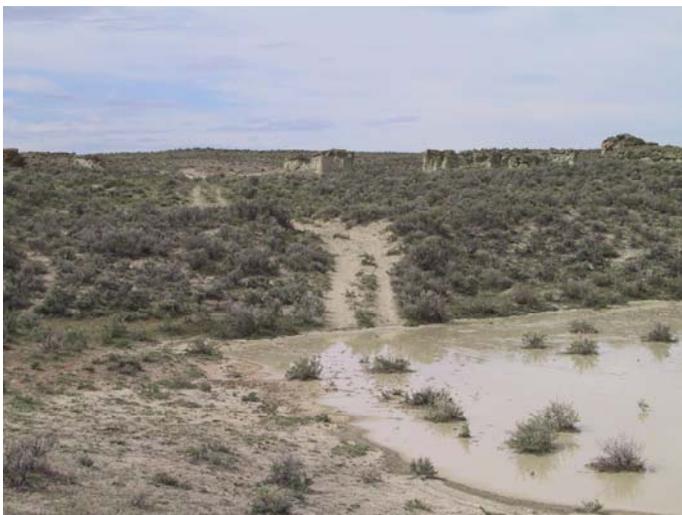
Photo #EMM38-16

Route emerges from swamp. This  
is an impasse to all vehicles dur-  
ing the wet season.

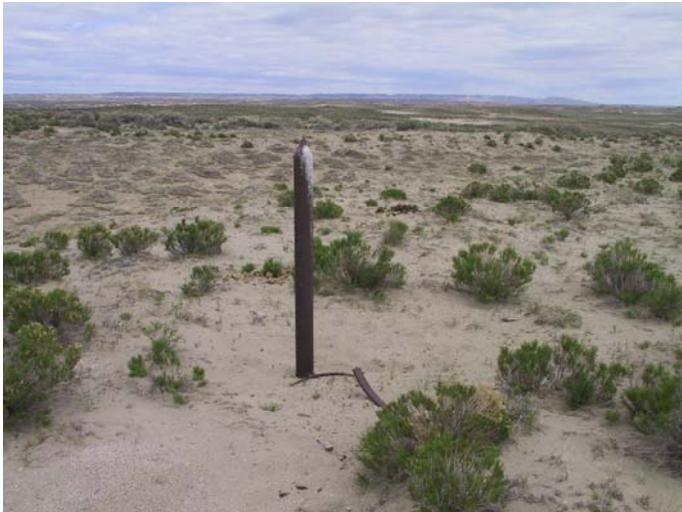
Photo #EMM38-22

Dry hole--Husky Oil Co., TD  
3595 ft., plugged and abandoned  
5/11/76. No evidence of access  
route here.

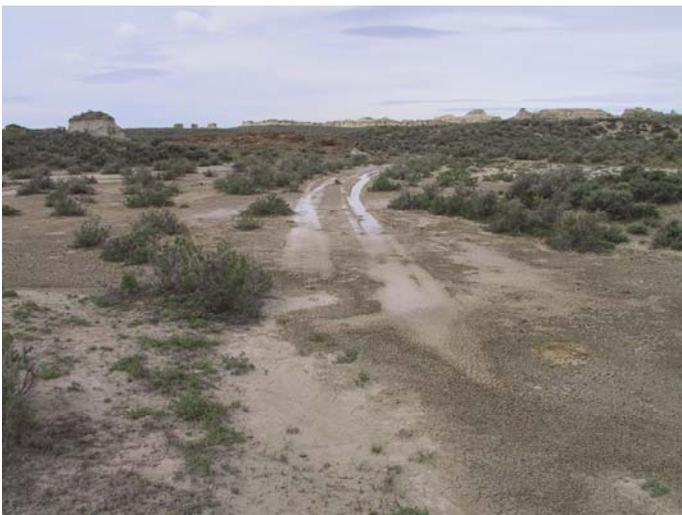
Photo #EMM38-15

Route crosses flooded clay pans.  
This is a seasonal impasse to all  
vehicular access.

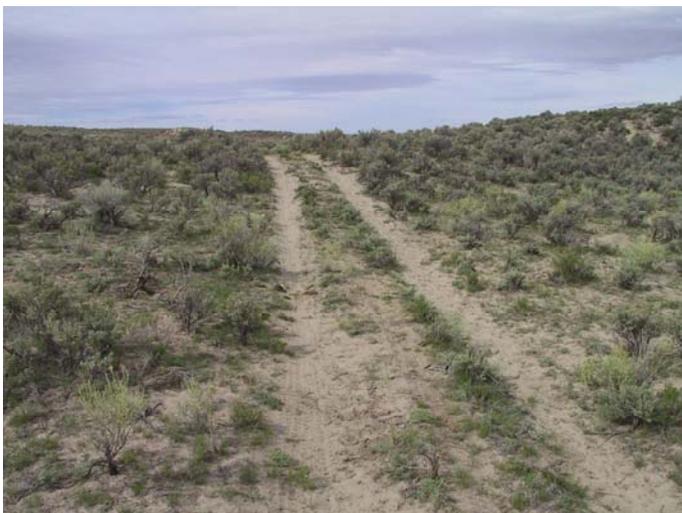
Photo #EMM38-14

Route climbs onto stabilized  
dunes.

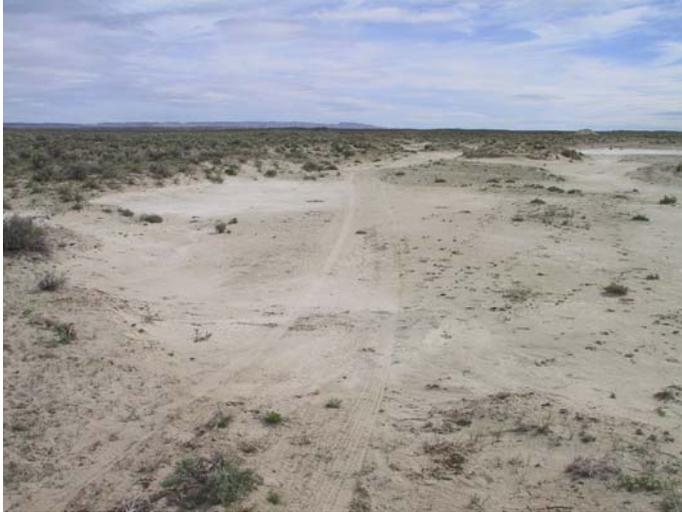
Photo #EMM38-13

Route departs from its erstwhile course in a wash bed.

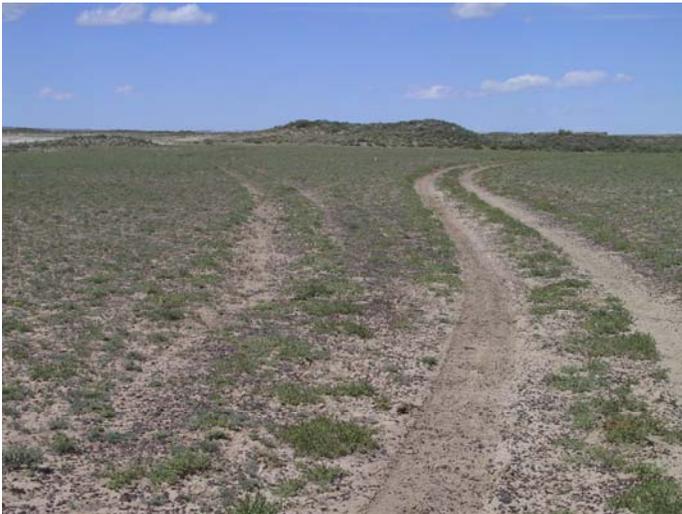
Photo #EMM45-71

Very faint jeep trail AT-6 (at left) splits away from AT-7. There are no signs of vehicle use. Note section line monument in middle distance.

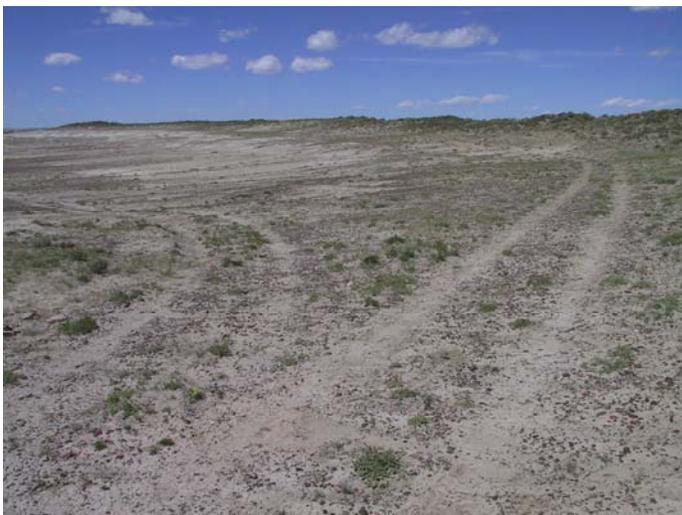
Photo #EMM45-72

Trail splits--original route runs to the west (left), while old drive-around route is to the north (at right).

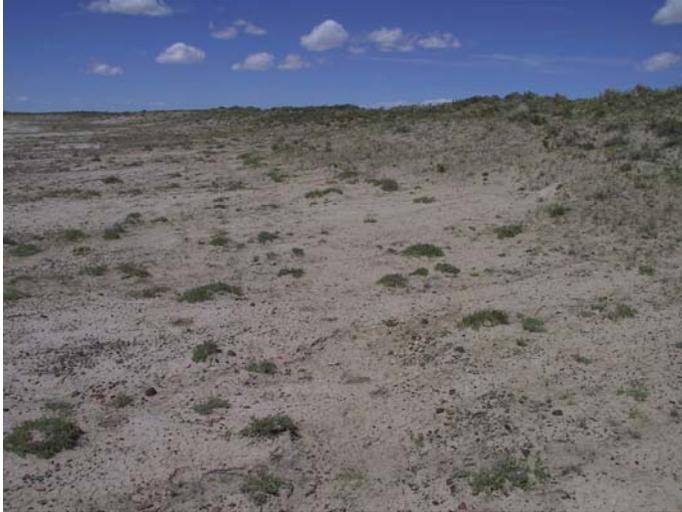
Photo #EMM45-73

Upper route quickly fades to nothing..

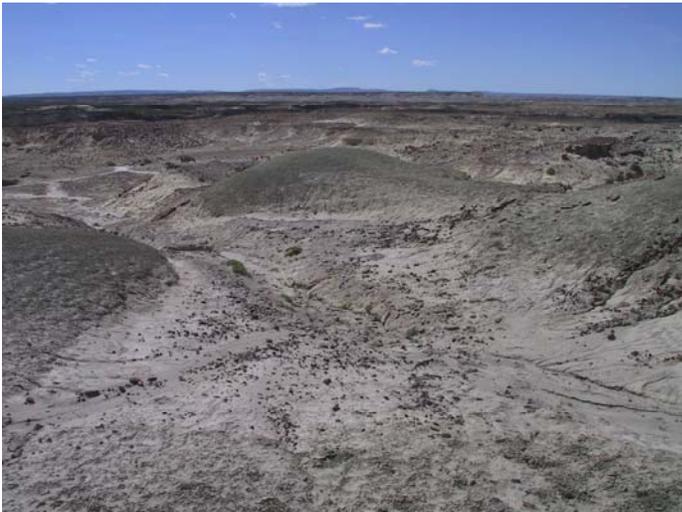
Photo #EMM45-74

Main route is impassable at this point. It is fully reclaimed crossing clay badlands.

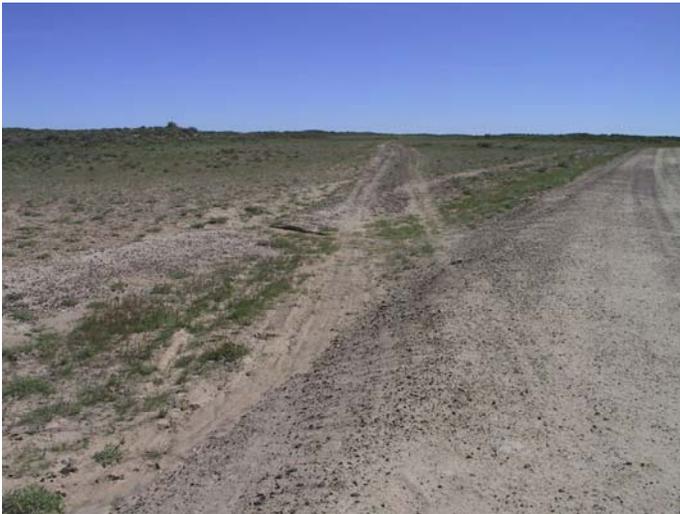
Photo #EMM45-15

Route AT-7 (at left) departs from  
AT-9.

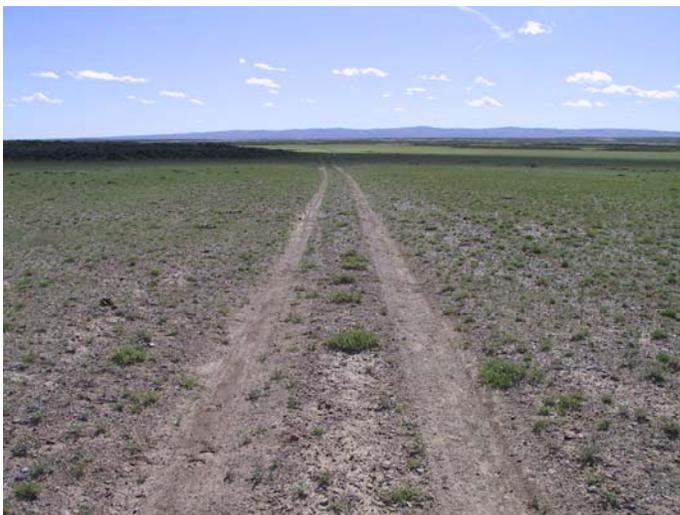
Photo #EMM45-83

Typical view of route AT-7 in  
flats.

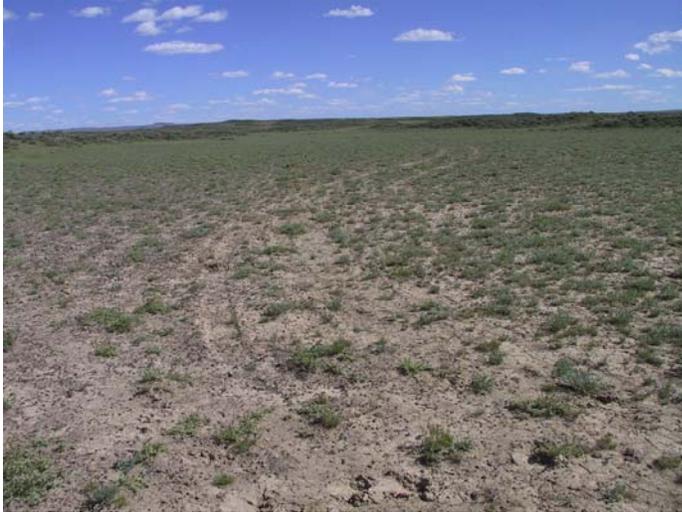
Photo #EMM45-82

One-time-use track departs southward from AT-7.

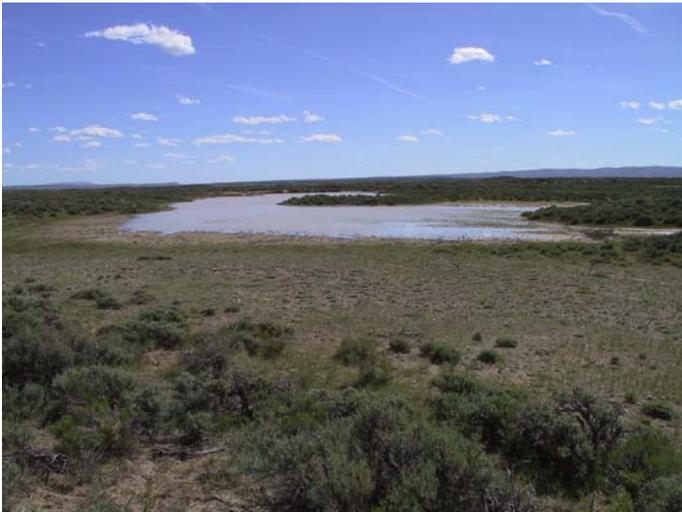
Photo #EMM45-81

Cut Reservoir, just south of AT-7. This reservoir was constructed but not maintained, is sound, and holds water.

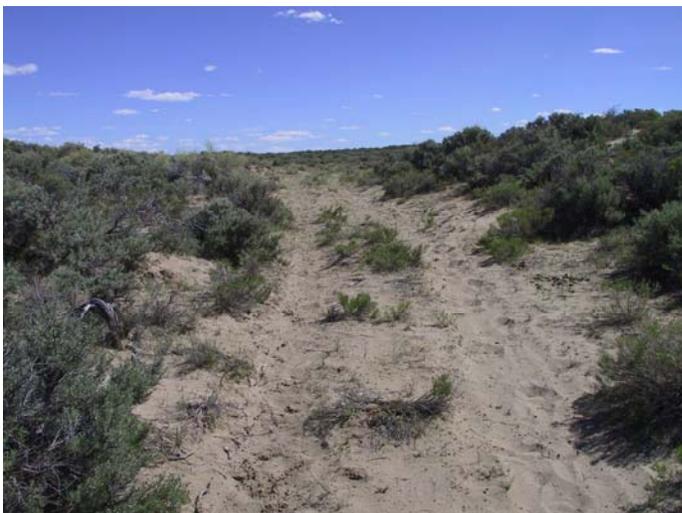
Photo #EMM45-76

Typical of route AT-7 in sandy hillocks.

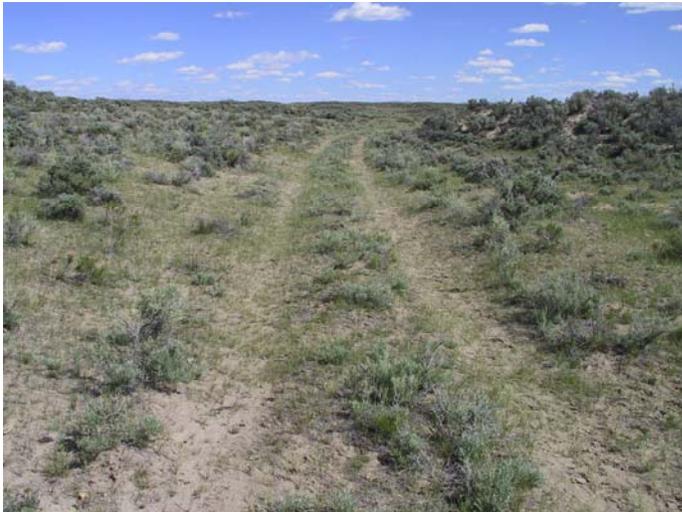
Photo #EMM45-75

Route AT-7 is well-reclaimed at this point.

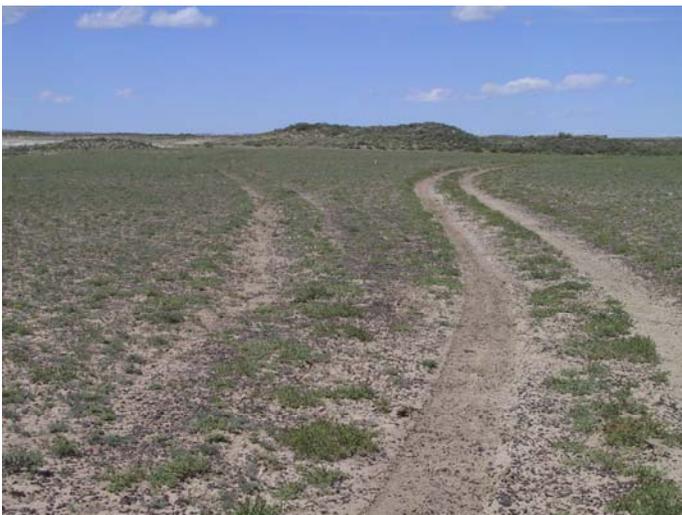
Photo #EMM45-71

Route AT-7 (at right) at its junction with AT-6. This is exemplary of the route at its best.

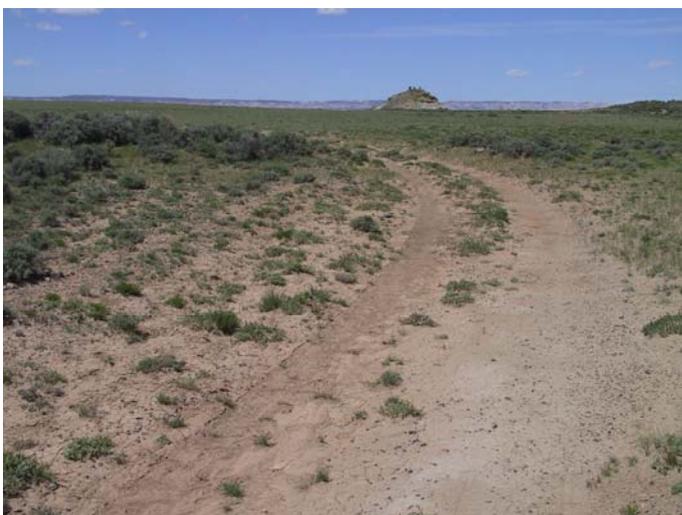
Photo #EMM45-69

Route AT-7 departs westward from cutoff routes to AT-8 and AT-10.

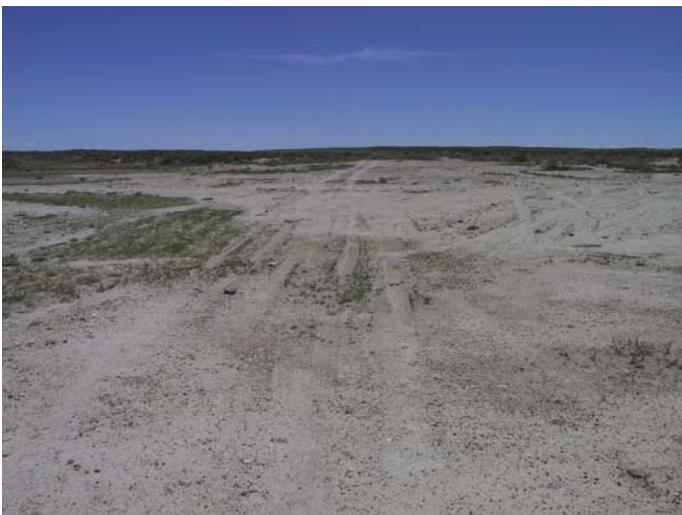
Photo #EMM45-31

Route AT-8 departs from inactive gas well pad.

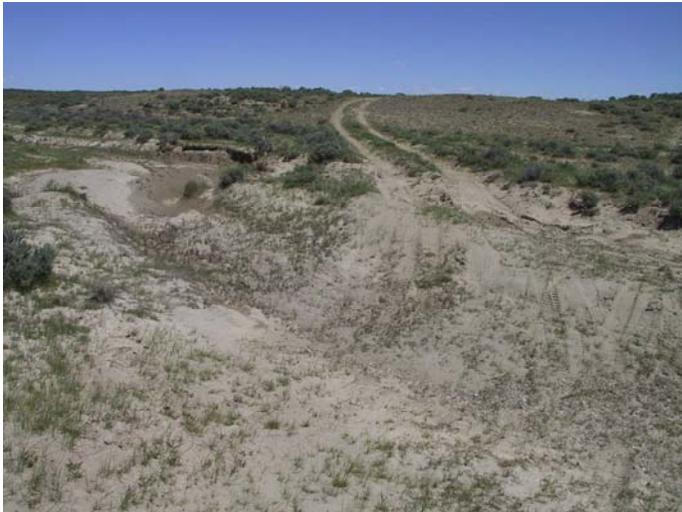
Photo #EMM45-43

Difficult wash crossings like this are characteristic of route AT-8.

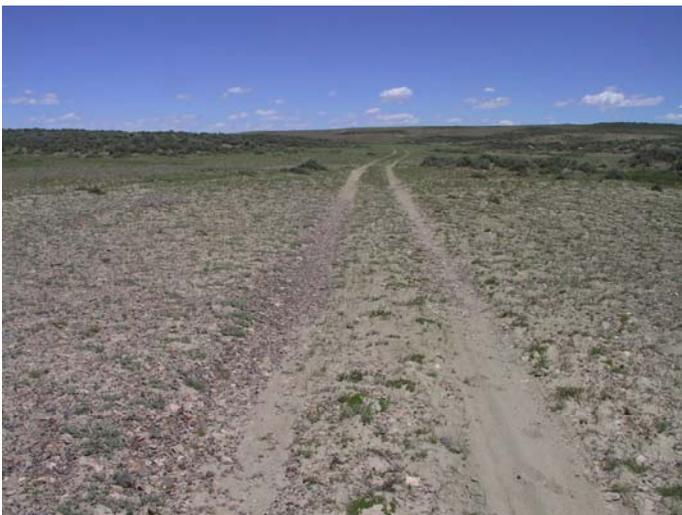
Photo #EMM45-45

Typical view of route AT-8.

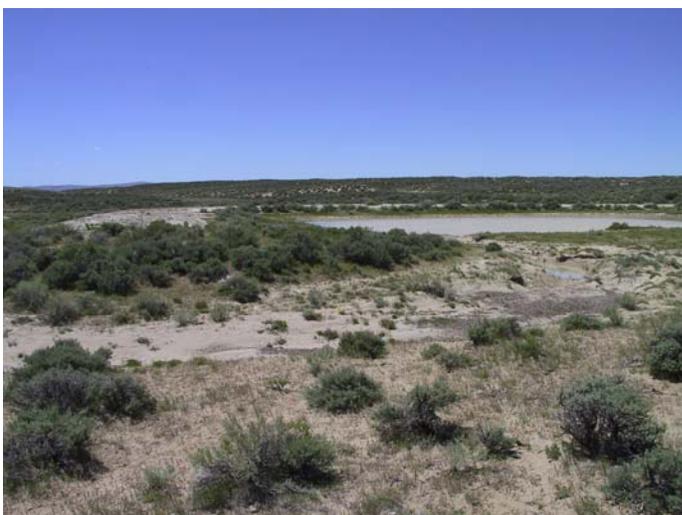
Photo #EMM45-51

Windy Reservoir, constructed but not maintained, holds water but eroding at eastern corner.

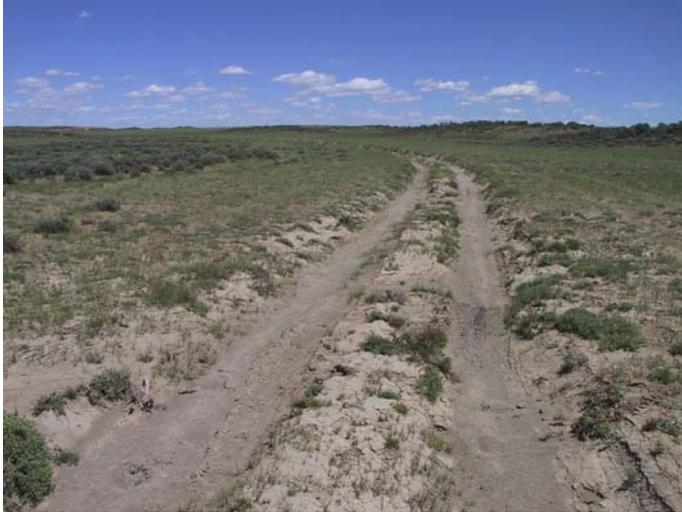
Photo #EMM45-52

Route AT-8 is deeply eroded at this point.

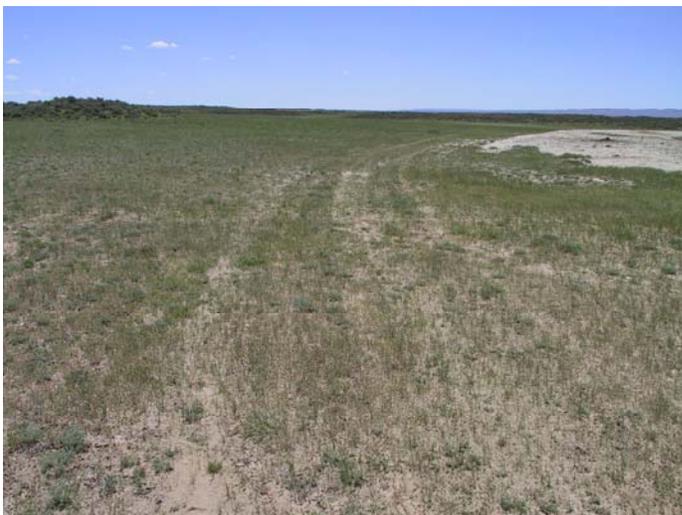
Photo #EMM45-54

Upper Draw Reservoir. Constructed but not maintained, sound, holds water.

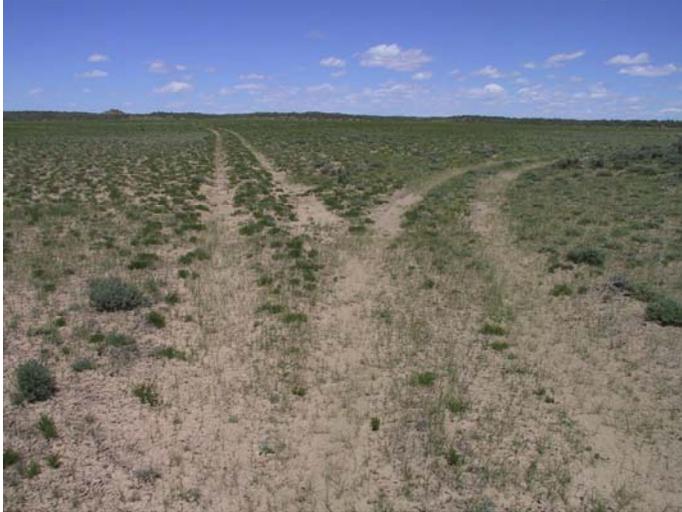
Photo #EMM45-55

Route is most reclaimed as it passes Upper Draw Reservoir.

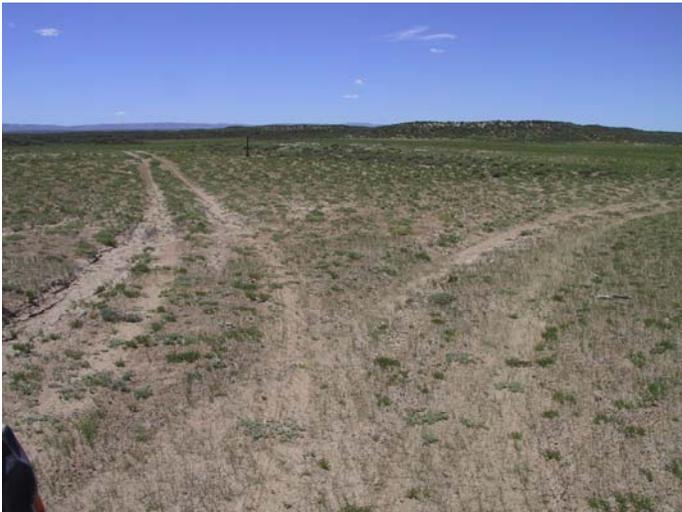
Photo #EMM45-56

Route splits: cutoff to AT-7 is at left, with route to AT-10 at right.

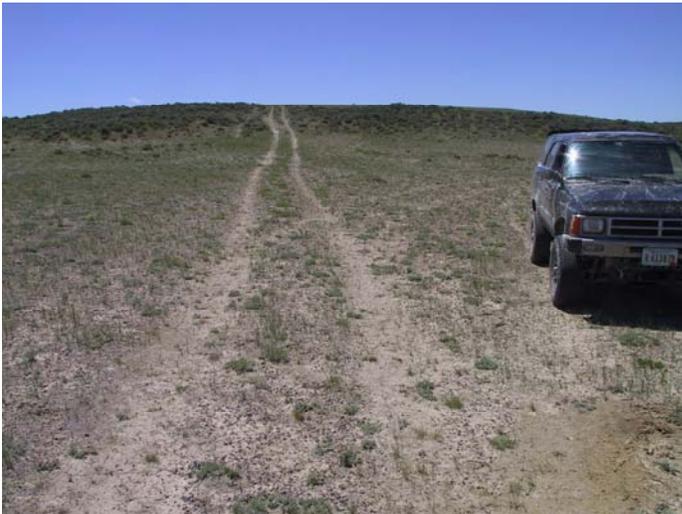
Photo #EMM45-48

This route runs to a hilltop and dead-ends. It is associated with illegal off-trail vehicle use.

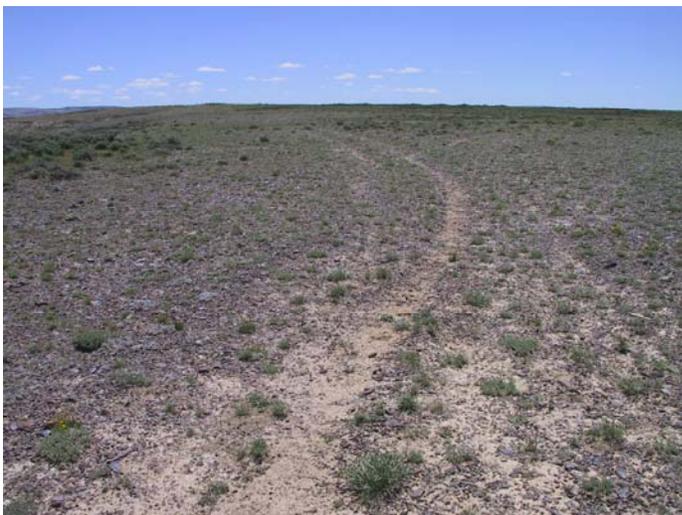
Photo #EMM45-49

Route AT-8a (at left) departs from  
AT-8 near Windy Reservoir.

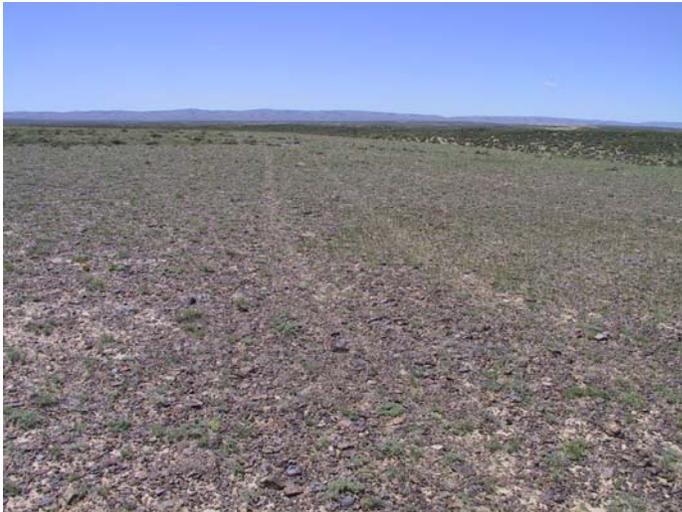
Photo #EMM45-50

Route AT-8A fades out atop rise.

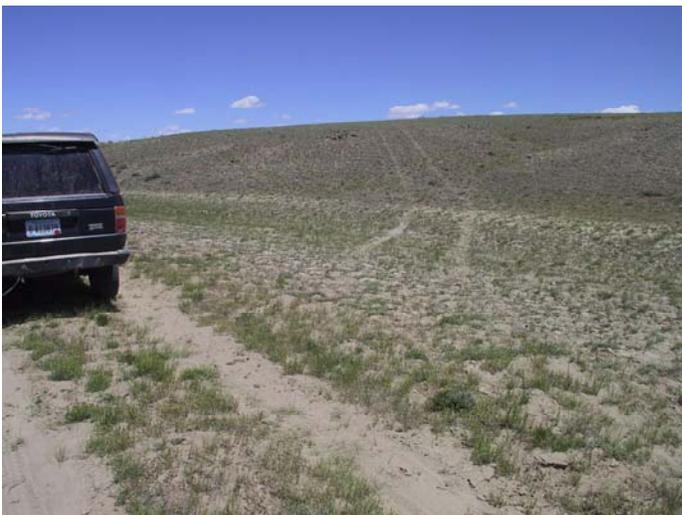
Photo #EMM45-46

Illegal one-time-use trail to the south.

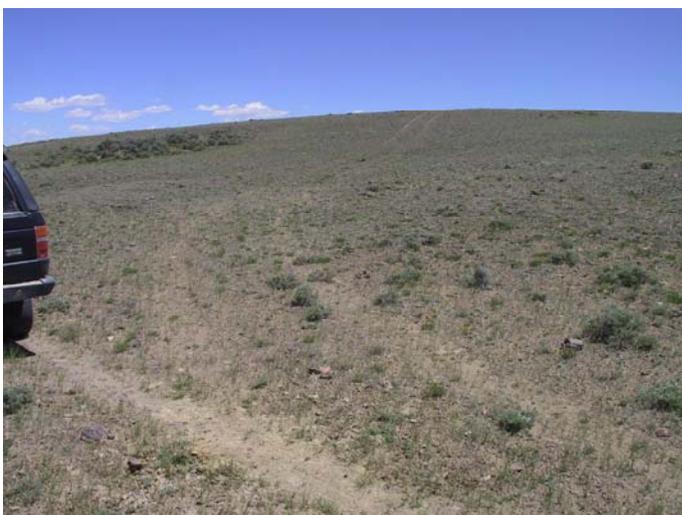
Photo #EMM45-47

Origin of illegal-use trail (right center) from Route AT-8.

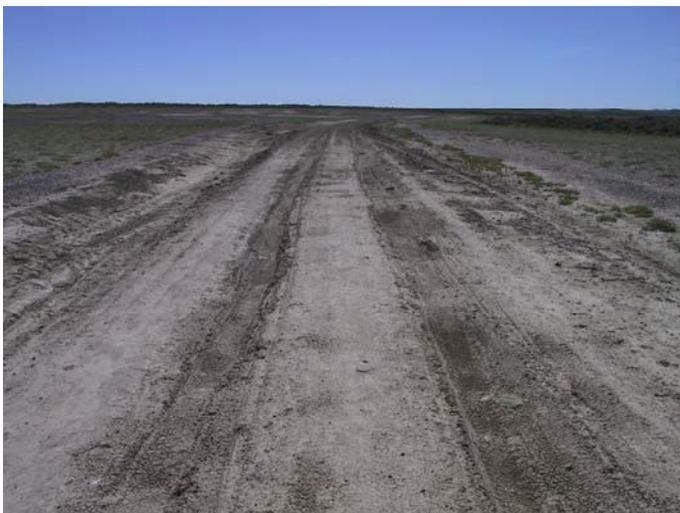
Photo #EMM45-16  
Route AT-9  
UTM 0721029 4557876  
5/22/01

Route AT-9 has become rutted  
and sloppy as a result of wet-  
weather use.

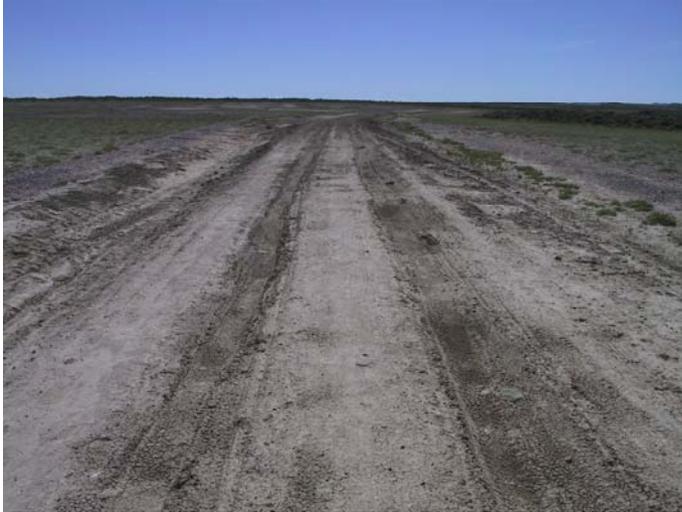
Photo #EMM45-16

Route AT-9 has become rutted and sloppy as a result of wet-weather use.

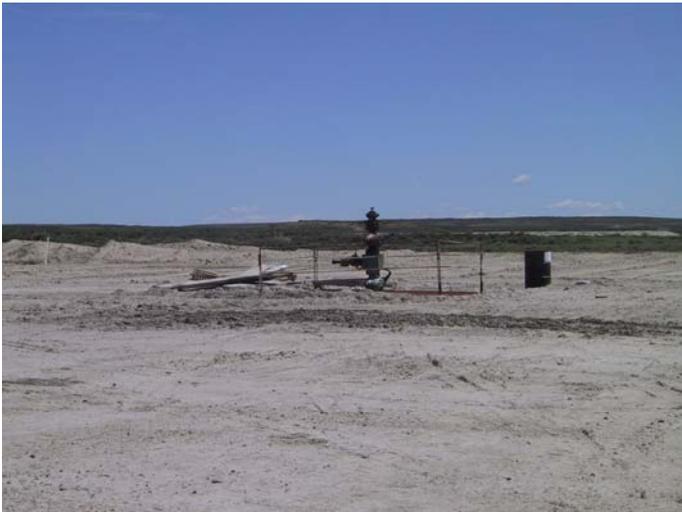
Photo #EMM45-23

Drilling pad. Well tree on north-west side.

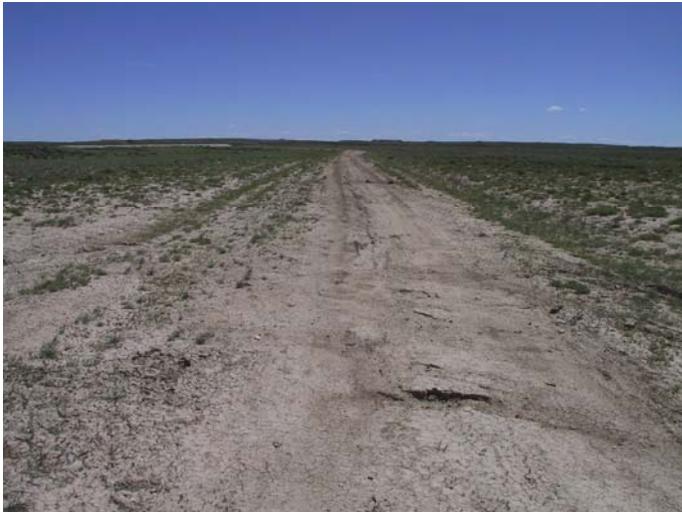
Photo #EMM45-25

Route is more primitive beyond first well pad. Note erosion, plants growing on route crown indicating a lack of blading.

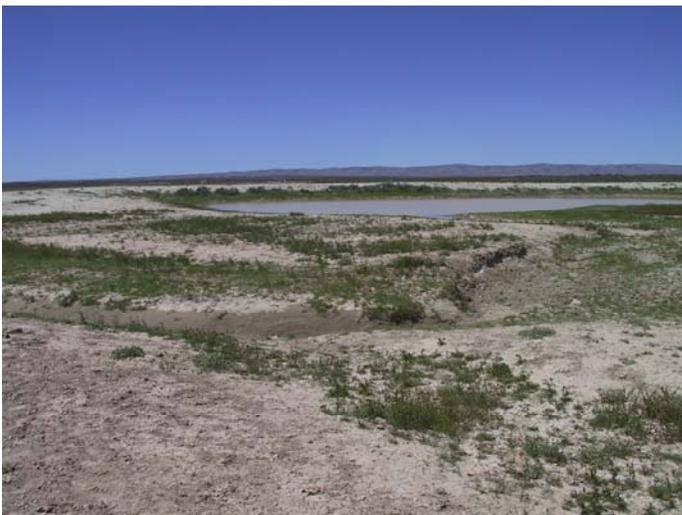
Photo #EMM45-26

Dead Cow Reservoir. This reservoir is constructed but not maintained, is sound and holds water.

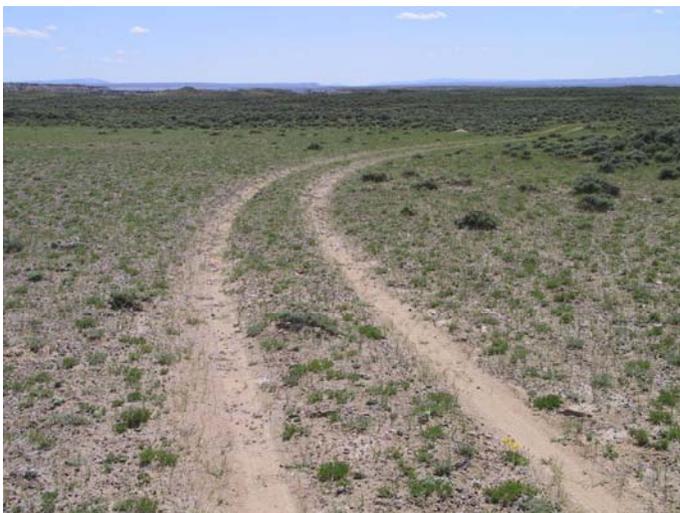
Photo #EMM45-67  
Route AT-10  
UTM 0721029 4557876  
5/22/01

Route in typical condition.

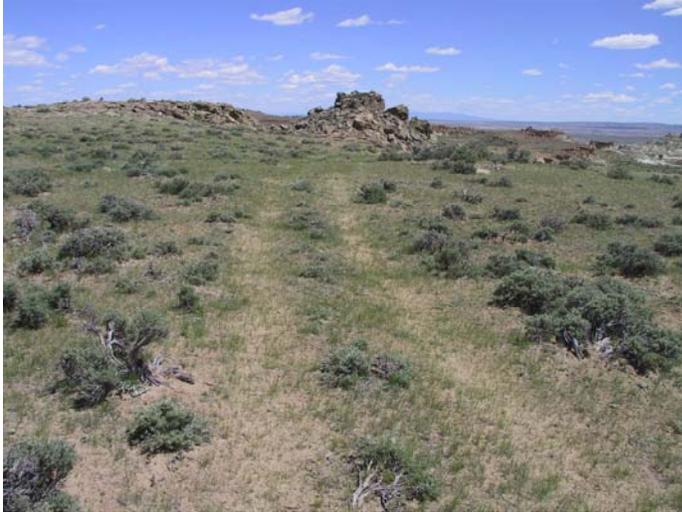
Photo #EMM45-61

Route AT-10 is much fainter here.  
There is no evidence of recent  
vehicle use beyond this point.

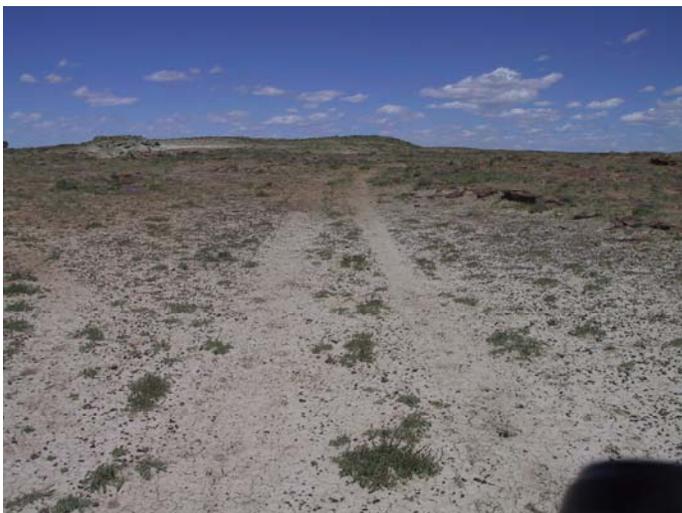
Photo #EMM45-62

Route AT-10 is very faint as it  
crosses clay beds.

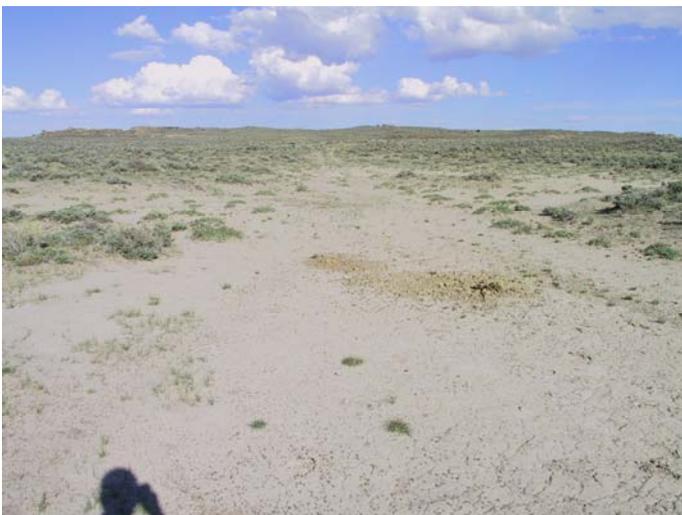
Photo #EMM37-99

Route AT-12 departs from AT-4.  
It is very faint at this point.

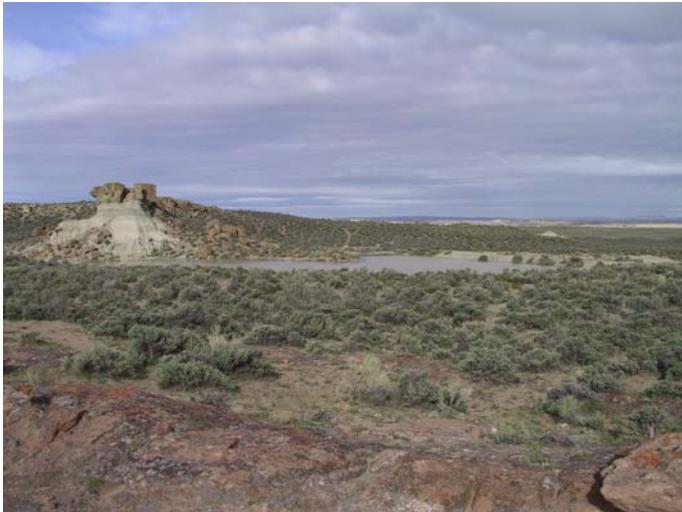
Photo #EMM38-1

No Name Reservoir. Constructed but not maintained; sound, holds water.

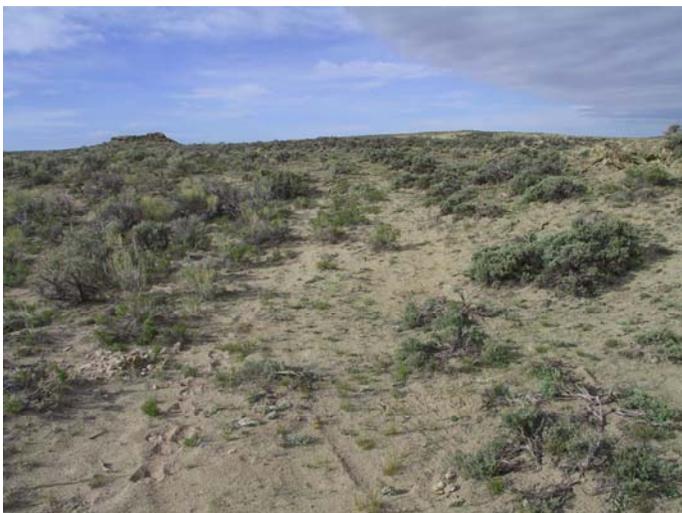
Photo #EMM38-4

Route is very faint and well-reclaimed at this point.

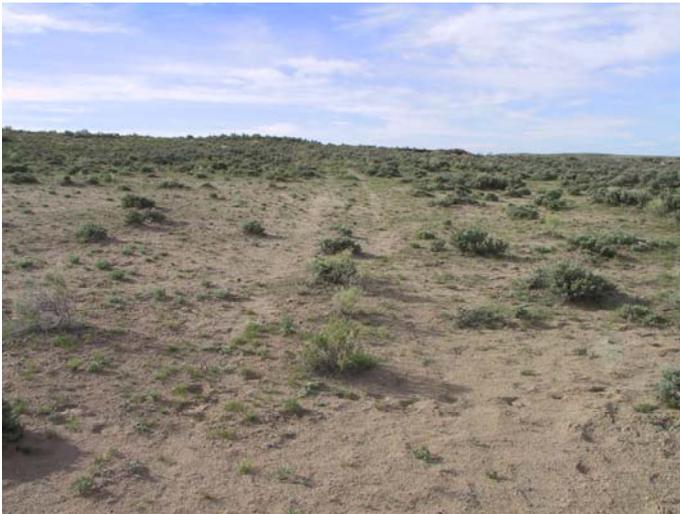
Photo #EMM38-3

Route AT-13 runs southeast from junction above No Name Reservoir. It is well-reclaimed at this point.

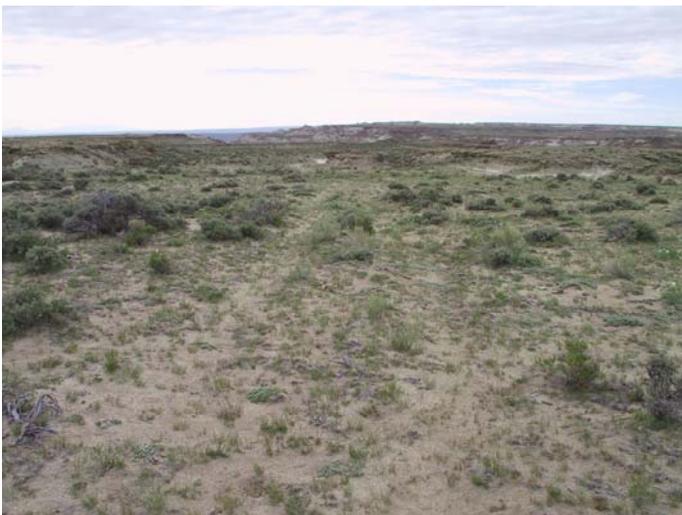
Photo #EMM38-10

Route is very faint here.
