**BLM Unit Identification:** Adobe Town WY-030-401 and WY-040-408

**Description** Adobe Town is proposed by the conservation community for wilderness designation. The area proposed for wilderness includes all of the Adobe Town Wilderness Study Area, plus additional lands of wilderness quality in The Haystacks, along Willow Creek and the Willow Creek Rim, and south of the WSA to the Powder Rim and just beyond it. All of these areas possess the full complement of required characteristics for wilderness in abundance: outstanding opportunities for both solitude *and* primitive and unconfined recreation, wilderness-quality naturalness, size (at over 180,000 acres, the citizens proposed Adobe Town wilderness is well above the 5,000-acre minimum), and in addition has outstanding supplemental values such as abundant wildlife, wild horse herds, unique geology, and abundant archaeological and paleontological resources.

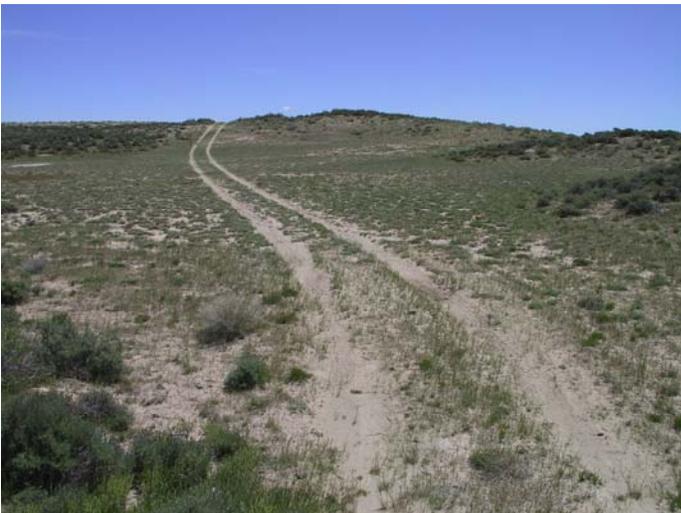
Photo #EMM45-32

Jeep trail AT-14 runs east from well pad.

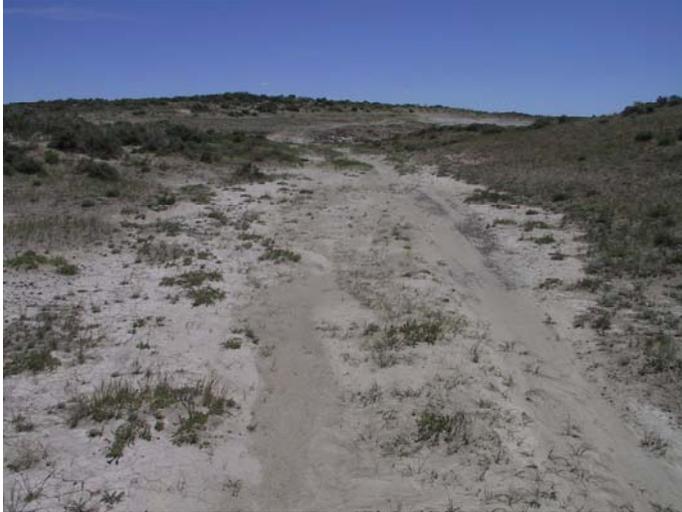
Photo #EMM45-33

Jeep trail is less evident at this point.

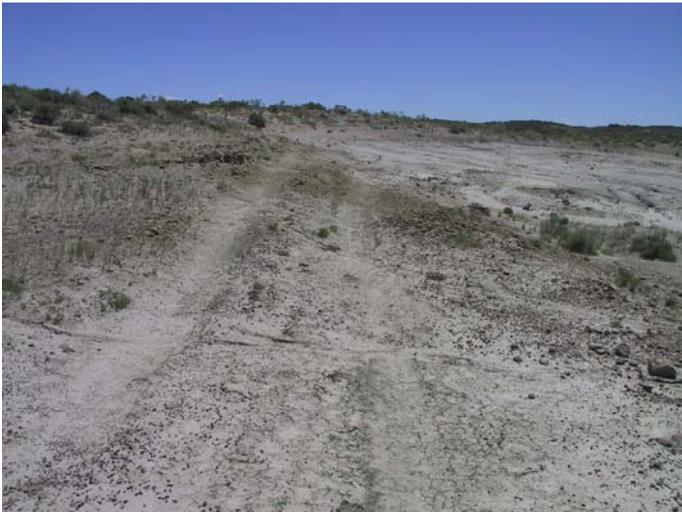
Photo #EMM45-39

Jeep trail is most primitive here.

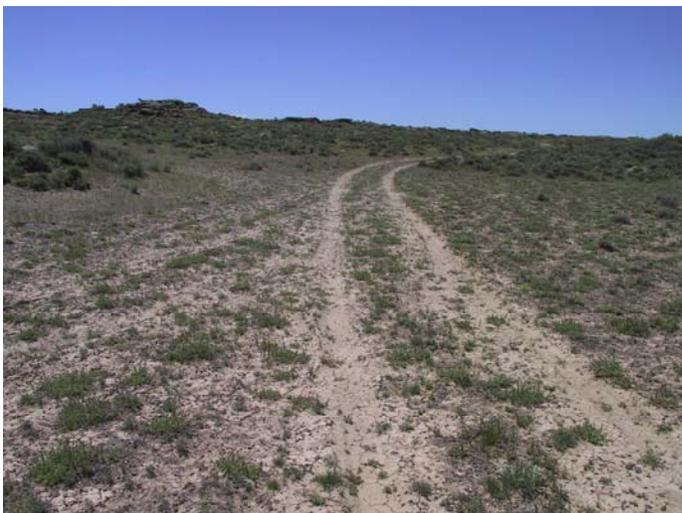
Photo #EMM45-34

Main track AT-14 is typical as it runs south from its junction with AT-14A.

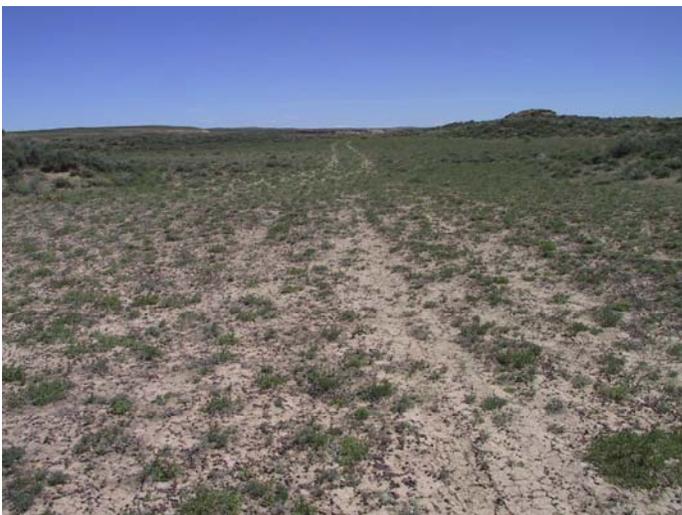
Photo #EMM45-35

Trail to north has the character of  
a one-time-use track as it departs  
from AT-14.

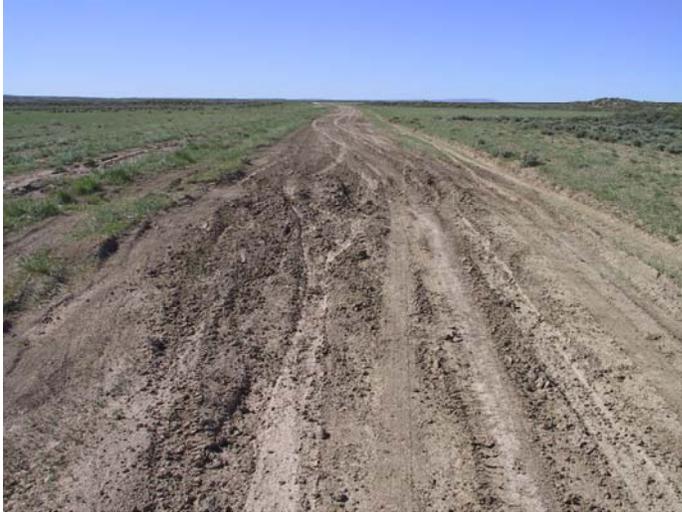
Photo #EMM45-8

Route is in poor condition here  
due to wet-weather use.

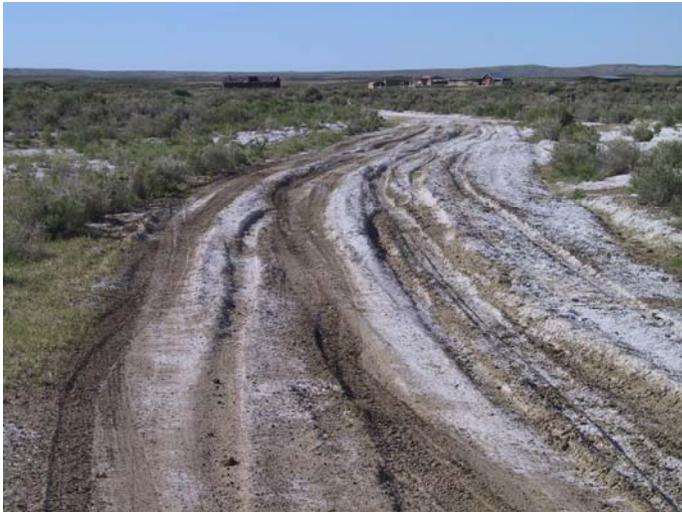
Photo #EMM46-2

View south along AT-16 from junction with cutoff to AT-9. This portion of route crosses an alkali bog, and is in very poor condition. Note buildings of Cow Creek Ranch in background.

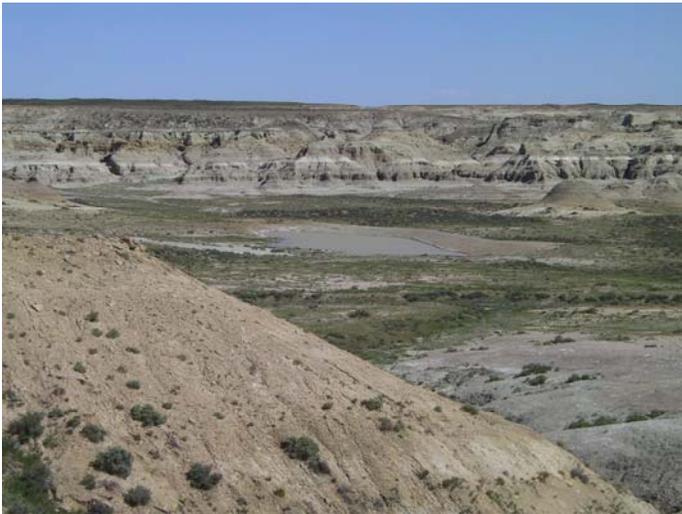
Photo #EMM46-15

Miserable Reservoir, which lies within Adobe Town WSA. The reservoir was constructed but not maintained, and is sound with water present.

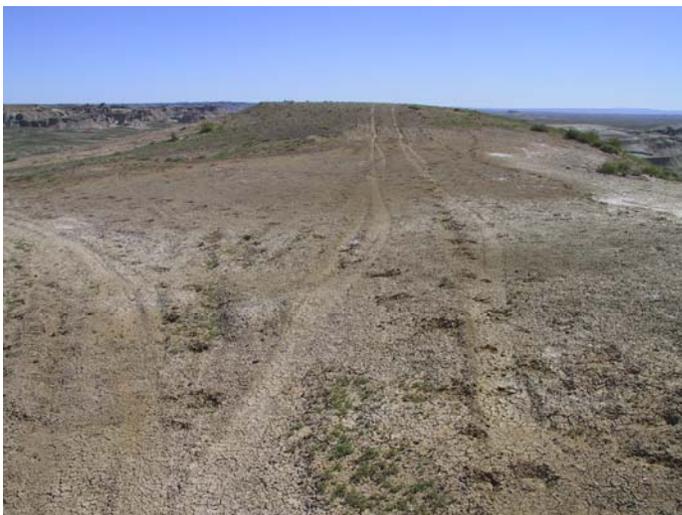
Photo #EMM46-16

The one-time-use track to the top of the knob represents the original course of the route. It is now impassable with a drive-around to the north.

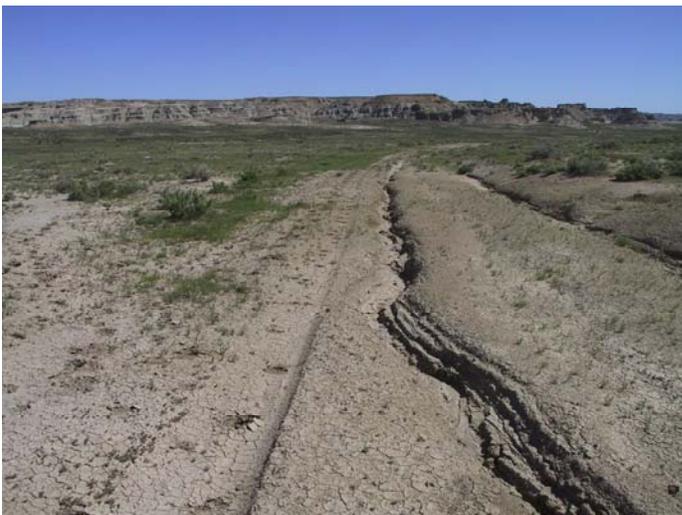
Photo #EMM46-19

The main route is eroding badly here.

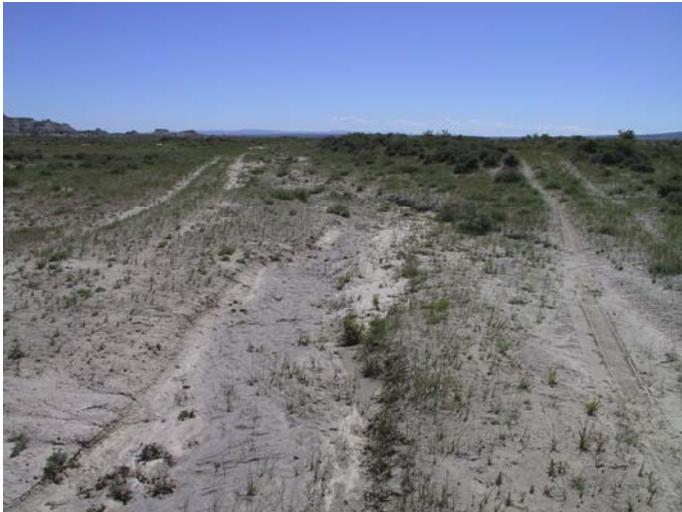
Photo #EMM46-21

Heavy erosion along former route AT-17 (at left). Junction with seismograph trail AT-38. All vehicle traffic now follows AT-38 (at right), with AT-17 totally abandoned beyond this point.

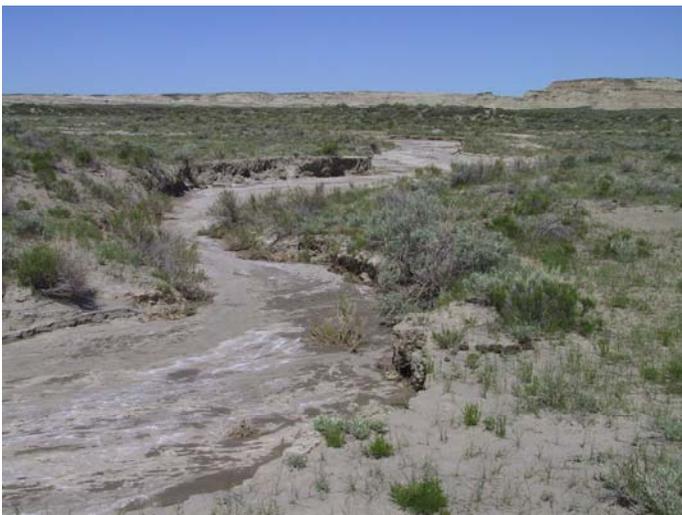
Photo #EMM46-24

Boundary route AT-17 is impassable with no use here. View is west from Adobe Draw Reservoir. The route cannot be said to exist here.

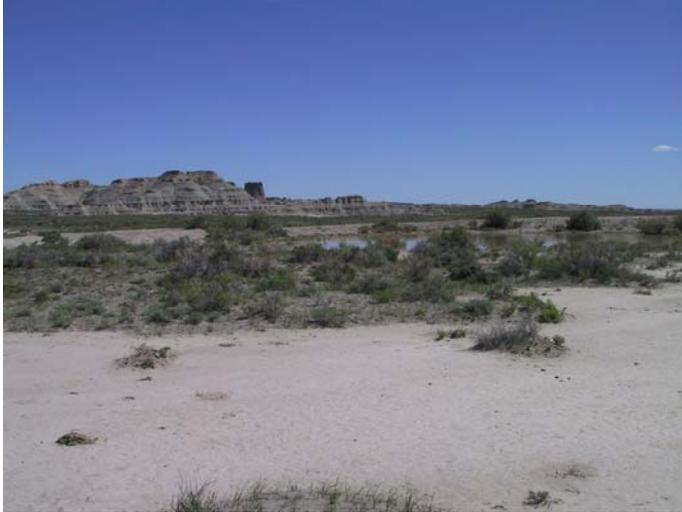
Photo #EMM46-23

Adobe Draw Reservoir. Constructed but not maintained, it still holds a little water, but the main wash has bypassed it.

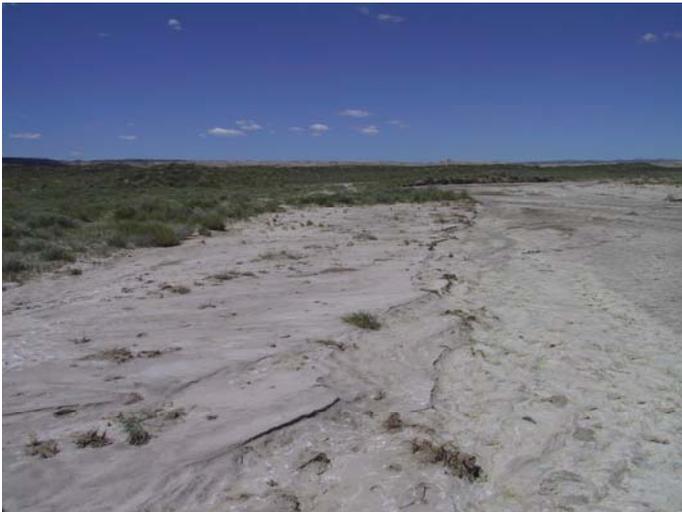
Photo #EMM46-29

Location of boundary route AT-17, which has been entirely erased by natural degradation and no longer exists. View west.

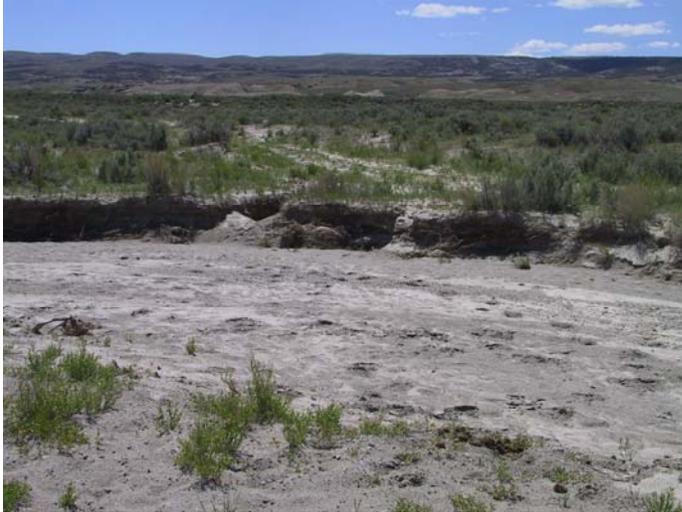
Photo #EMM46-34

Impasse along original route at wash crossing. There is a primitive drive around to the west.

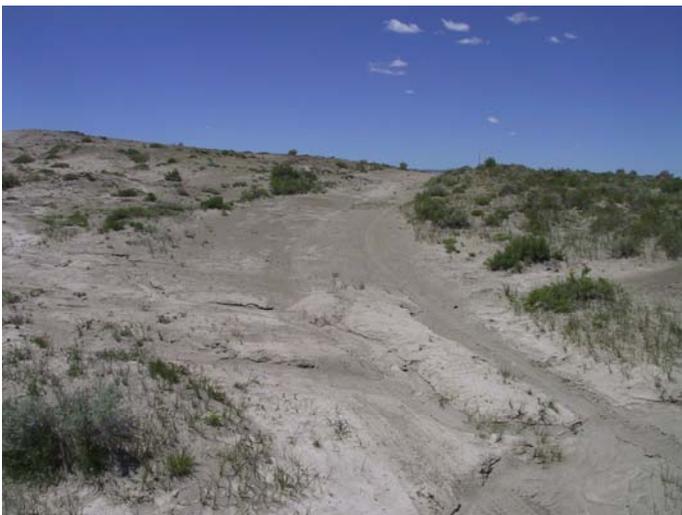
Photo #EMM46-44

Route AT-18 runs west from its junction with AT-52.

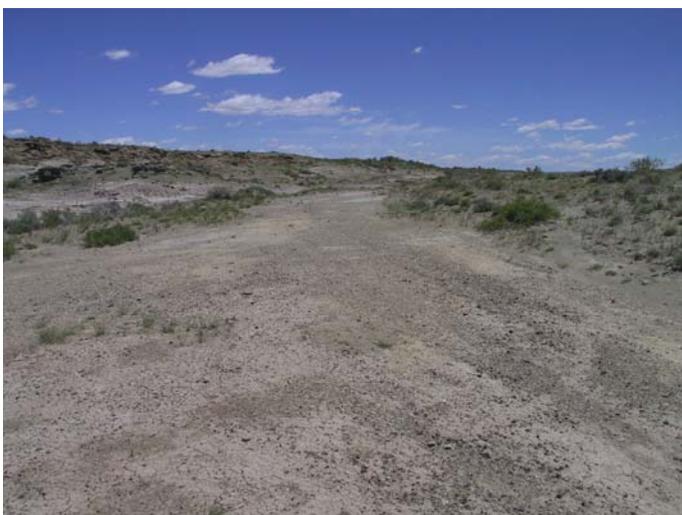
Photo #EMM46-42

View north on AT-18 from its junction with AT-17. Very light use from this point northward.

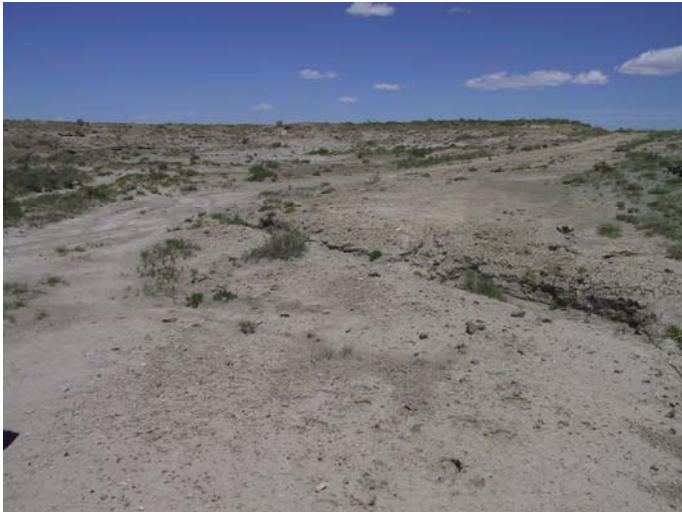
Photo #EMM46-45

View east on AT-18 from its junction with AT-17.

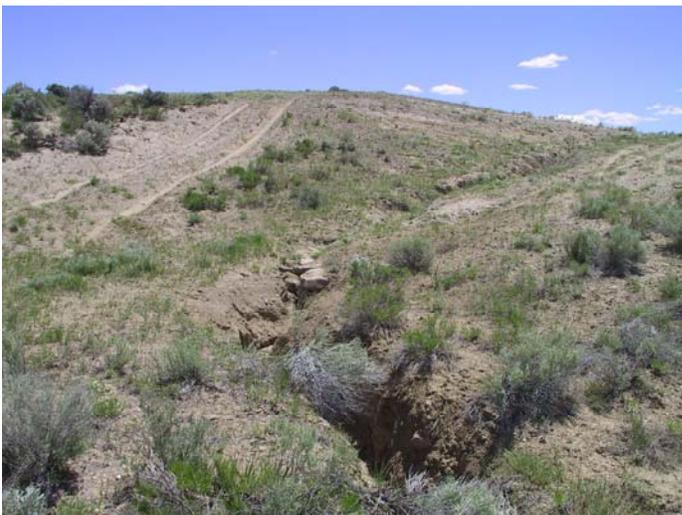
Photo #EMM46-46

Impasse with drive-around on AT-18.

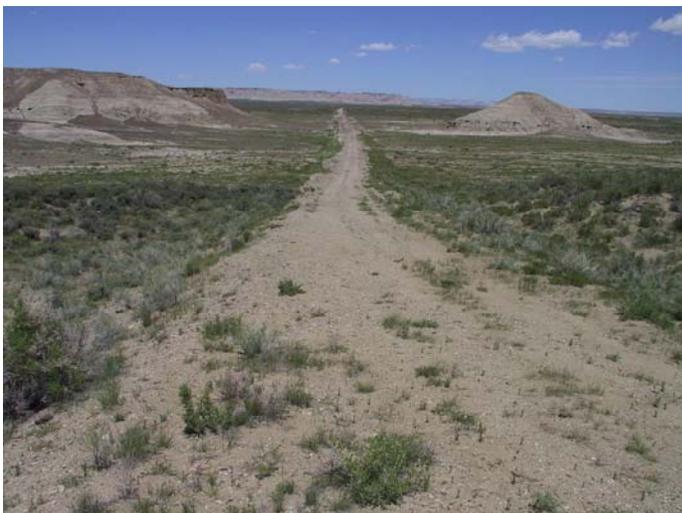
Photo #EMM46-47

Impasse (foreground) with steep drive-around (at left), view south-east.

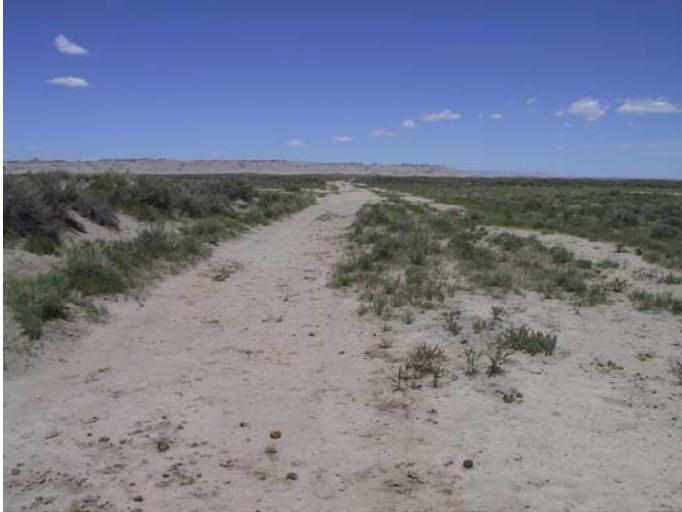
Photo #EMM46-48

View north on AT-18 from impasse. Route in best condition here.

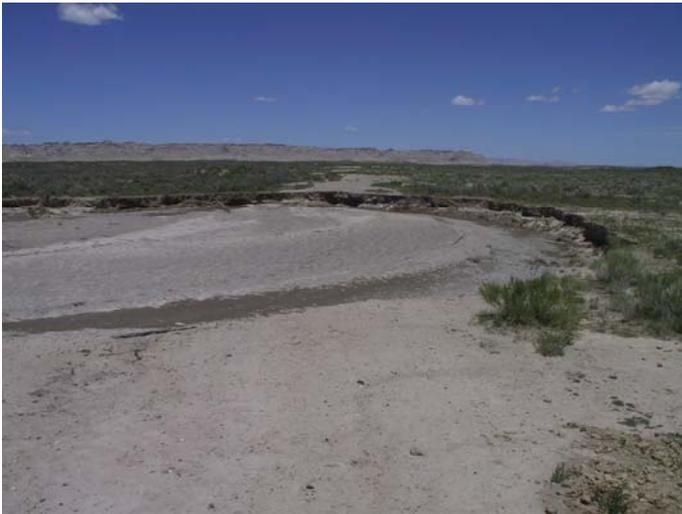
Photo #EMM46-49

Plants grow in old route bed at this point.

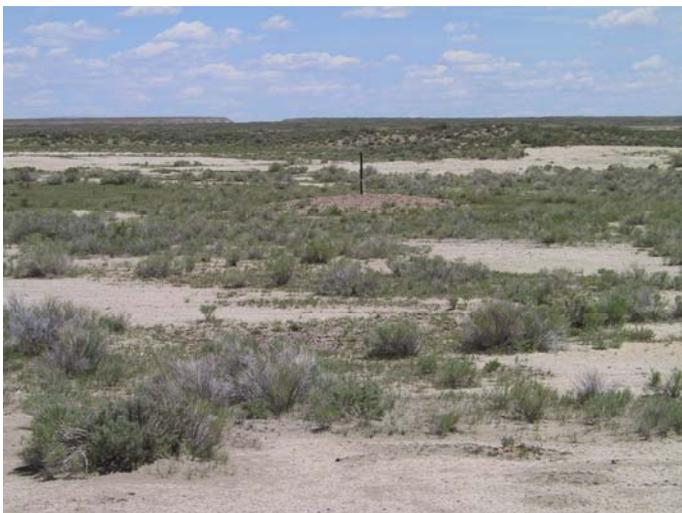
Photo #EMM46-50

Route has been undercut by Skull Creek Wash at this point.  
Impasse.

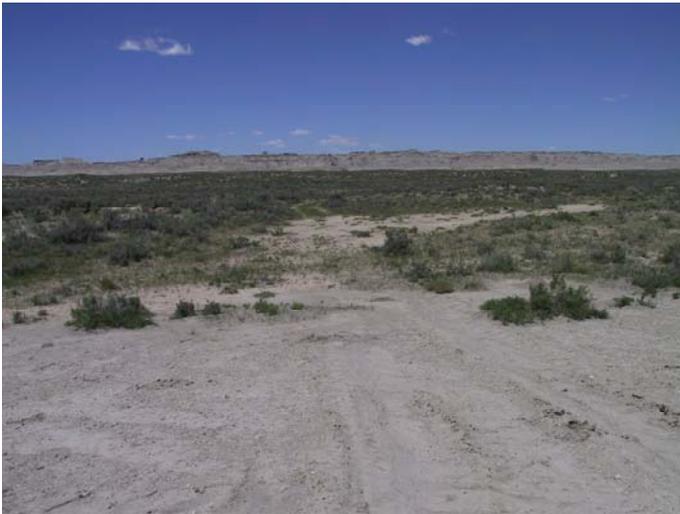
Photo #EMM46-51

Marked as “Jeep Trail” on the USGS Prehistoric Rim quad, Route AT-19 is largely impassable and can no longer be said to even exist along much of its length. It forms part of the southeastern boundary of Adobe Town WSA.

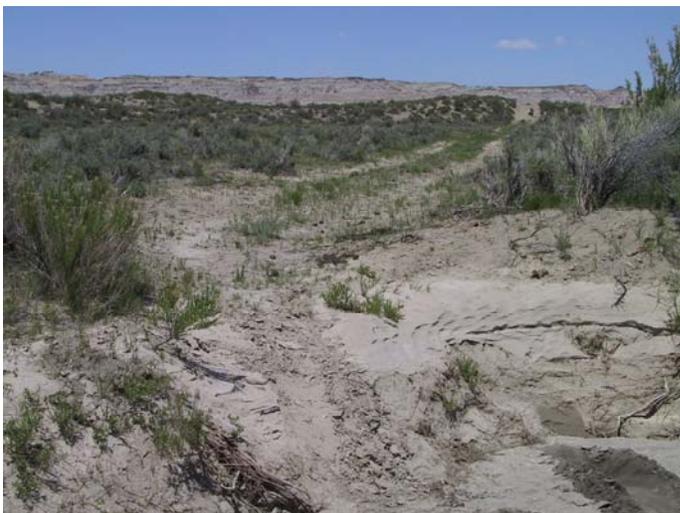
Photo #EMM46-52

Route AT-19 departs from the end of AT-18. It show little evidence of use here.

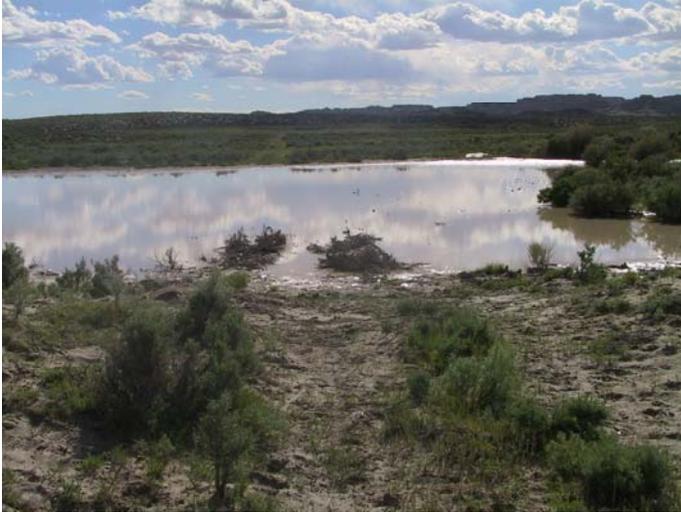
Photo #EMM46-108

Impasse -wash crossing with 3-foot walls. There is no drive-around to circumvent this obstacle, and there is no evidence of use on the far bank.

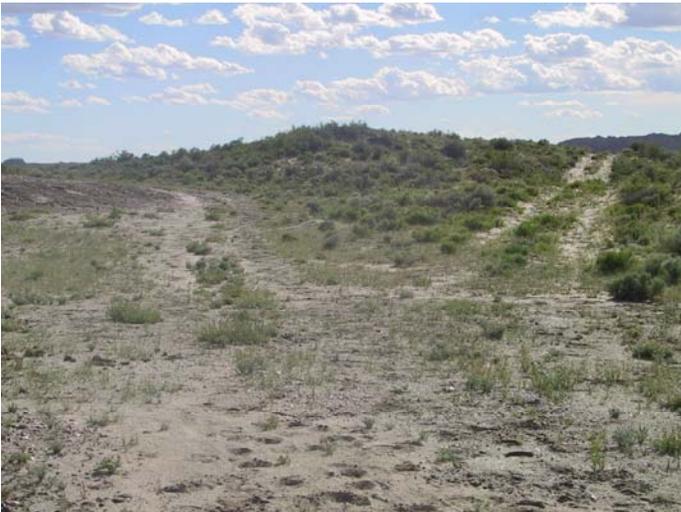
Photo #EMM46-107

Westward progress on AT-19 is blocked by pond. There is no evidence of vehicle use on the far side, and the track is becoming revegetated.

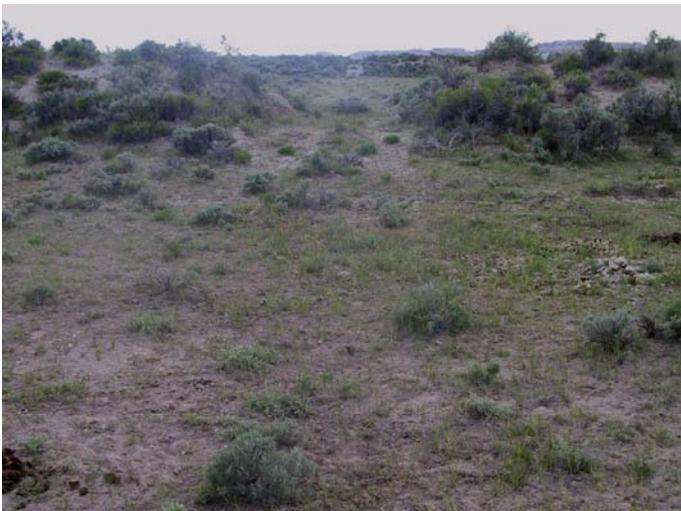
Photo #EMM46-98

Junction of AT-19 (at right) with AT-57. AT-20 departs northeast from this point.

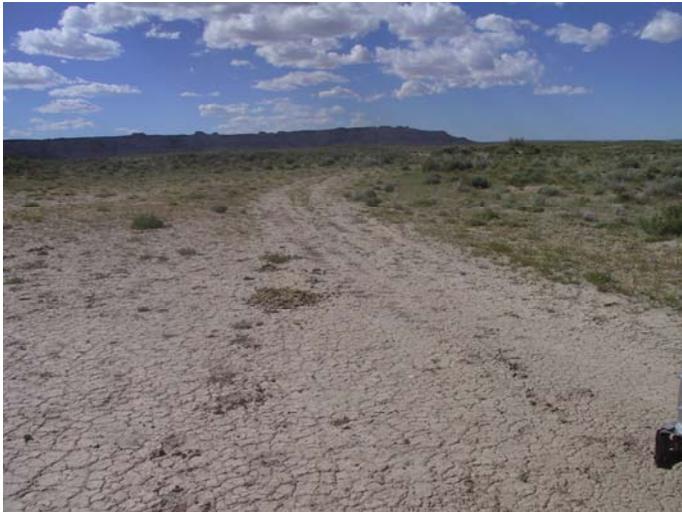
Photo #EMM46-97

View west on AT-19 from its junction with the eastern cutoff to AT-20.

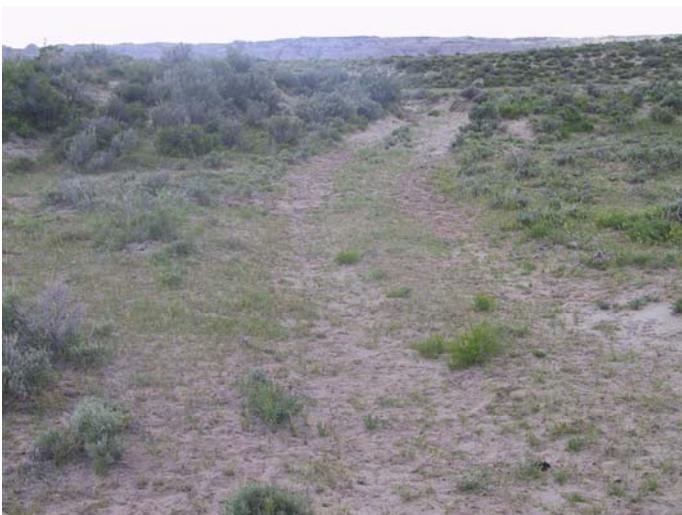
Photo #EMM46-99

This two-track route runs north from AT-19 to dead-end at Skull Creek Wash. It forms part of the south-eastern boundary of Adobe Town WSA.

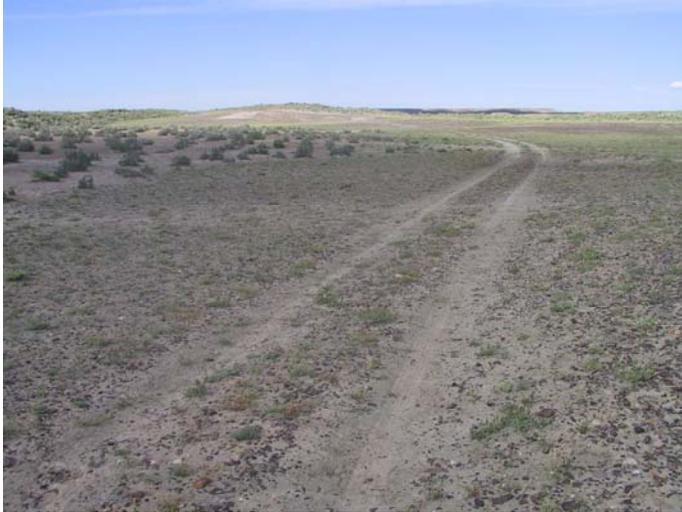
Photo #EMM46-106

Eastern cutoff to AT-20 runs north from Route AT-19.

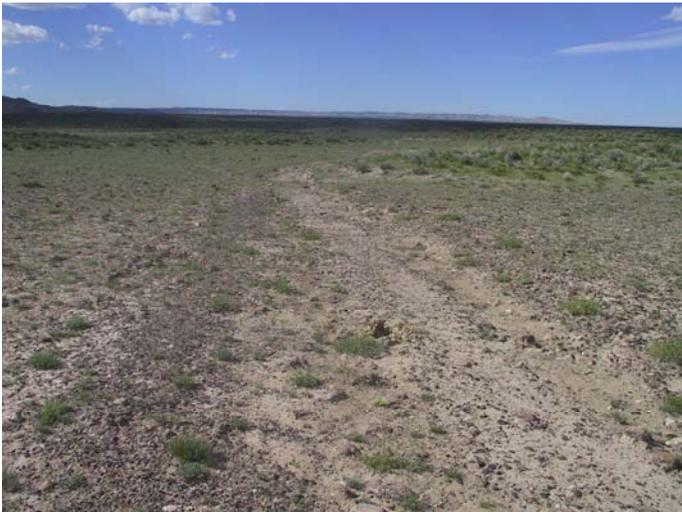
Photo #EMM46-100

Route AT-20 runs northeast from  
its junction with AT-19.

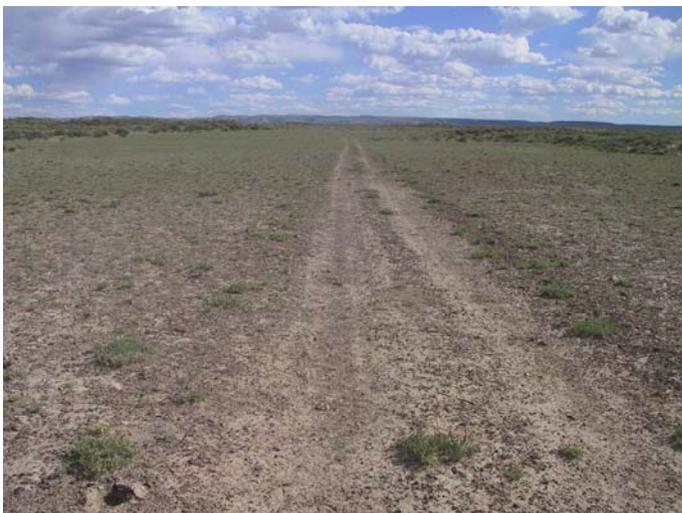
Photo #EMM46-104

Route AT-20 is faintest at this  
point.

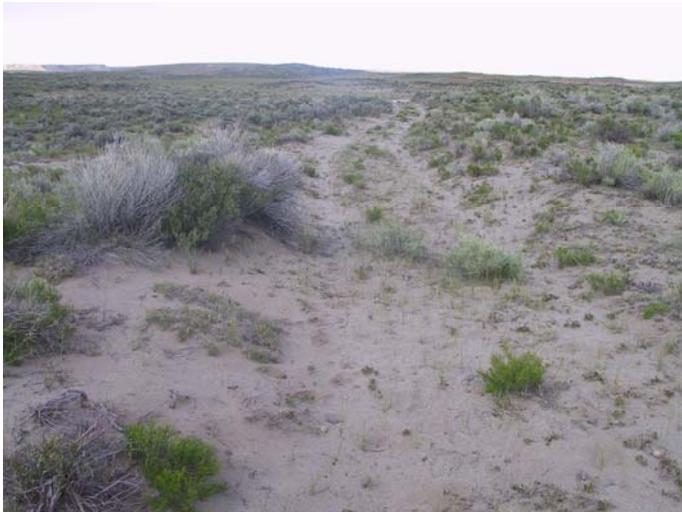
Photo #EMM46-101

Route AT-20 in its best condition.

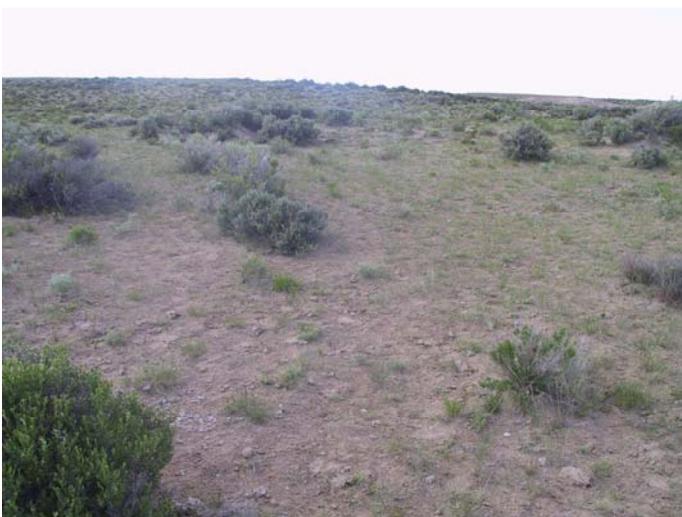
Photo #EMM46-103

The reclaimed quality of the AT-20 shown in this view is typical for this segment of the route.

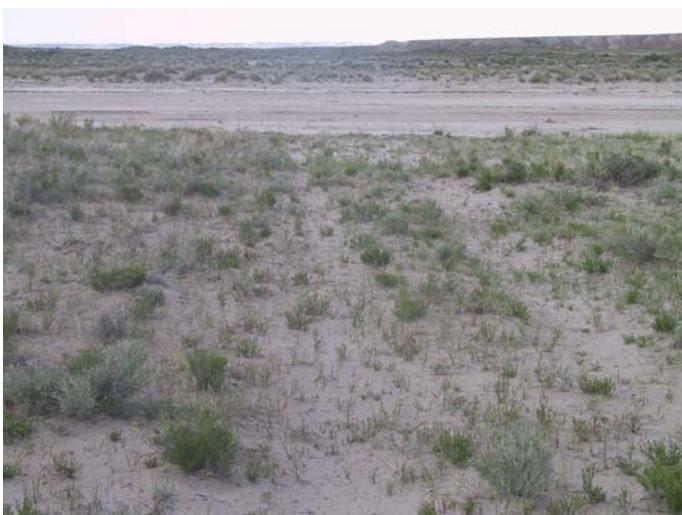
Photo #EMM46-102

Although the USGS Prehistoric Rim quad map shows Route AT-20 running northwest along the highlands at this point, there is no evidence that a route ever existed here.

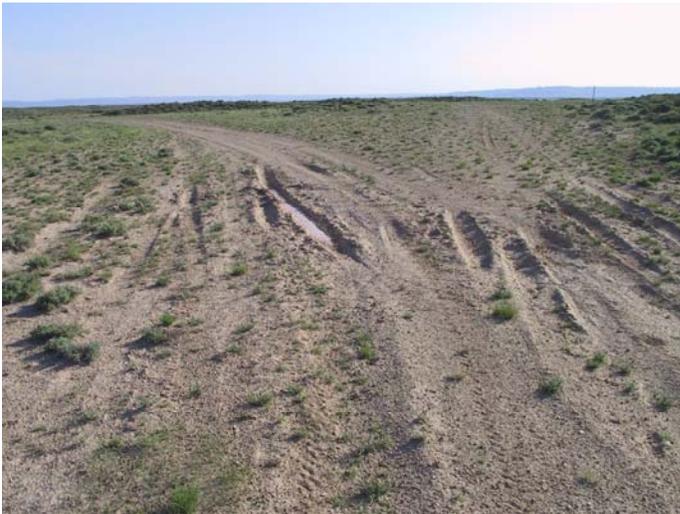
Photo #EMM40-77

This jeep trail does not exist beyond Haystack Wash, and receives very light use along the rest of its length. It is becoming reclaimed through natural degradation. AT-21 forms part of the southeast boundary of Adobe Town WSA.

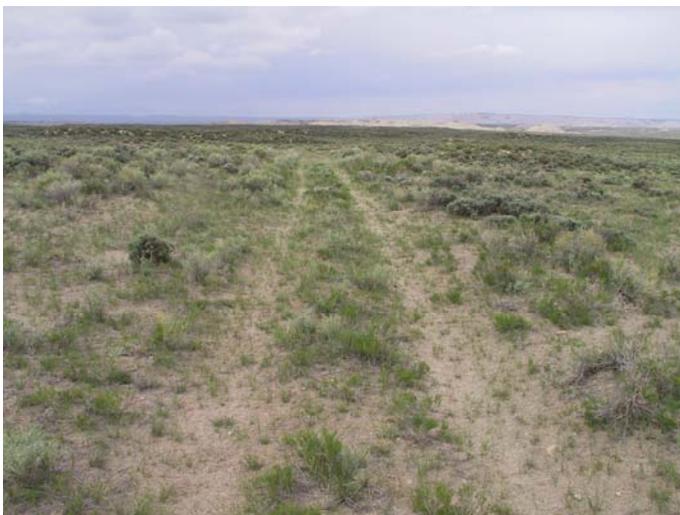
Photo #EMM41-25

Route AT-21 (at right) splits away from AT-23. It shows little use here.

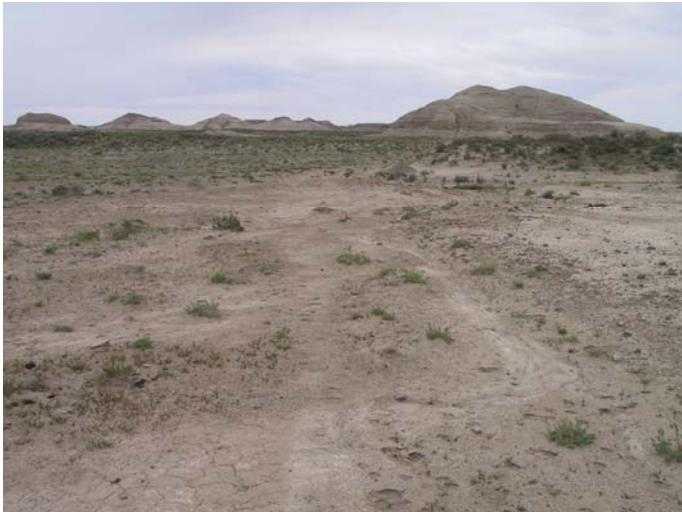
Photo #EMM41-30

Route AT-21 is recovering nicely at this point; note vegetation growing in tracks.

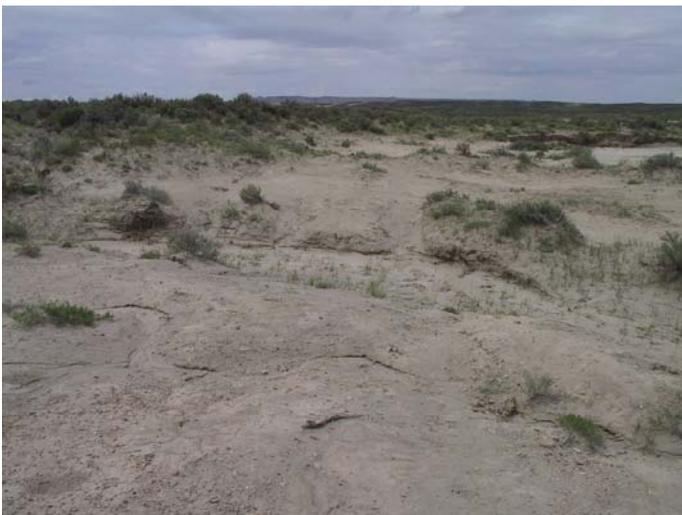
Photo #EMM41-31

Route AT-18 is faint here as it follows wash.

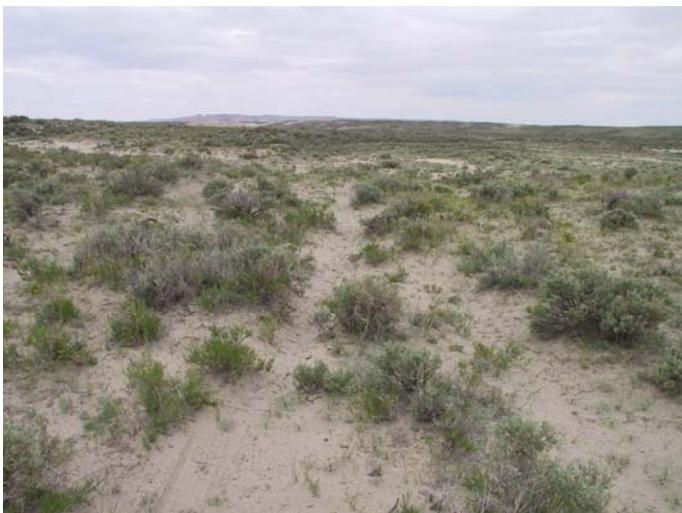
Photo #EMM41-32

Route AT-21 is very faint here, with no sign of use.

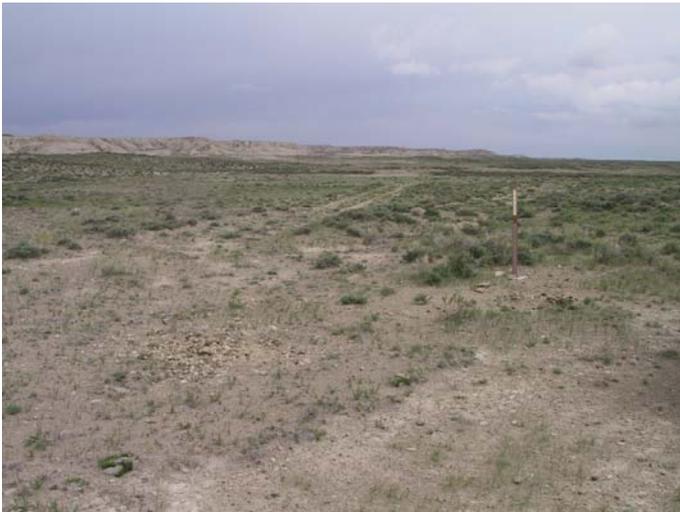
Photo #EMM41-26

This route was built to construct or access Blank Reservoir. It receives little use at present. It falls entirely within Adobe Town WSA.

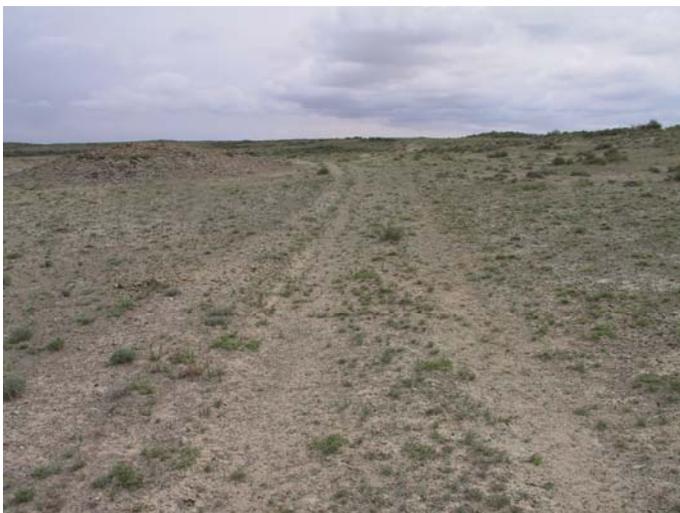
Photo #EMM41-27

Route AT-22 departs from route AT-21. Note WSA boundary marker.

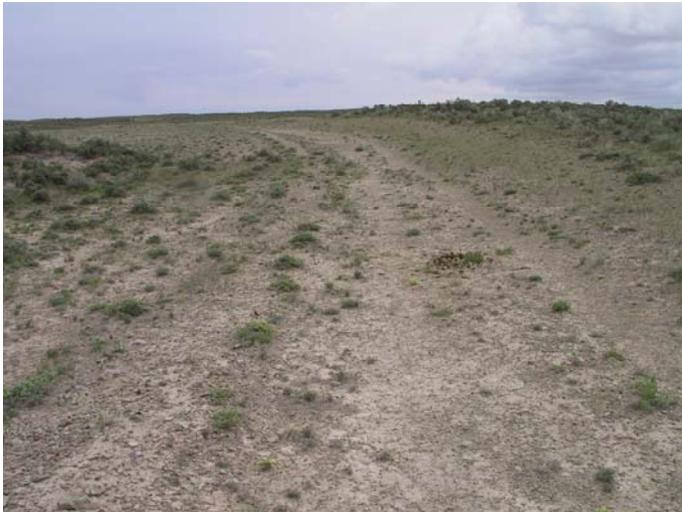
Photo #EMM41-28

Route is faint at this point; there is definite evidence of blading visible here.

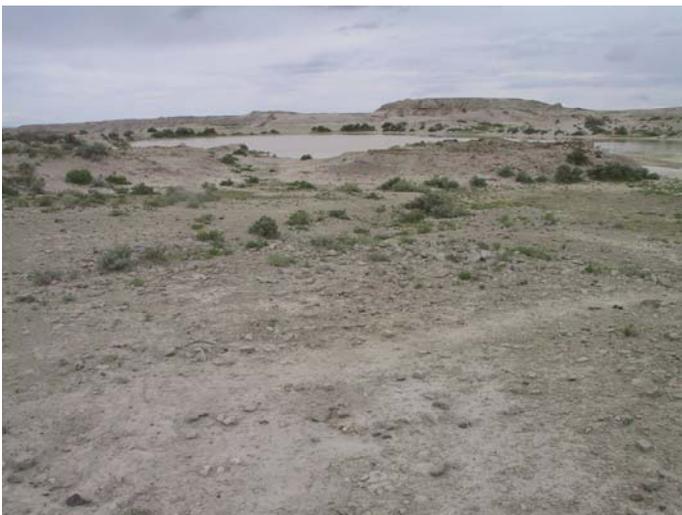
Photo #EMM41-29

Route in its best condition.

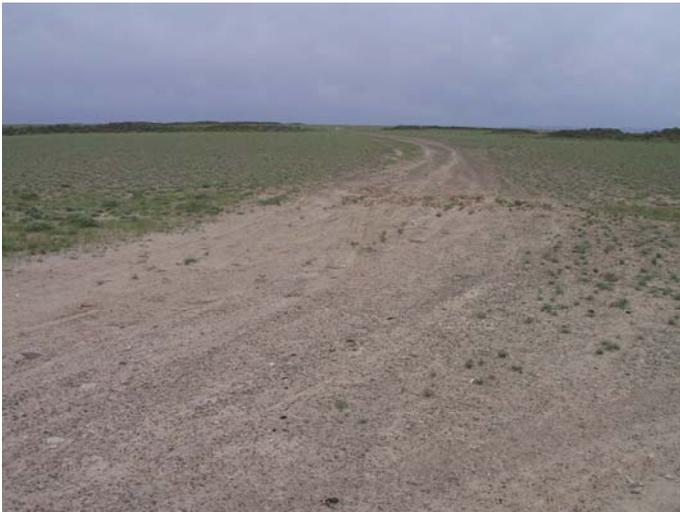
Photo #EMM40-47

This route was originally constructed, then reclaimed through harrowing and re-seeding. It currently exists as a two-track maintained solely by the passage of vehicles, superimposed over a revegetation strip. This route forms a major stretch of the east boundary of Adobetown WSA.

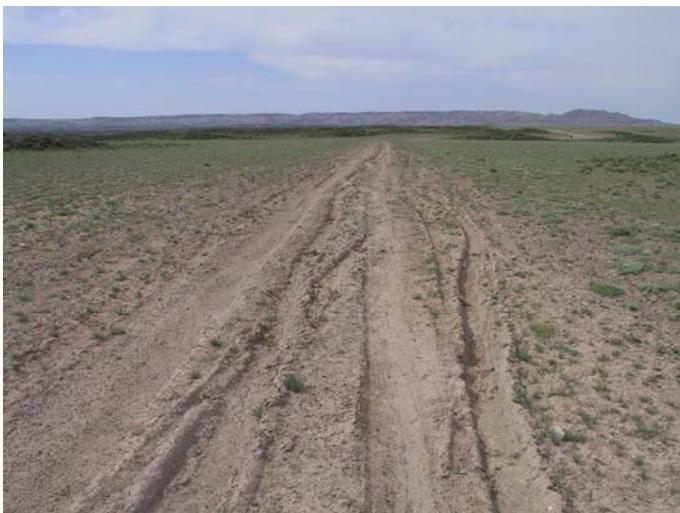
Photo #EMM40-61

Route AT-23 departs southward from its junction with AT-27. There is evidence of past blading here.

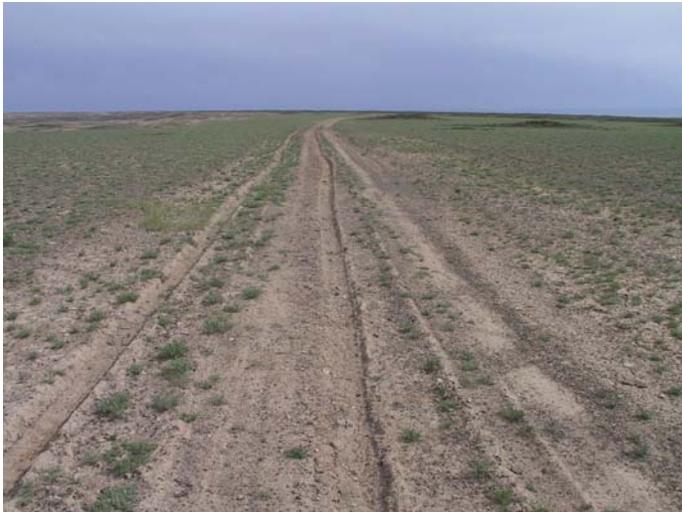
Photo #EMM40-62

Route is sloppy at this point, from wet-weather driving.

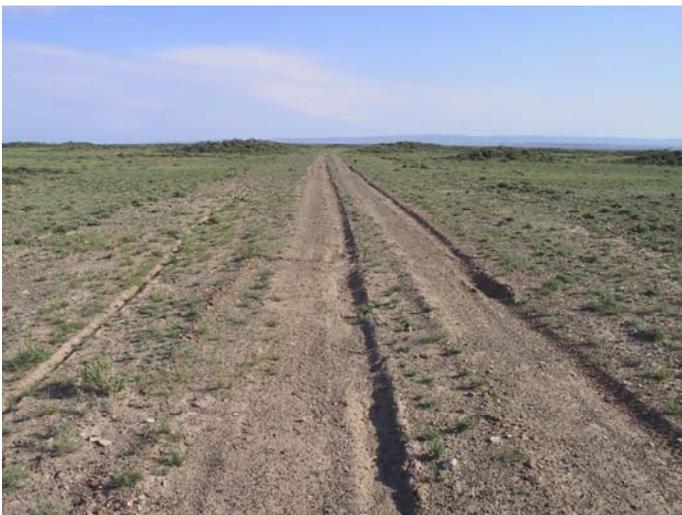
Photo #EMM40-76

Typical view of route--a two-track worn in on top of an old revegetation strip..

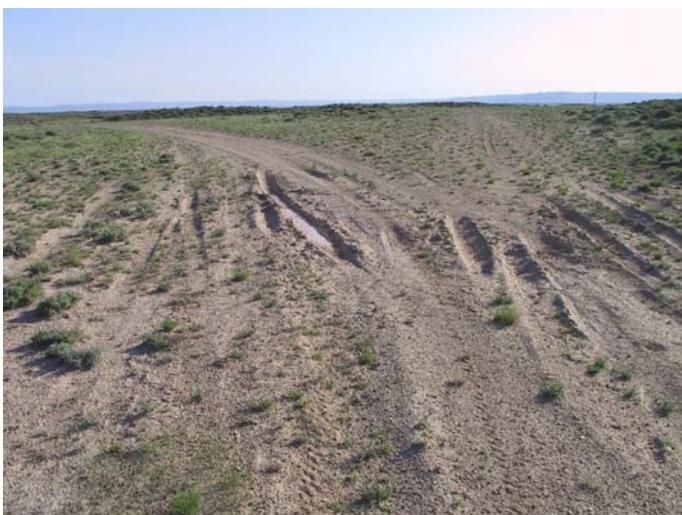
Photo #EMM40-77

This view is typical of this stretch of AT-23.

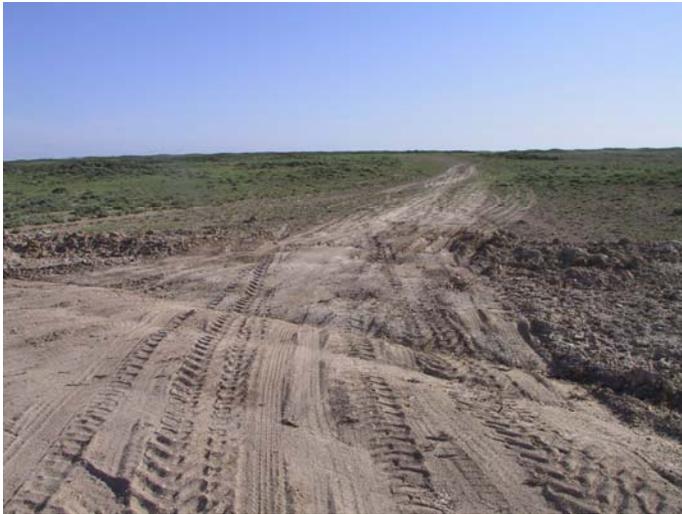
Photo #EMM41-9

View of route AT-23 (at left) from its junction with AT-21.

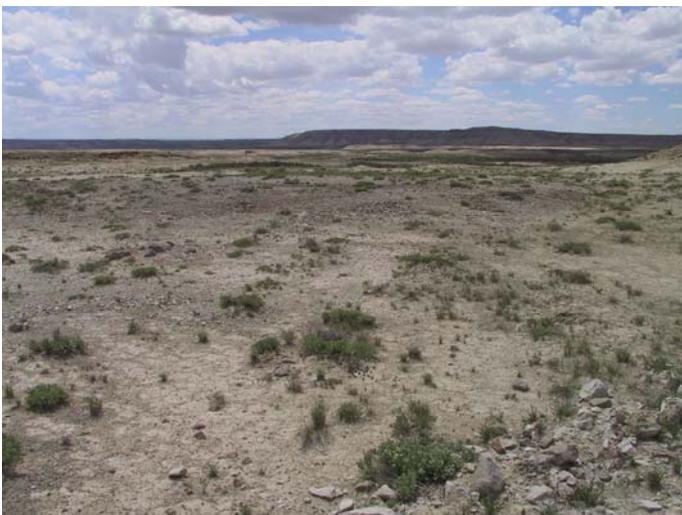
Photo #EMM42-53

Parts of this route are shown on the USGS Salazar Butte quad, while other portions not shown on the quad are shown on the BLM Kinney Rim 1:100,000-scale map. There is no evidence that this route ever existed on the ground.

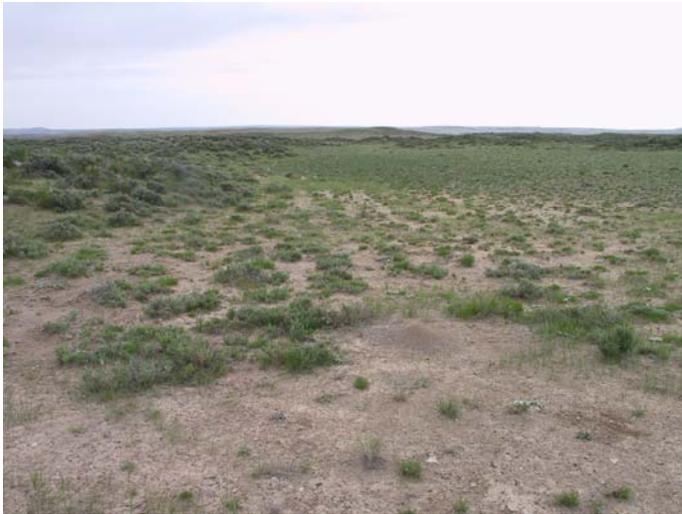
Photo #EMM41-19

View of location of AT-24 from Route AT-81. Nothing remains of any jeep trail that might once have been here.

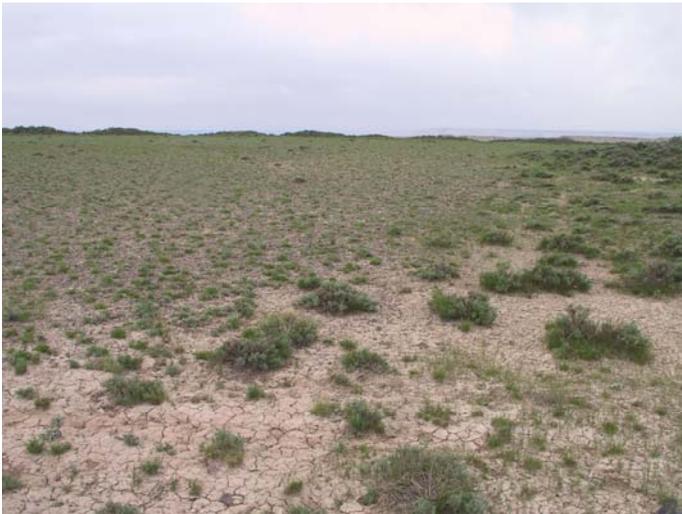
Photo #EMM41-20

Location of Route AT-24 at its junction with AT-23, as shown on Kinney Rim map. View east. There is no sign of any route diverging in this area.

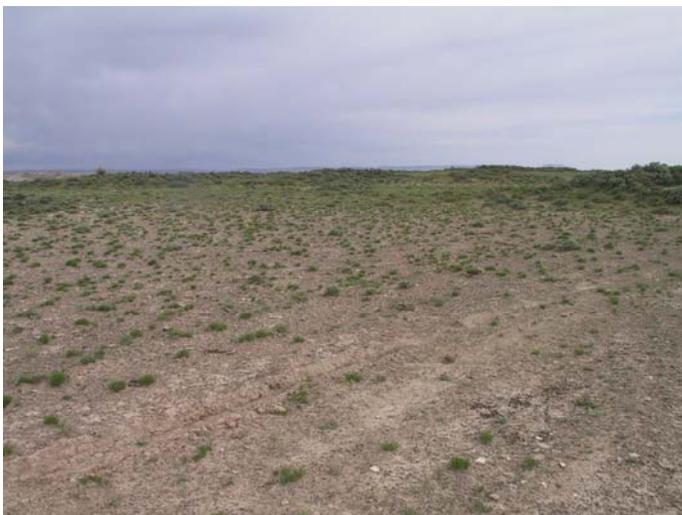
Photo #EMM41-18

Location of Route AT-24 at its junction with AT-23, as shown on Kinney Rim map. View west. There is no sign of any route diverging in this area.

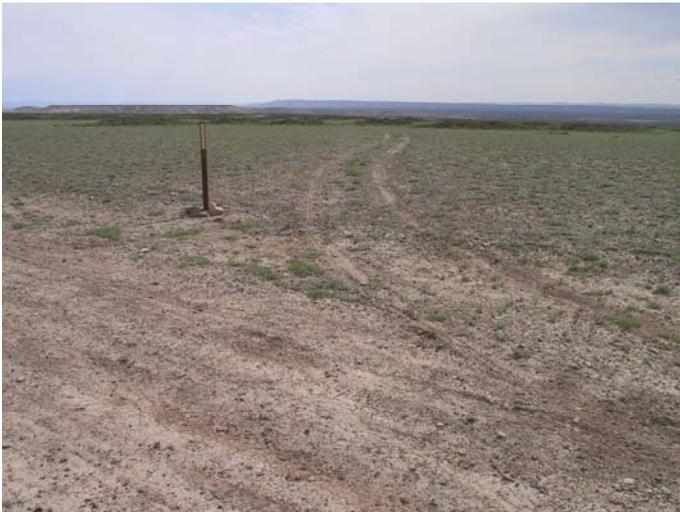
Photo #EMM40-65

Route AT-25  
UTM 0740421 4576477  
5/17/01

Route AT-25 departs from AT-23,  
bound west. Note its faint and  
well-reclaimed nature.

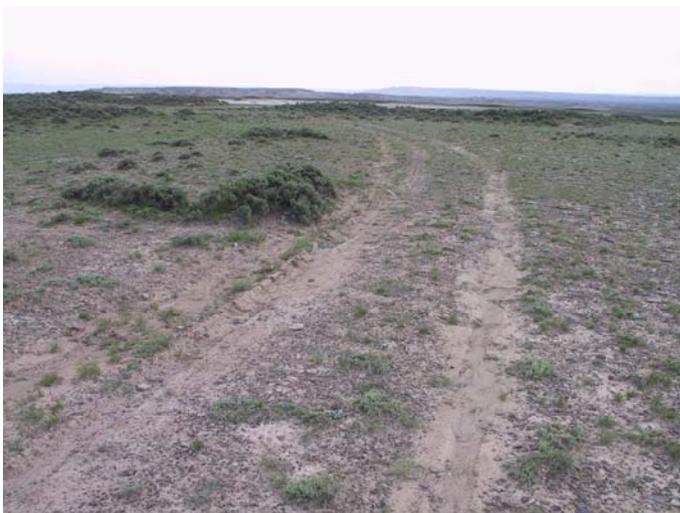
Photo #EMM40-66

Route AT-25  
UTM 0740060 4576102  
5/17/01

Typical condition of Route  
AT-25.

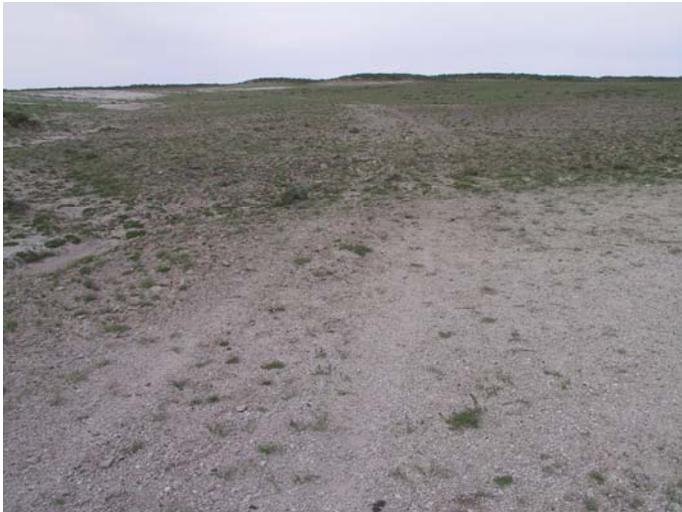
Photo #EMM40-67

Route AT-25  
UTM 0739838 4575825  
5/17/01

Route is rather faint in this area.

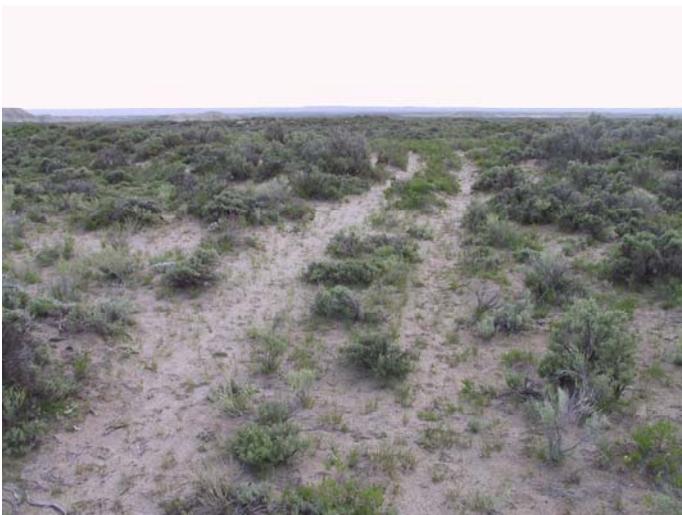
Photo #EMM40-68

Route AT-25  
UTM 0739260 4575371  
5/17/01

This view is typical of this stretch  
of AT-25.

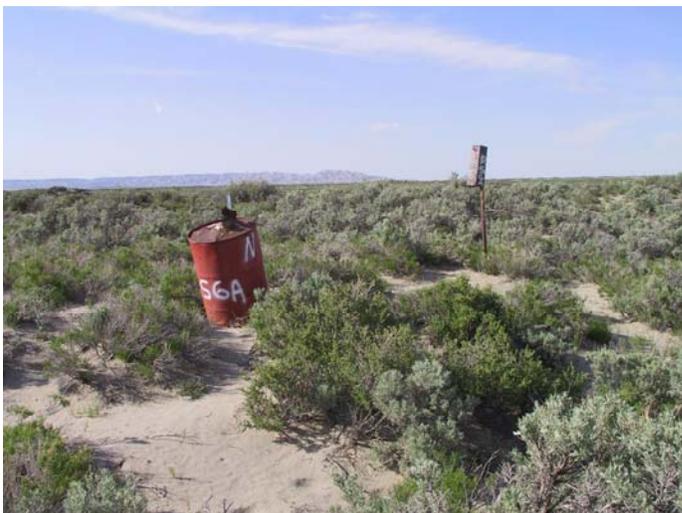
Photo #EMM40-75

Route AT-25  
UTM 0739040 4575289  
5/17/01

Oil exploration debris 75m north  
of Route AT-25.
