**BLM Unit Identification:** Adobe Town WY-030-401 and WY-040-408

**Description** Adobe Town is proposed by the conservation community for wilderness designation. The area proposed for wilderness includes all of the Adobe Town Wilderness Study Area, plus additional lands of wilderness quality in The Haystacks, along Willow Creek and the Willow Creek Rim, and south of the WSA to the Powder Rim and just beyond it. All of these areas possess the full complement of required characteristics for wilderness in abundance: outstanding opportunities for both solitude *and* primitive and unconfined recreation, wilderness-quality naturalness, size (at over 180,000 acres, the citizens proposed Adobe Town wilderness is well above the 5,000-acre minimum), and in addition has outstanding supplemental values such as abundant wildlife, wild horse herds, unique geology, and abundant archaeological and paleontological resources.

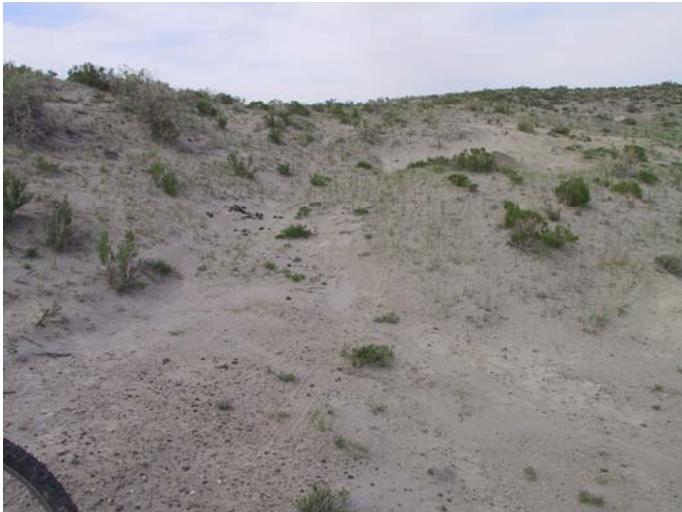
Photo #EMM40-69

Route AT-25  
UTM 0738672 4574703  
5/17/01

Route is essentially nonexistent here. View east.

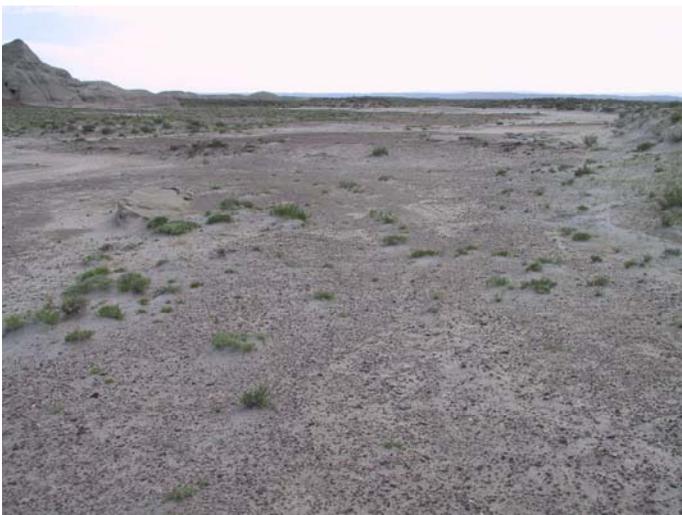
Photo #EMM40-70

Route AT-25  
UTM 0738672 4574703  
5/17/01

Route is essentially nonexistent here. View west.

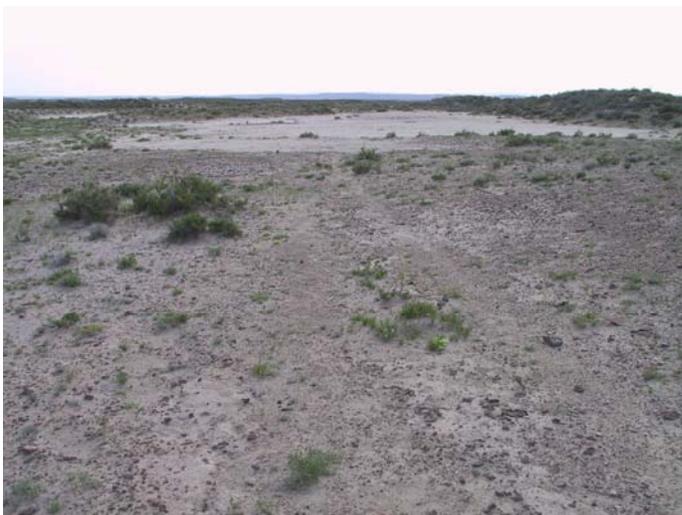
Photo #EMM40-71

Route AT-25  
UTM 0738405 4574563  
5/17/01

This view is typical of this stretch of route.

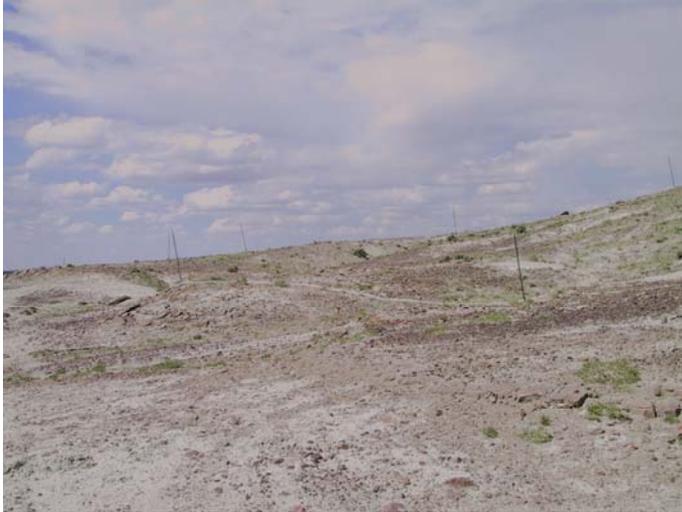
Photo #EMM40-72

Route fades out here, and no longer exists southbound. Note fence posts--possible wild horse trap?

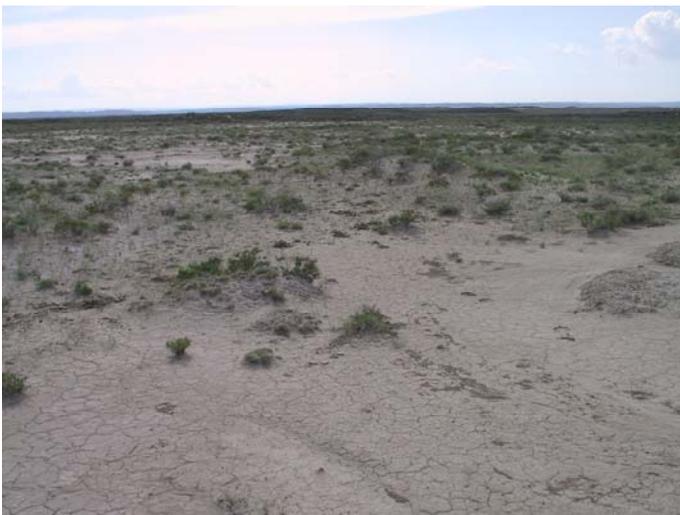
Photo #EMM40-73

Route AT-25A  
UTM 0738114 4574401  
5/17/01

Location of route AT-25A, which cannot be seen, at its departure from AT-25.

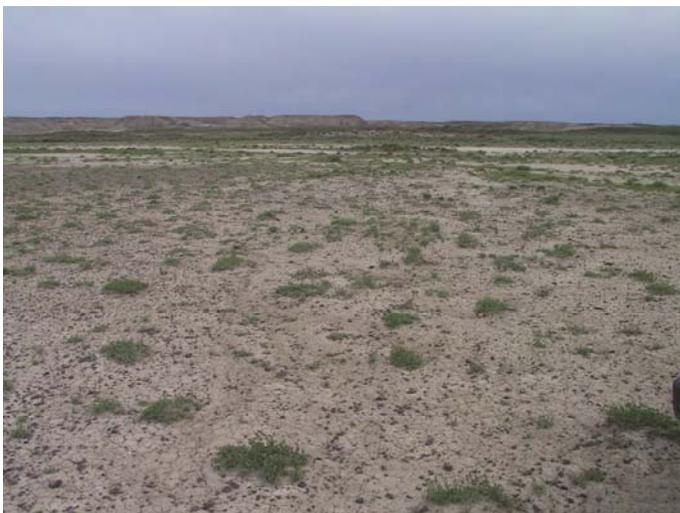
Photo #EMM40-60  
Route AT-25A  
UTM 0737589 4574637  
5/17/01

Location of Route AT-25A at its departure from AT-26. There is no route here.

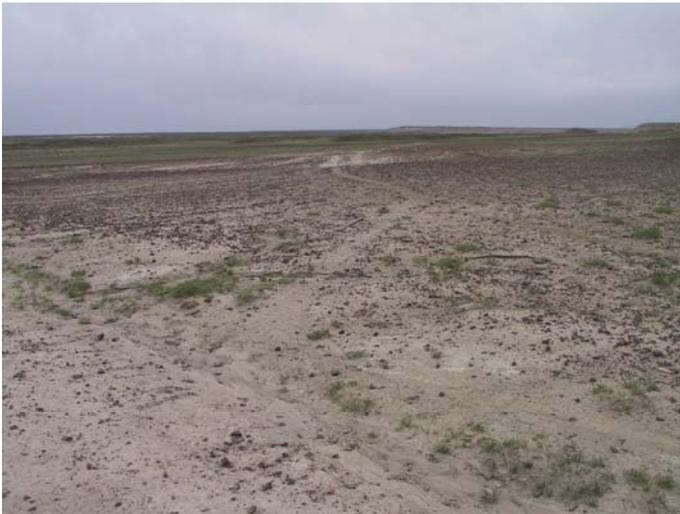
Photo #EMM40-53

Route AT-26  
UTM 0737329 4577579  
5/17/01

Departure of Route AT-26 from  
Route AT-27. Note very faint and  
reclaimed nature of route.

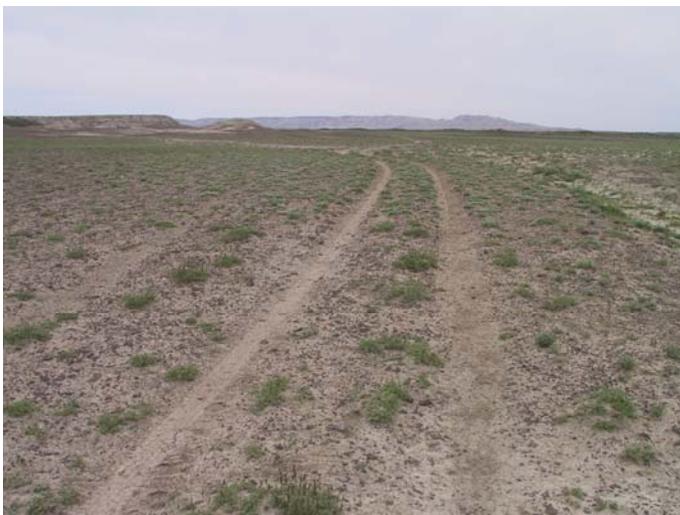
Photo #EMM40-55  
Route AT-26  
UTM 0737604 4576282  
5/17/01

Route is in good condition here.  
View of drive-around. Original,  
eroded route is visible at far right.

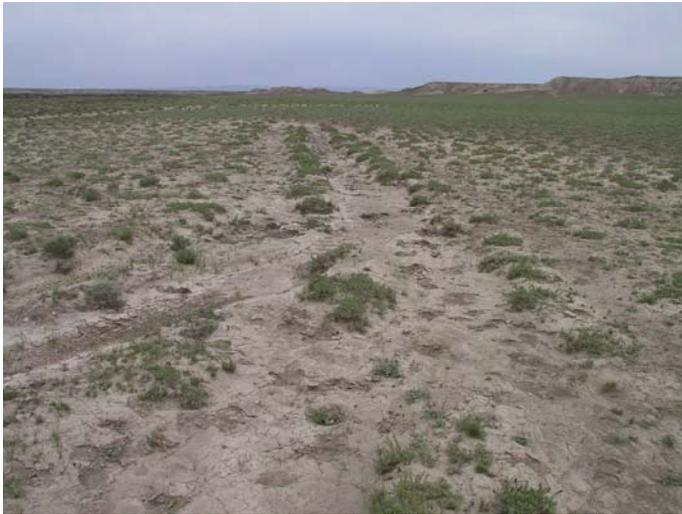
Photo #EMM40-54

Route AT-26  
UTM 0737604 4576282  
5/17/01

Route is in poor condition here.

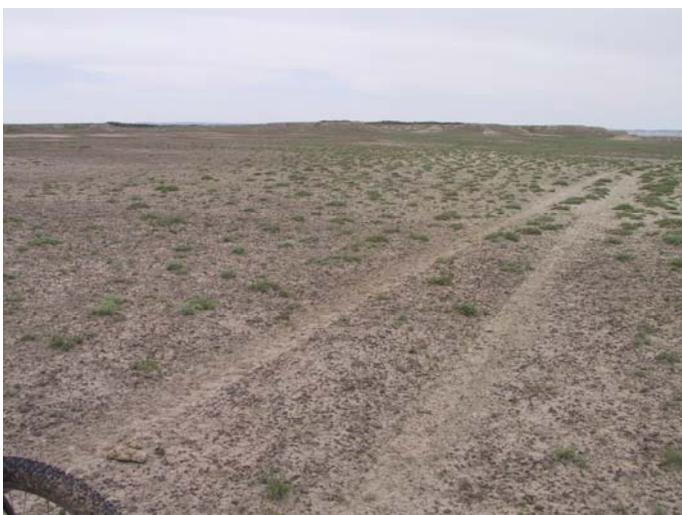
Photo #EMM40-57

Route AT-26  
UTM 0737593 4575308  
5/17/01

Typical view of route AT-26. This is the point where the route shown on the Barrel Springs SW quad would have joined. There is no evidence of its existence here.

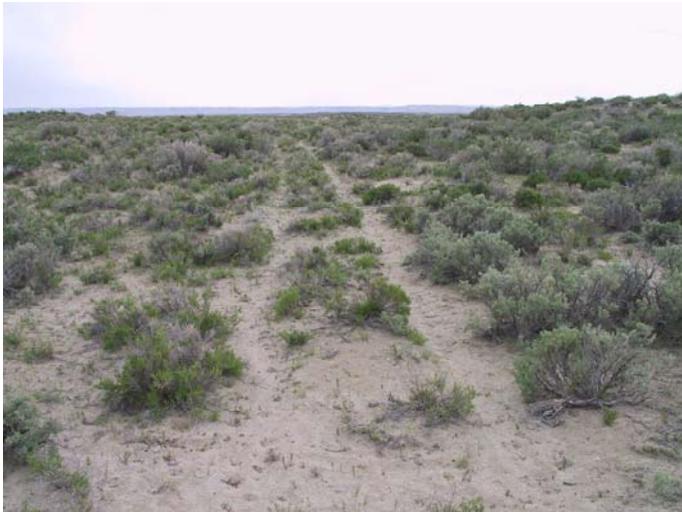
Photo #EMM40-58

Route AT-26  
UTM 0737296 4574396  
5/17/01

Typical of route beyond intersec-  
tion of non-route AT-26.

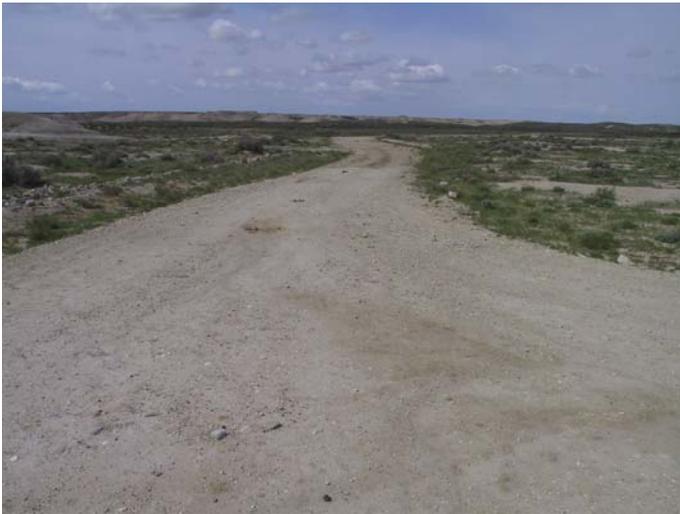
Photo #EMM40-8

Route AT-27 runs west from AT-85. There are signs of maintenance along this stretch.

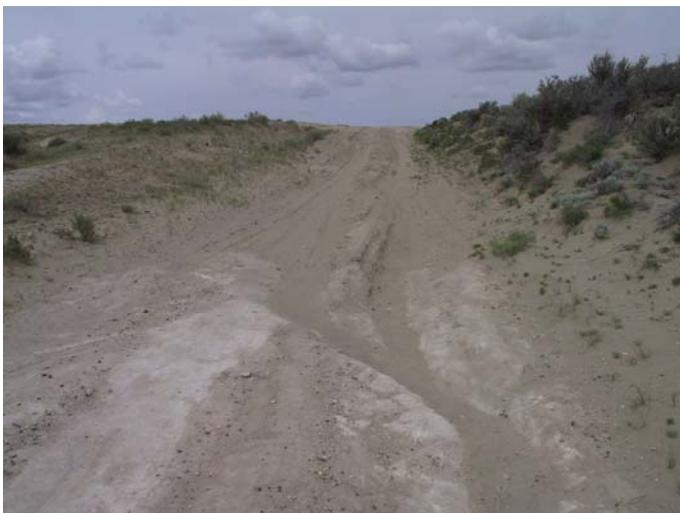
Photo #EMM40-17

Route is sloppy with erosion at hill climb.

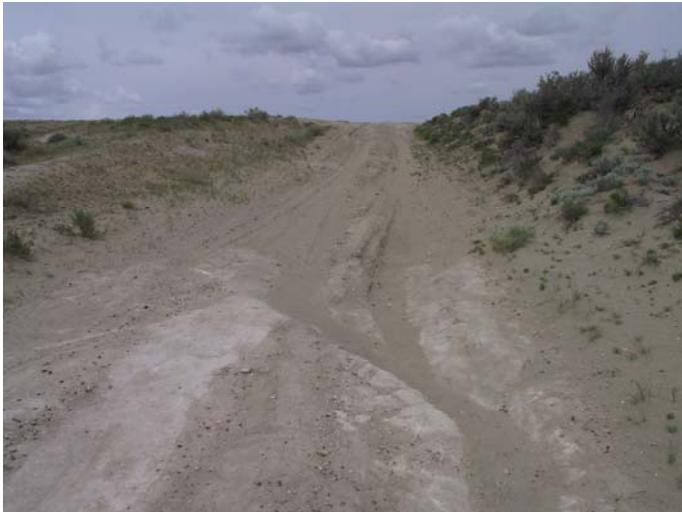
Photo #EMM40-17

Route AT-27  
UTM 0740178 4578214  
5/17/01

Route eroded and messy at hill  
climb.

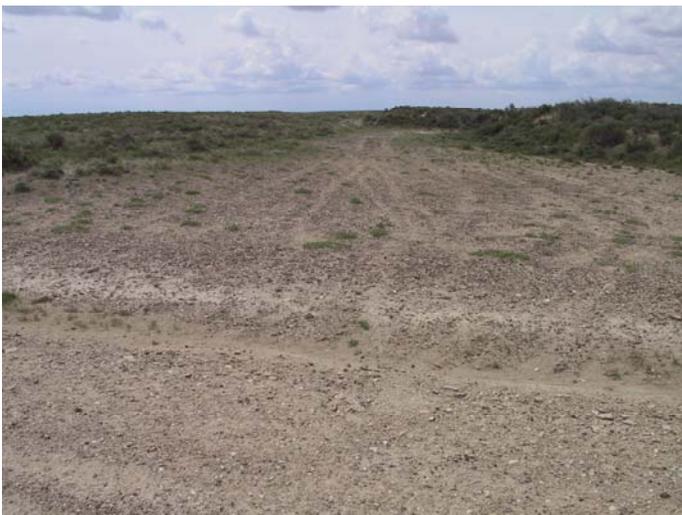
Photo #EMM40-18

Route AT-27  
UTM 0740059 4578212  
5/17/01

Jeep trail departs southward from  
AT-27.

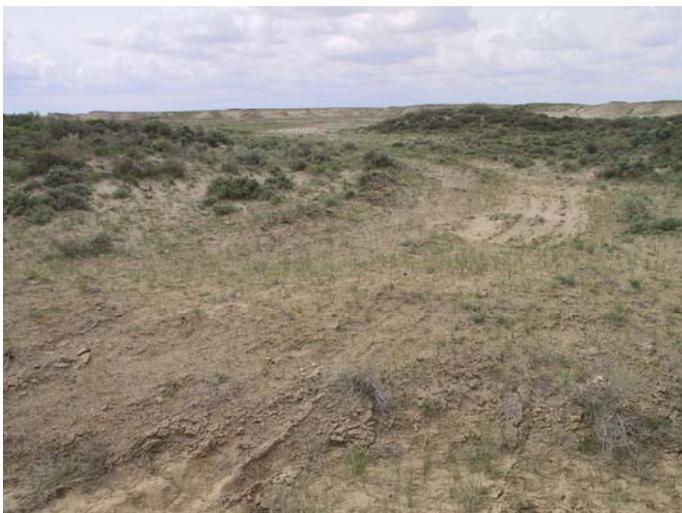
Photo #EMM40-19

Route AT-27  
UTM 0739893 4578249  
5/17/01

Jeep trail departs AT-27 to south.

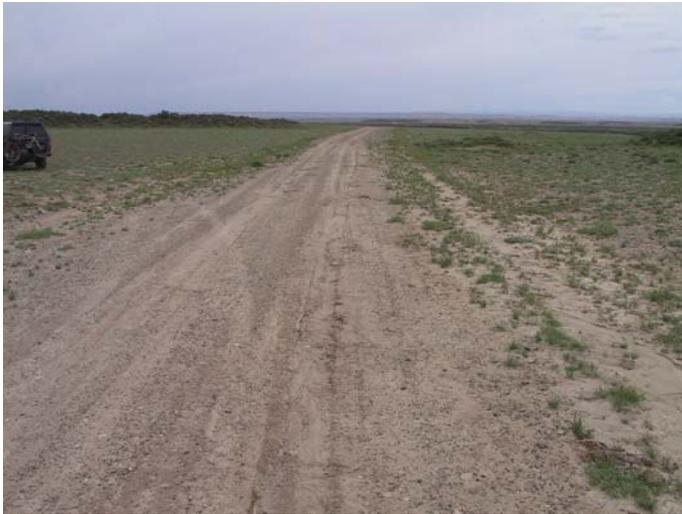
Photo #EMM40-46

Route AT-27  
UTM 0739354 4578099  
5/17/01

View west on AT-27 from junction with AT-23. Note plants encroaching at edges of route crown.

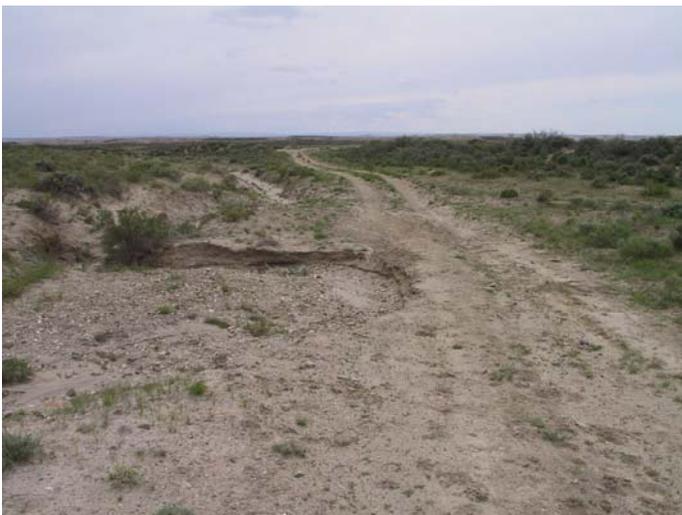
Photo #EMM40-48

Route AT-27  
UTM 0738631 4577679  
5/17/01

Severe erosion. Route changes temporarily to a two-track here, with no signs of construction.

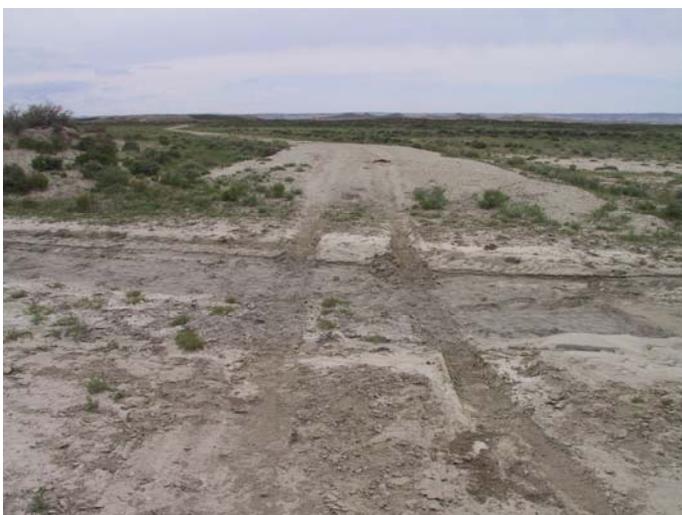
Photo #EMM40-49

Route AT-27  
UTM 0738366 4577556  
5/17/01

Wash crossing. A patch of constructed route can be seen ahead.

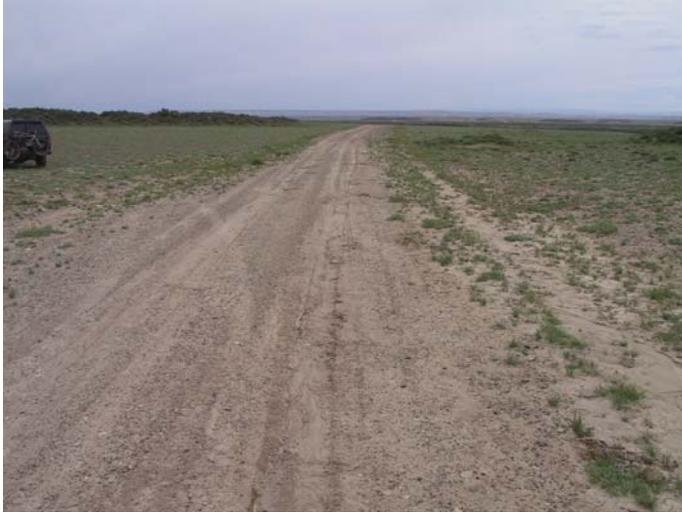
Photo #EMM40-46

Route AT-27  
UTM 0739354 4578099  
5/17/01

View west on AT-27 from junction with AT-23. Note plants encroaching at edges of route crown.

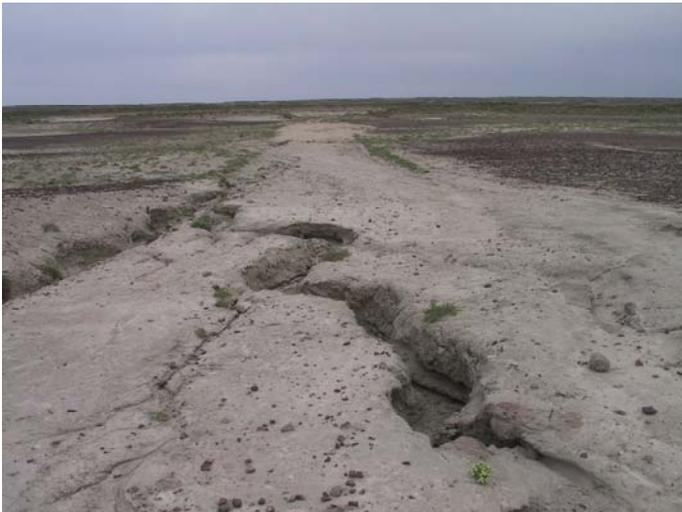
Photo #EMM40-50

Route AT-27  
UTM 0737329 4577579  
5/17/01

Large crevasse crossing route.

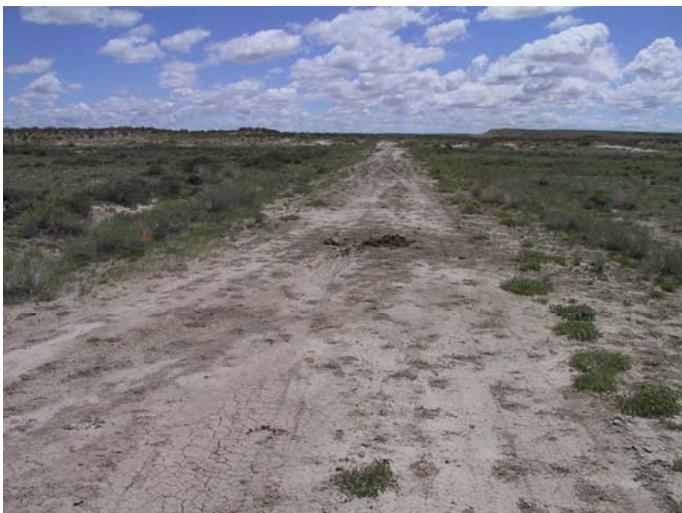
Photo #EMM44-7

Route AT-27  
UTM 0736396 4577570  
5/21/01

View east on AT-27 from its junction with AT-30. Vegetation encroaching on route bed.

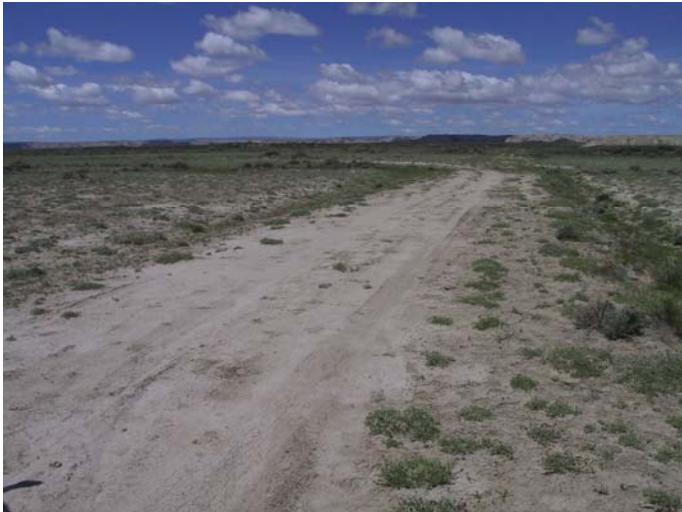
Photo #EMM44-10

Route AT-27  
UTM 0736396 4557570  
5/21/01

View southwest along AT-27  
from its junction with AT-30.

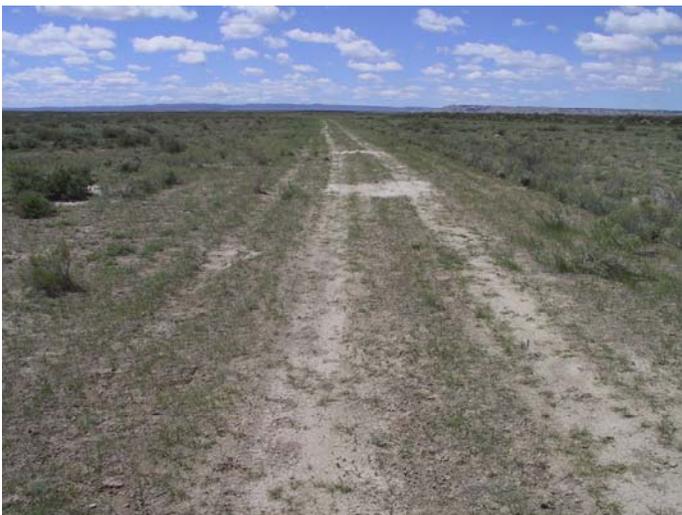
Photo #EMM44-11

Route AT-27  
UTM 0736265 4577347  
5/21/01

View typical of this segment--a  
faint two-track superimposed over  
a revegetation strip.

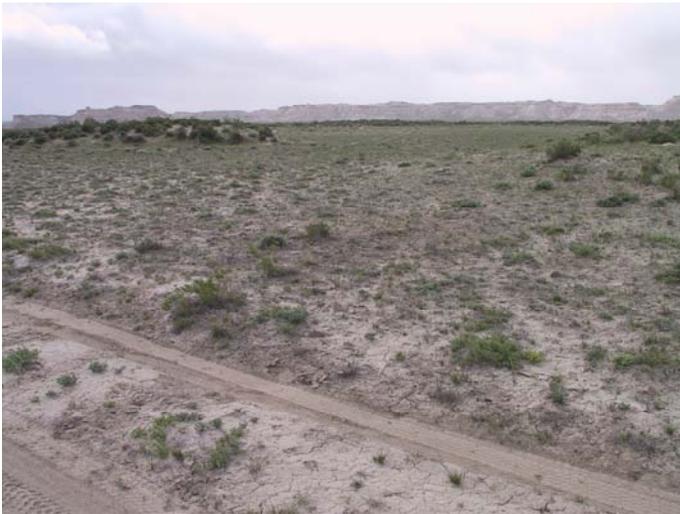
Photo #EMM43-49

Route AT-28  
UTM 0732249 4574713  
5/20/01

Very faint route departs northward from AT-4 (foreground), taking the form of a one-time-use track.

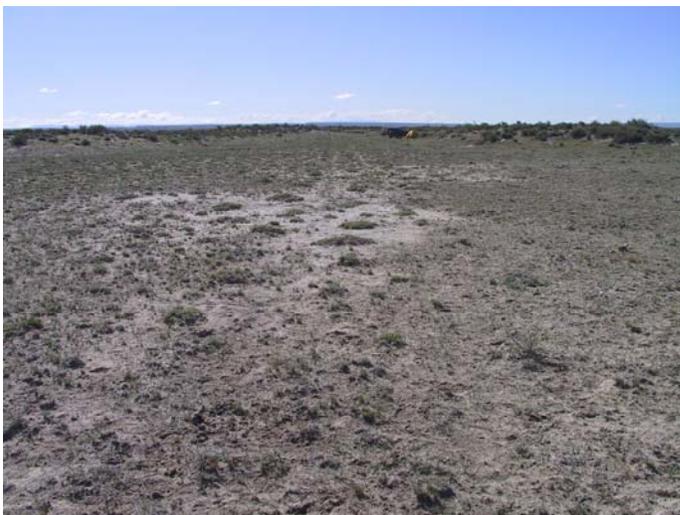
Photo #EMM43-57  
Route AT-28  
UTM0732142 4574774  
5/21/01

One-time-use track ends. View southeast.

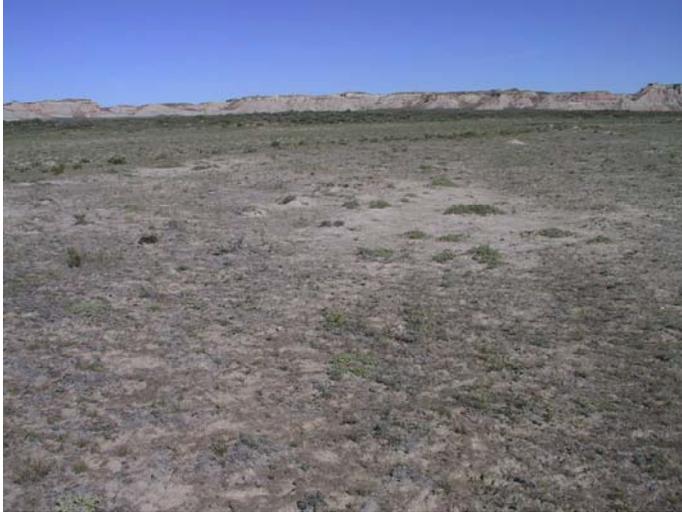
Photo #EMM43-58

Route AT-28  
UTM 0732142 4574774  
5/21/01

View northwest from end of one-time-use track along original course of AT-28. It no longer exists.

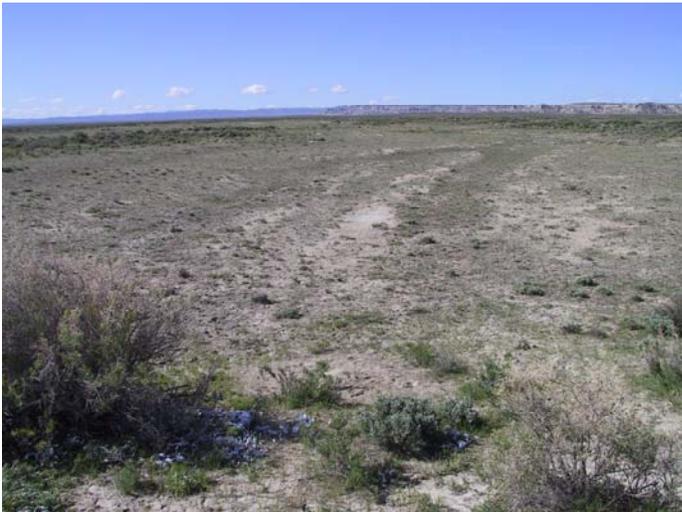
Photo #EMM43-60

Route AT-28  
UTM 0731869 4575739  
5/21/01

View south along disappeared jeep trail AT-28 from reservoir.

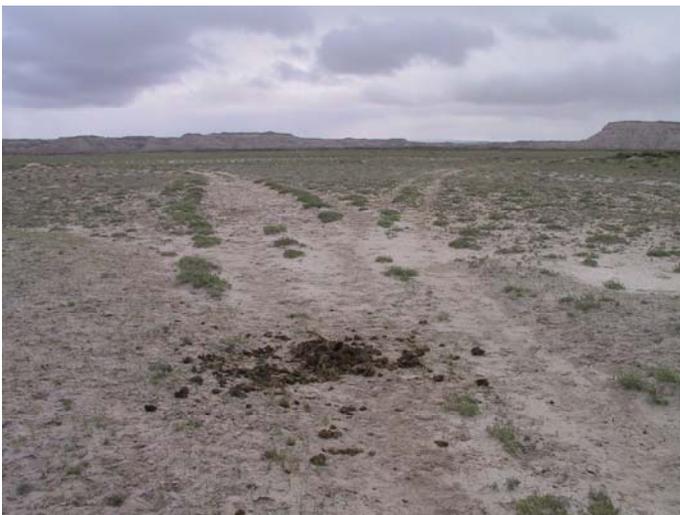
Photo #EMM43-50

Route AT-29  
UTM 0731822 4574398  
5/20/01

Route AT-29 (right distance)  
splits away from AT-4.

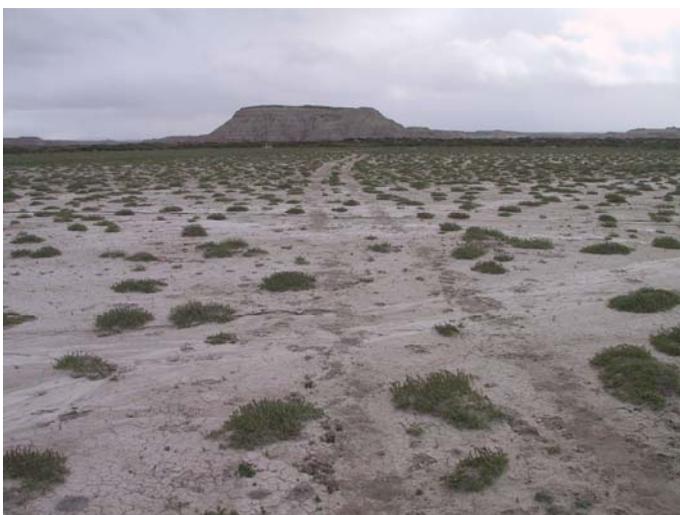
Photo #EMM43-51  
Route AT-29  
UTM 0731413 4574354  
5/21/01

View of route in typical condition.

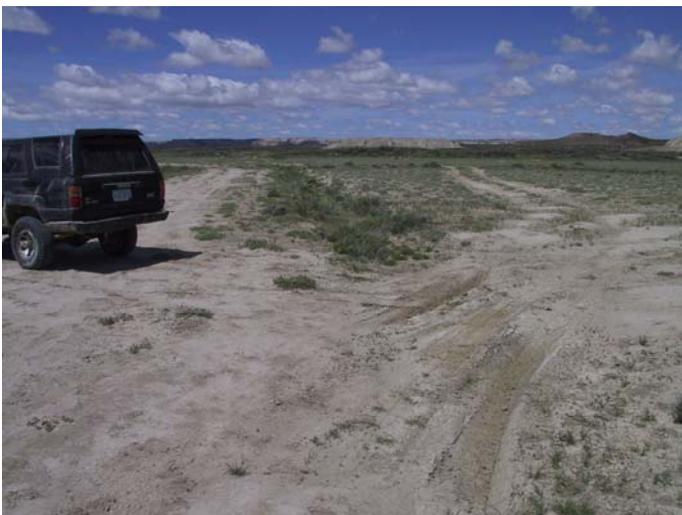
Photo #EMM44-8

Route AT-30 (at right) runs west from its junction with AT-27.

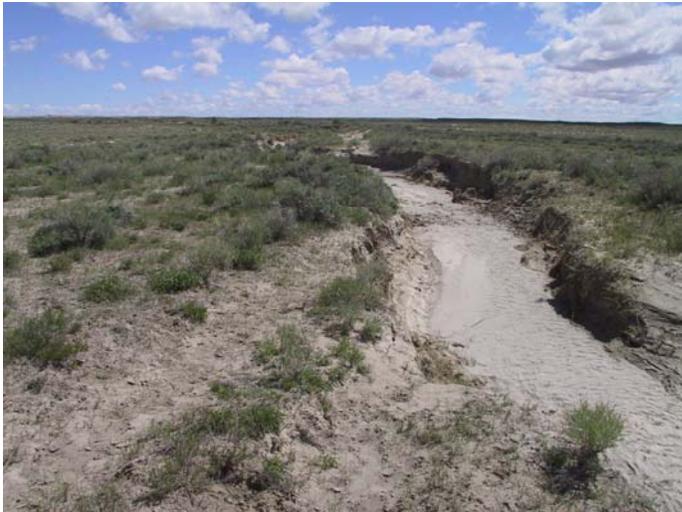
Photo #EMM44-3

Impasse at wash crossing--long  
drive-around to north. View east.

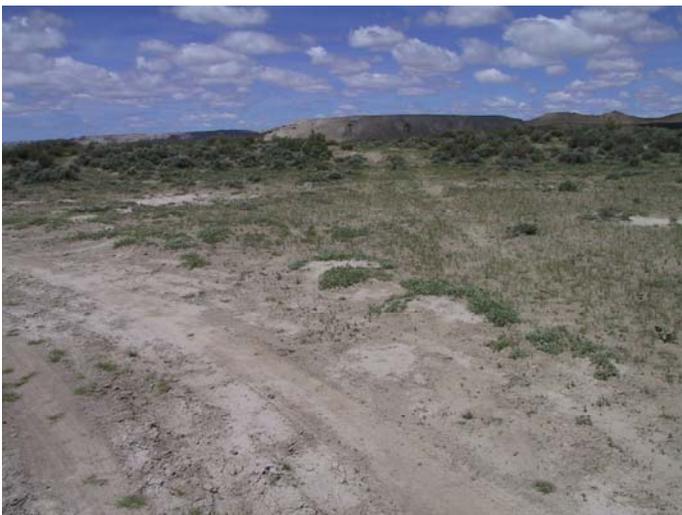
Photo #EMM44-13

Unused two-track to west--con-  
nects to drive-around.

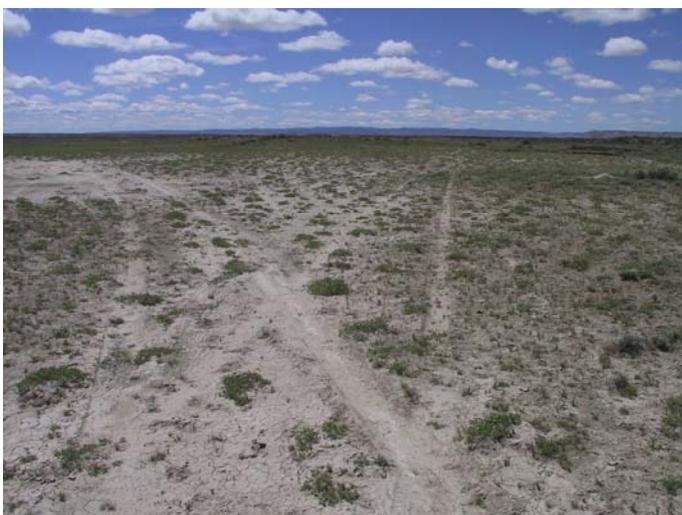
Photo #EMM44-14

View south along portion of  
drive-around bypass. Note diver-  
gent routes.

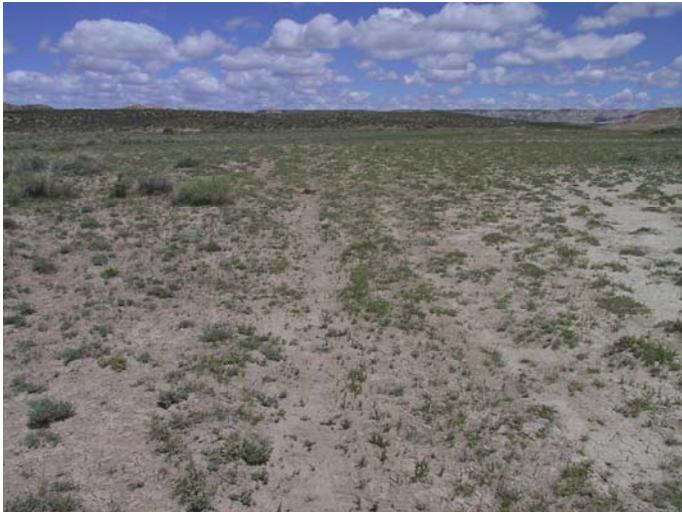
Photo #EMM44-15

View north on old bypass--no use, route ends. There is no longer an upstream wash crossing in this area.

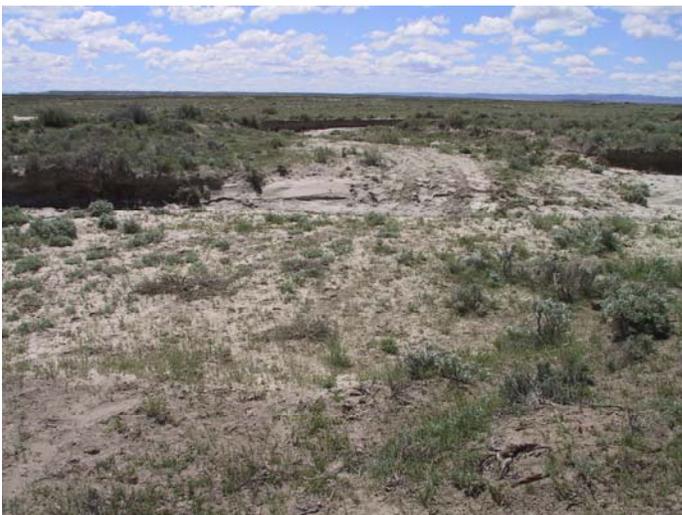
Photo #EMM44-6

Current wash crossing of drive-around. Very rough.

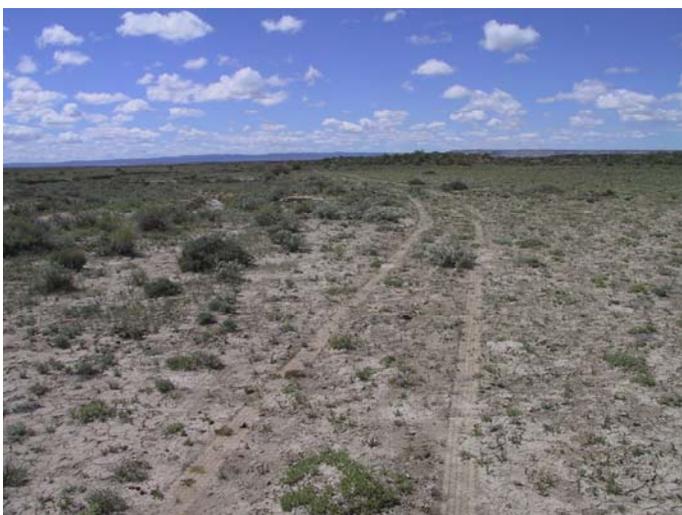
Photo #EMM44-4

View south from the end of abandoned northern bypass route--there is no longer a wash crossing this far north.

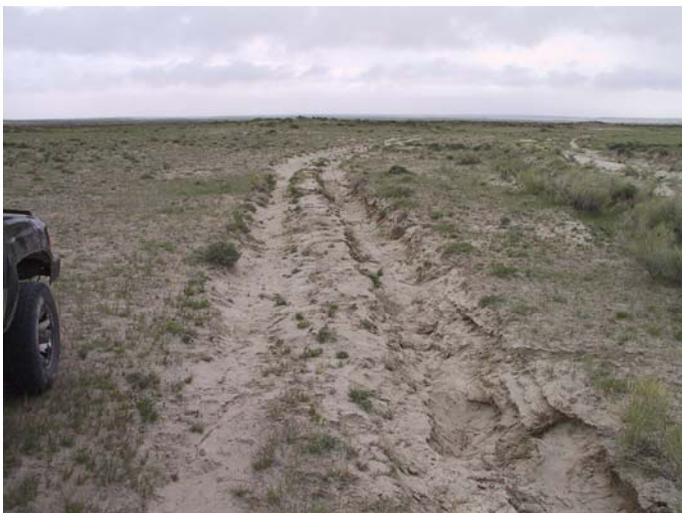
Photo #EMM43-45

Route gullied 2 ½ feet deep.

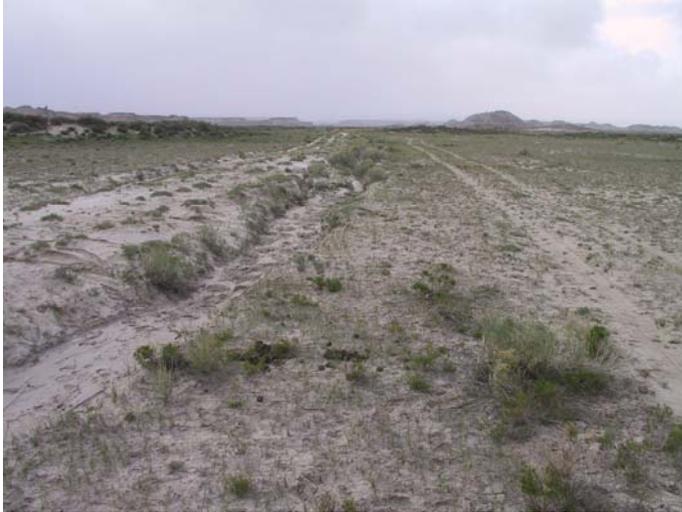
Photo #EMM43-44

Multiple trailing. Original route is gullied 3 feet deep here.

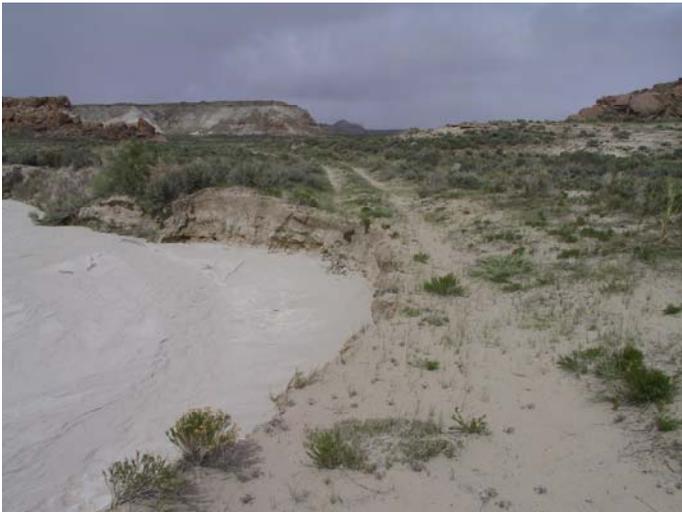
Photo #EMM43-43

Wash erosion has undermined the route at this point.

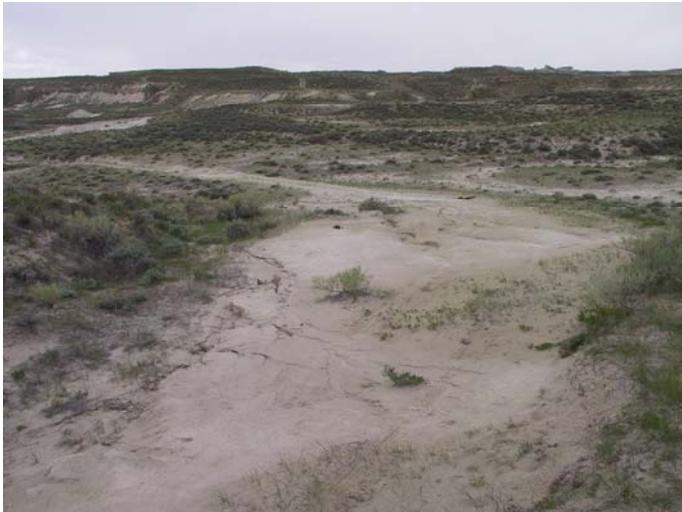
Photo #EMM43-31

Route is least road-like here.

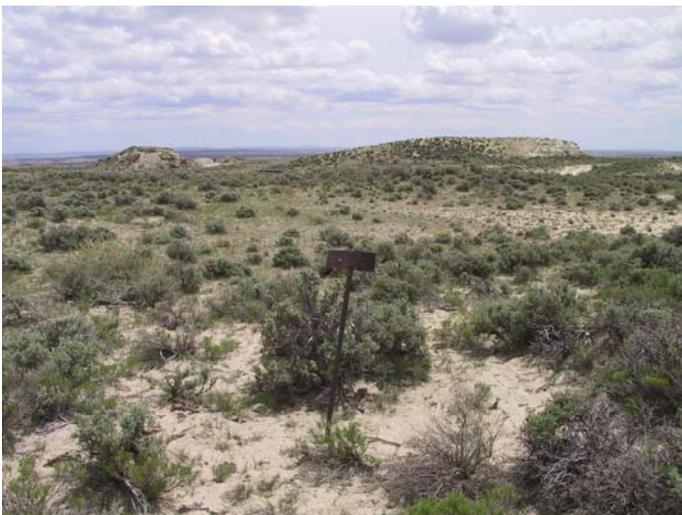
Photo #EMM43-15

Old rusty sign, perhaps marking private land boundary. No writing is visible.

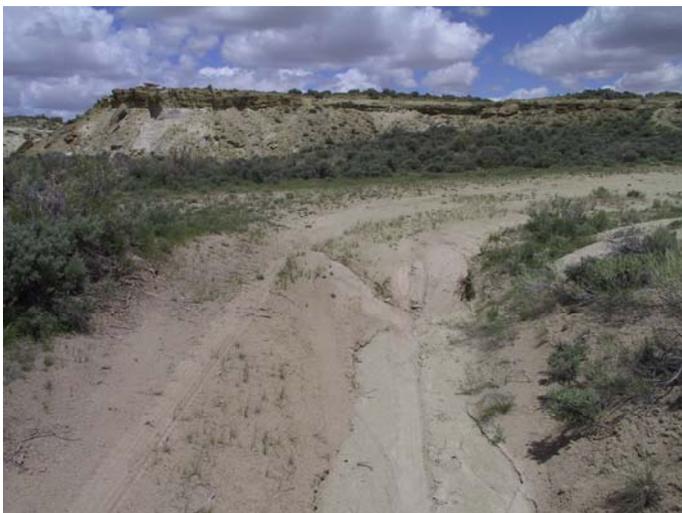
Photo #EMM43-13

Two foot rise on one wheel track--almost impassable.

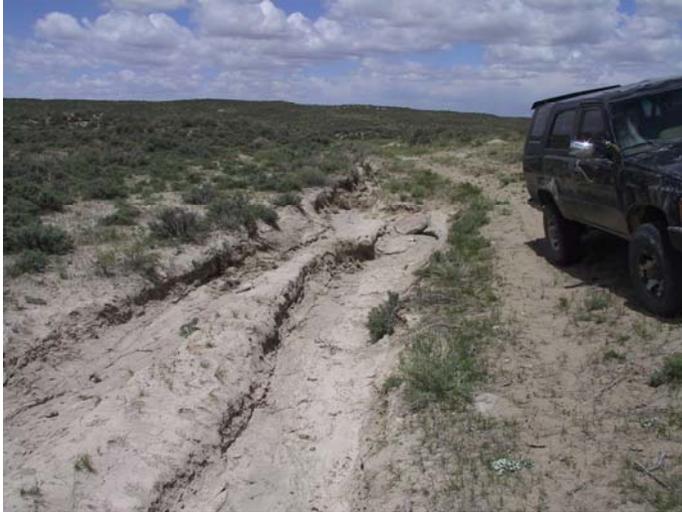
Photo #EMM43-11

Original route is deeply eroded  
and impassable. Drive-around.

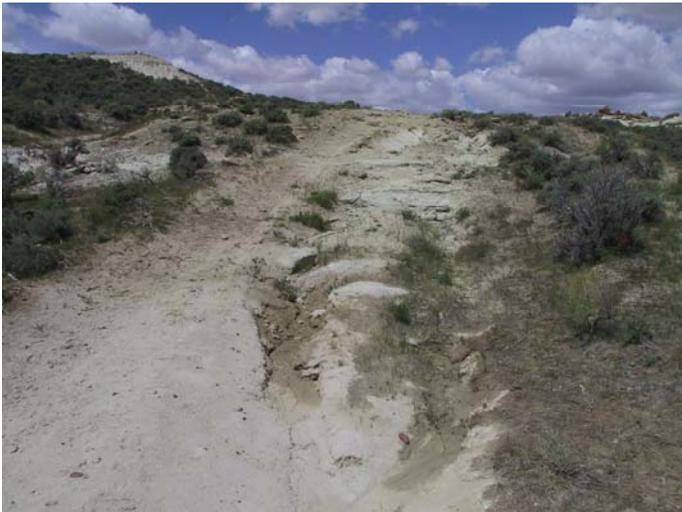
Photo #EMM43-14

Route is rough and rocky on east-  
ern descent from Manuel Gap.

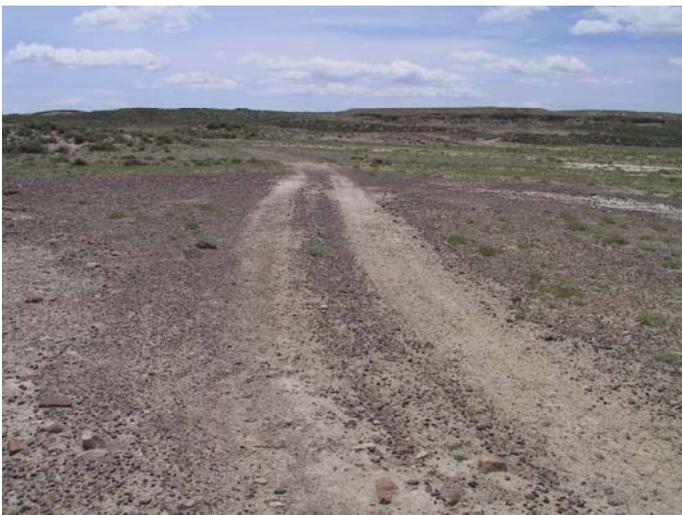
Photo #EMM43-2

Route AT-30 runs south from its junction with old oil pad route. End of all signs of past construction and maintenance; southeast of this point, the route is a way maintained by the passage of vehicles.

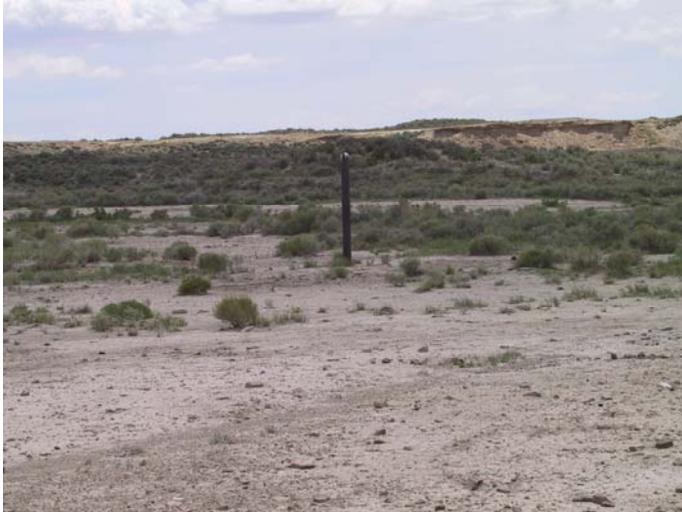
Photo #EMM43-3

Dry hole, Amoco Champlin 535  
A#1.

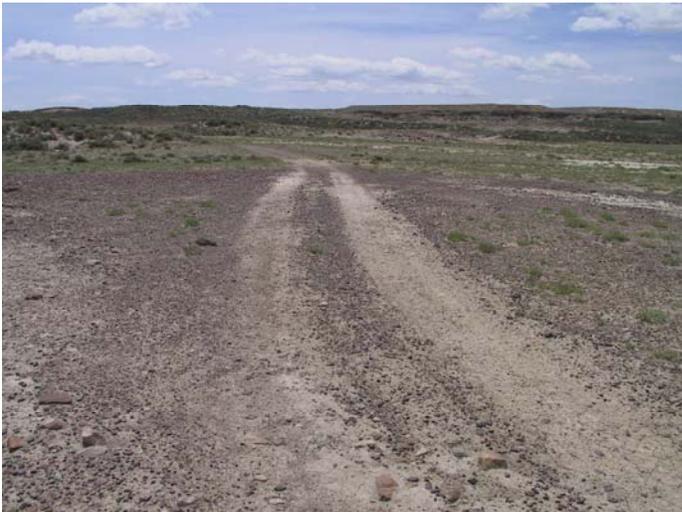
Photo #EMM43-2

Route AT-30 runs south from its  
junction with old oil pad route.  
End of all signs of past construc-  
tion and maintenance; southeast of  
this point, the route is a way main-  
tained by the passage of vehicles.

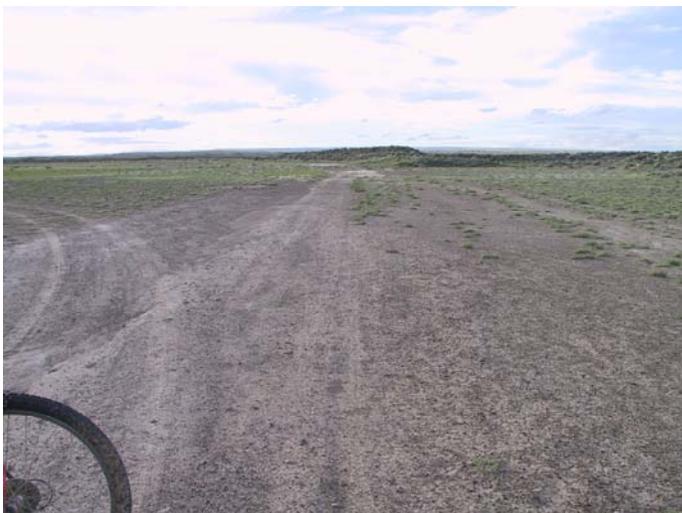
Photo #EMM38-50

AT-30 running south from its  
junction with AT-96 and AT-106.  
The route is accompanied by a  
50-foot revegetation strip at this  
point.

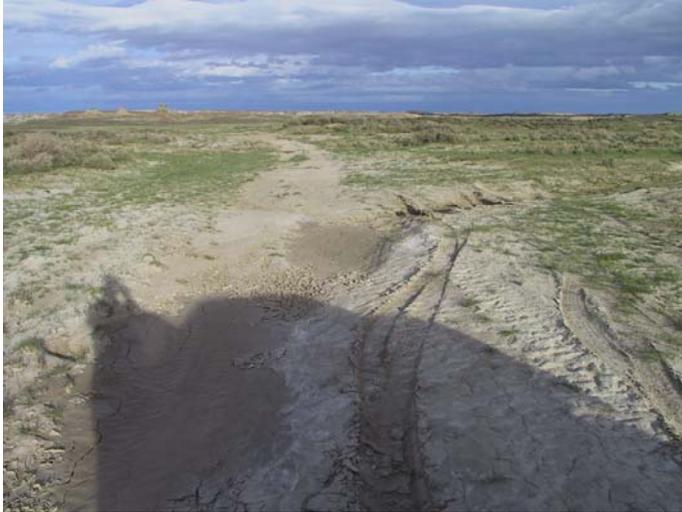
Photo #EMM38-46

Messy wash crossing on AT-30.

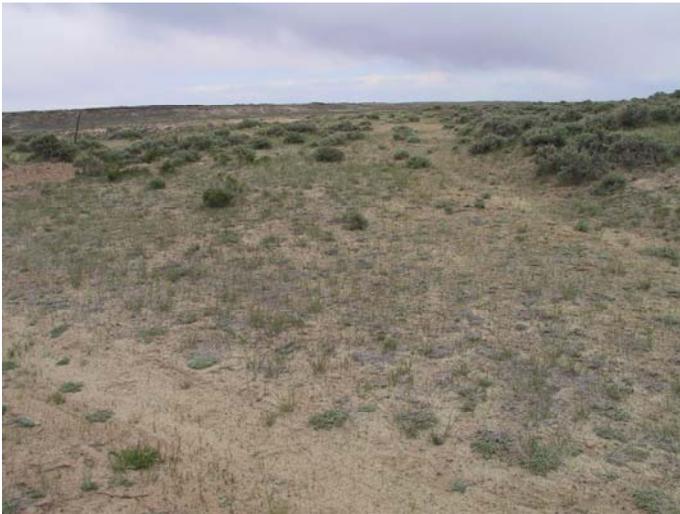
Photo #EMM43-32

Route AT-31 (right center)  
Departs southward from its  
junction with AT-30. Note grasses  
growing abundantly in wheel  
tracks.

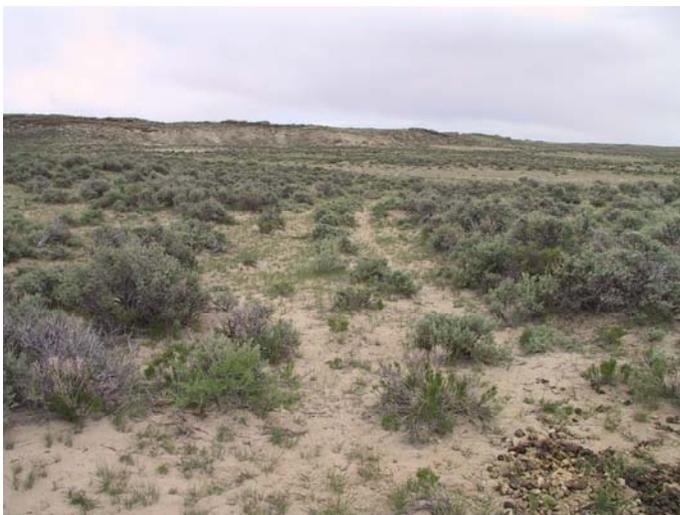
Photo #EMM43-33

Route in typical condition.

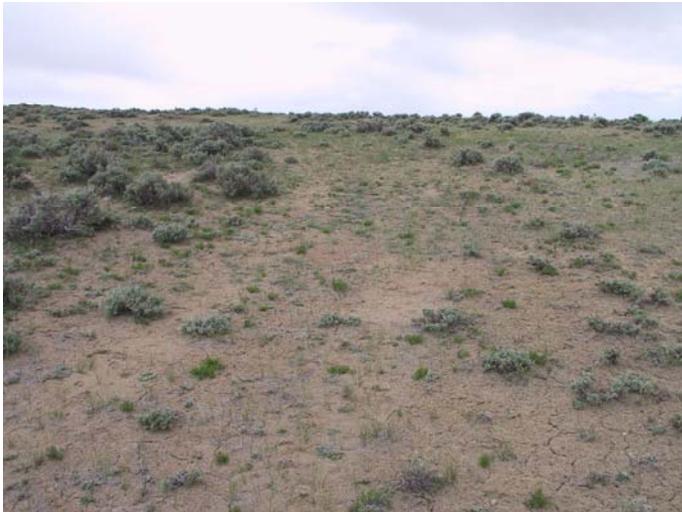
Photo #EMM43-34

Route is virtually invisible at this point.

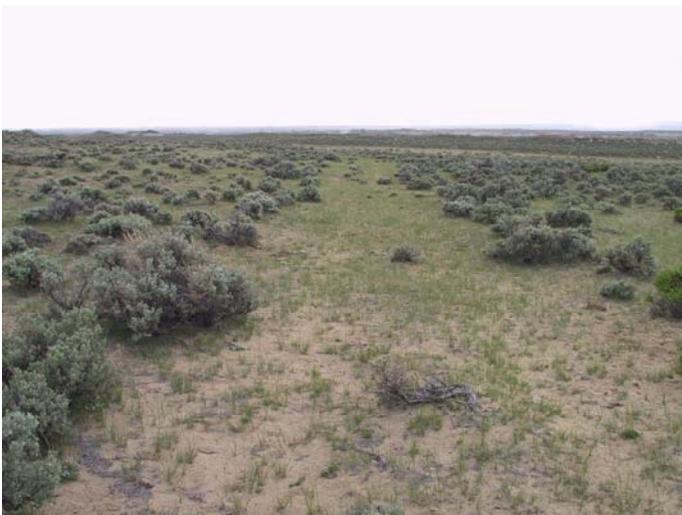
Photo #EMM43-35

Route is very faint, and appears only as a clearing in the sagebrush.

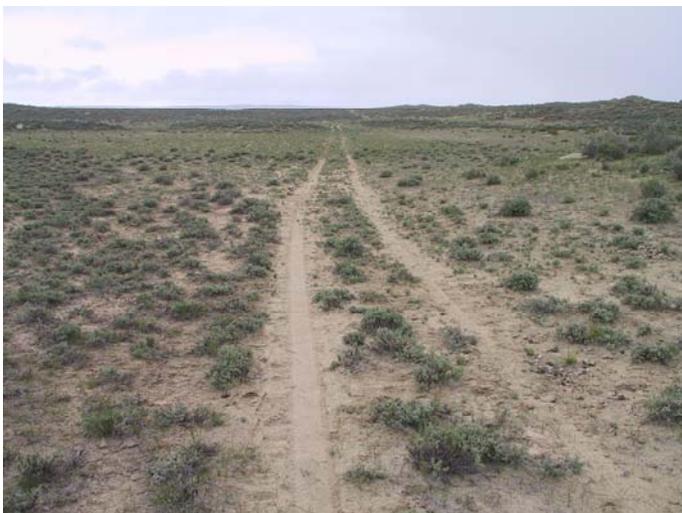
Photo #EMM43-39

Route in its most well-worn condition.

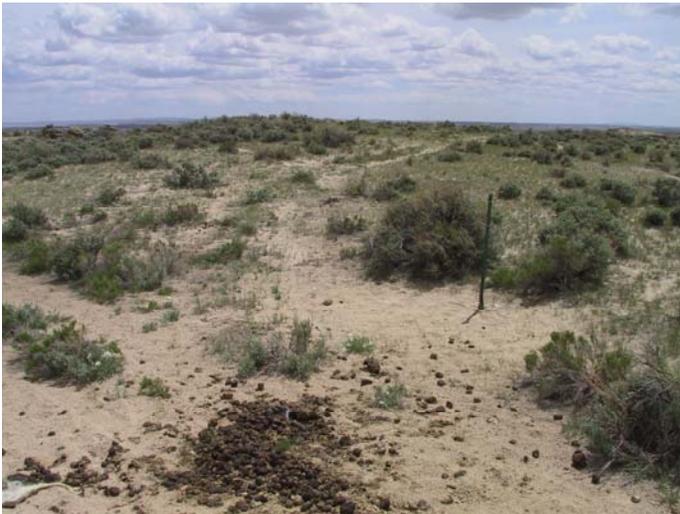
Photo #EMM43-19

Route AT-32 departs southward  
from its junction with AT-30.  
Note the lack of vehicle use.

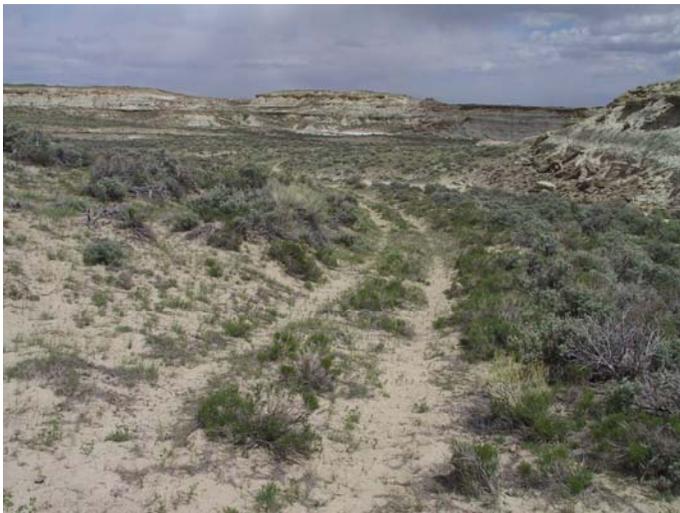
Photo #EMM43-20

Route in typical condition.

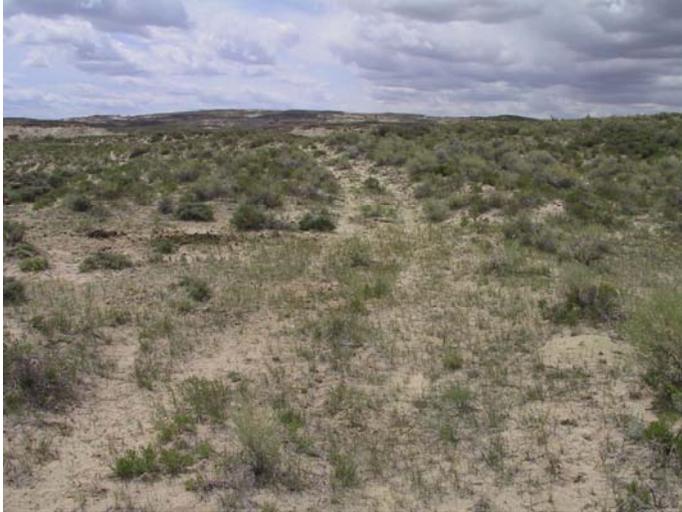
Photo #EMM43-21

Route is well-reclaimed at this point. Note vegetation growing throughout route bed.

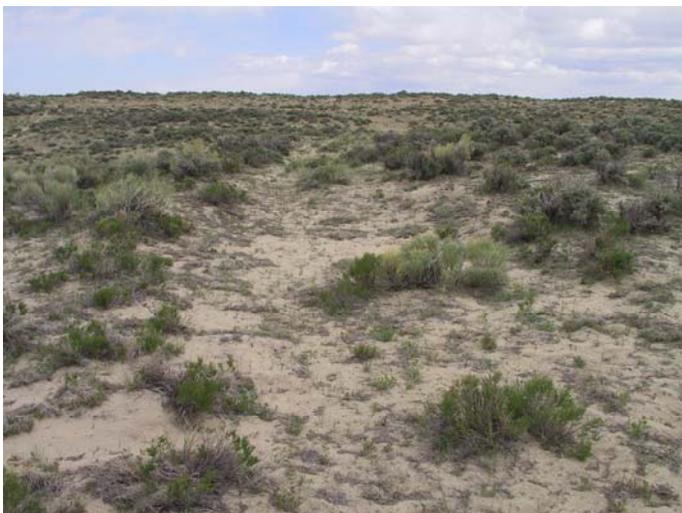
Route AT-32  
UTM 0725839 4575212  
5/20/01

Route is well-reclaimed at this point.

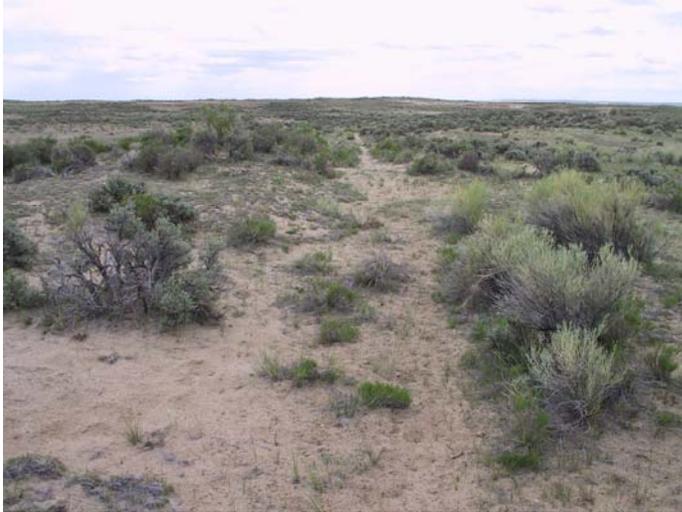
Route AT-32  
UTM 0726627 4574501  
5/20/01

Not constructed.  
No maintenance.  
Does not exist.  
No use.

This route is shown as a primitive road on the USGS Manuel Gap quad, but there is no evidence of its existence on the ground.
