**BLM Unit Identification:** Adobe Town WY-030-401 and WY-040-408

**Description** Adobe Town is proposed by the conservation community for wilderness designation. The area proposed for wilderness includes all of the Adobe Town Wilderness Study Area, plus additional lands of wilderness quality in The Haystacks, along Willow Creek and the Willow Creek Rim, and south of the WSA to the Powder Rim and just beyond it. All of these areas possess the full complement of required characteristics for wilderness in abundance: outstanding opportunities for both solitude *and* primitive and unconfined recreation, wilderness-quality naturalness, size (at over 180,000 acres, the citizens proposed Adobe Town wilderness is well above the 5,000-acre minimum), and in addition has outstanding supplemental values such as abundant wildlife, wild horse herds, unique geology, and abundant archaeological and paleontological resources.

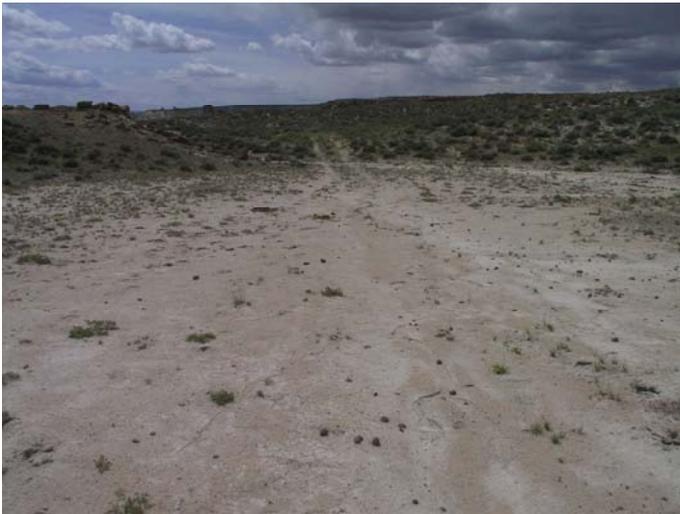
Route AT-33  
UTM 0725326 4575341  
5/20/01

Route AT-33 departs westward  
from its junction with AT-32.  
Note the lack of vehicle use.

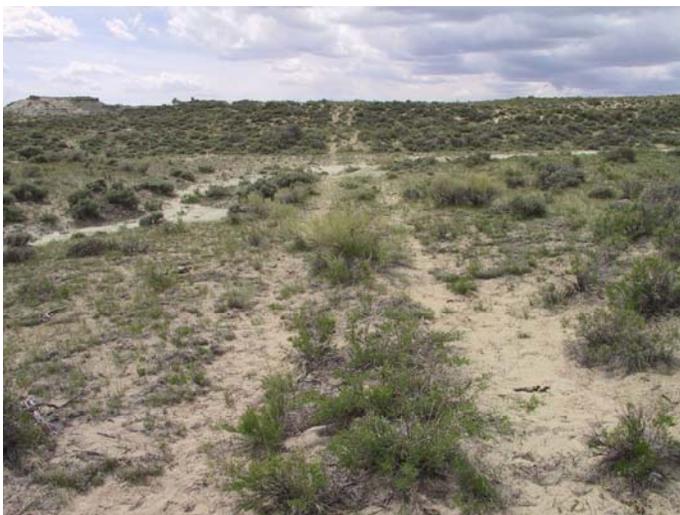
Route AT-33  
UTM 0724864 4575121  
5/20/01

Route in typical condition.

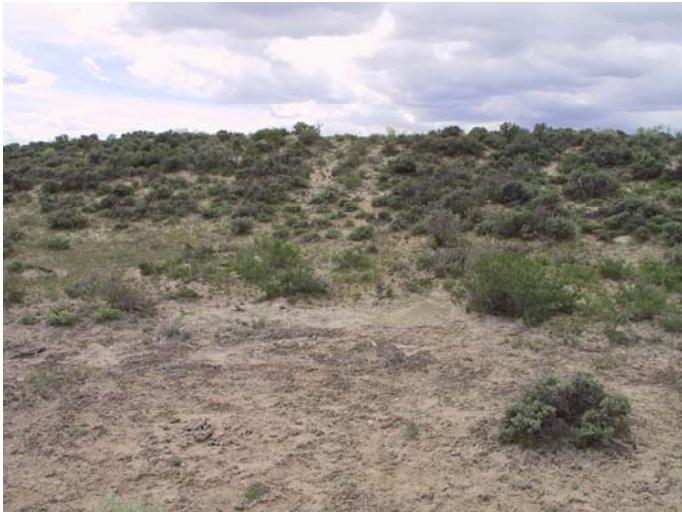
Route AT-33  
UTM 0724802 4575126  
5/20/01

Original route runs due west from this point.

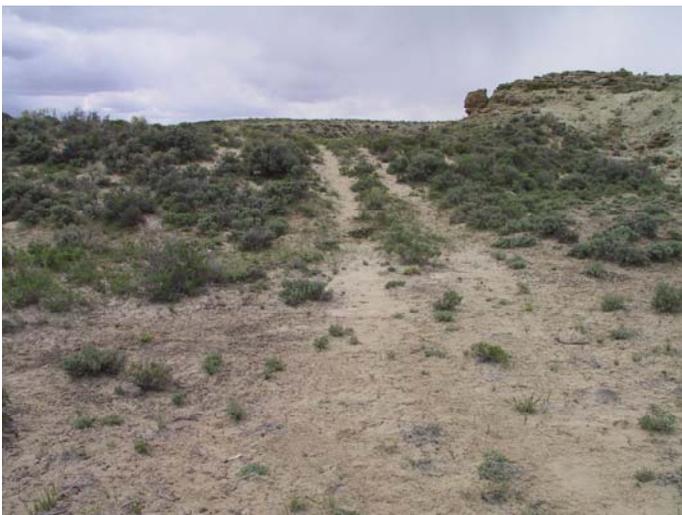
Route AT-33  
UTM 0724802 4575126  
5/20/01

Newer route runs slightly north of original route. Still shows no use.

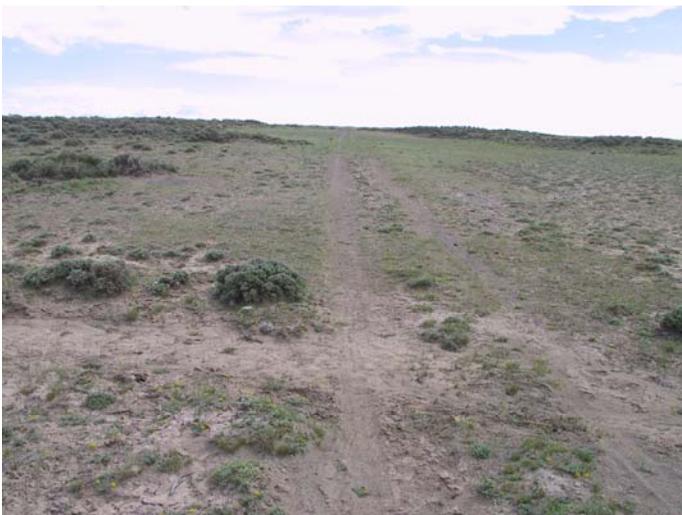
Route AT-34  
UTM 0718866 4574337  
5/14/01

Route AT-34 is very faint here.

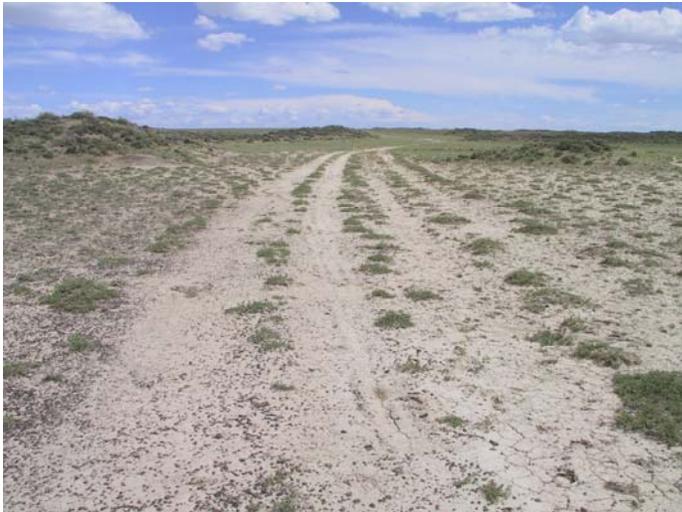
Route AT-34  
UTM 0718941 4570437  
5/14/01

Multiple trailing along boundary route.

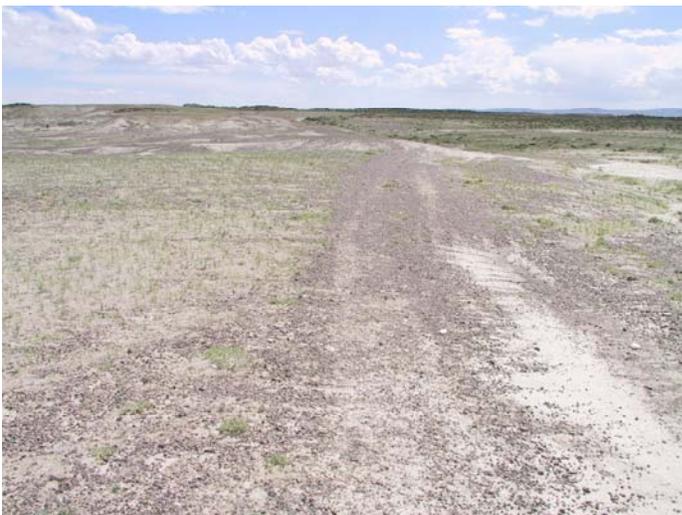
Route AT-34  
UTM 0719343 4569721  
5/14/01

Route is very poorly defined at this point.

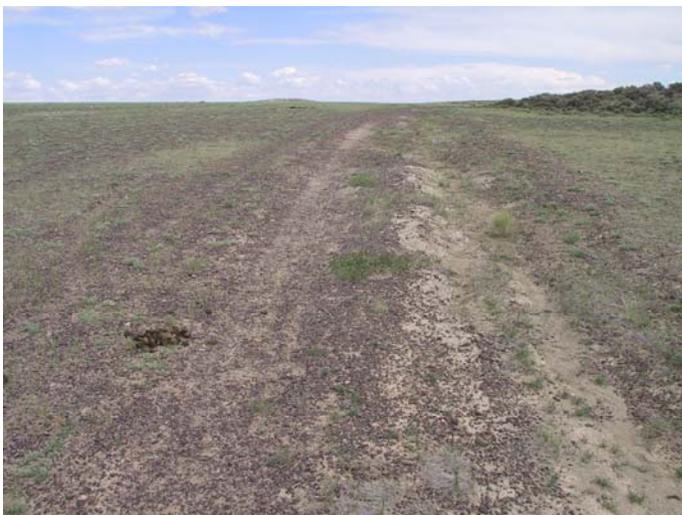
Route AT-34  
UTM 0719792 4569287  
5/14/01

Route displays double-trailing here, and deep erosion in original bed (at right).

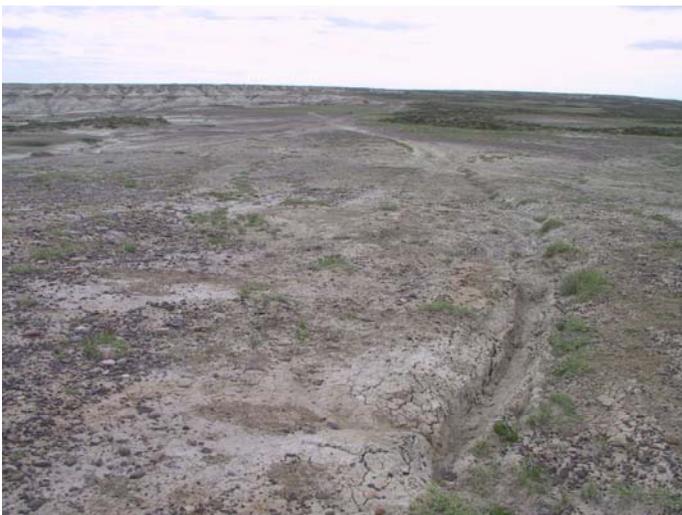
Route AT-34  
UTM 0719414 4568146  
5/15/01

Route is in poor shape here. Note  
pipeline crossing.

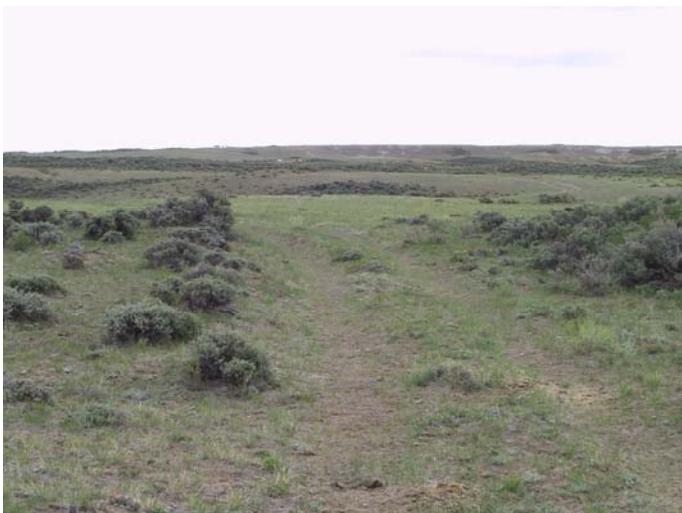
Route AT-34  
UTM 0719621 4566785  
5/15/01

Route is being overtaken by grass  
at this point.

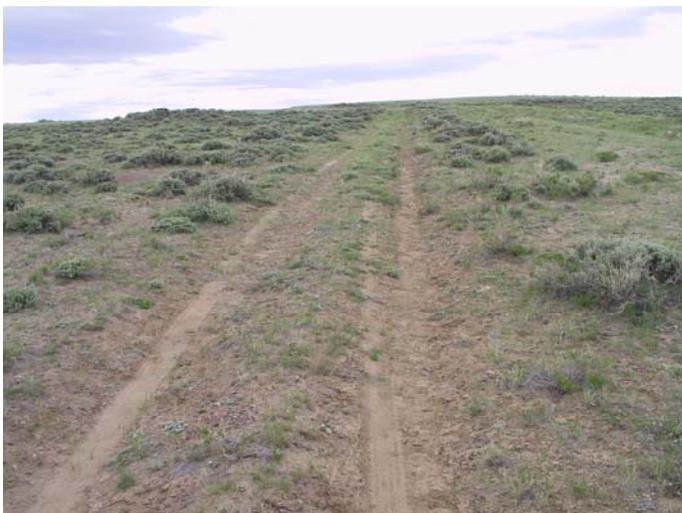
Route AT-34  
UTM 0718520 4563667  
5/15/01

Route is deeply gullied here. The pipeline now bends away to the south.

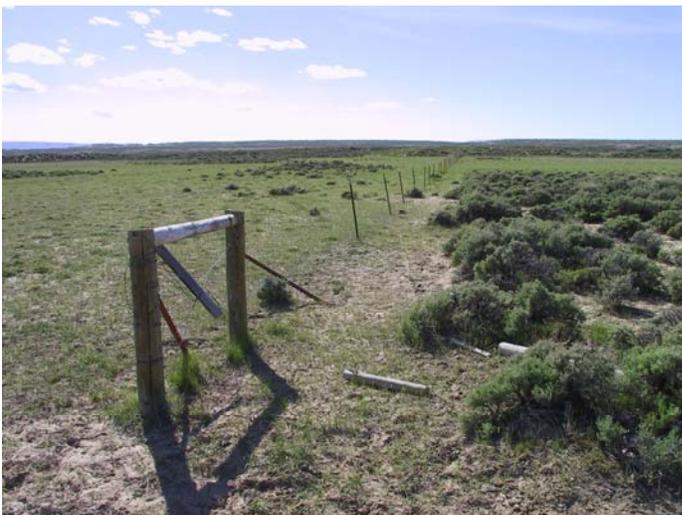
Route AT-35  
UTM 0712501 4562079  
5/22/01

Fence crosses Route AT-5. The wire is down here. View north-west.

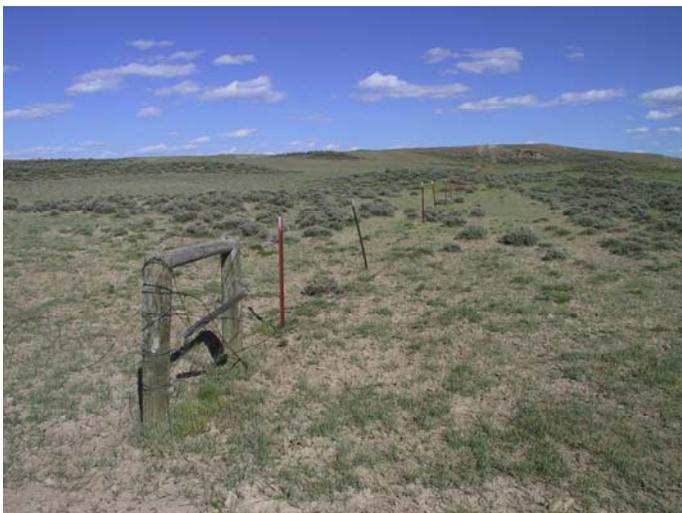
Route AT-35  
UTM 0712501 4562079  
5/22/01

Fence crosses Route AT-5. The wire is down here. View south-east.

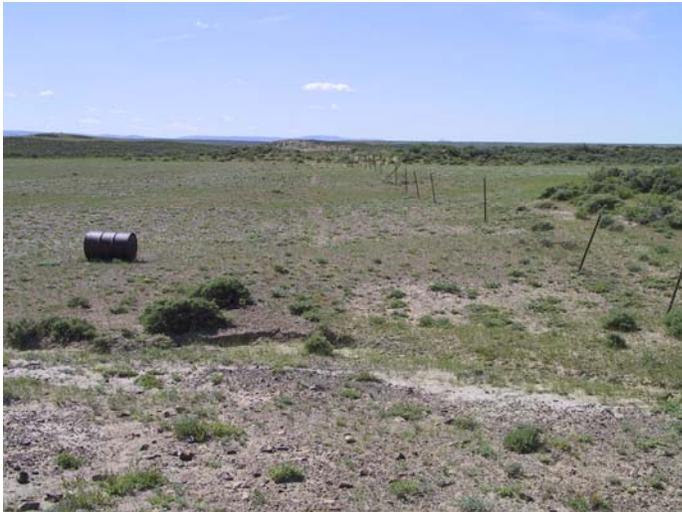
Route AT-35  
UTM 0723031 4561356  
5/22/01

View west along fence at gate crossing of AT-7. There is no gate present. The fence is down at this locale. Note rusting barrel.

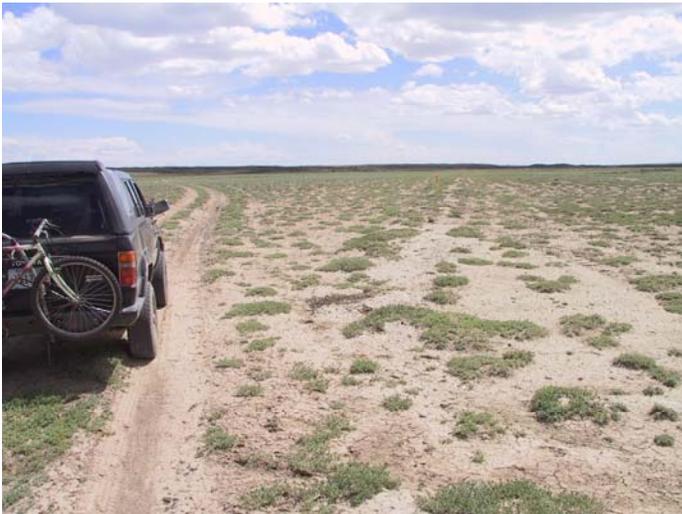
Photo #EMM37-57

Pipeline swings away from  
AT-34. View north.

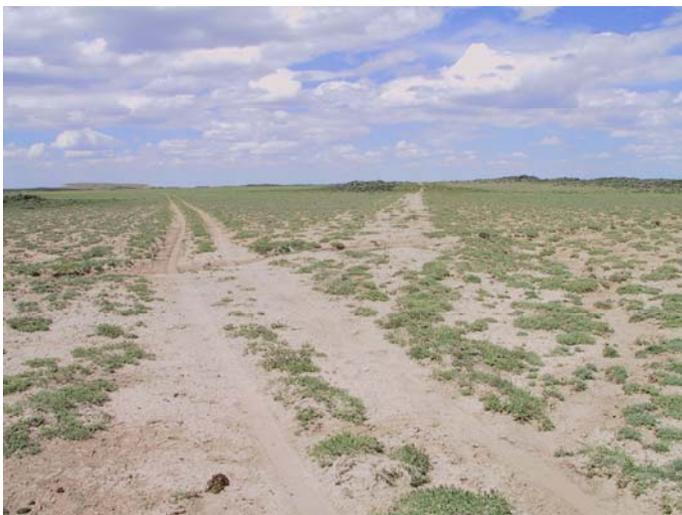
Photo #EMM37-56

Pipeline (at right) crosses AT-34.  
View south.

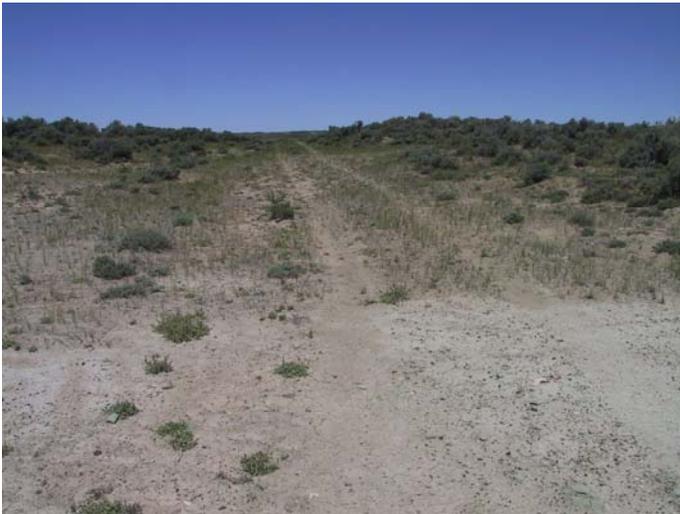
Photo #EMM45-40

This jeep trail runs northwest from the well site at the end of AT-9 and dead-ends.

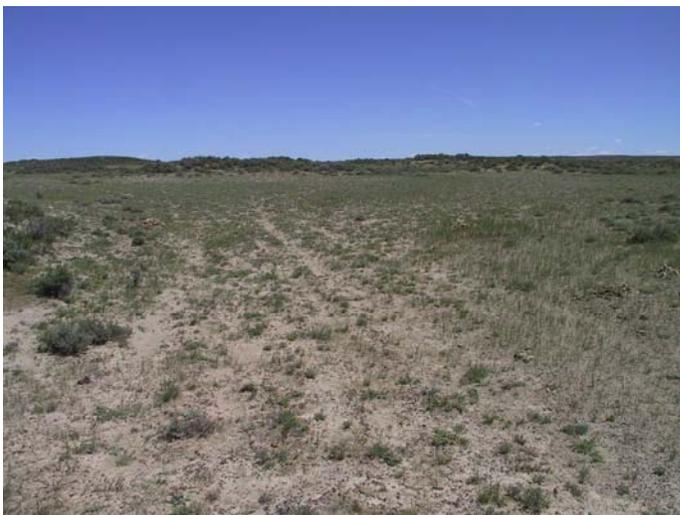
Photo #EMM45-41

Route AT-37 departs from well pad at the end of Route AT-9.

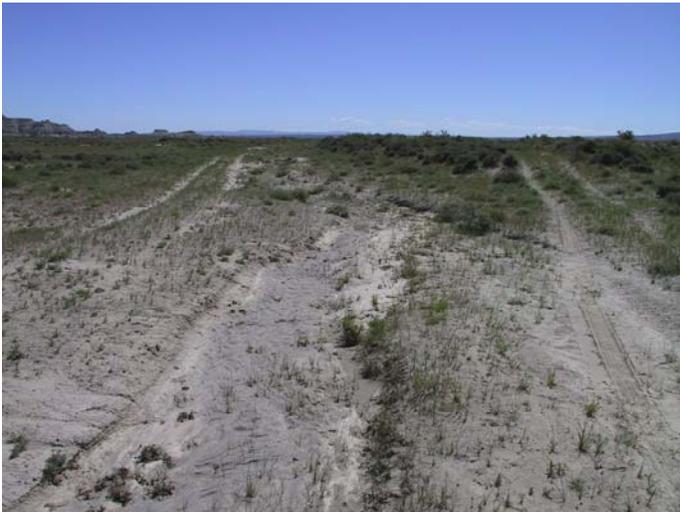
Photo #EMM46-21

This old seismograph trail parallels the abandoned WSA boundary route AT-17, and what little vehicle traffic this area gets follows this route. It is almost entirely reclaimed.

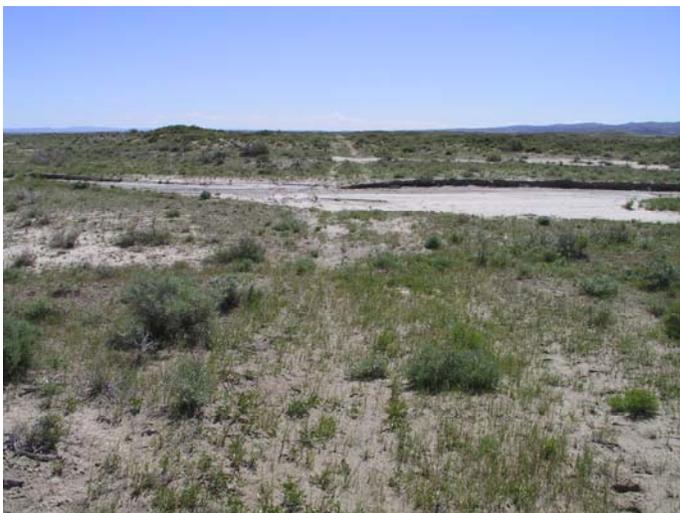
Photo #EMM46-22

Route AT-37 (at right) splits away from AT-17.

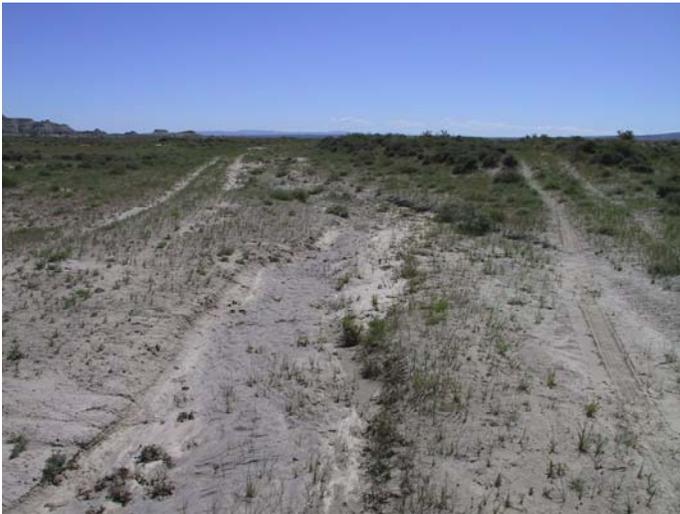
Photo #EMM46-21

This old seismograph trail parallels the abandoned WSA boundary route AT-17, and what little vehicle traffic this area gets follows this route. It is almost entirely reclaimed.

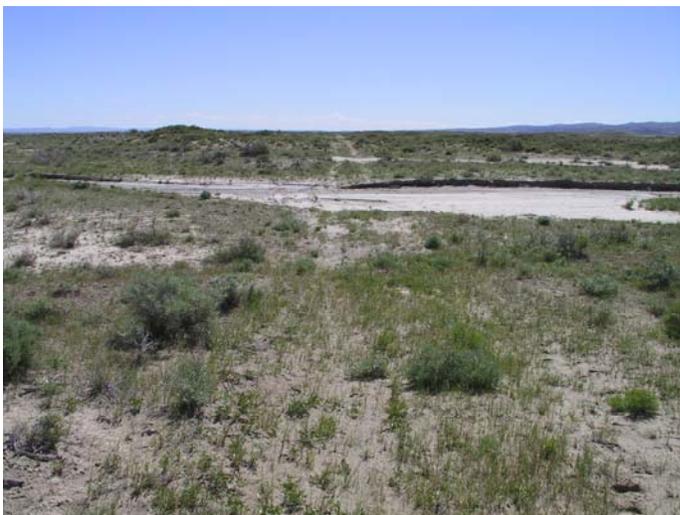
Photo #EMM46-22

Route AT-37 (at right) splits away from AT-17.

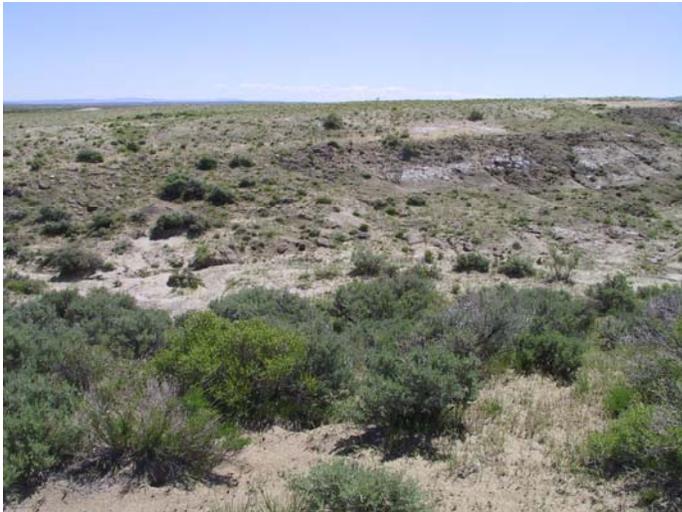
Photo #EMM46-26

Seismograph trail continues east; signs of blading. Typical of route.

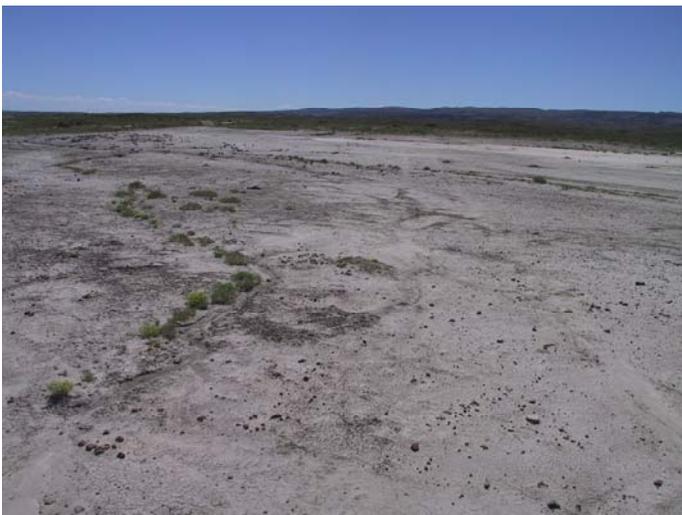
Photo #EMM46-27

Seismograph trail reaches  
impasse--drive-around to the  
north. Sage grouse sighted here.

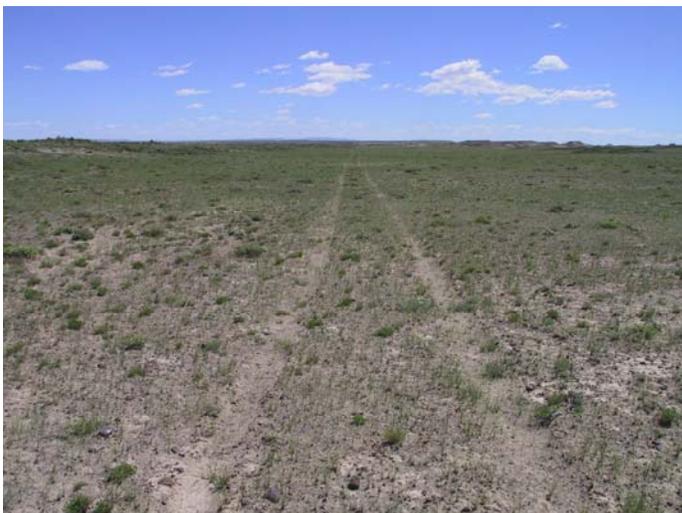
Photo #EMM46-31

Seismograph trail is very faint as  
it crosses playa.

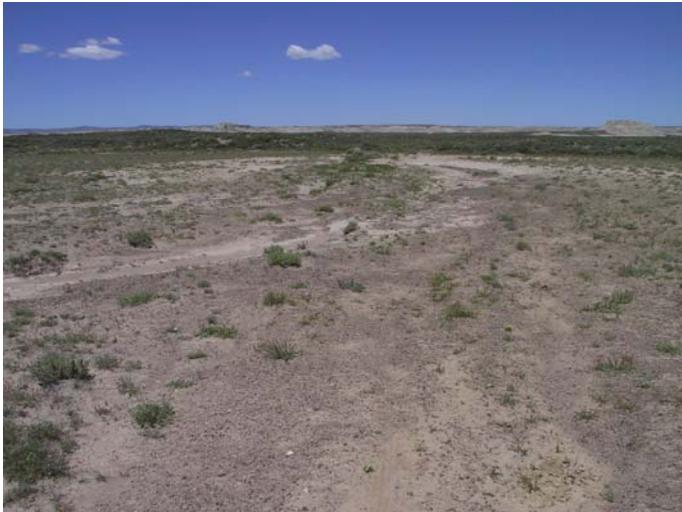
Photo #EMM46-32

Route is very faint as it crosses  
grasslands.

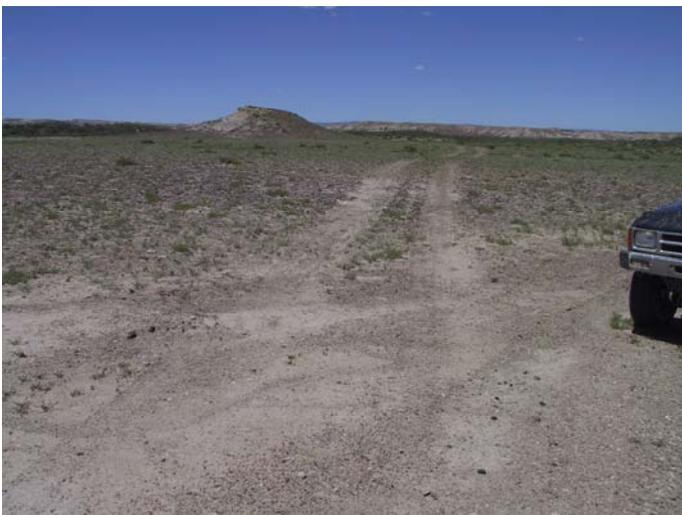
Photo #EMM46-37

This jeep trail may once have accessed Last Reservoir, but now is merely a dead-end.

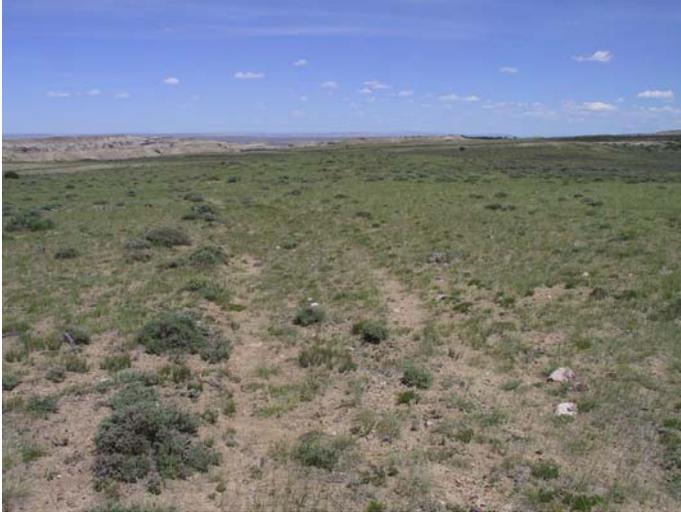
Photo #EMM47-89

Jeep trail departs westward from  
AT-17.

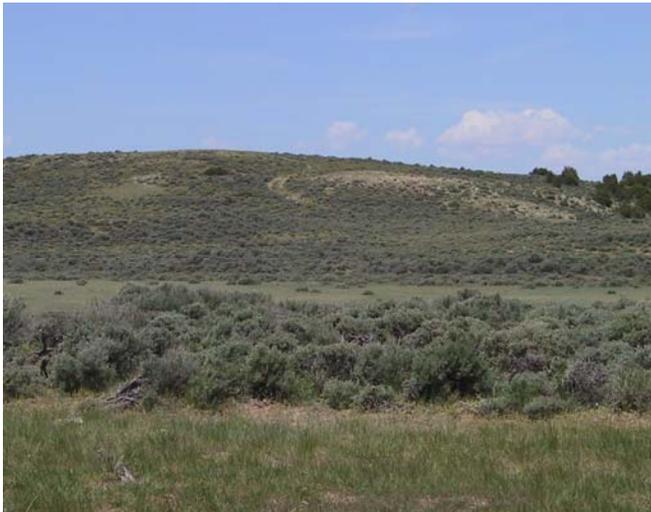
Photo #EMM47-87

Route is fully reclaimed here.

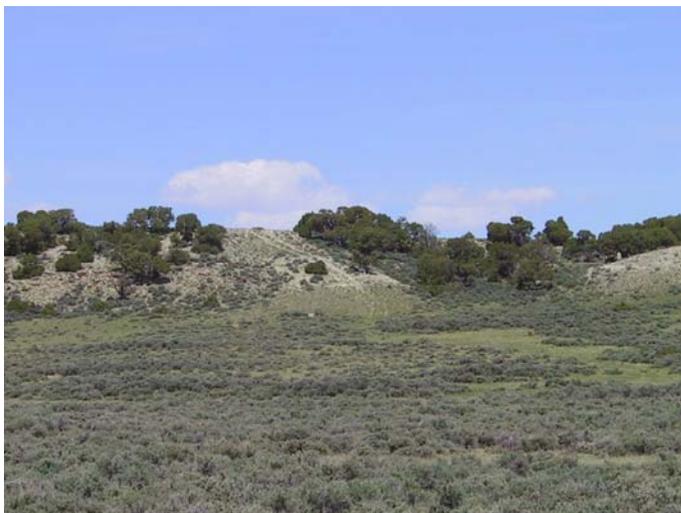
Photo #EMM47-86

A lost segment of AT-40 (at center on hill), as seen from Route AT-16.

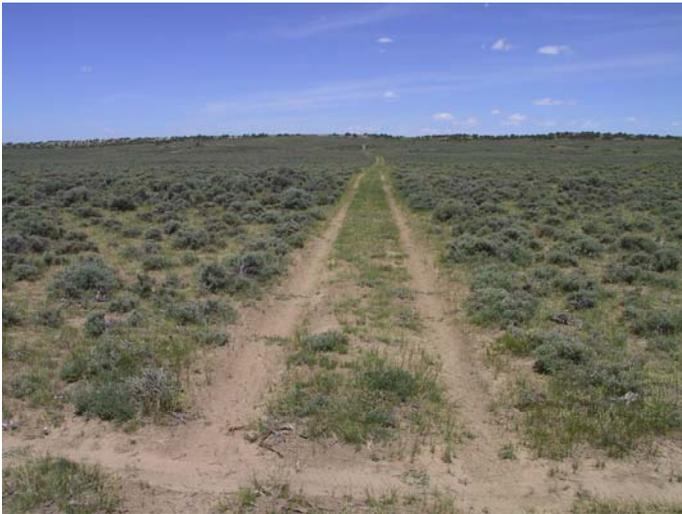
Photo #EMM47-80

This old seismograph trail has been improved recently probably in association with new exploration activity. It serves no purpose beyond seismograph testing.

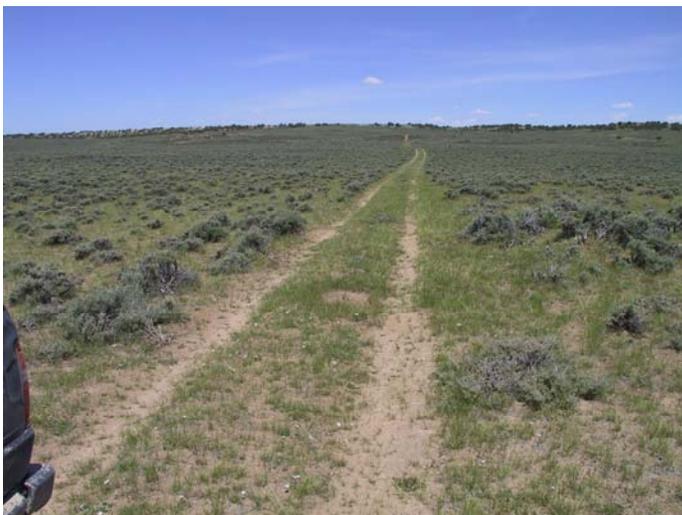
Photo #EMM47-75

Route AT-41 runs north from its  
junction with AT-44.

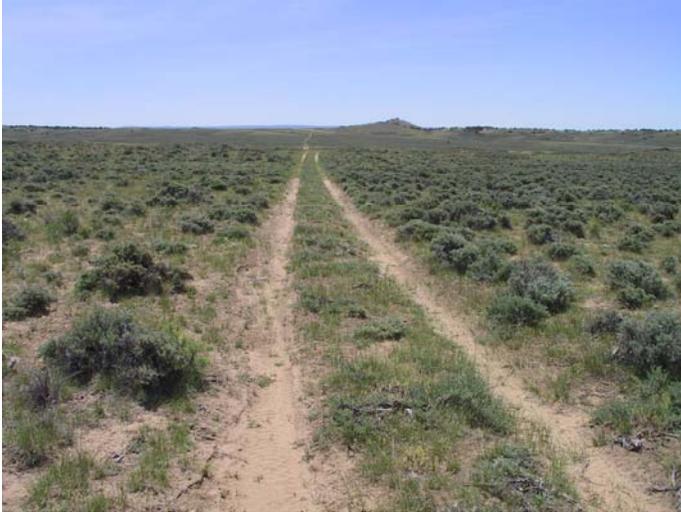
Photo #EMM47-71

View north on seismograph trail  
from unused northern cutoff of  
AT-44.

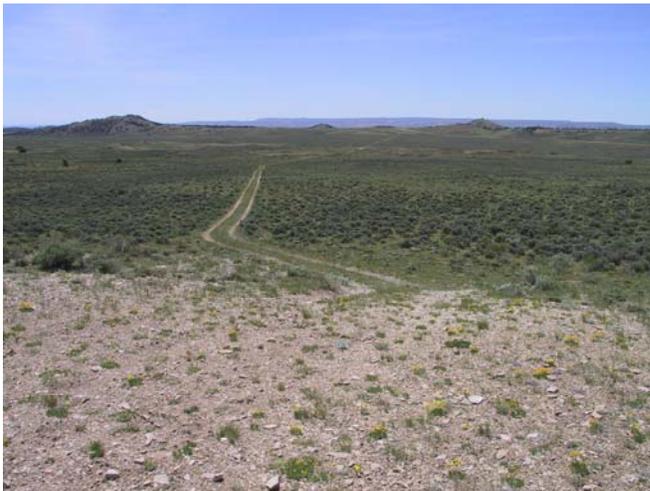
Photo #EMM47-64

Route is typical here--note abundant grass between tracks.

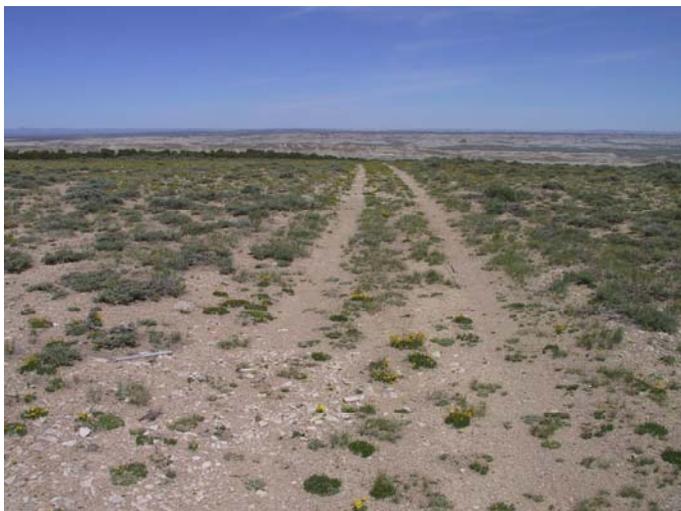
Photo #EMM47-65

View south from ridgetop junction with AT-42.

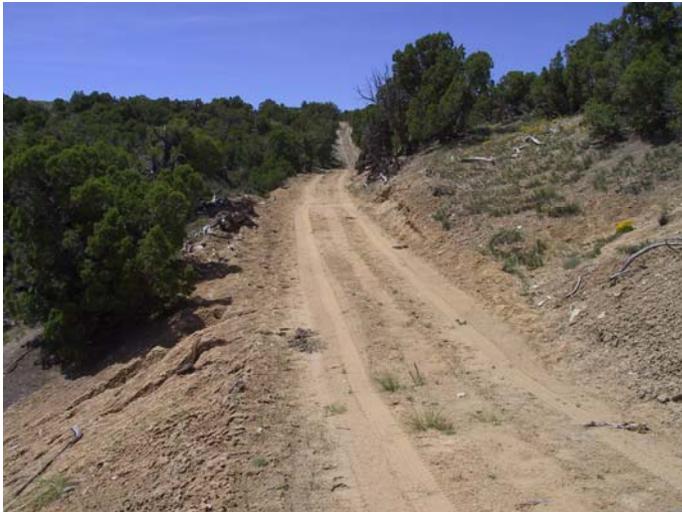
Photo #EMM47-67

View north from ridgetop junction with AT-42.

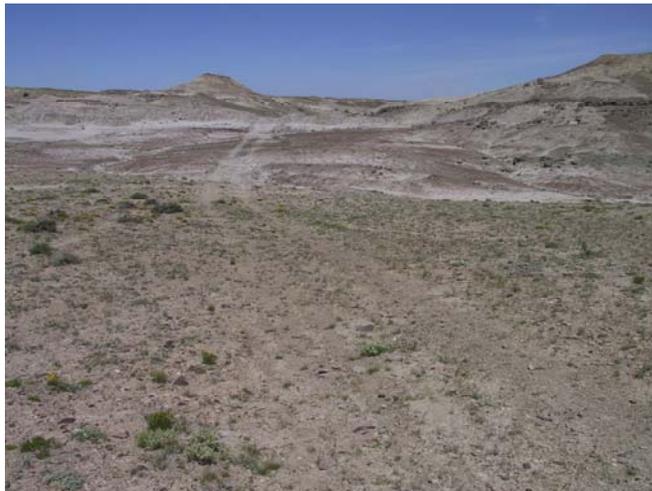
Photo #EMM47-68

Exemplary of the recent blading  
along this stretch.

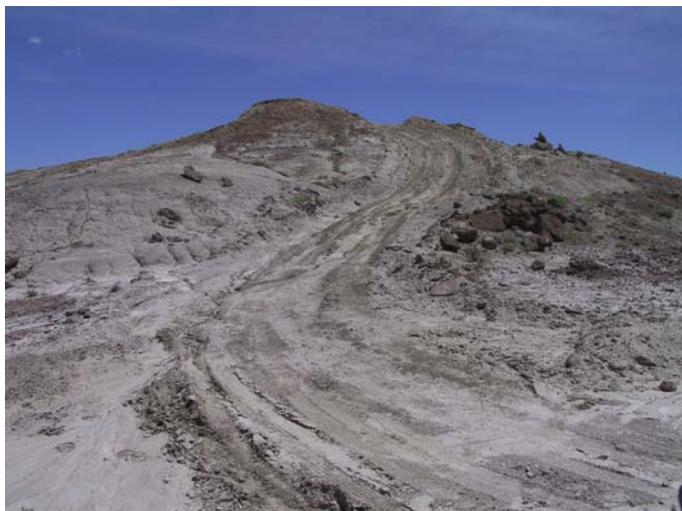
Photo #EMM47-70

Route is very faint as it  
approaches badlands.

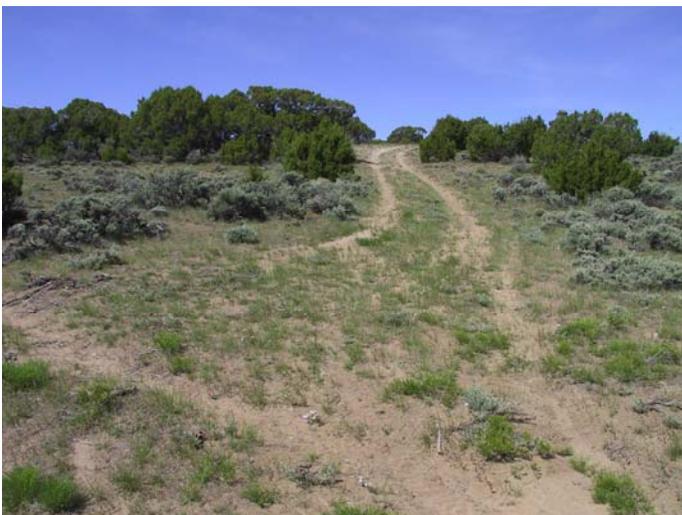
Photo #EMM47-43

This jeep trail follows the top of the Powder Rim for about one mile.

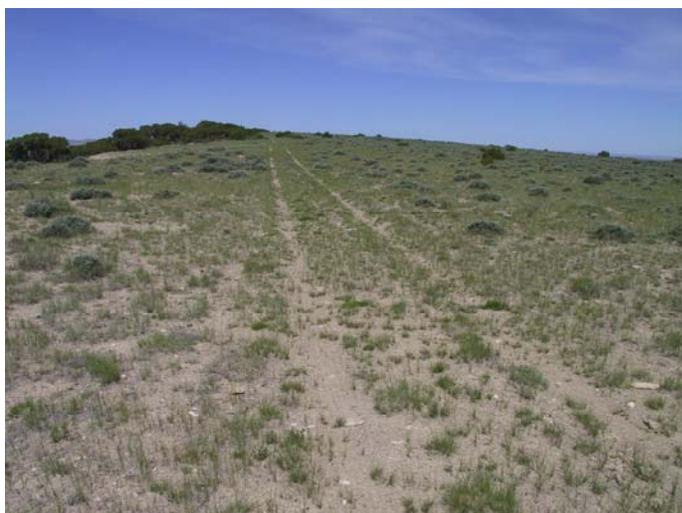
Photo #EMM47-51

View east from junction with AT-45.

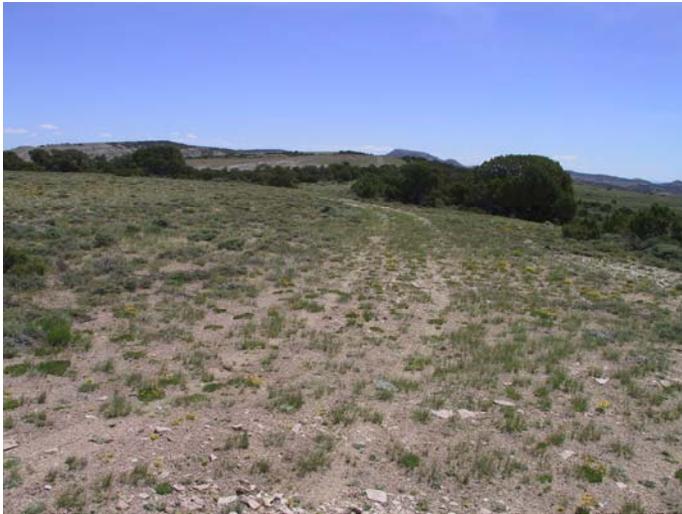
Photo #EMM47-66

View west from junction with AT-45.

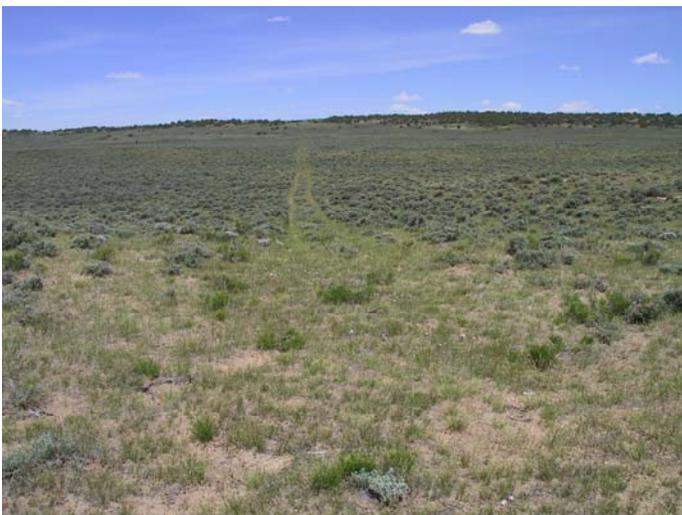
Photo #EMM47-77

This short, abandoned jeep trail links AT-44 with AT-42. It may be a portion of an old seismograph trail.

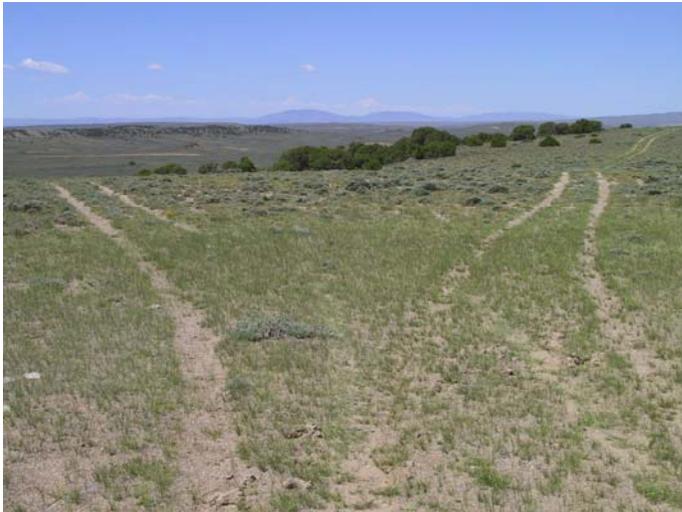
Photo #EMM47-61

Old seismograph trail runs north from AT-44. It is fully reclaimed here.

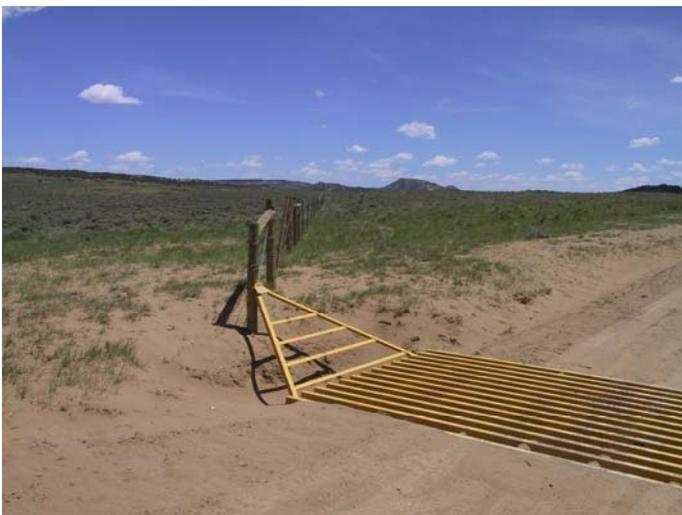
Photo #EMM47-83  
Rt. AT-43  
UTM 0725737 4547556  
5/24/01

This newly built fence is paralleled by a very faint, reclaimed two-track that probably originated with the construction of the fence.

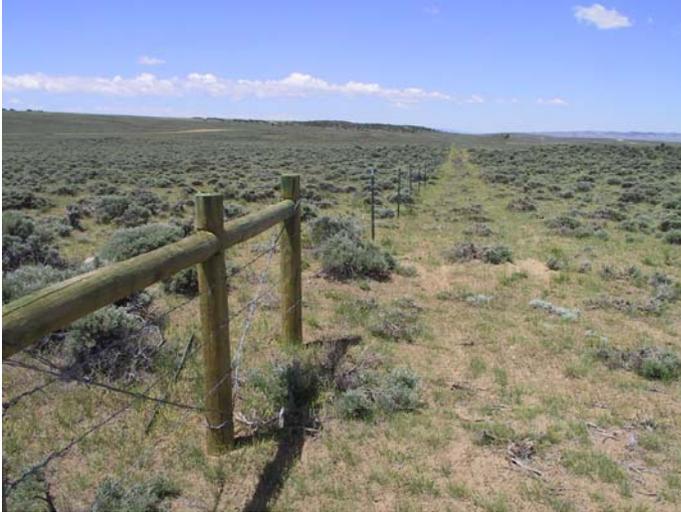
Photo #EMM47-72

View east along fence from  
AT-16. There is a cattleguard  
crossing on this latter road. The  
fence access route has been bisect-  
ed by the fence here.

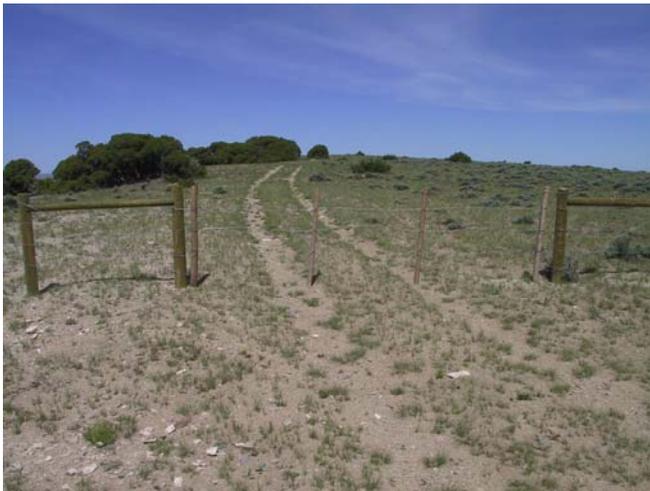
Photo #EMM47-49

View west along fence from gated crossing of AT-41. Note old access two-track.

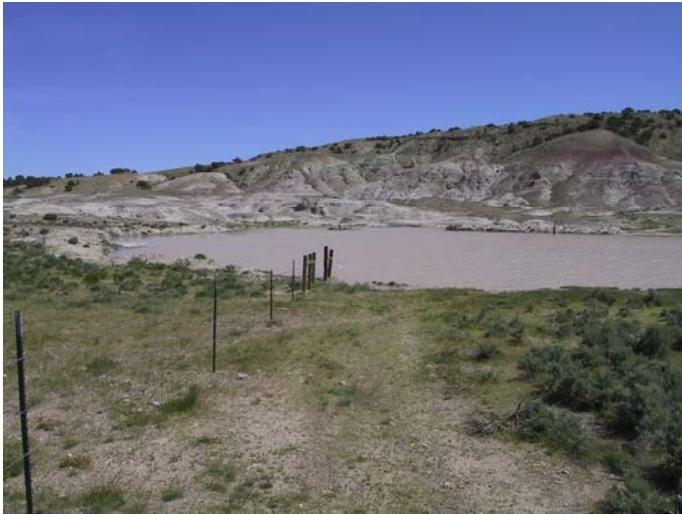
Photo #EMM47-47

View southwest along fence from its junction with AT-42.

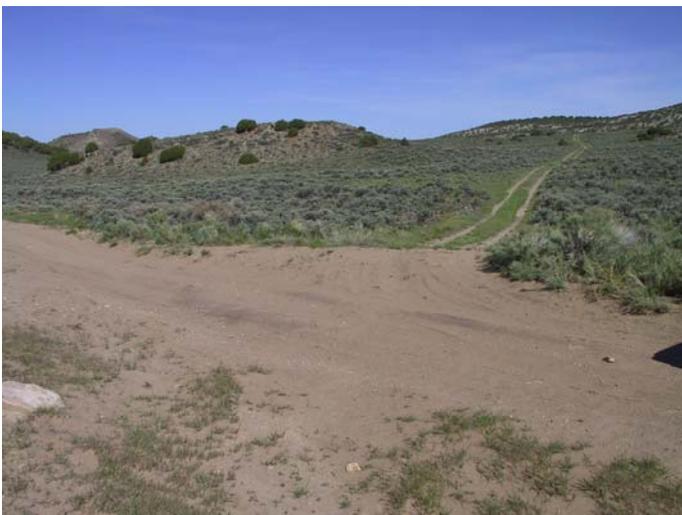
Photo #EMM47-14  
Rt. AT-44  
UTM 0732376 4547225  
5/24/01

This route, although not constructed or maintained, does receive regular use and it serves as the south boundary for the proposed expansion of Adobe Town WSA.

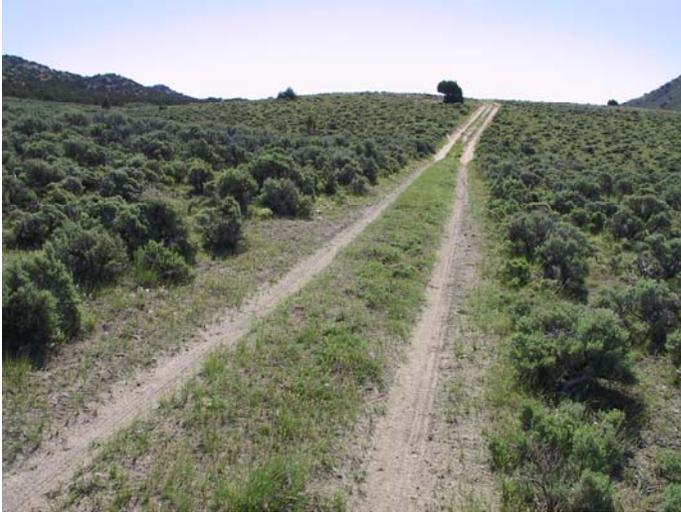
Photo #EMM47-18

Route AT-44 (upper right) departs  
northwst from the Cherokee Trail  
Road, AT-50.

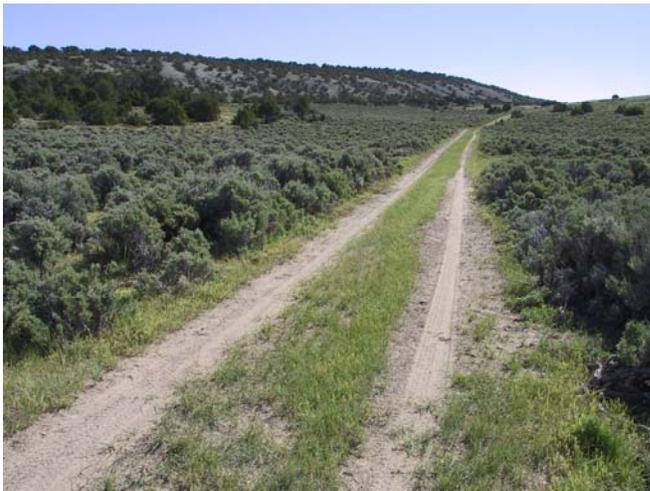
Photo #EMM47-22

View east along AT-44 from its junction with the camping spur AT-44A.

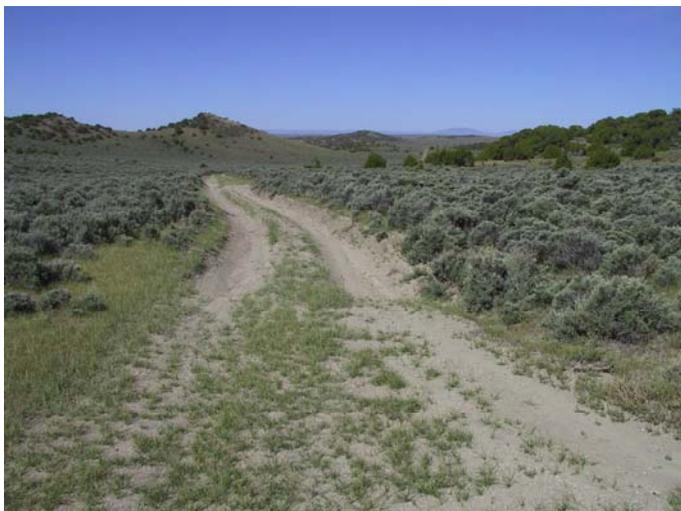
Route AT-44  
UTM 0730371 4547917  
5/24/01

View east on AT-44 from its junction with AT-48.

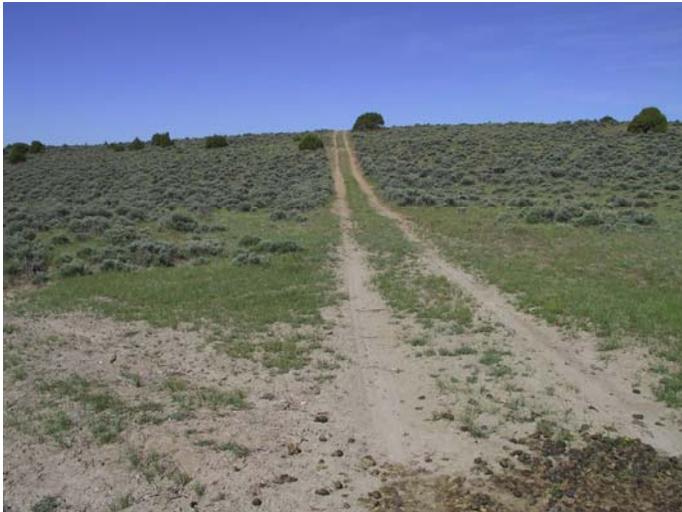
Route AT-44  
UTM 0730371 4547917  
5/24/01

View west on AT-44 from its junction with AT-48.

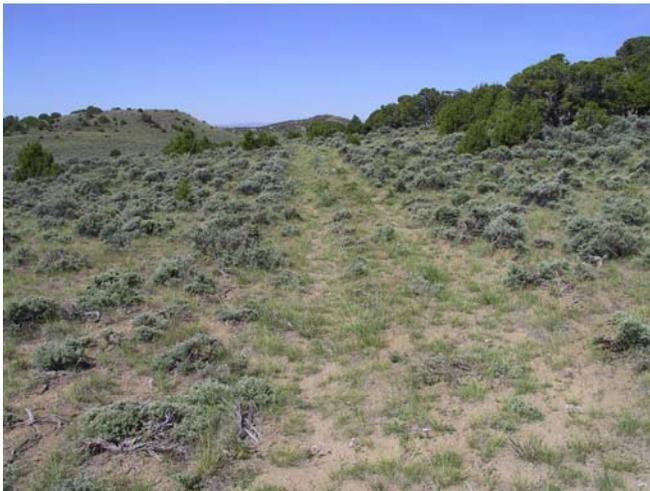
Route AT-44  
UTM 0729713 4547710  
5/24/01

View west along AT-44 from its  
junction with AT-47.

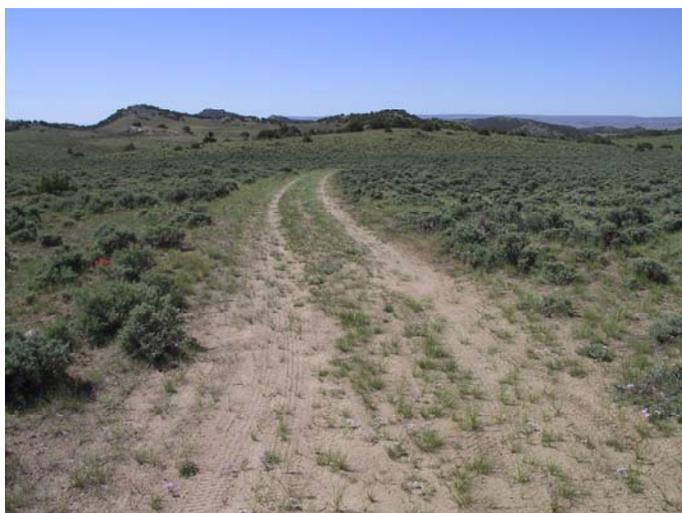
Route AT-44  
UTM 0729312 4547646  
5/24/01

Old segment of AT-44 is  
abandoned; current route is just  
south.

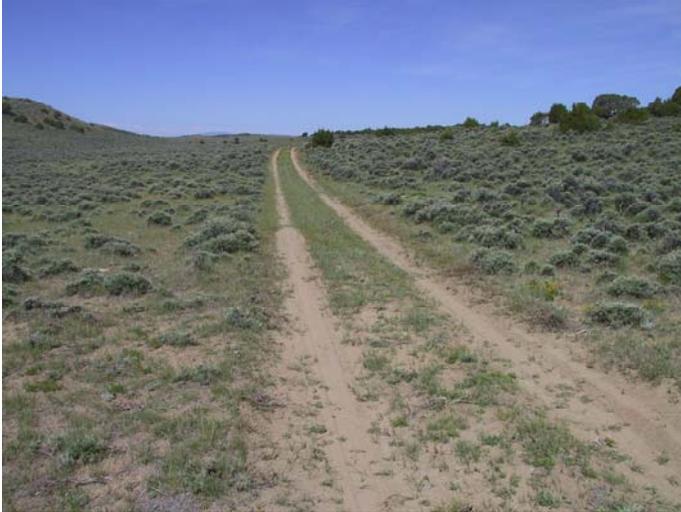
Route AT-44  
UTM 0729312 4547646  
5/24/01

View south on AT-44 from its  
junction abandoned route  
segment.

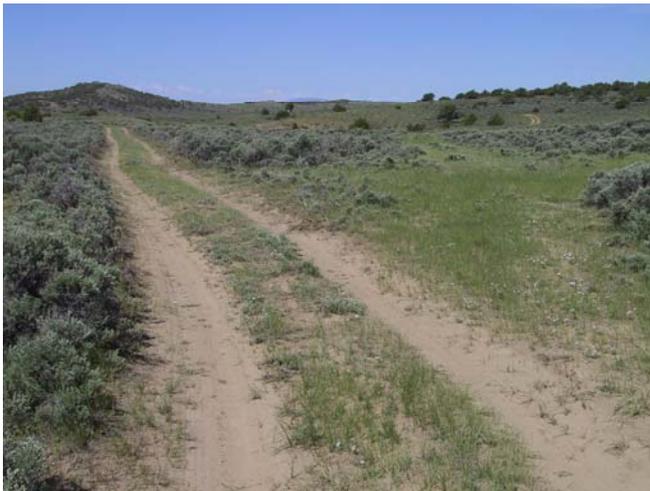
Route AT-44  
UTM 0729276 4547568  
5/24/01

AT-44 runs west from its junction  
with abandoned route.

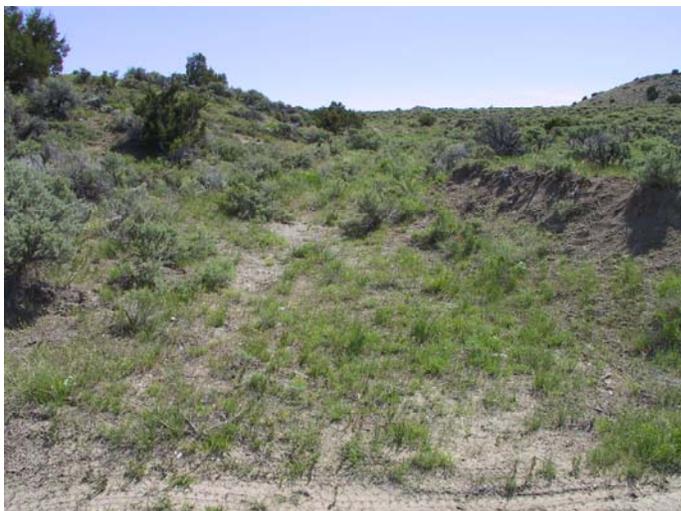
Route AT-44  
UTM 0729072 4547549  
5/24/01

Old, unused, reclaimed route (at  
right) splits away from AT-44.

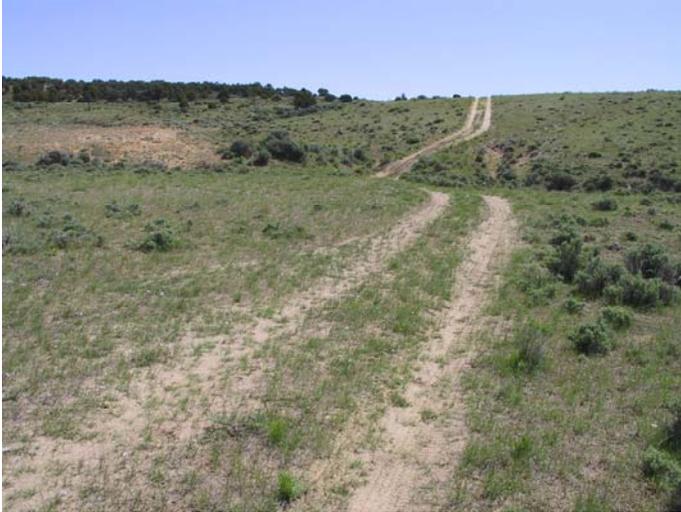
Route AT-44  
UTM 0728803 4547484  
5/24/01

Main route is rejoined by aban-  
doned segment (seen here).

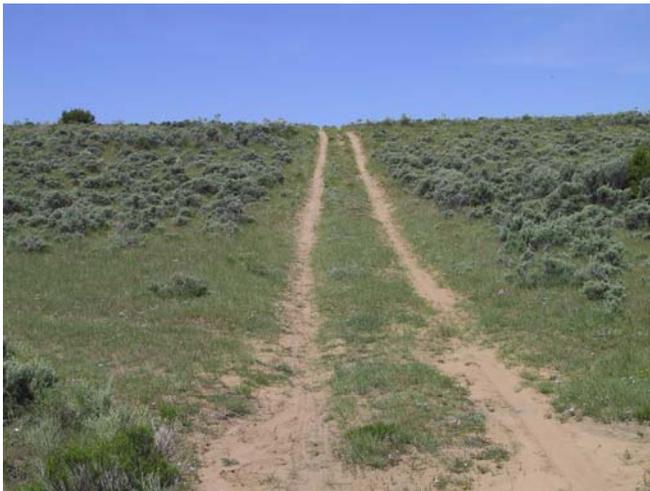
Route AT-44  
UTM 0728322 4547351  
5/24/01

AT-44 runs east from its junction  
with AT-46.

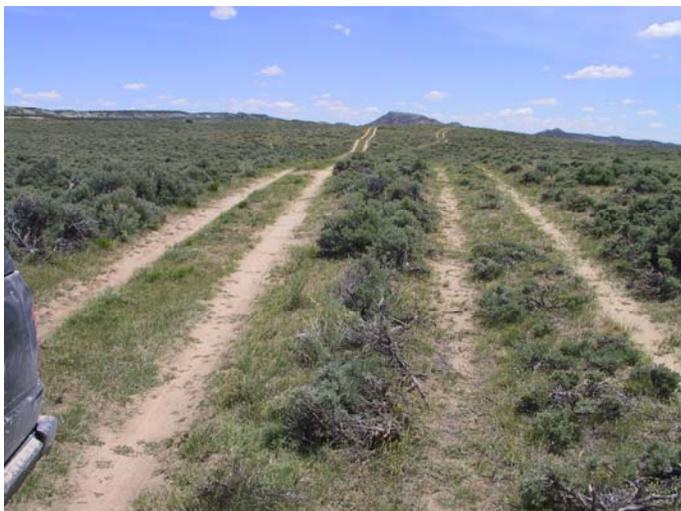
Route AT-44  
UTM 0728322 4547351  
5/24/01

AT-44 runs west from its junction  
with AT-46.

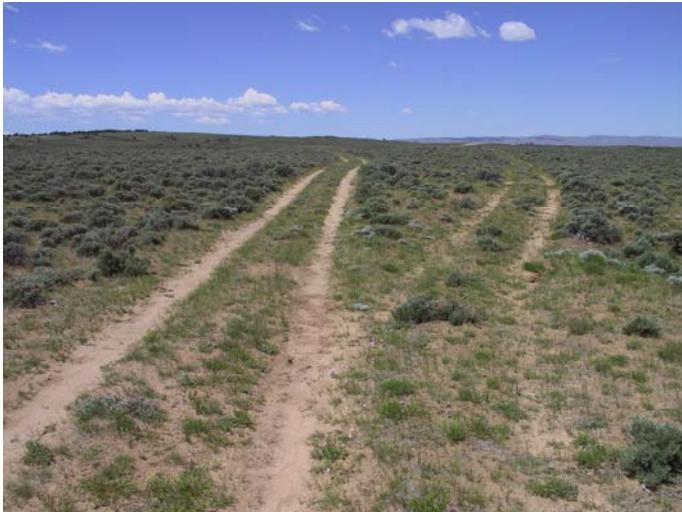
Route AT-44  
UTM 0727311 4547135  
5/24/01

Route AT-44 is joined by route to  
Upper Powder Spring (at right,  
very light use). Hen sage grouse  
with chicks sighted at this  
junction.
