**BLM Unit Identification:** Adobe Town WY-030-401 and WY-040-408

**Description** Adobe Town is proposed by the conservation community for wilderness designation. The area proposed for wilderness includes all of the Adobe Town Wilderness Study Area, plus additional lands of wilderness quality in The Haystacks, along Willow Creek and the Willow Creek Rim, and south of the WSA to the Powder Rim and just beyond it. All of these areas possess the full complement of required characteristics for wilderness in abundance: outstanding opportunities for both solitude *and* primitive and unconfined recreation, wilderness-quality naturalness, size (at over 180,000 acres, the citizens proposed Adobe Town wilderness is well above the 5,000-acre minimum), and in addition has outstanding supplemental values such as abundant wildlife, wild horse herds, unique geology, and abundant archaeological and paleontological resources.

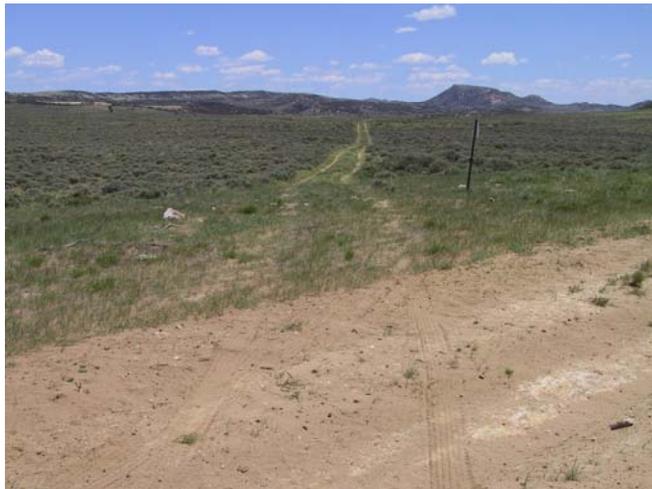
Route AT-44  
UTM 0726830 4547154  
5/24/01

Route AT-44 splits, with the north track (at right) receiving very light use and the south track getting most of the vehicle traffic..

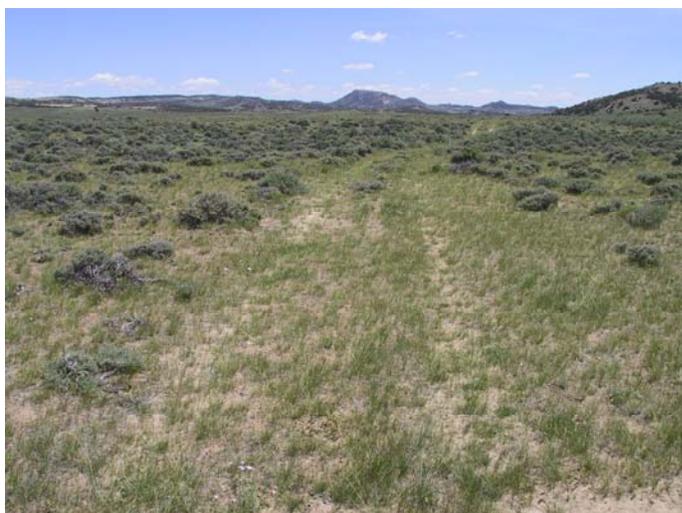
Route AT-44  
UTM 0726288 4547141  
5/24/01

Main (south) branch of AT-44 ends at junction with AT-16.

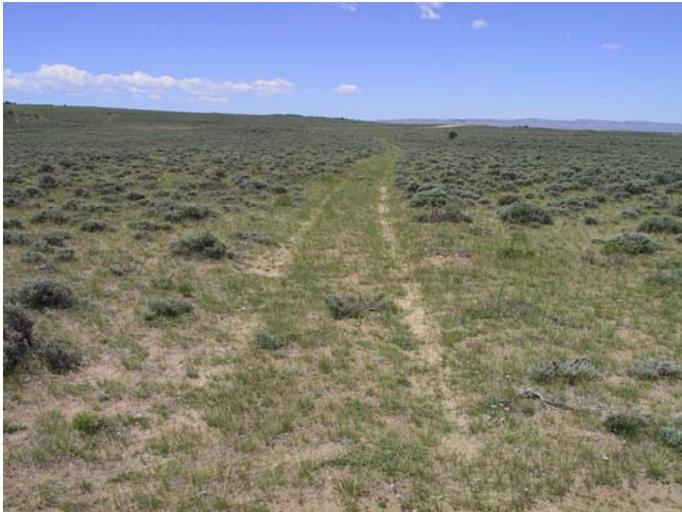
Route AT-44  
UTM 0726571 4547225  
5/24/01

Lesser (north) leg of AT-44 at junction with AT-41, view east.

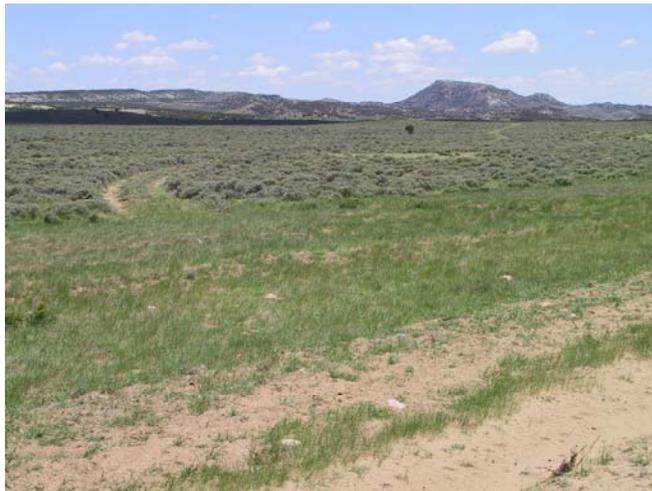
Route AT-44

Lesser (north) leg of AT-44 running west from its junction with AT-41.

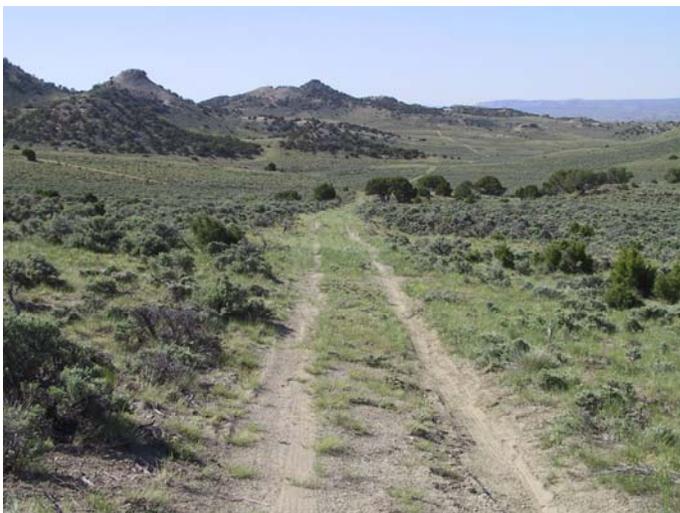
Route AT-44A  
UTM 0731574 4547617  
5/24/01

Route AT-44A departs northward  
from AT-44.

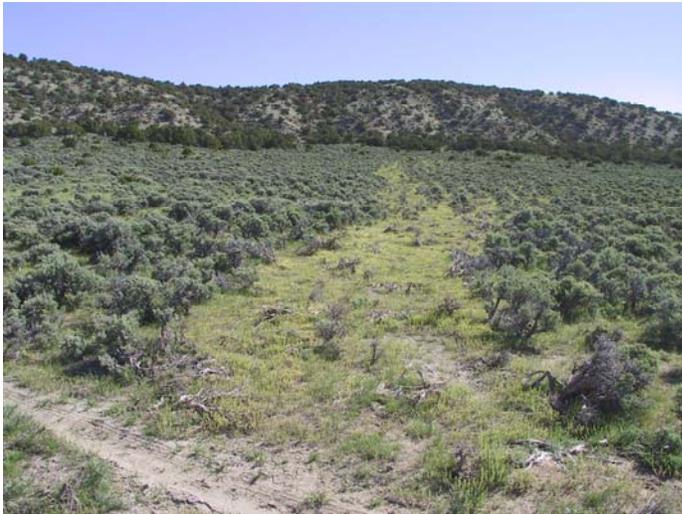
Route AT-44A  
UTM 0731477 4547917  
5/24/01

Route ends at camp spot. View  
south.

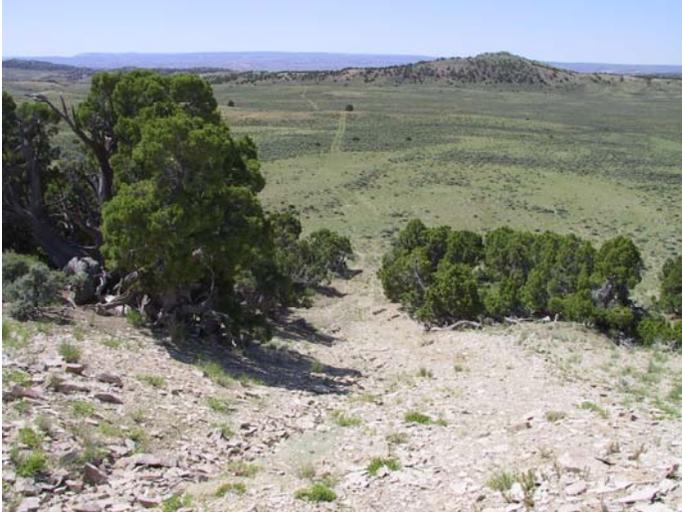
Photo #EMM47-78  
Rt. AT-45  
UTM 0727737 4547190  
5/24/01

Route AT-45 begins by departing northward from AT-44. It is fully revegetated here.

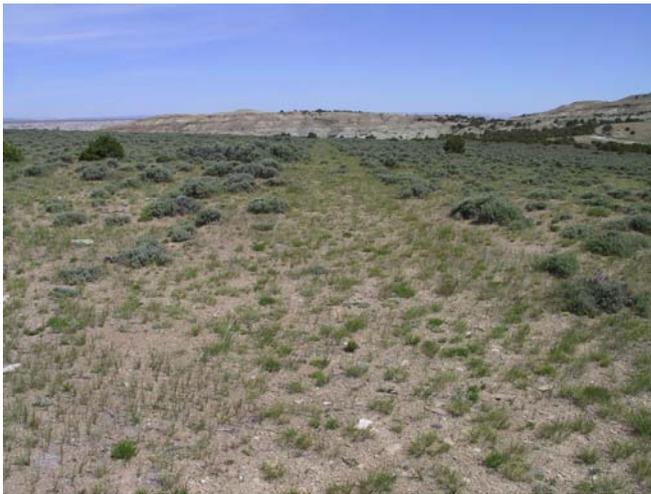
Route AT-45  
UTM 0727679 4547991  
5/24/01

View south on AT-45 from its junction with AT-42. The descent is very steep, and the route is fully reclaimed with no vehicular use.

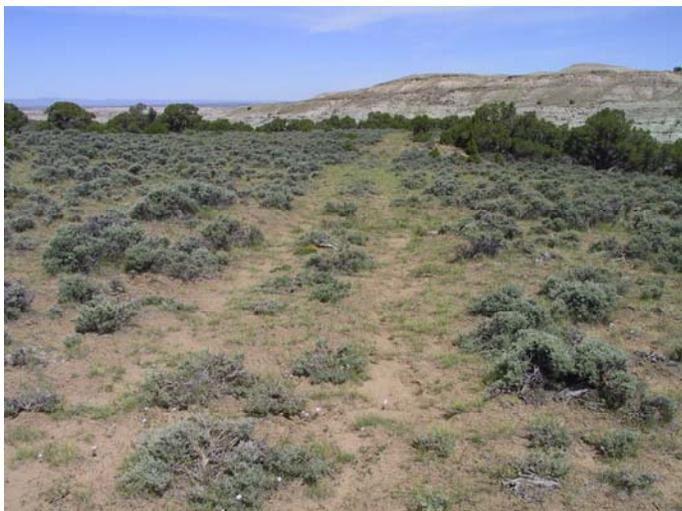
Route AT-45  
UTM 0727679 4547991  
5/24/01

View north on AT-45 from its junction with AT-42.

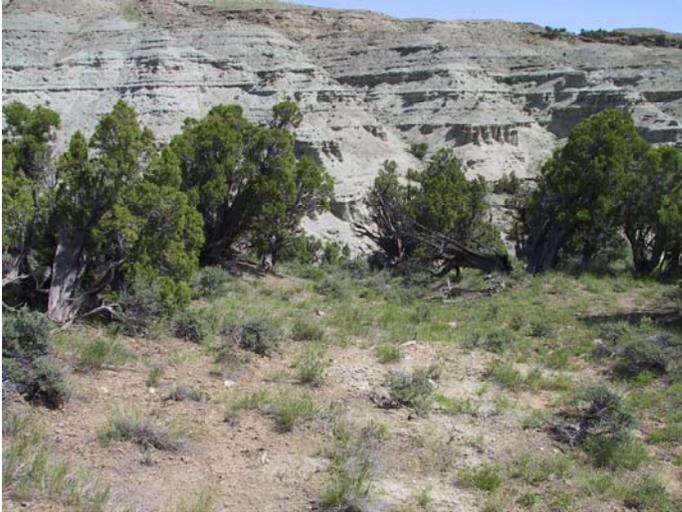
Route AT-45  
UTM 0727664 4548425  
5/24/01

View north from junction with cutoff that runs east toward Adobe Reservoir. There is no sign of use on either leg.

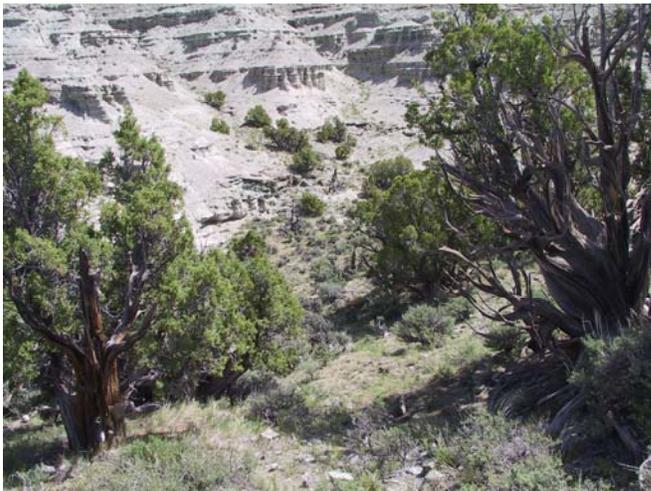
Route AT-45  
UTM 0727641 4548575  
5/24/01

North leg of route ends at steep dropoff.

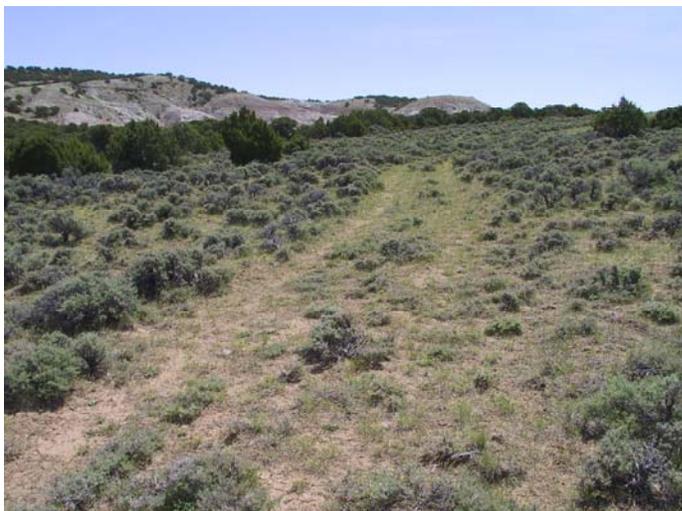
Route AT-45  
UTM 0727657 4548577  
5/24/01

No sign of track in the draw bottoms near end of route.

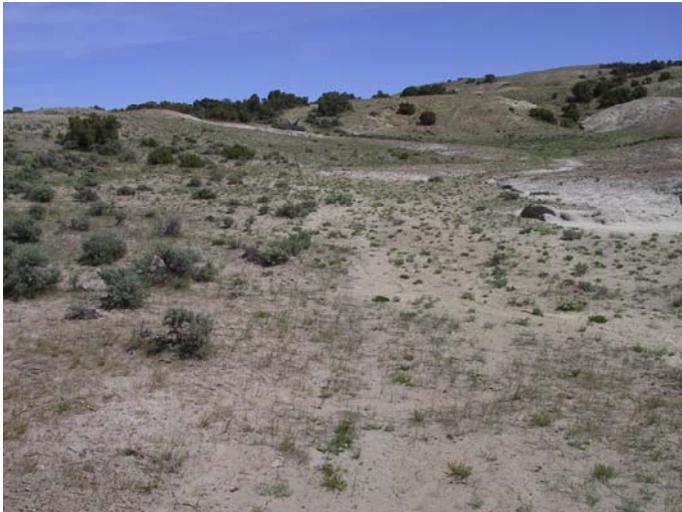
Route AT-45  
UTM 0727664 4548425  
5/24/01

No use on track ascending from reservoir.

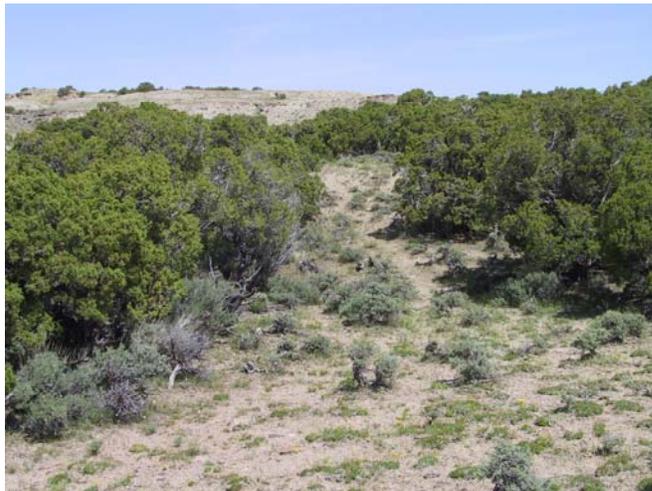
Route AT-45  
UTM 0727881 4548379  
5/24/01

Route is invisible as mapped  
crossing draw bottoms.

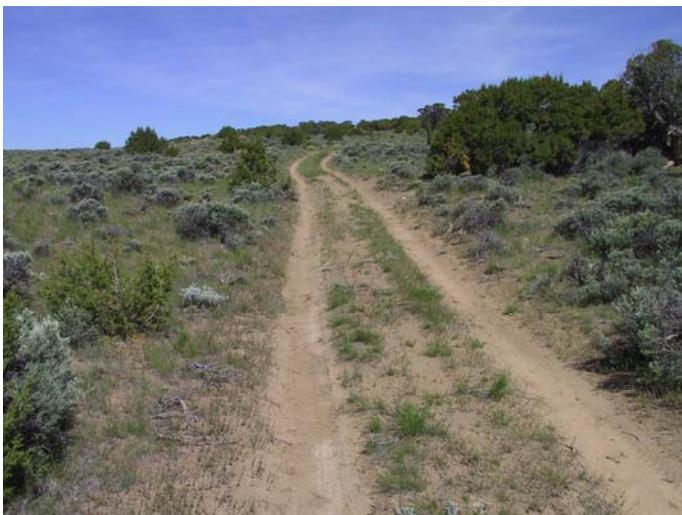
Route AT-46  
UTM 0728322 4547351  
5/24/01

Jeep trail AT-46 runs north from  
AT-44.

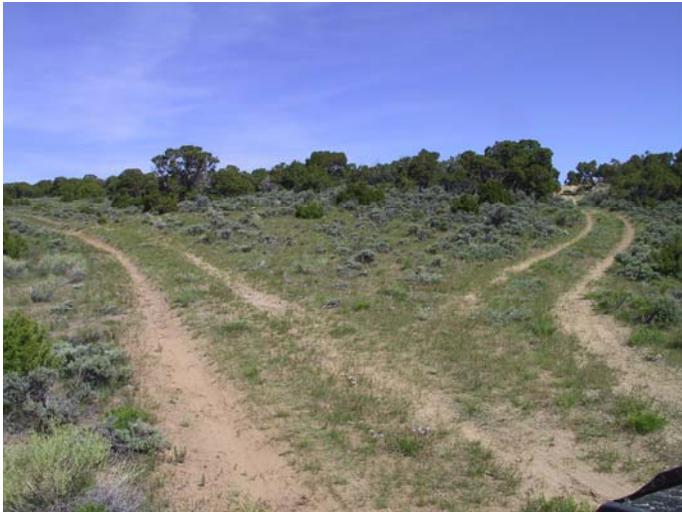
Route AT-46  
UTM 0728156 4547644  
5/24/01

View typical of route AT-46.

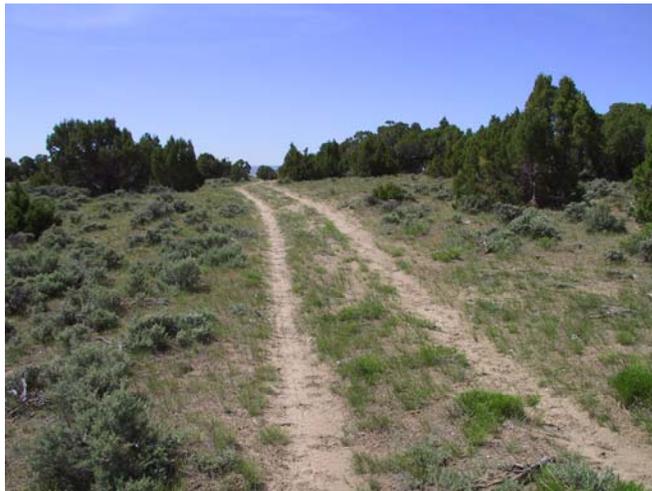
Route AT-46  
UTM 0728112 4547678  
5/24/01

Route AT-46 divides, with left (west) route getting the bulk of the vehicle use.

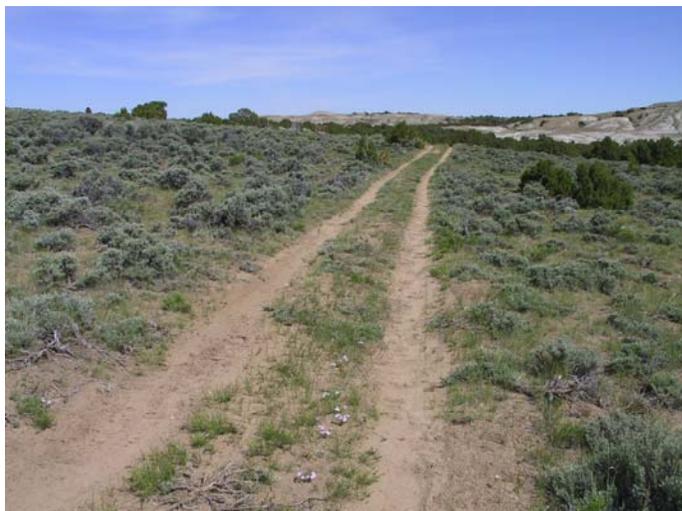
Route AT-46  
UTM 0728982 4547938  
5/24/01

View south on AT-46 from its junction with AT-42.

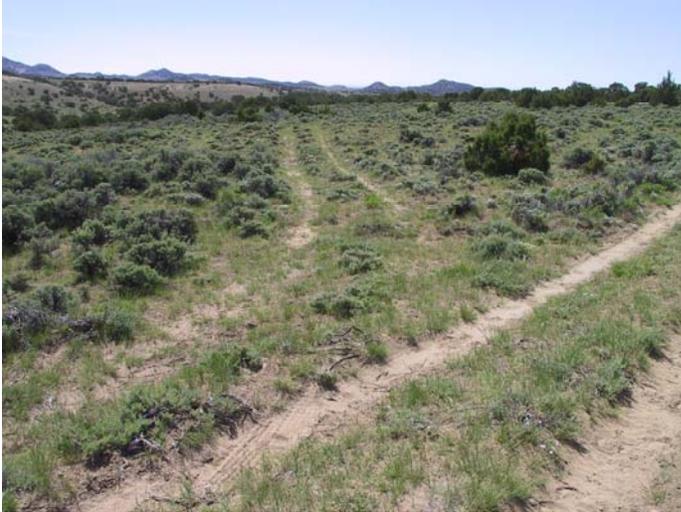
Route AT-46  
UTM 0728982 4547938  
5/24/01

View north on AT-46 from its junction with AT-42.

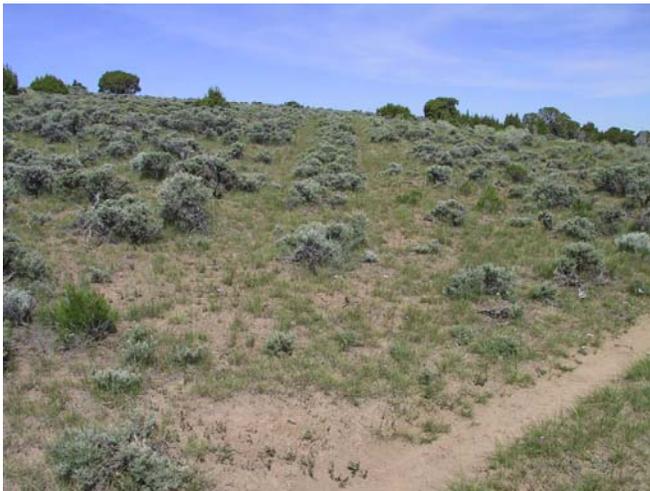
Route AT-46  
UTM 0727976 4547967  
5/24/01

Lesser-used eastern leg of AT-46  
rejoins main track (lower right).  
View southeast.

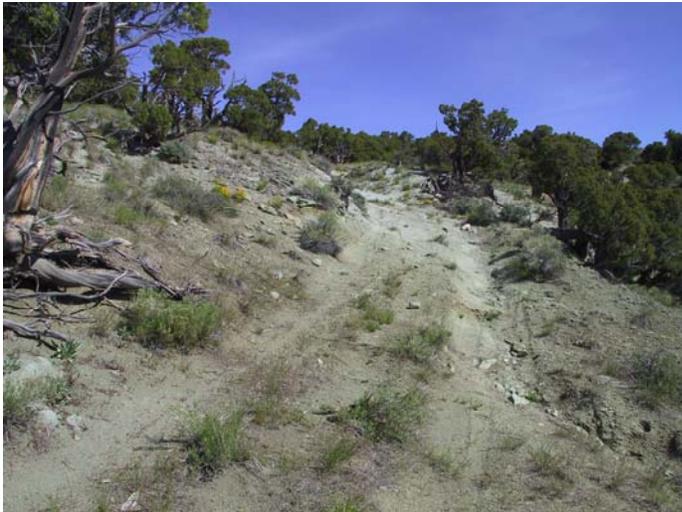
Photo #EMM47-26  
Rt. AT-47  
UTM 0729713 4547710  
5/24/01

Jeep trail AT-47 runs north from AT-44.

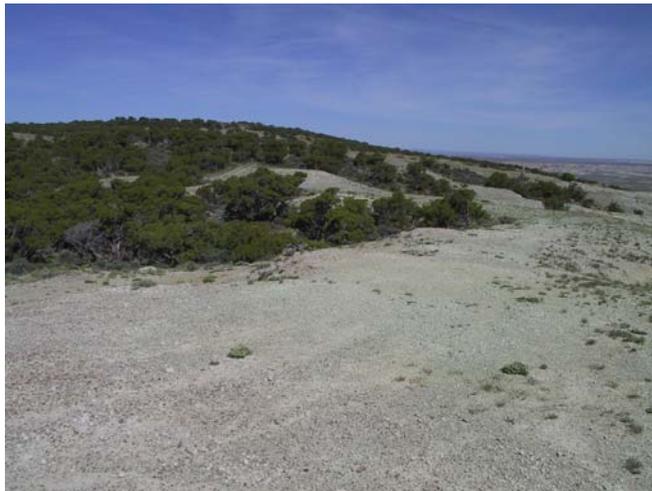
Route AT-47  
UTM 0729534 4548243  
5/24/01

Route is difficult to traverse on  
hill climb.

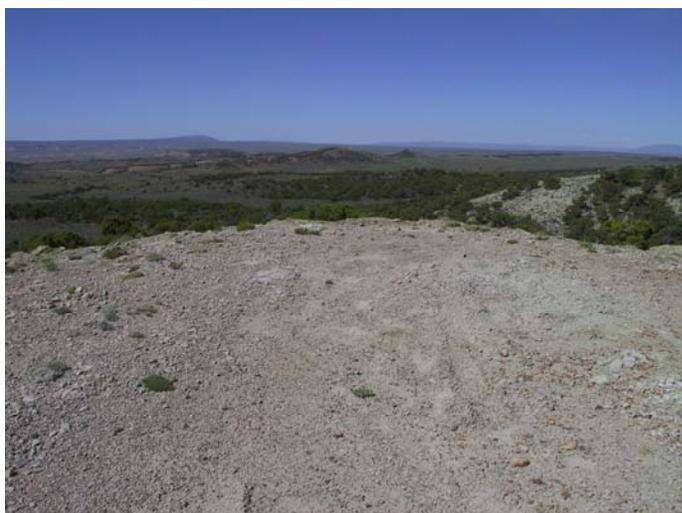
Route AT-46  
UTM 0729532 4548371  
5/24/01

Route is very faint at this point.

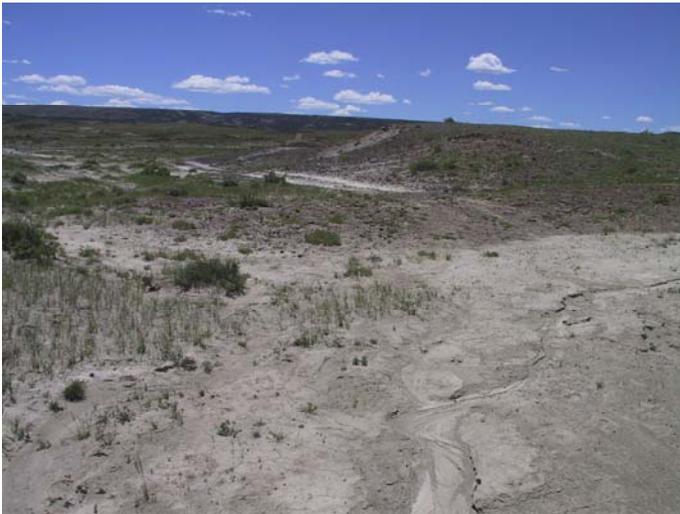
Photo #EMM46-41

Route AT-48  
UTM 0730952 4552359  
5/24/01

Jeep trail begins by running south  
from AT-17.

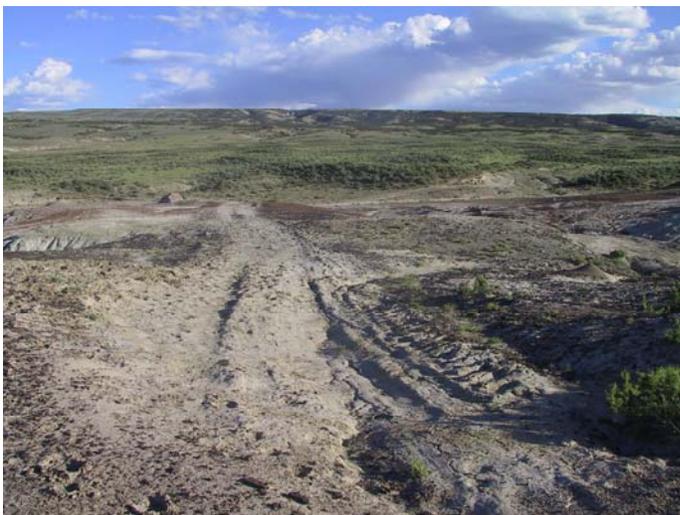
Photo #EMM46-127

Route AT-48  
UTM 0730952 4551803  
5/24/01

Jeep trail is rough and faint  
crossing clay.

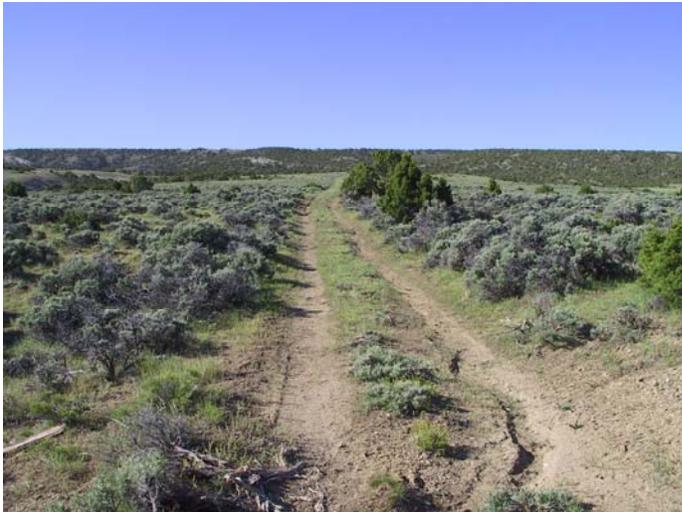
Photo #EMM47-1

Route AT-48  
UTM 0730764 4549922  
5/24/01

Jeep trail is typical in this view.

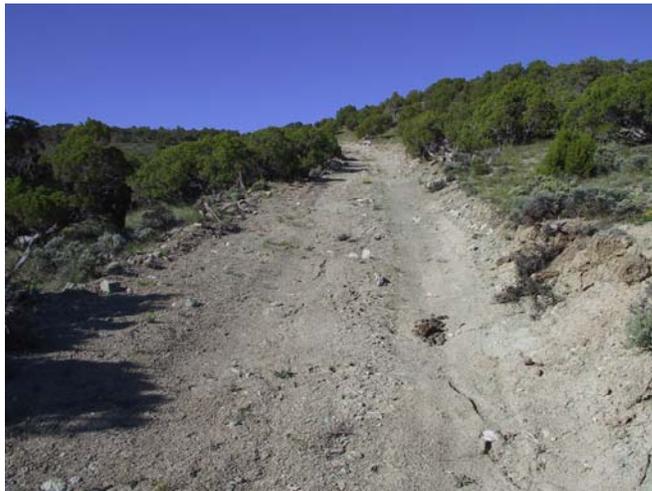
Photo #EMM47-2

Route AT-48  
UTM 0730584 4549019  
5/24/01

Signs of recent blading on steeper section of route.

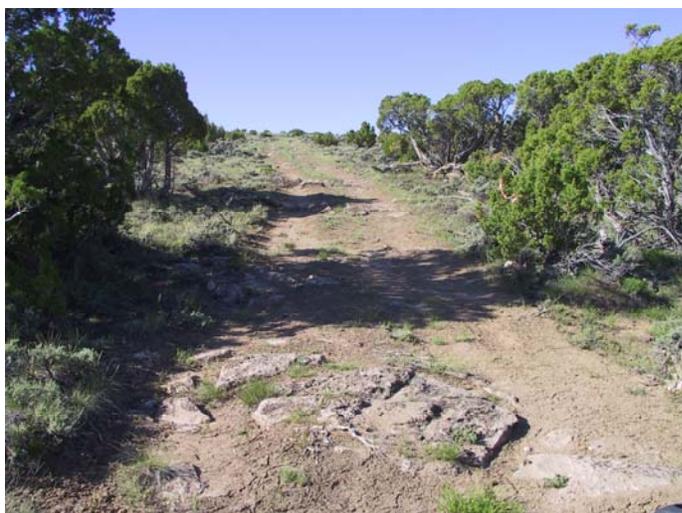
Photo #EMM47-3

Route AT-48  
UTM 0730441 4548679  
5/24/01

Route reverts to primitive condition atop grade.

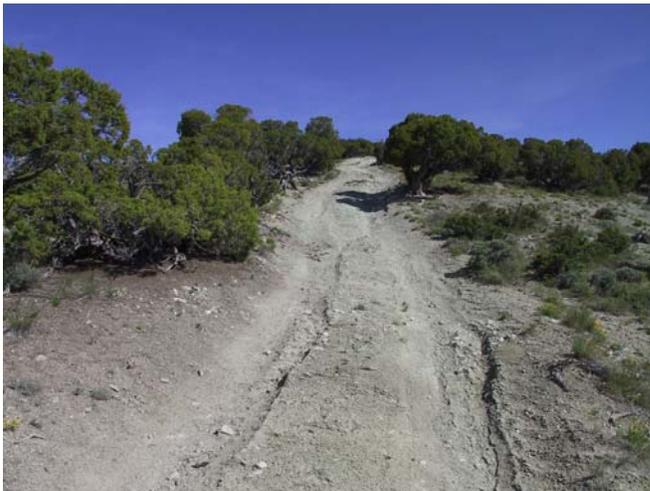
Photo #EMM47-25

Route AT-48  
UTM 0730314 4548231  
5/24/01

Route is very rough but well-worn  
here.

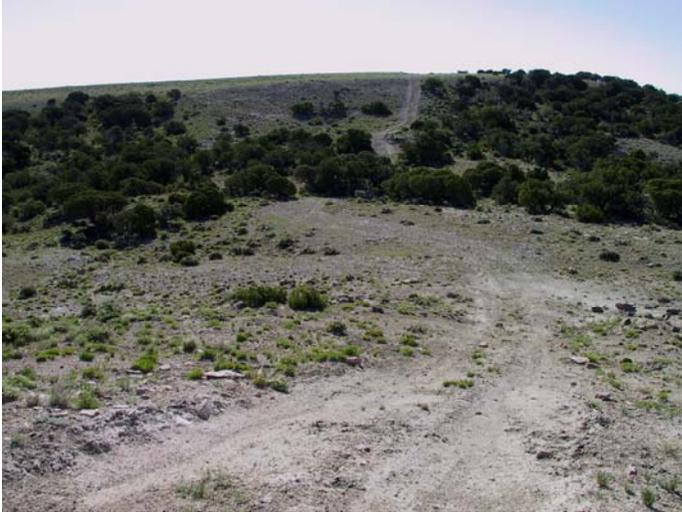
Photo #EMM47-7

Route AT-49  
UTM 0731451 4548214  
5/24/01

View east along steep drop into low saddle. Note steep climb ahead.

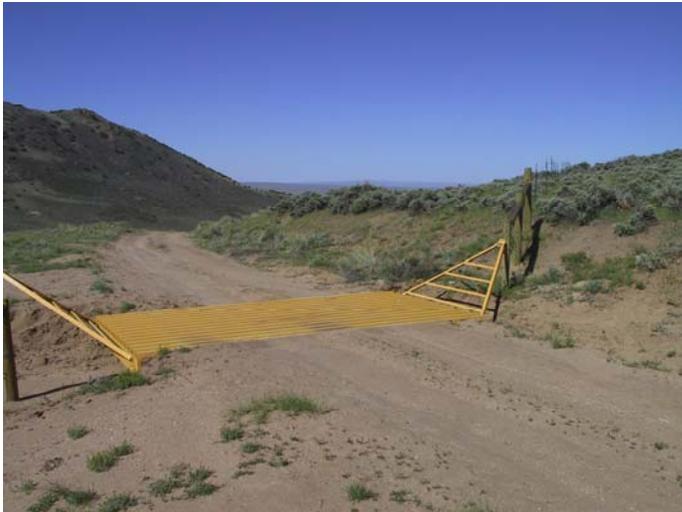
Photo #EMM47-13

Route AT-50  
UTM 0733199 4547706  
5/24/01

New cattleguard crosses route,  
with fence running northwest.

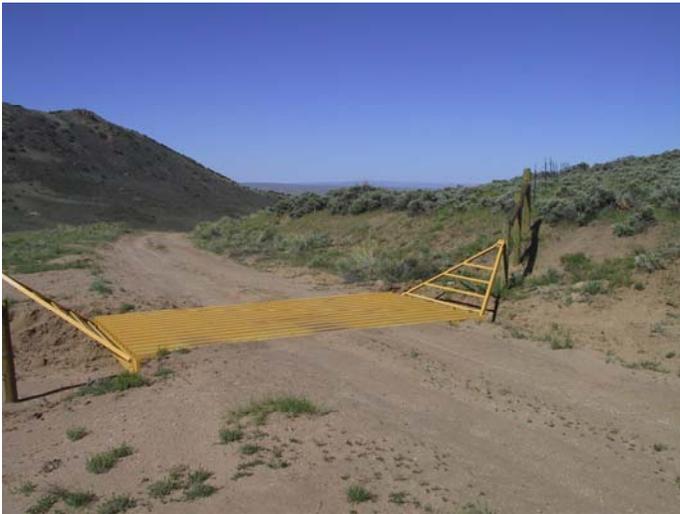
Photo #EMM47-13

Route AT-51  
UTM 0733199 4547706  
5/24/01

Fence crossing AT-50 with cattle-guard.

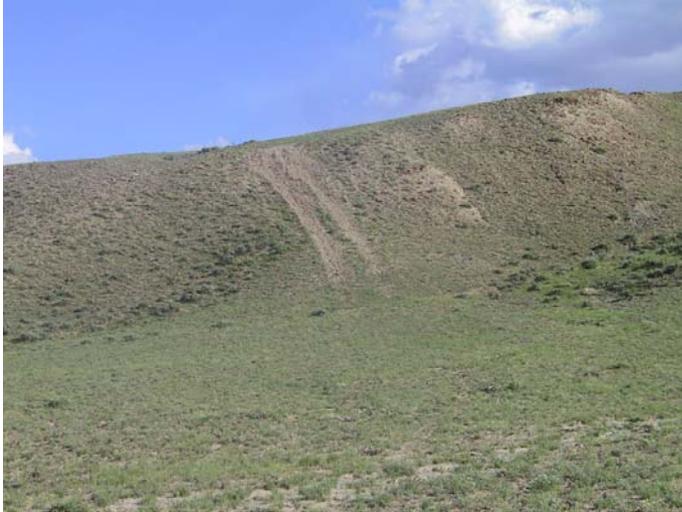
Photo #EMM46-121

Route AT-54  
UTM 0735288 4557357  
5/23/01

Hill-climb damage from illegal  
off-trail driving.

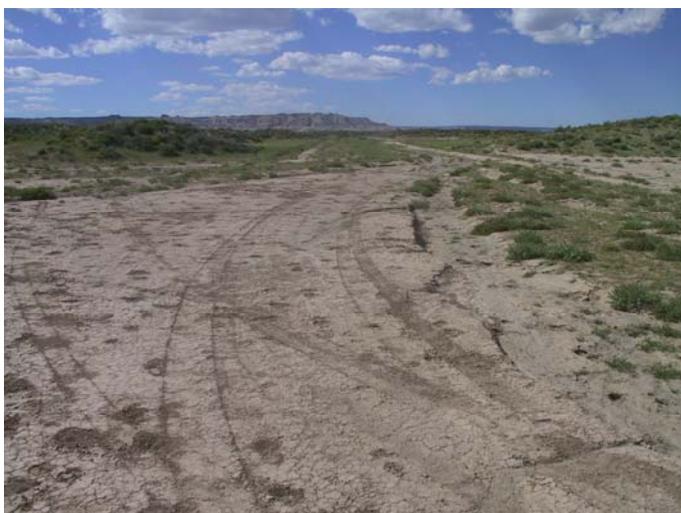
Photo #EMM46-92

Route AT-55  
UTM 0734902 4559174  
5/23/01

Route AT-55 is quite primitive, as seen here running north from its junction with AT-56.

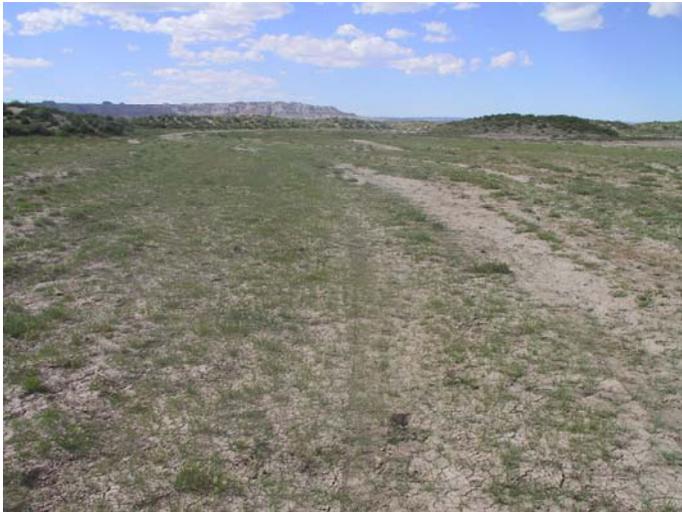
Photo #EMM46-94

Route AT-55  
UTM 0734703 4559658  
5/23/01

Route AT-55 in its most  
reclaimed state.

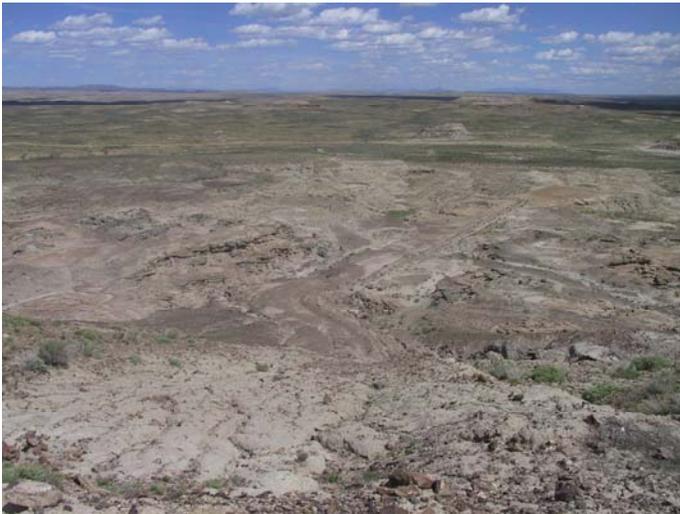
Photo #EMM46-77

Route AT-55A  
No UTM  
5/23/01

Pipeline ascends to rim from the east. It can be seen snaking across the depression below.

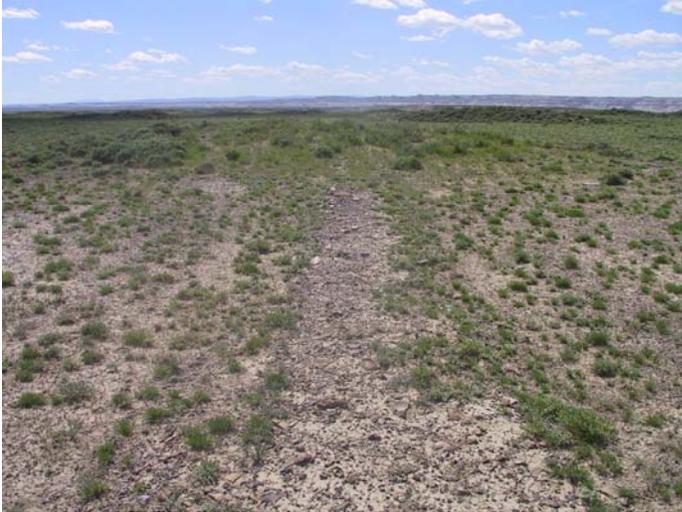
Photo #EMM46-76

Pipeline runs east from its junction with AT-59.

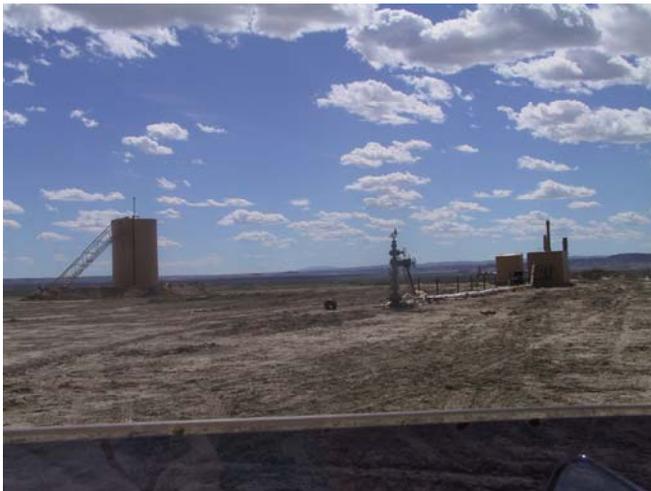
Photo #EMM46-83

View west along pipeline from its  
junction with AT-59.

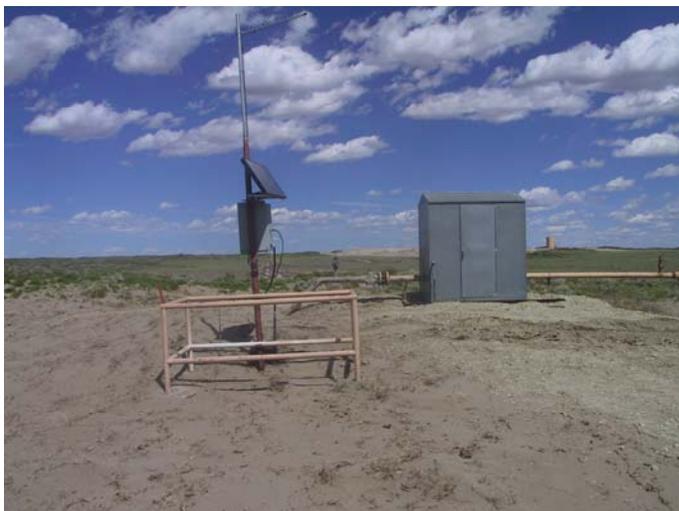
Photo #EMM46-84

Active natural gas well.

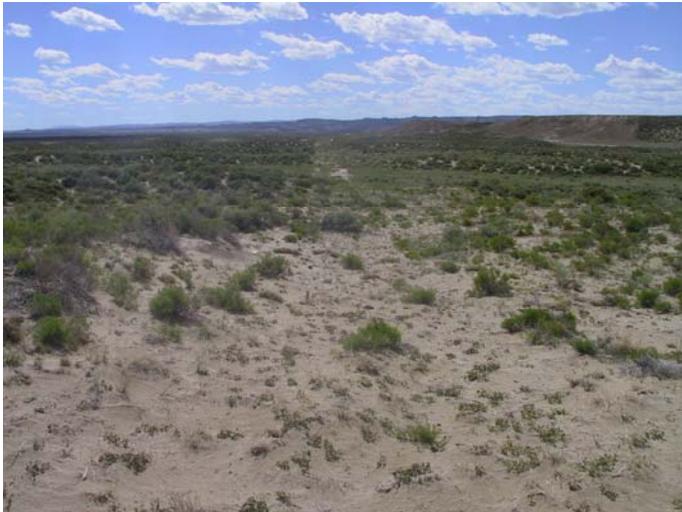
Photo #EMM46-85

Pipeline substation. View east  
along pipeline from the end of  
Route AT-118.

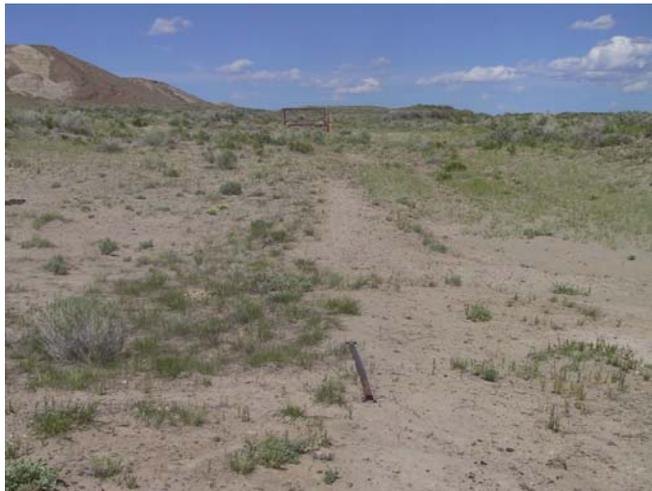
Photo #EMM46-89

View west along pipeline right of way from the end of AT-118.

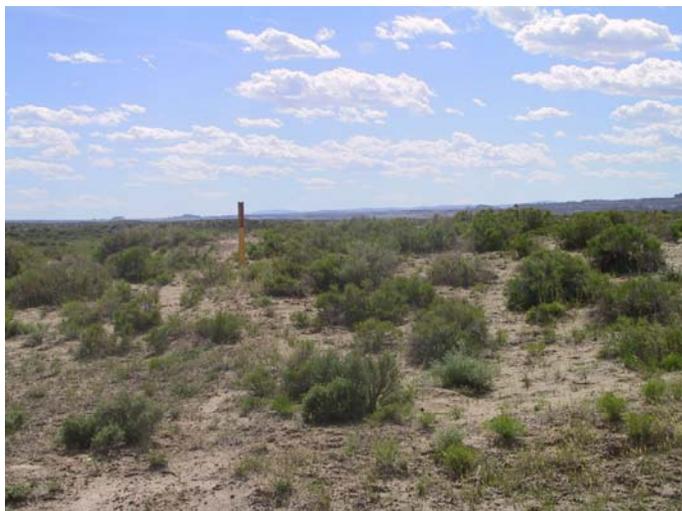
Photo #EMM46-90

Pipeline crosses route AT-58.  
View east.

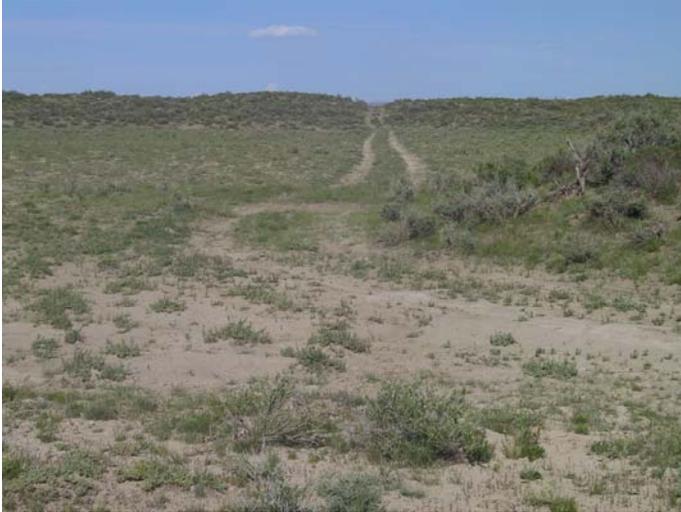
Photo #EMM46-112

Typical view of AT-56.

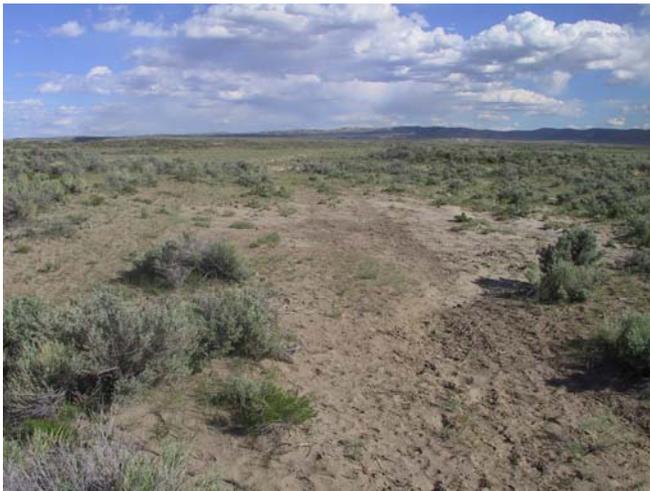
Photo #EMM46-111

Route in its best condition.

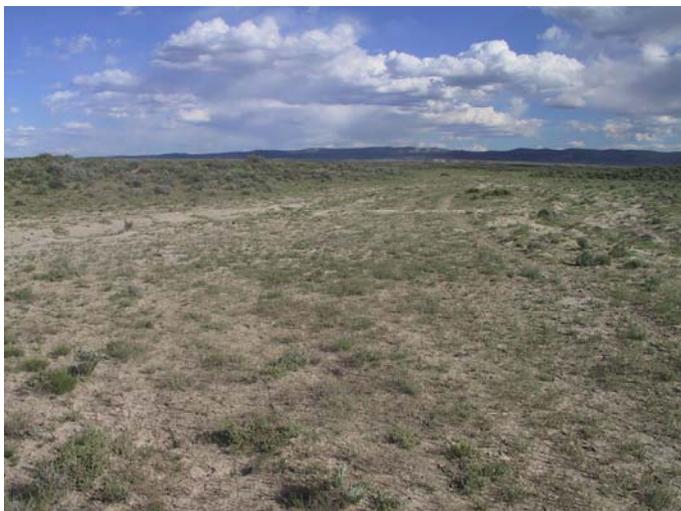
Photo #EMM46-113

Route is faint after turning corner.

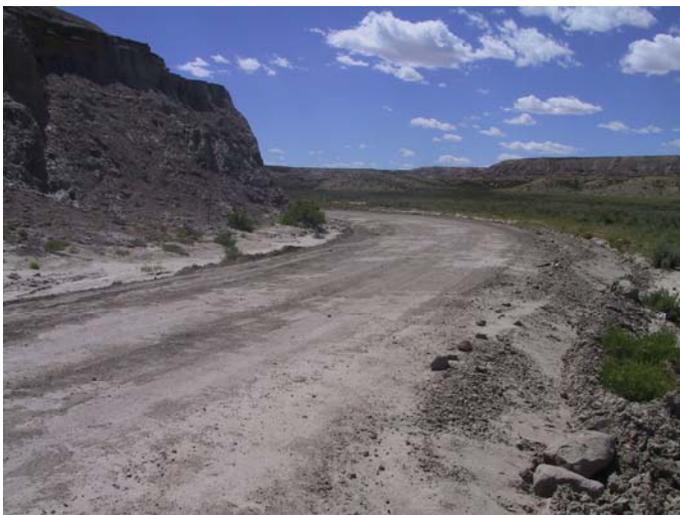
Photo #EMM46-67

Active well. Route is maintained south of this point.

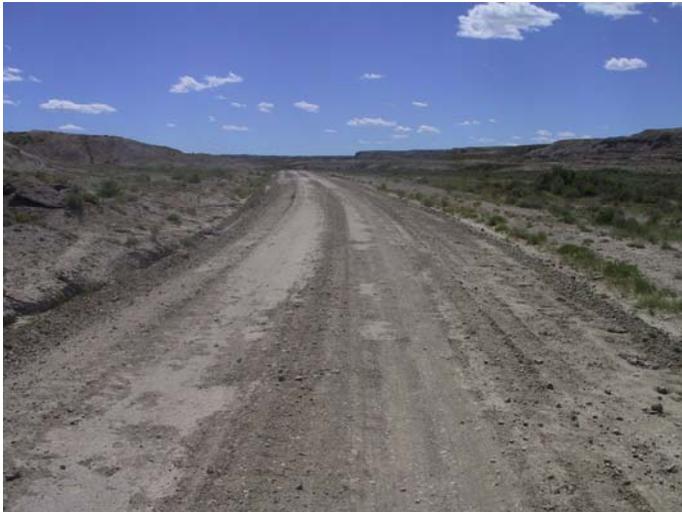
Photo #EMM46-68

Route AT-60 runs southwest from its junction with AT-119.

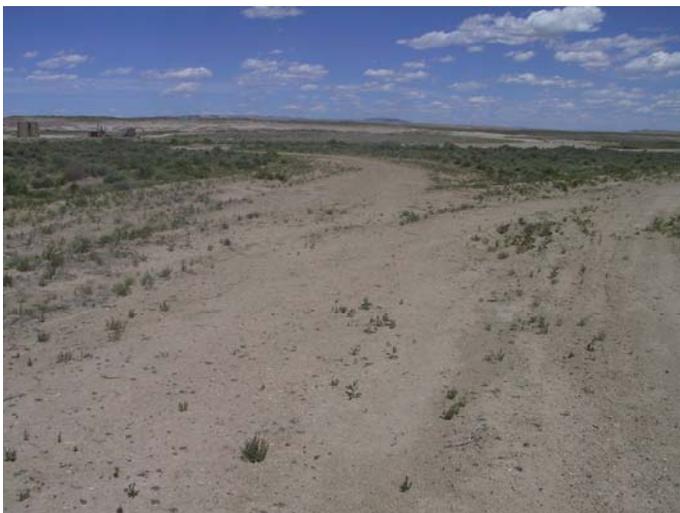
Photo #EMM46-63

Mapped jeep trail heads for cross-  
ing of Sand Creek Wash. Not  
receiving any use.

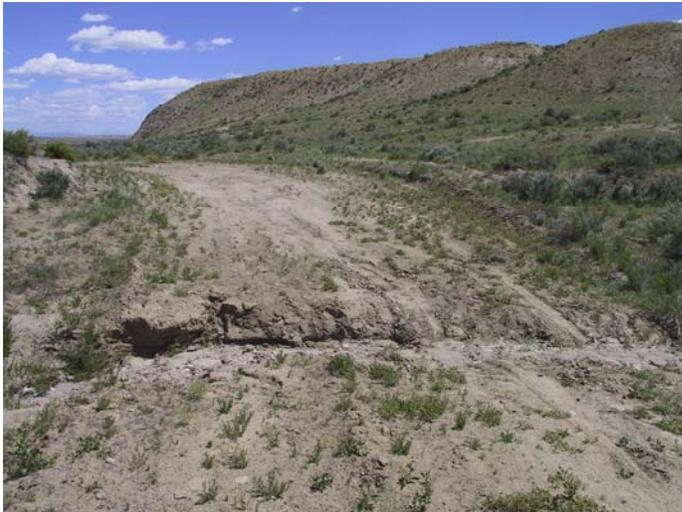
Photo #EMM46-59

Former route across Sand Creek  
Wash departs to the east. It no  
longer crosses.

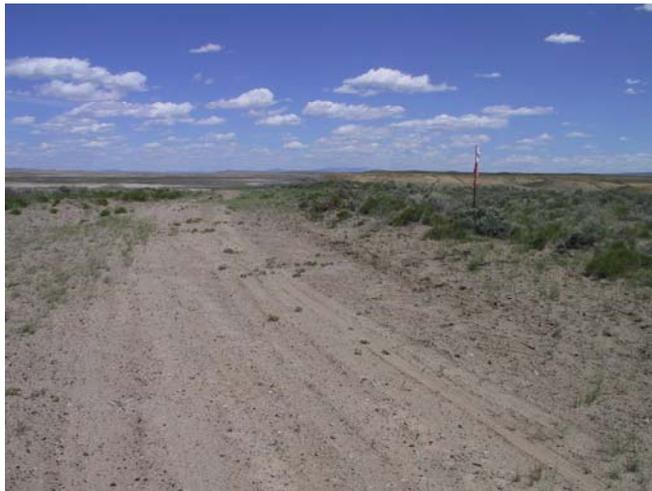
Photo #EMM46-58

Difficult gulch crossing-- four wheel drive required.

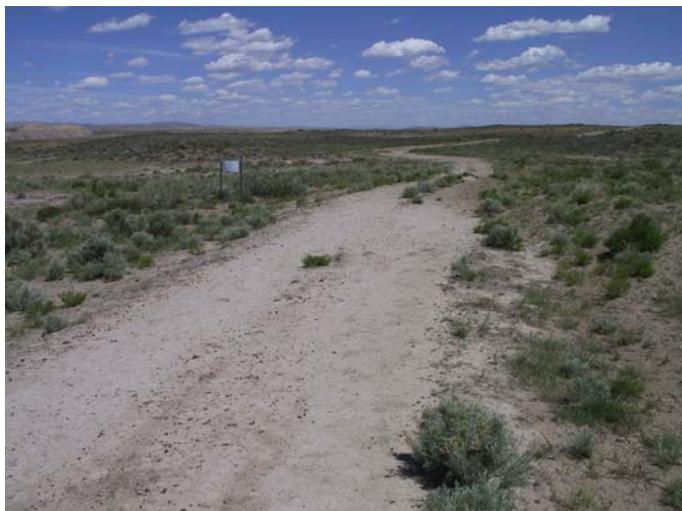
Photo #EMM46-57

Flag-- possible planned drill site.

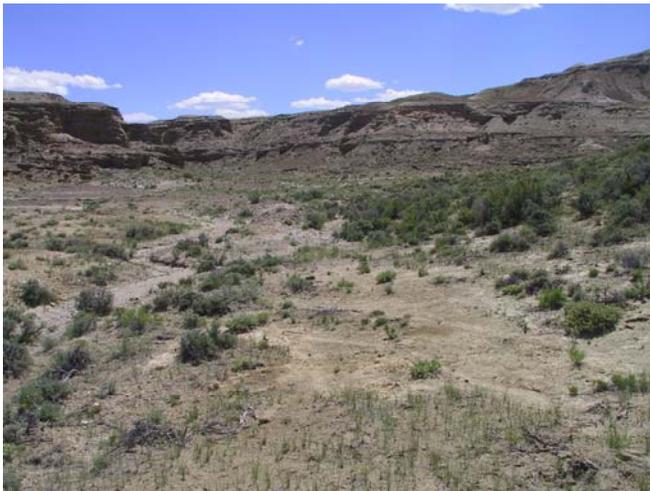
Photo #EMM46-60

This route is apparently the result of off-trail wandering by heavy equipment.

Tractor trail typical.

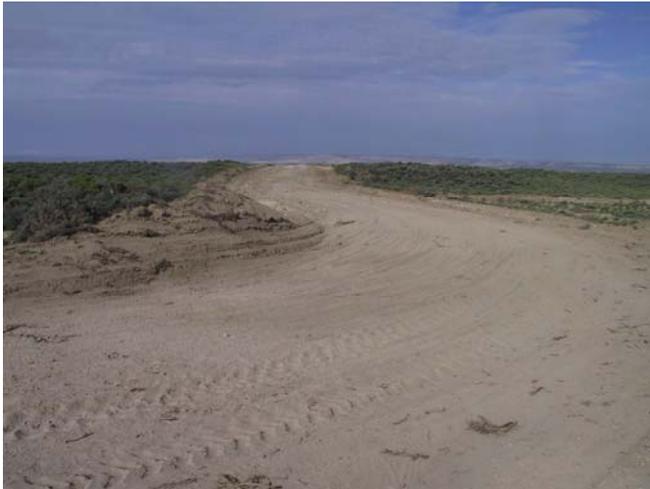
Photo #EMM41-10

Route at its worst. The dust is rather deep and soft here.

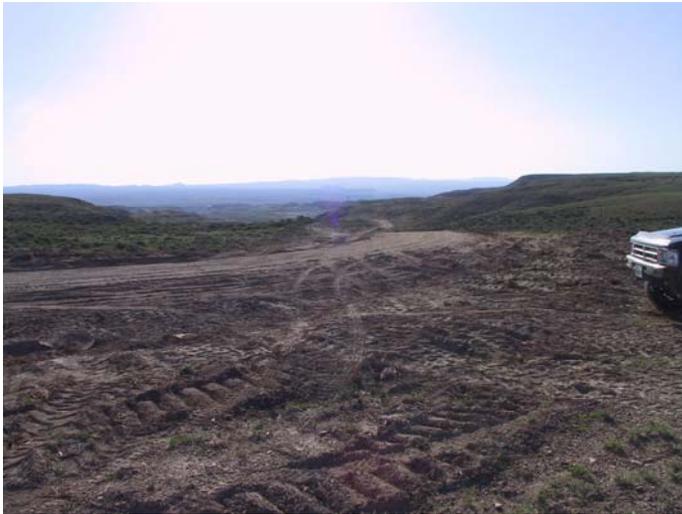
Photo #EMM41-5

Improved route runs north from its junction with AT-63A.

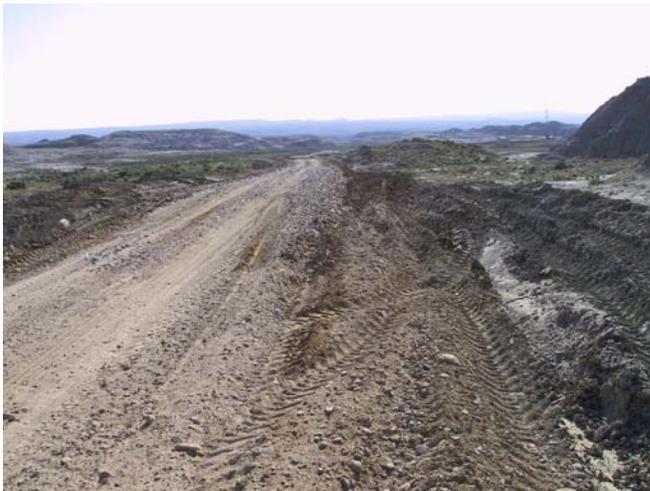
Photo #EMM41-8

Route AT-63 descends from  
Willow Creek Rim at its junction  
with AT-63A

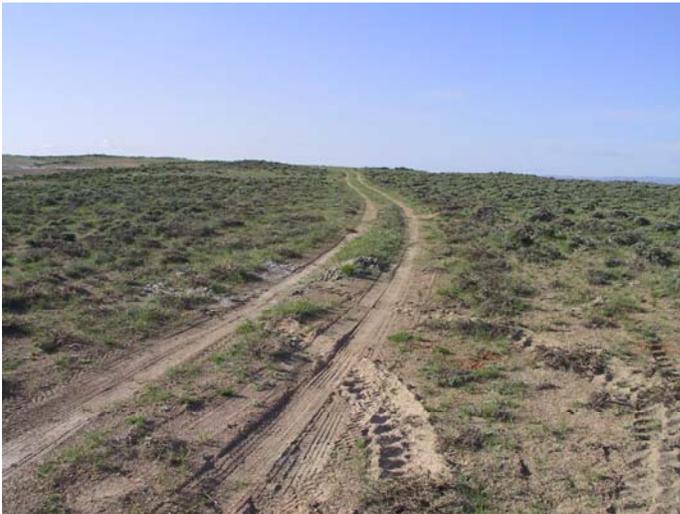
Photo #EMM41-6

This jeep trail follows the Willow Creek Rim. Flags along the way indicate that drilling activity may be imminent here.

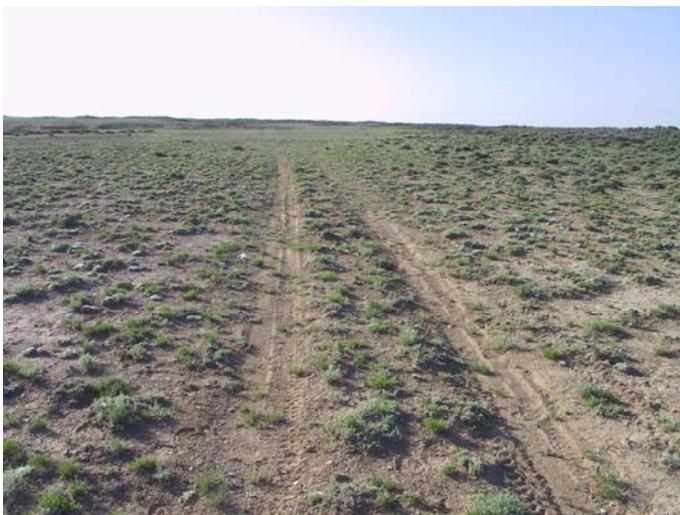
Photo #EMM41-2

Jeep trail runs southeast along rim  
from its junction with AT-63.

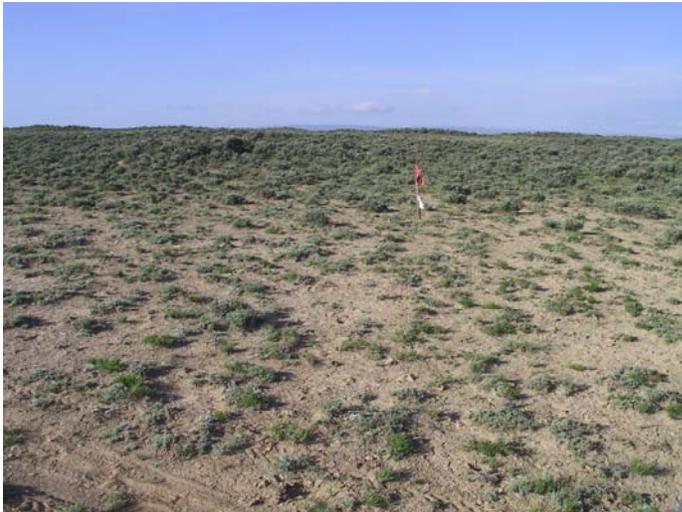
Photo #EMM41-1

Route typical.

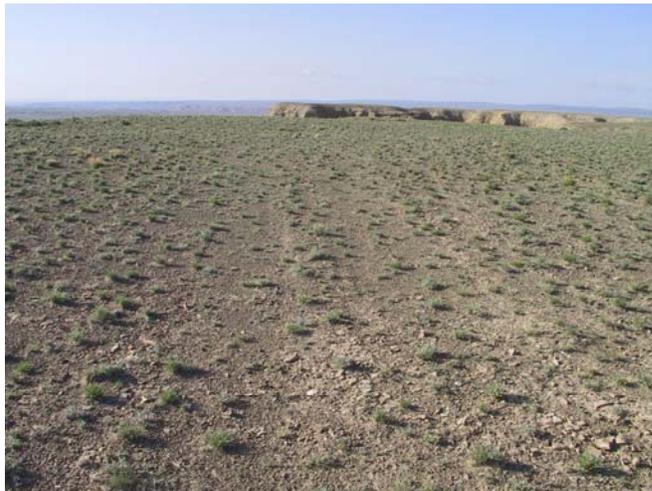
Photo #EMM41-3

Flag indicates site of future drilling.

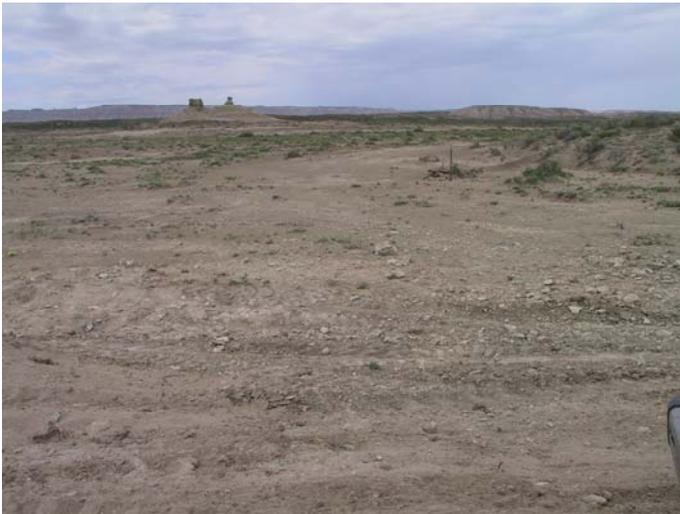
Photo #EMM41-34

This dead-end jeep trail runs northwest from AT-63 for a distance of about one mile.

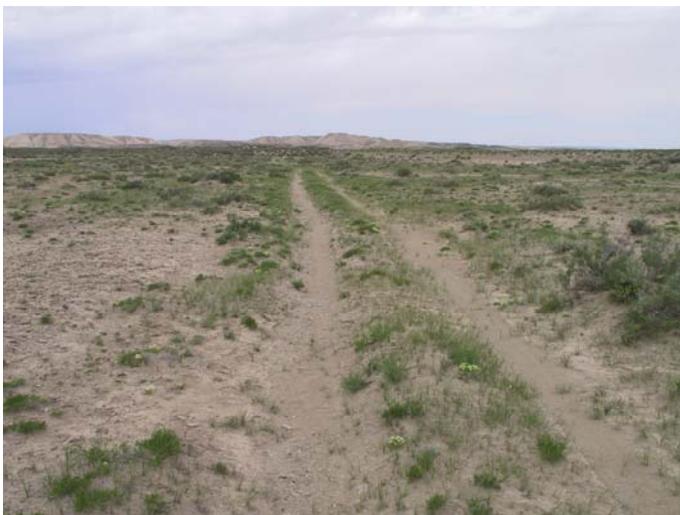
Photo #EMM41-36

Jeep trail AT-64 runs west from  
its junction with AT-63.

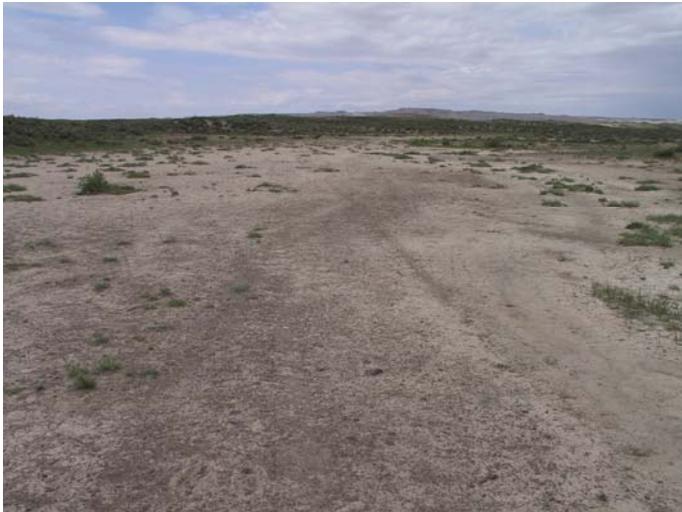
Photo #EMM41-37

Route is well-entrenched here.
