**BLM Unit Identification:** Adobe Town WY-030-401 and WY-040-408

**Description** Adobe Town is proposed by the conservation community for wilderness designation. The area proposed for wilderness includes all of the Adobe Town Wilderness Study Area, plus additional lands of wilderness quality in The Haystacks, along Willow Creek and the Willow Creek Rim, and south of the WSA to the Powder Rim and just beyond it. All of these areas possess the full complement of required characteristics for wilderness in abundance: outstanding opportunities for both solitude *and* primitive and unconfined recreation, wilderness-quality naturalness, size (at over 180,000 acres, the citizens proposed Adobe Town wilderness is well above the 5,000-acre minimum), and in addition has outstanding supplemental values such as abundant wildlife, wild horse herds, unique geology, and abundant archaeological and paleontological resources.

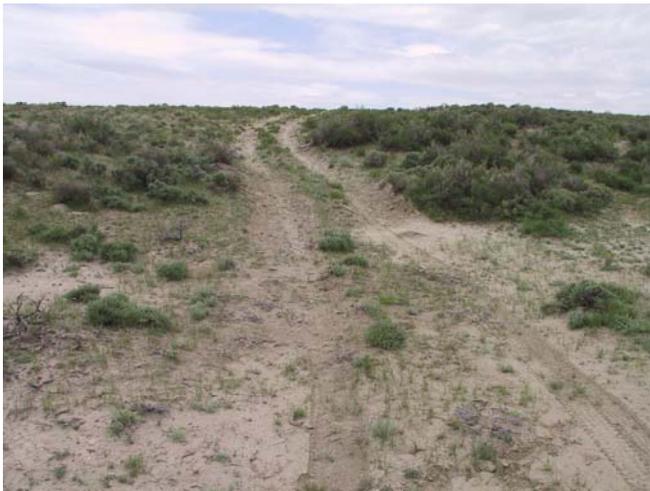
Photo #EMM41-38

Route is not apparent at this point.

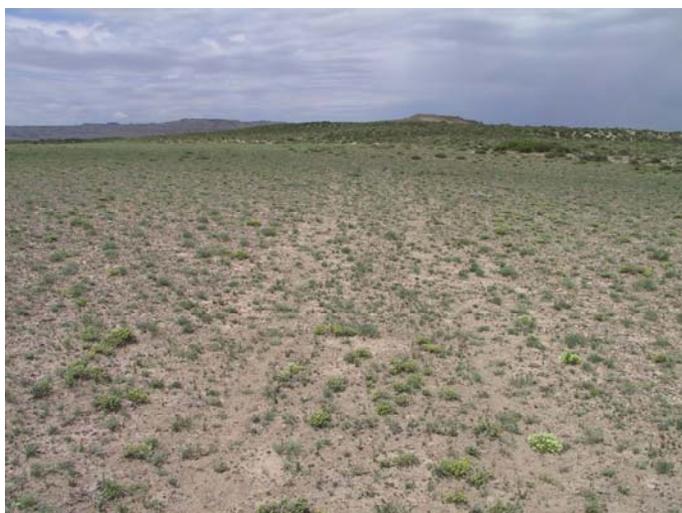
Photo #EMM41-39

Route is obvious again as it  
climbs sandy hill.

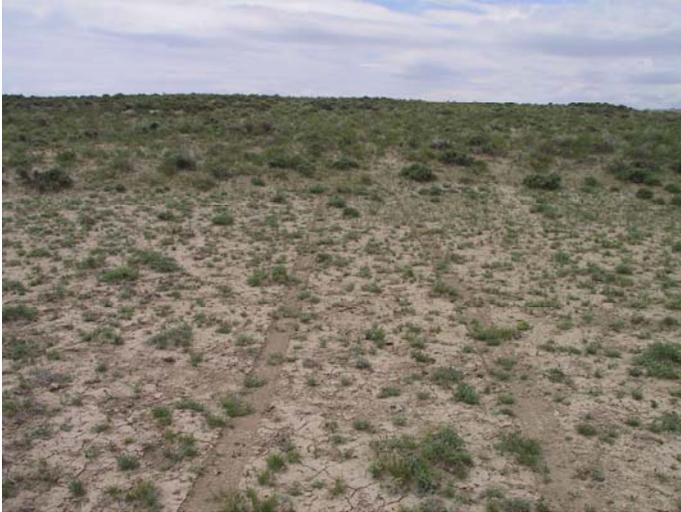
Photo #EMM41-40

Route is very faint in places atop  
rise. Route now becomes a one-  
time-use track.

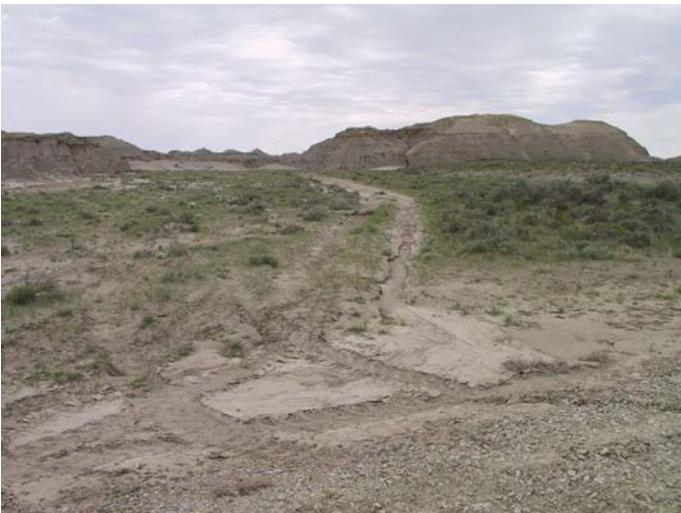
Photo #EMM41-43

This jeep trail runs to an abandoned wild horse trap.

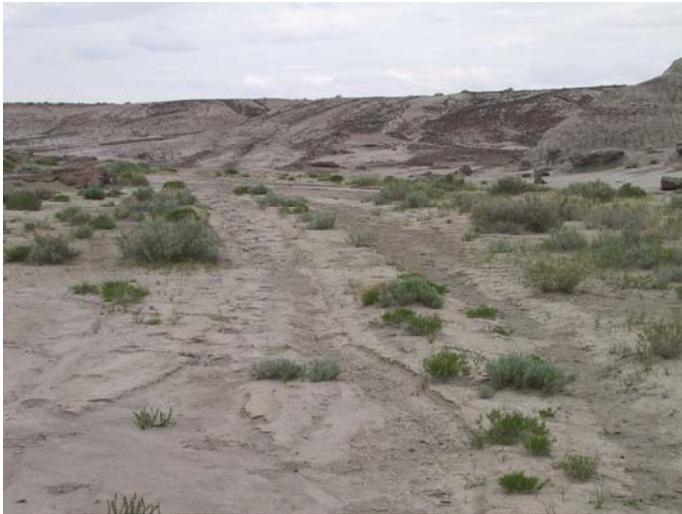
Photo #EMM41-44

Route AT-65 departs from route  
AT-66.

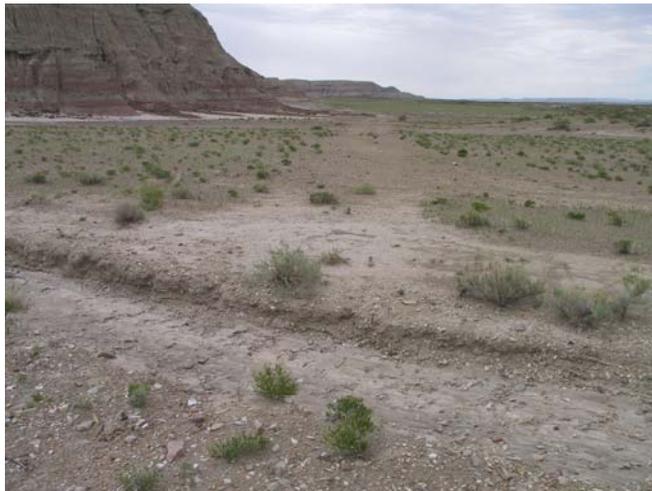
Photo #EMM41-45

Route typical (foreground), then  
faint as it climbs onto clay beds.

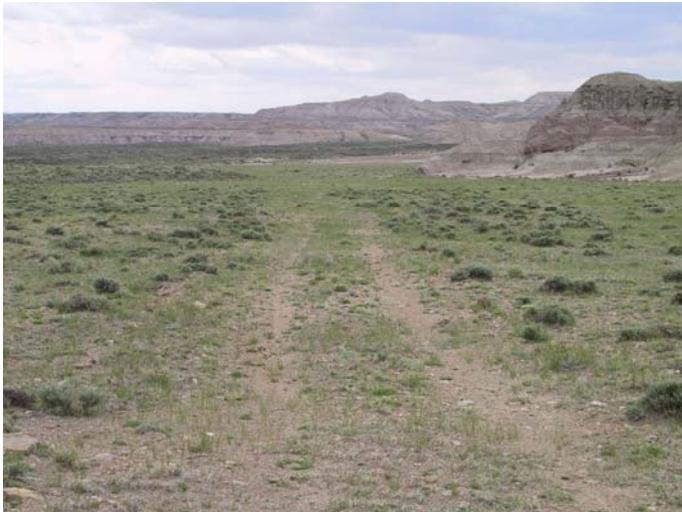
Photo #EMM41-48

Typical view of this stretch of  
AT-65.

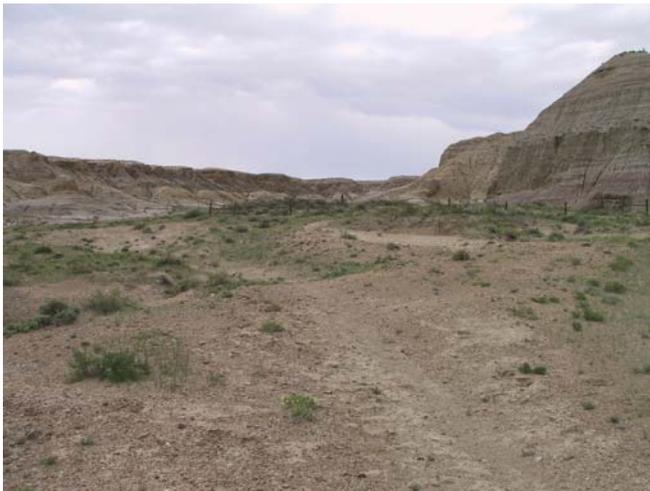
Photo #EMM41-47

Route is faintest here.

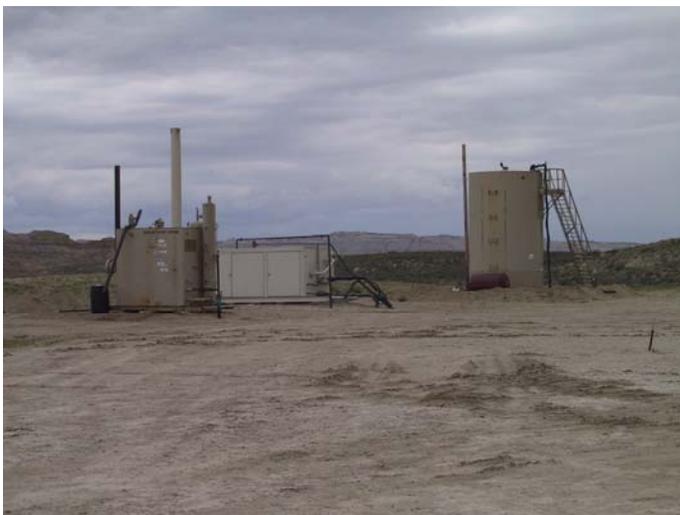
Photo #EMM41-42

Working well marks the end of  
AT-66.

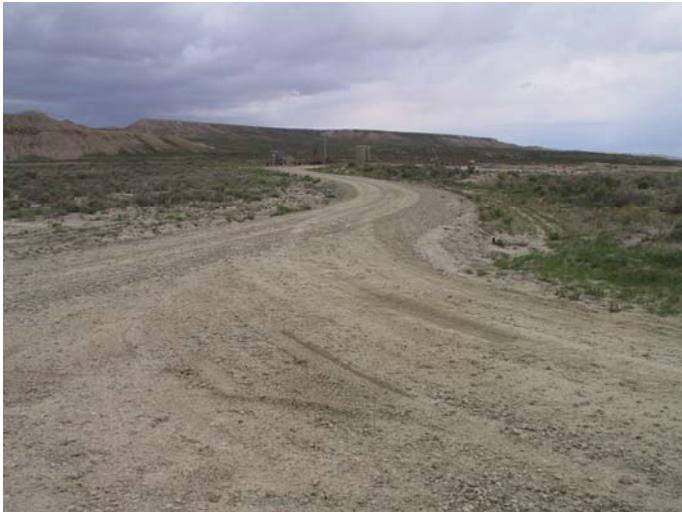
Photo #EMM41-49

View of southern end of well pad.

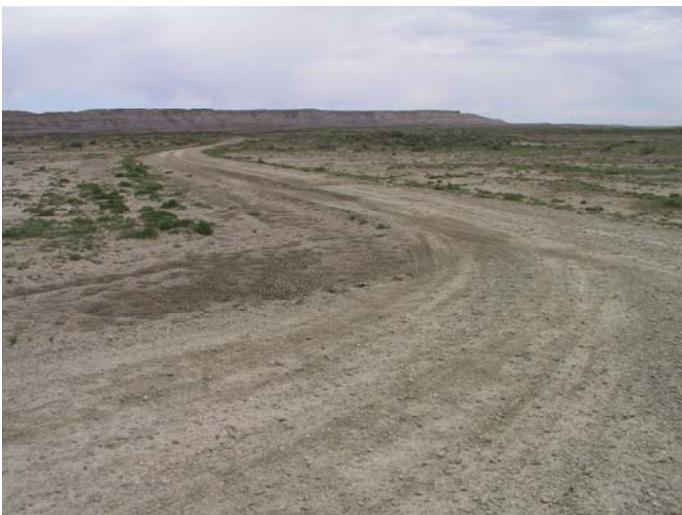
Photo #EMM41-53

This improved gravel road provides access to an active well in T14N R95W Section 9 SE 1/4. It forms part of the southeastern boundary of the proposed Adobe Town WSA expansion.

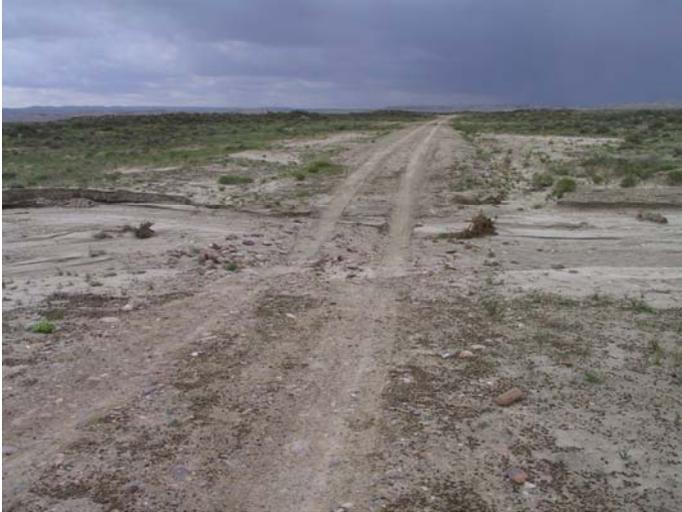
Photo #EMM41-54

Lesser-used AT-66A runs north from its junction with AT-66.

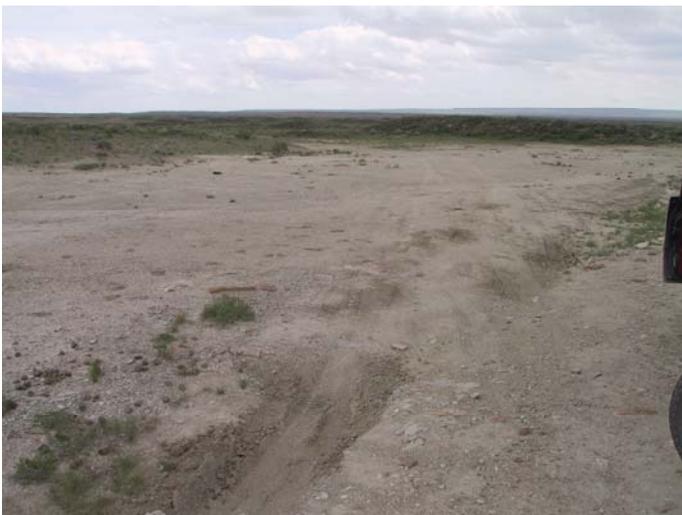
Photo #EMM41-57

This jeep trail has been improved with blading in places. A pipeline follows the route from photopoint emm41-60 eastward.

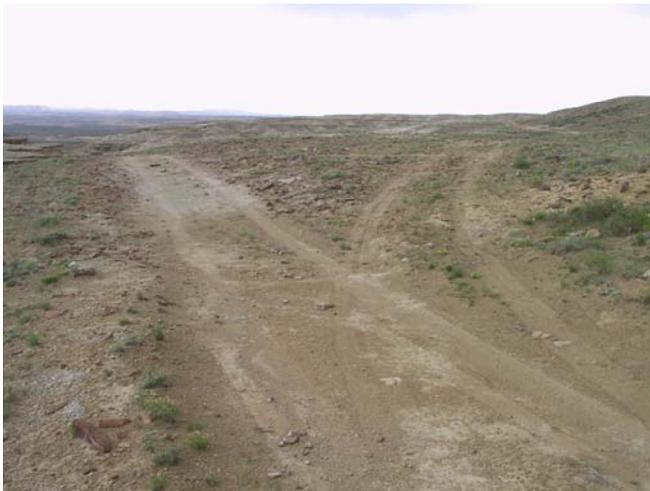
Photo #EMM41-60

Jeep trail in best condition.

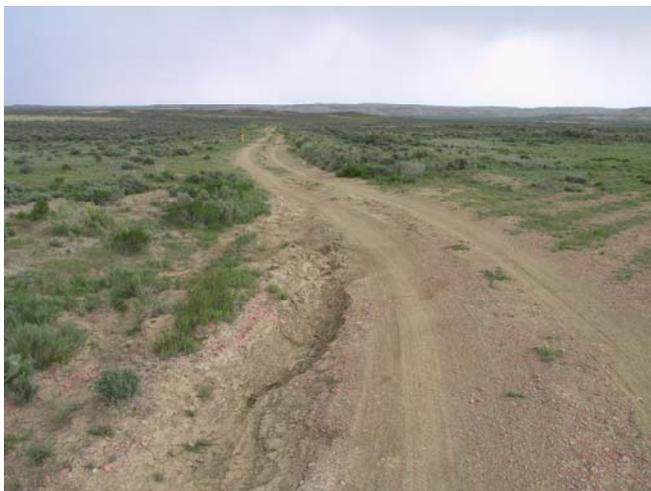
Photo #EMM41-63

Side route departs southeast, while AT-67 (at left) continues east. Beginning of blading along this route.

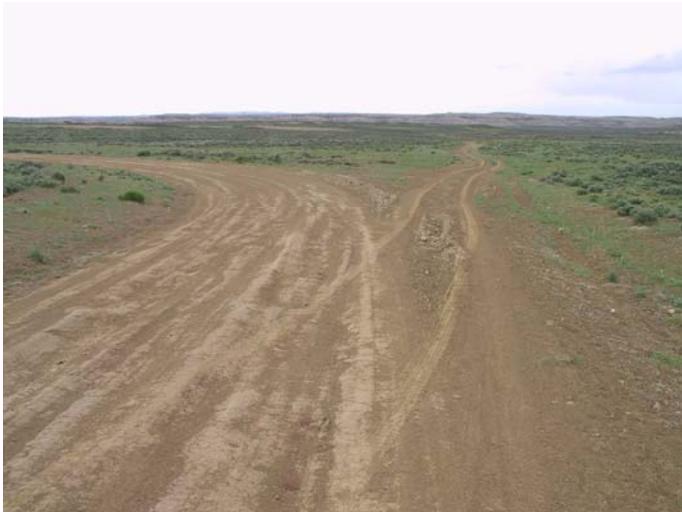
Photo #EMM41-89

View west from junction with AT-69. Improved gravel surface from this point eastward.

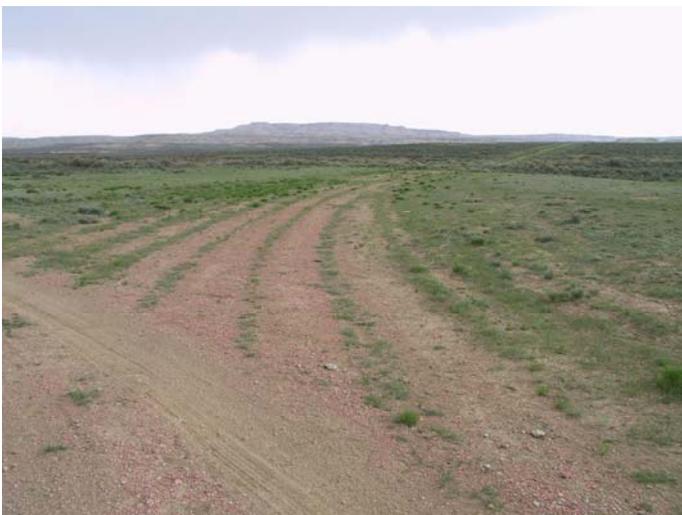
Photo #EMM41-62

This route was an improved gravel road that has been scarified and reclaimed with planted grass. It accesses several abandoned well sites.

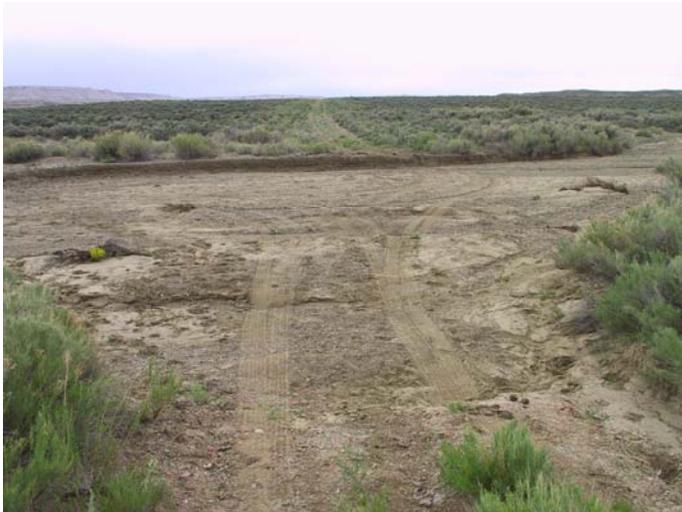
Photo #EMM41-64

Route AT-69 departs northwest  
from its junction with AT-67.

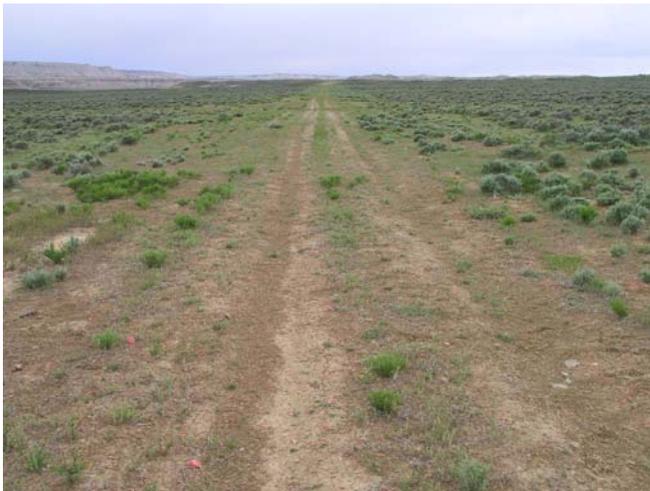
Photo #EMM41-65

Wash crossing with 2-foot walls.  
Impassable to vehicles.

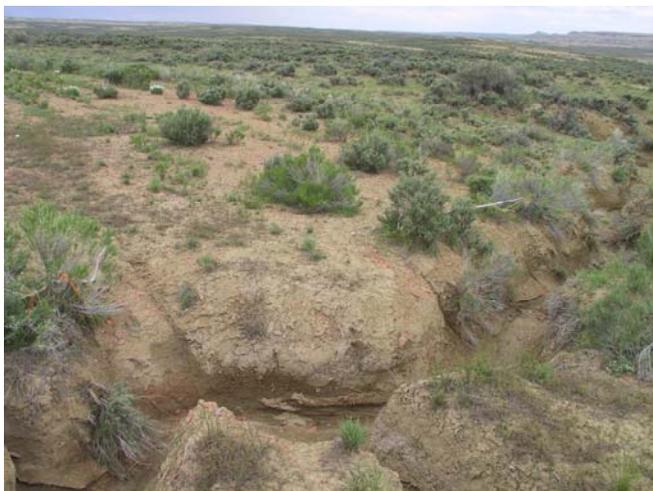
Photo #EMM41-68

Typical view of route. Track is  
maintained by wild horse use.

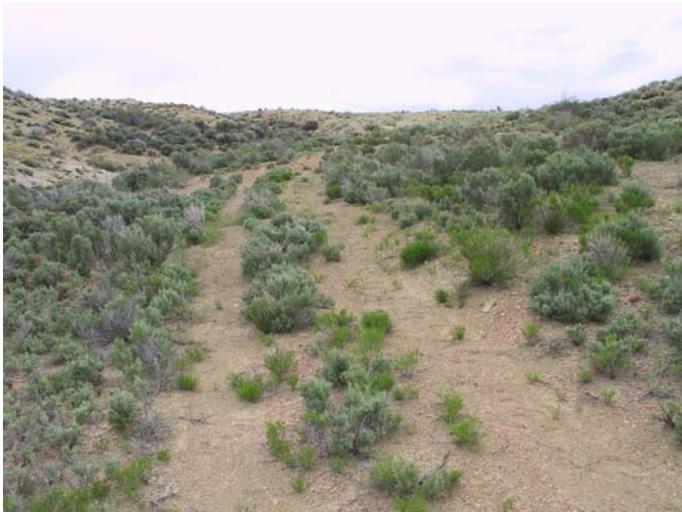
Photo #EMM41-70

30-inch gullying across route.

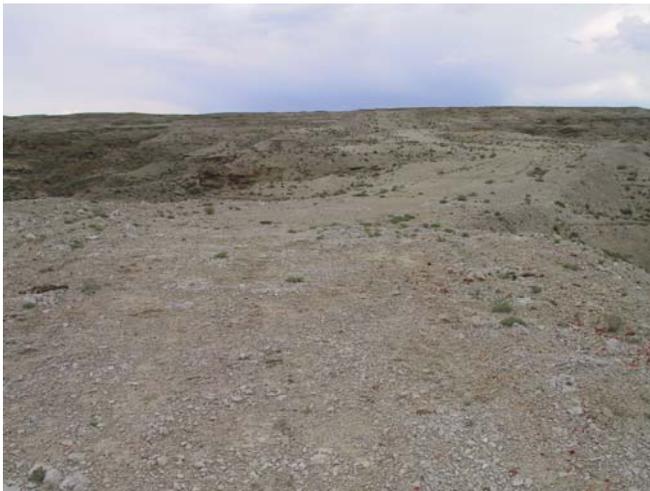
Photo #EMM41-71

Typical view of this segment of the route.

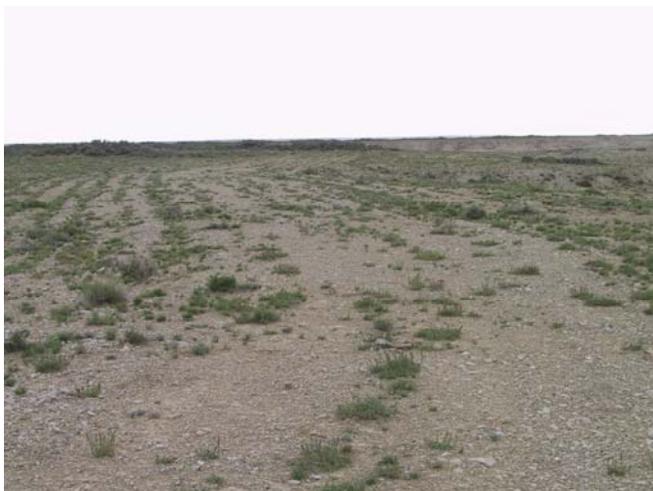
Route AT-69  
UTM 0746765 4568312  
5/18/01

Route is typical on ridgetop.

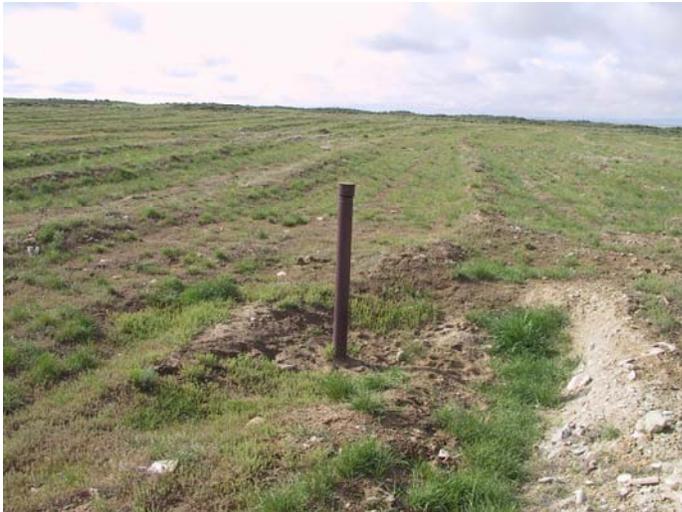
Route AT-69  
UTM 0747543 4568675  
5/18/01

View of route atop ridge.

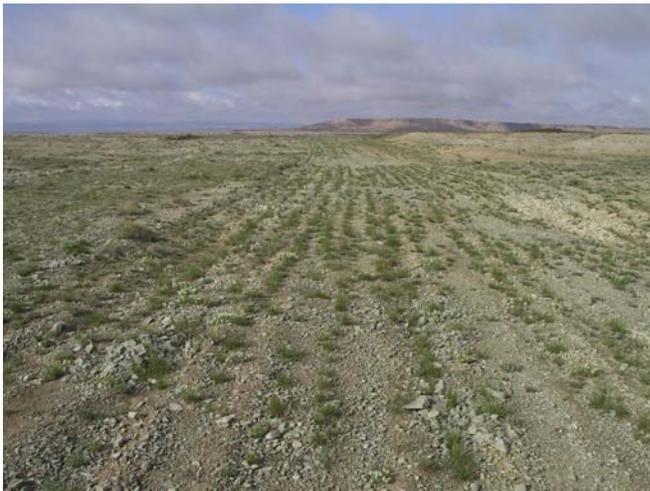
Route AT-69

Dry Hole -- Celsius Energy  
Mulligan Draw #19.

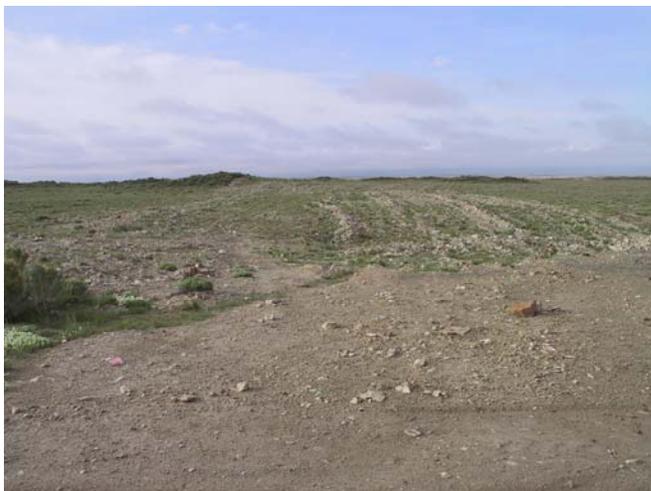
Route AT-69

Revegetation strip is now 100 feet  
wide.

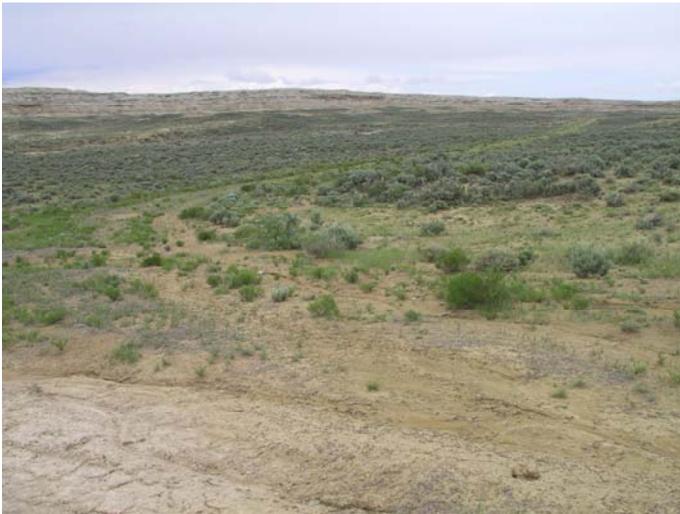
Route AT-69

Originally constructed but mechanically obliterated..  
Not maintained.  
25 feet wide.  
Impassable to vehicles.  
No use.

This revegetated strip is an abandoned and reclaimed route to a plugged and abandoned well.

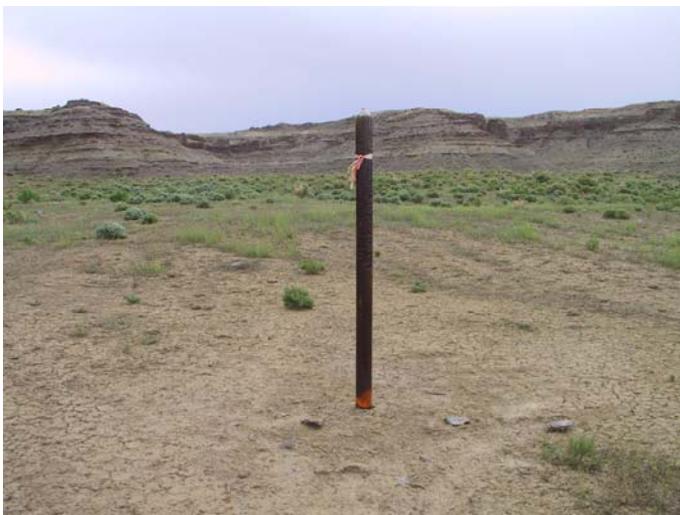
Route AT-69A  
UTM 0747673 4567403  
5/18/01

Revegetated strip departs northward from revegetated route AT-69.

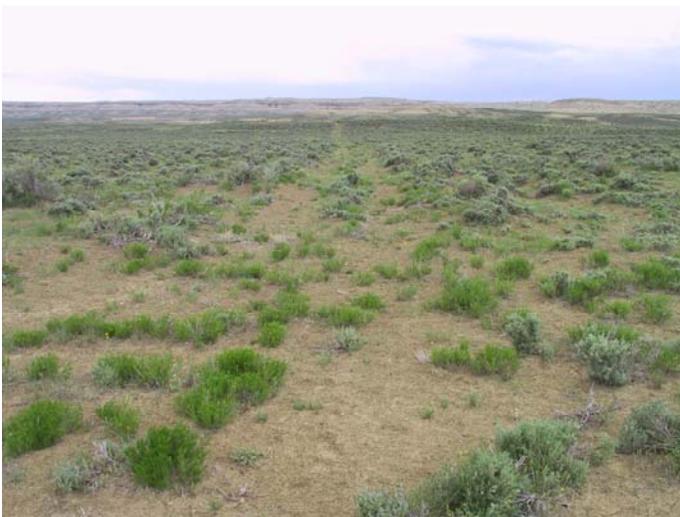
Route AT-69A  
UTM 0748221 4568211  
5/18/01

Not constructed.  
Not maintained.  
6 feet wide.  
Impassable to vehicles.  
No use.

This route is an abandoned and reclaimed seismograph trail.

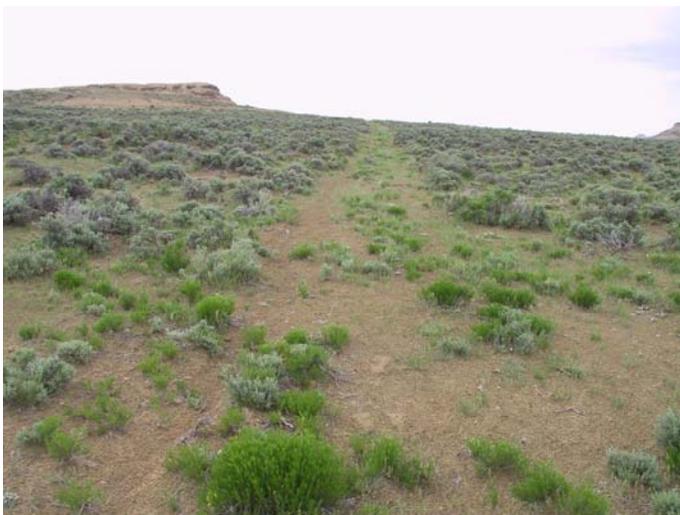
Route AT-70  
UTM 0748325 4567166  
5/18/01

View southwest on abandoned  
seismograph trail AT-70 from its  
junction with AT-69.

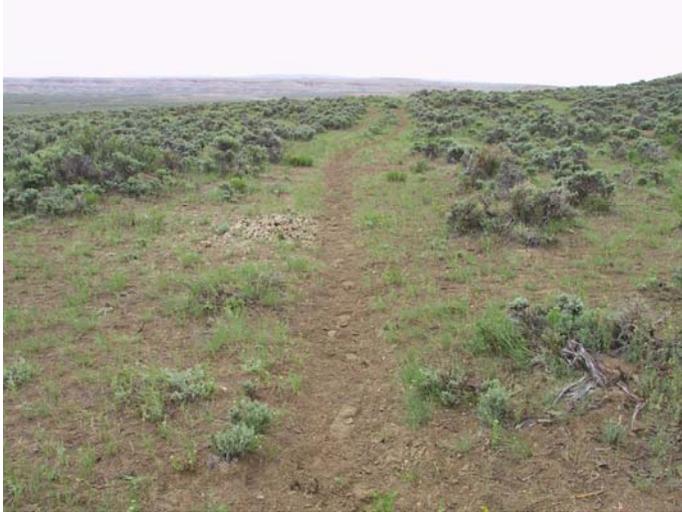
Route AT-70  
UTM 0748325 4567166  
5/18/01

View northeast along AT-70 from  
its junction with AT-69.

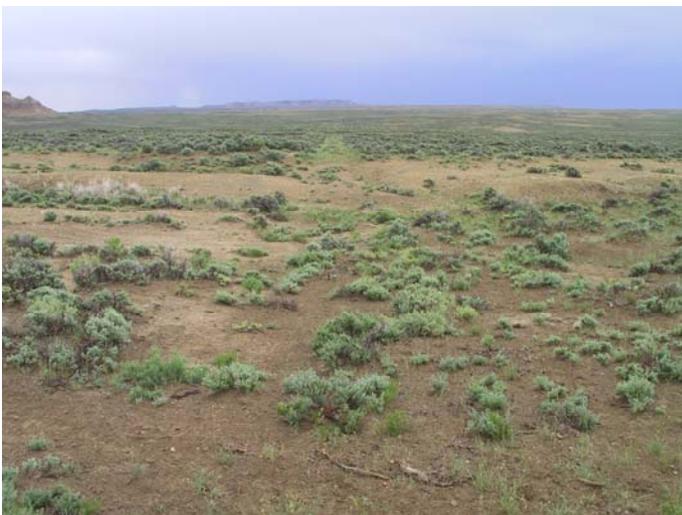
Route AT-70  
UTM 0748626 4567593  
5/18/01

Not constructed.  
Not maintained.  
6 feet wide.  
Impassable to vehicles.  
No use.

This route fragment is now isolated and no longer connects with a passable vehicle way.

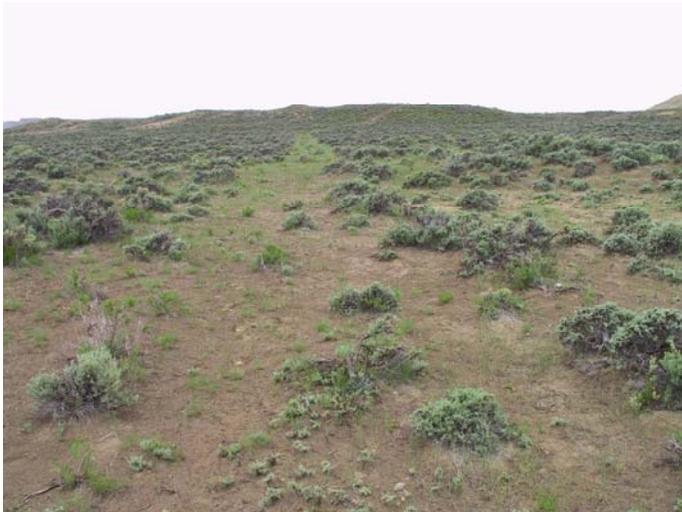
Rt. AT-71  
UTM 0748626 4567593  
5/18/01

Route AT-71 runs east from its  
junction with AT-70.

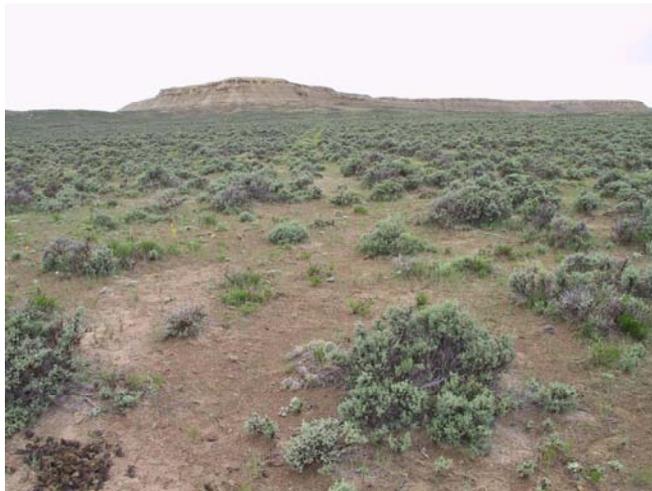
Route AT-71  
UTM 0758780 4567583  
5/18/01

View northwest along route fragment at bend.

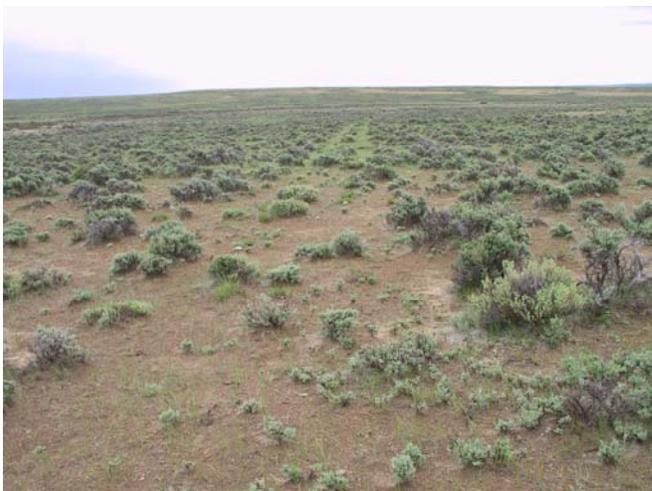
Route AT-71  
UTM 0748979 4567262  
5/18/01

View northwest near possible origins of route fragment. No trace farther southeast.

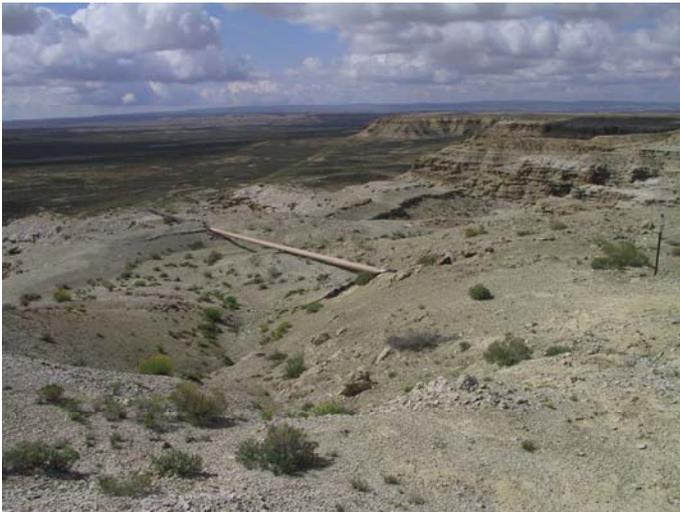
Route AT-71  
UTM 0748979 4567262  
5/18/01

Constructed.  
Not subsequently maintained.  
50 foot wide right-of-way.  
Impassable to vehicles.  
In use.

This 12-inch pipeline serves many of the Willow Creek gas wells. It forms part of the eastern boundary of the proposed Adobe Town WSA expansion.

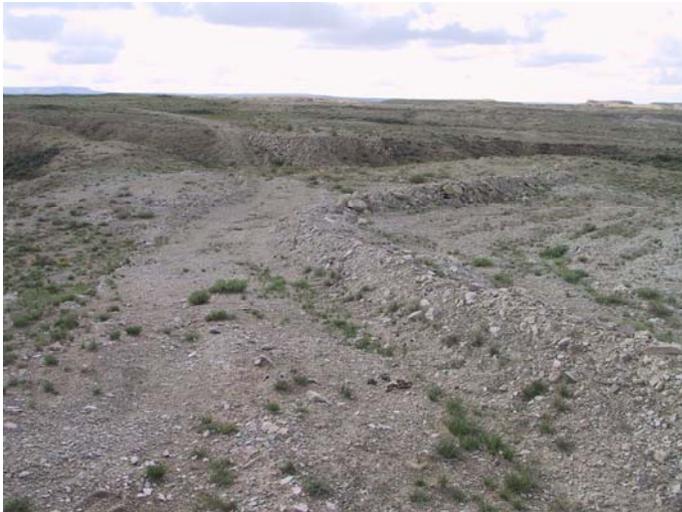
Route AT-72  
UTM 0749370 4570309  
5/19/01

Dry hole just north of pipeline.  
Texas Oil & Gas Windmill Draw  
#2, plugged and abandoned  
1/2/81.

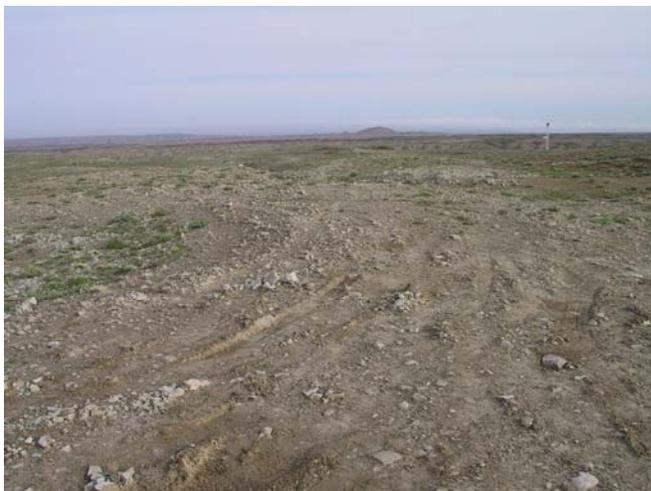
Route AT-72  
UTM 0748931 4570681  
5/19/01

Pipeline crosses route AT-75.  
View east. Note substation.

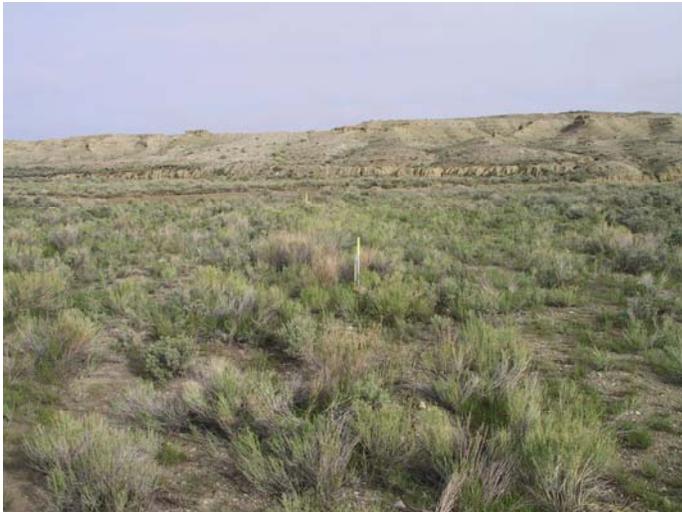
Route AT-72  
UTM 0748931 4570681  
5/19/01

Pipeline crosses route AT-75.  
View west.

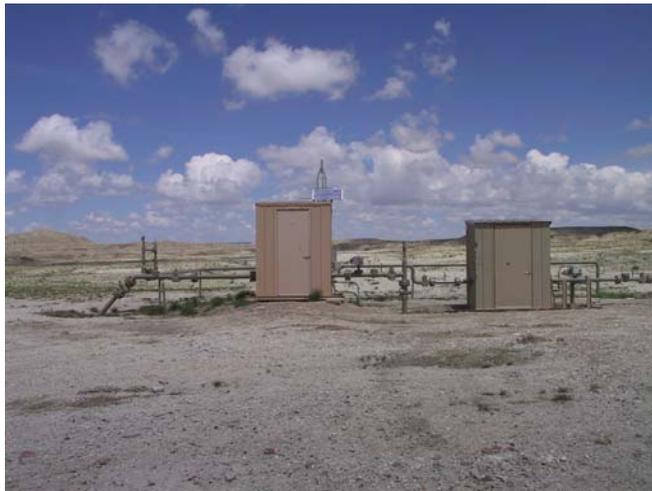
Route AT-72

Pipeline crosses AT-75 near well-site. View north.

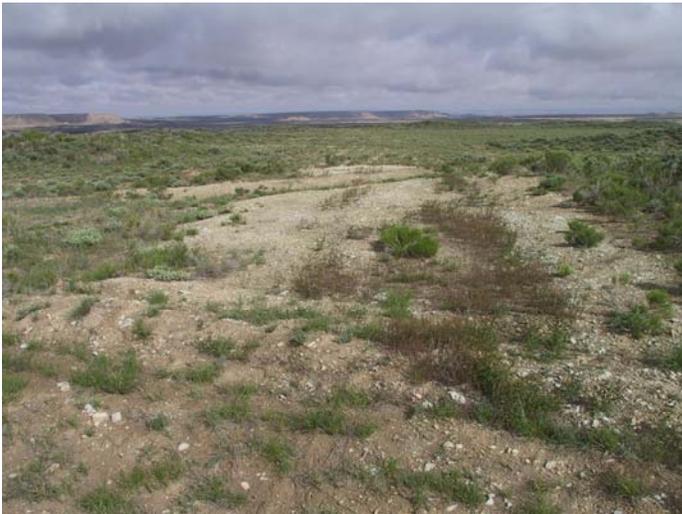
Route AT-72

Constructed.  
Eclaimed and not subsequently maintained.  
50 feet wide.  
Impassable to vehicles.  
No use.

This abandoned and reclaimed access route once served the Courthouse Butte F1 well.

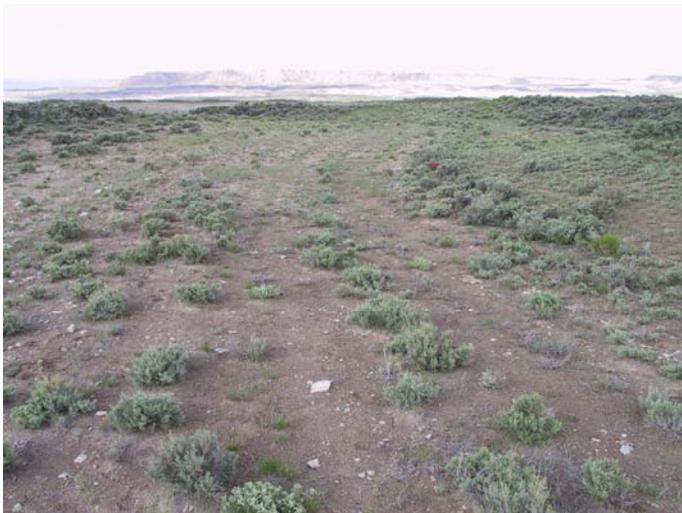
Route AT-73  
UTM 0747878 4569609  
5/19/01

Route AT-73 runs southwest from  
its junction with AT-69.

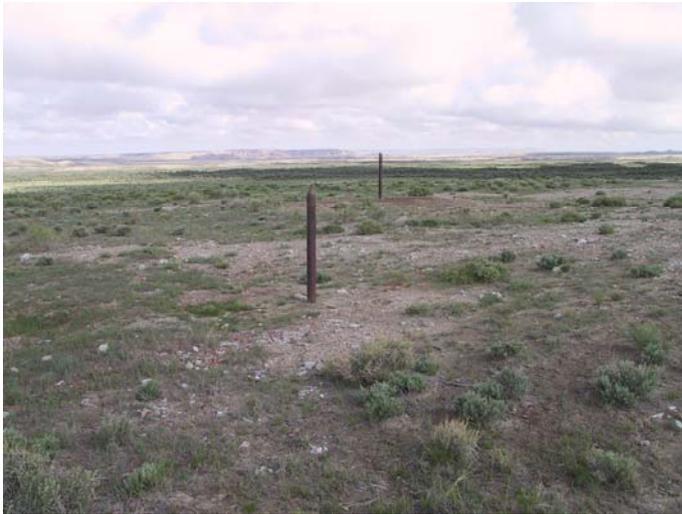
Route AT-73  
UTM 0747334 4569732  
5/19/01

Revegetation strip is well-re-  
claimed through sandy country.

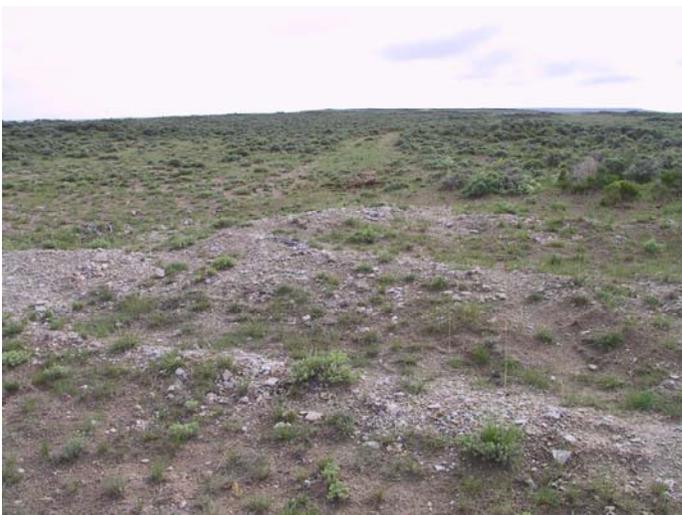
Route AT-73  
UTM 0746497 4569704  
5/19/01

Not constructed.  
Not maintained.  
6 feet wide.  
4 wheel drive.  
No use.

This jeep trail is now difficult to find and is completely abandoned. I is invisible at its junction with AT-75.

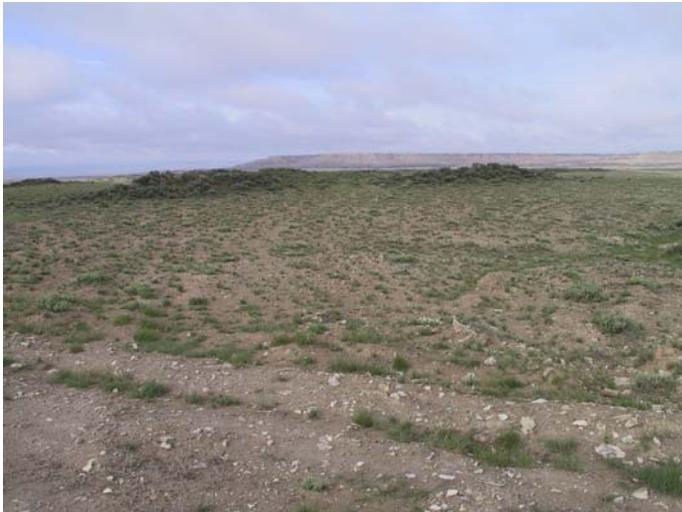
Rt. AT-74  
UTM 0748474 4570321  
5/19/01

View north on AT-74 from its junction with AT-69.

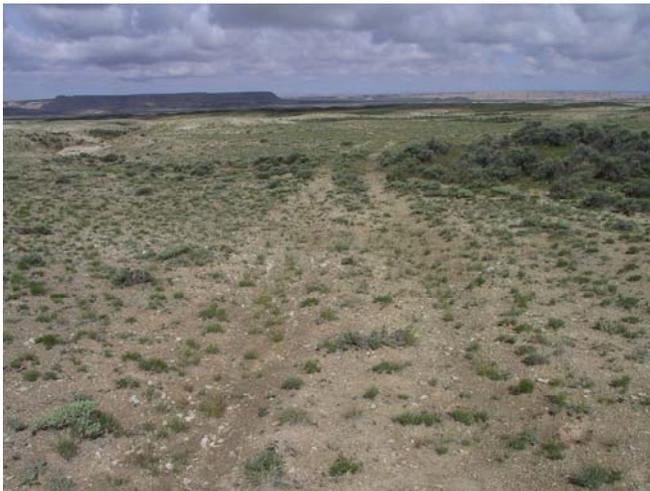
Route AT-74

View southwest on AT-74 from  
its junction with AT-75. Fully  
reclaimed.

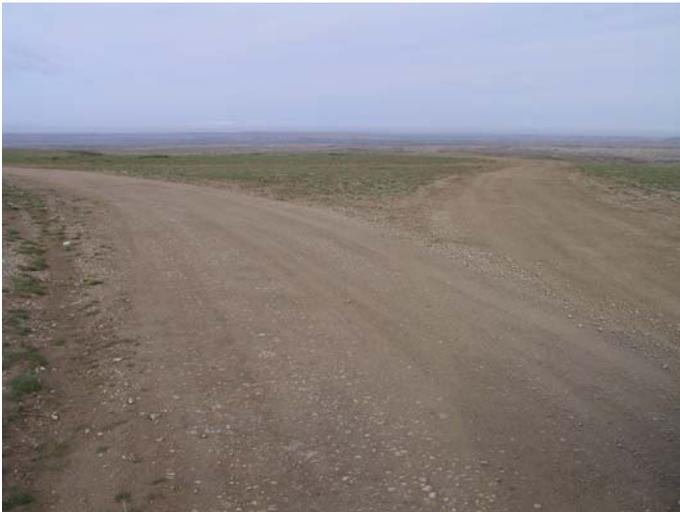
Route AT-72

Constructed.  
Regularly maintained.  
25 feet wide.  
2 wheel drive.  
Moderate use.

This improved gravel road provides access to gas wells in T15N R95W S25 and S24.

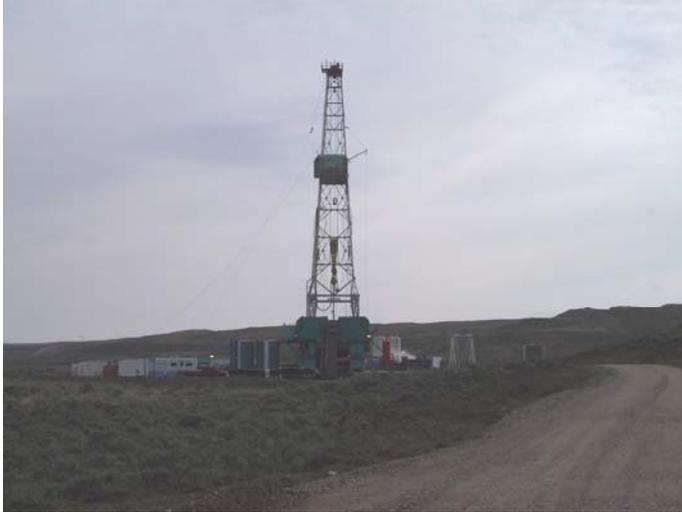
Route AT-75  
UTM 0748170 4570631  
5/19/01

Well in production: Mulligan  
Draw Unit #6.

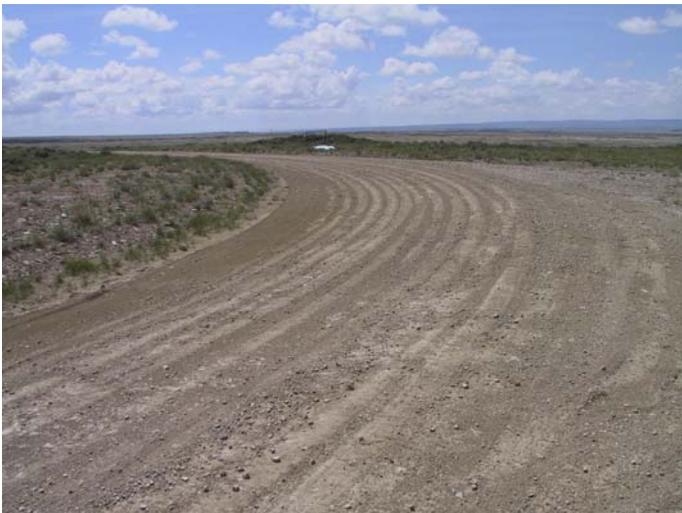
Route AT-75

Moderate use.

This improved gravel road provides access to active gas wells in T15N R95W S14 and S13. It is excluded from the proposed Adobe Town WSA expansion.

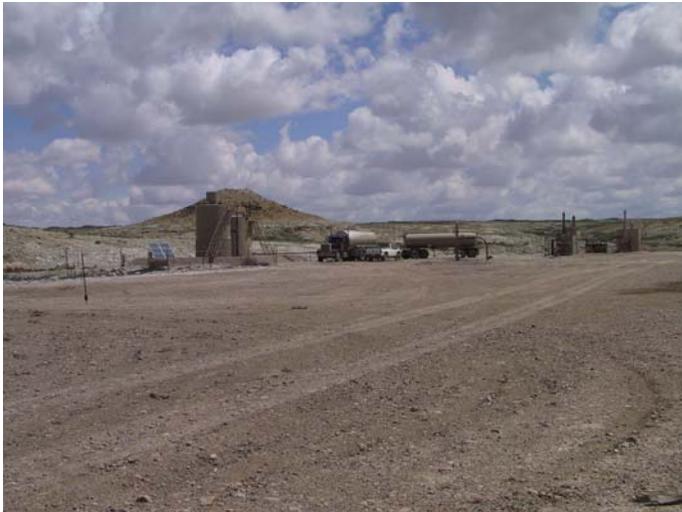
Rt. AT-76

Beginning of Route AT-76 from its junction with AT-127.

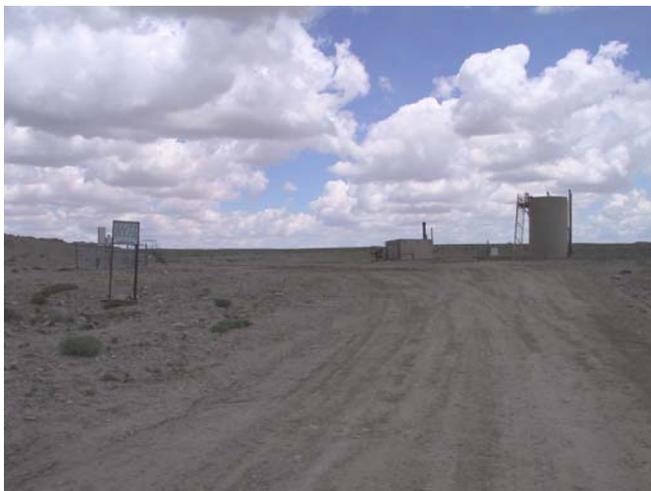
Route AT-76  
UTM 0745615 4571966  
5/19/01

Route crosses wash.

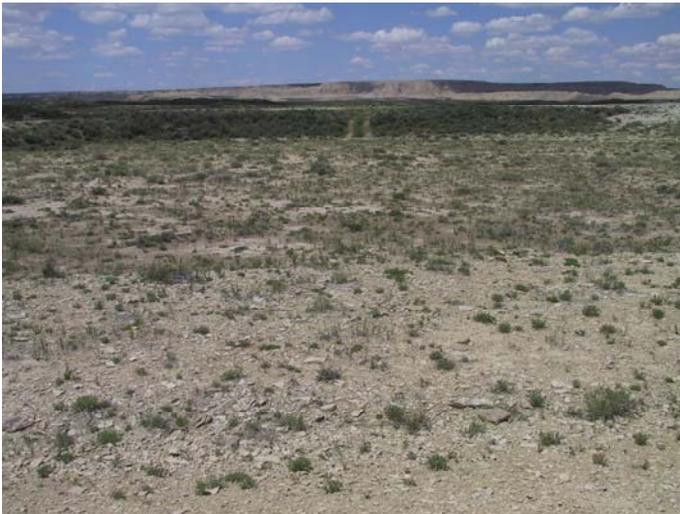
Route AT-76  
UTM 0745804 4573492  
5/19/01

Not constructed.  
Not maintained.  
6 feet wide.  
4 wheel drive.  
No use.

This abandoned jeep trail climbs to the top of a rise and ends.

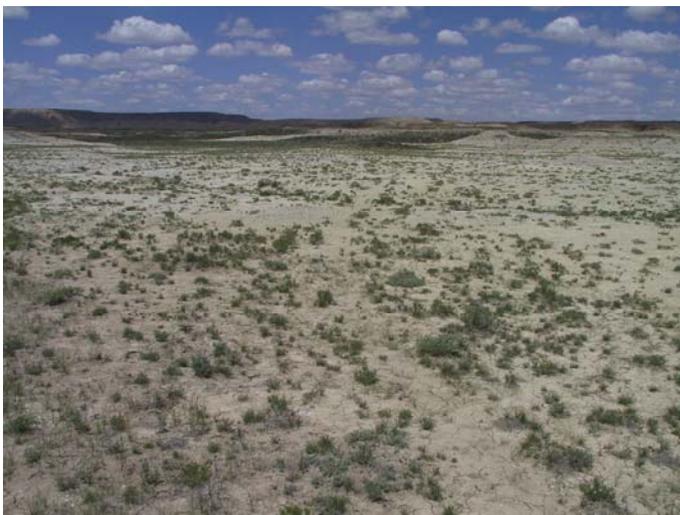
Route AT-76A  
UTM 0745370 4572452  
5/19/01

Route AT-76A runs west from  
Route AT-76.

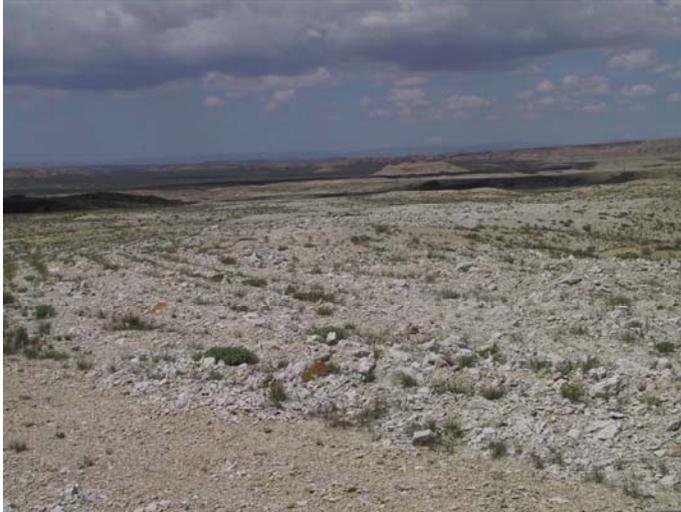
Route AT-76A  
UTM 0745246 4572507  
5/19/01

Constructed but then obliterated.  
Not maintained.  
25 feet wide.  
Not driveable.  
No use.

This abandoned and obliterated road lies entirely within the arc described by Route AT-76.

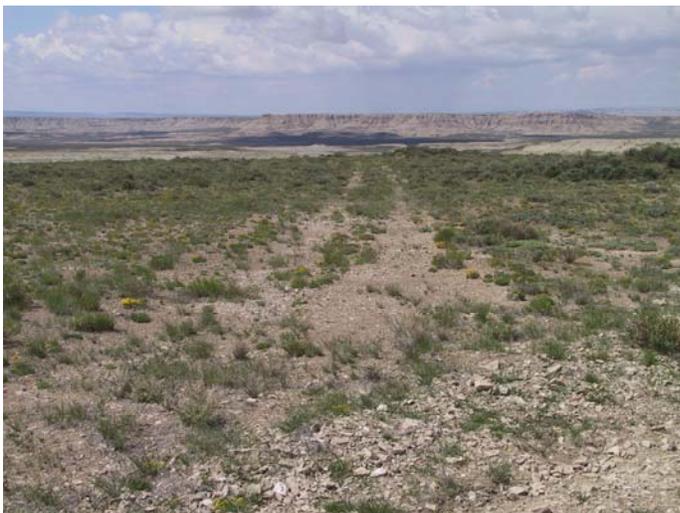
Route AT-77  
UTM 0746873 4572780  
5/19/01

Not constructed.  
Not maintained.  
6 feet wide.  
4 wheel drive.  
Ery light to no use.

Marked “jeep trail” on the USGS Salazar Butte quad, this route is impassable at the Willow Creek wash crossing and no longer receives regular use.

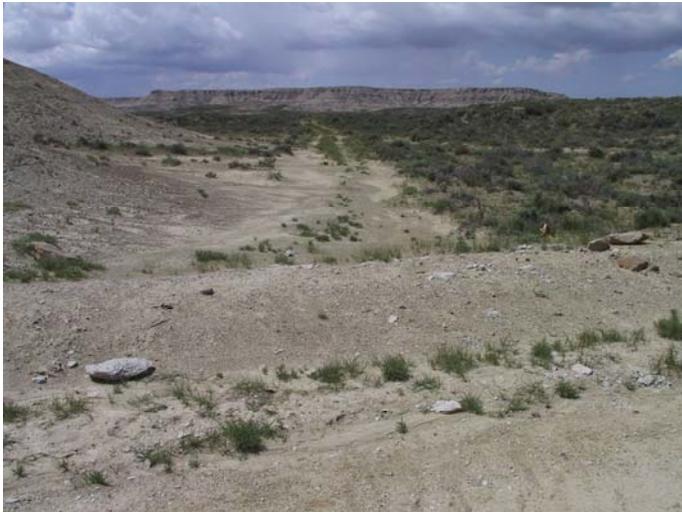
Route AT-78  
UTM 0747606 4574053  
5/19/01

Route AT-78 runs southwest from the junction of AT-76 and AT-127. This segment of the route is abandoned and fully reclaimed.

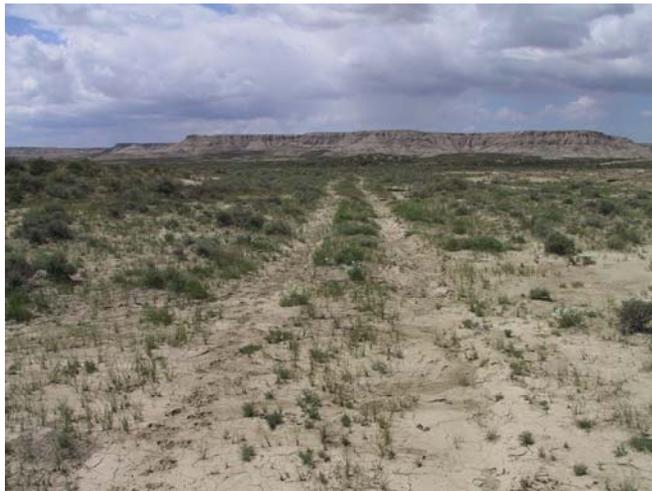
Route AT-78  
UTM 0745392 4572194  
5/19/01

Jeep trail AT-78 runs southwest  
from its junction with AT-76.

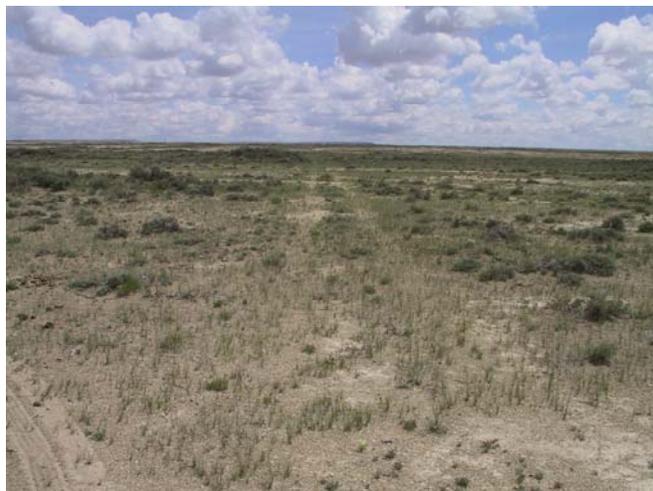
Route AT-78  
UTM 0745181 4571986  
5/19/01

Typical view of this portion of the  
route.

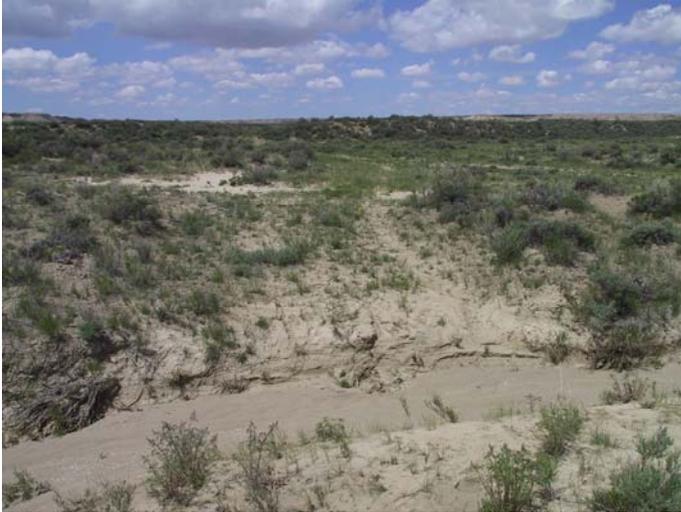
Photo #EMM42-40

Route AT-78  
UTM 0744946 4571612  
5/19/01

Old, fully-reclaimed trail joins  
from east. This may be a fragment  
of an old seismograph trail.

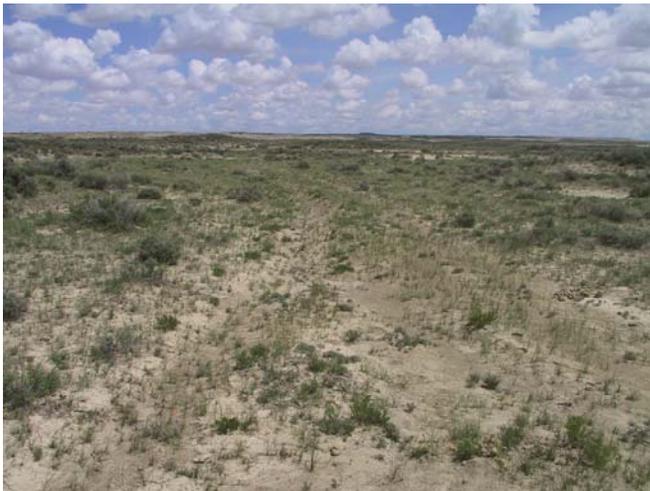
Photo #EMM42-42

Route AT-78  
UTM 0744776 4571657  
5/19/01

Difficult wash crossing.

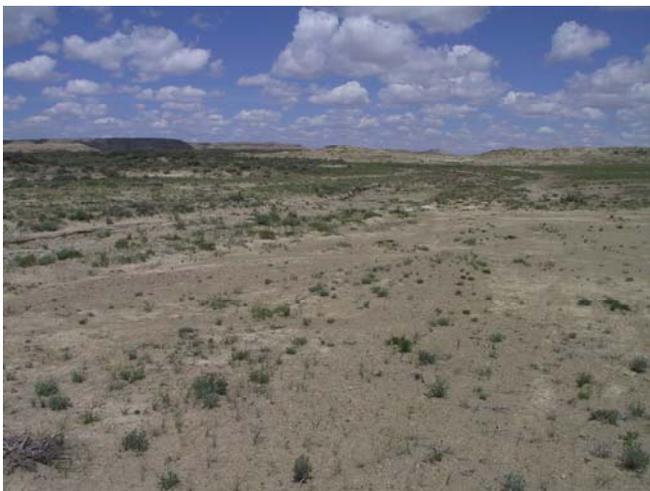
Photo #EMM42-41

Route AT-78  
UTM 0744736 4571660  
5/19/01

Even more reclaimed drive-around route to the north.
