**BLM Unit Identification:** Adobe Town WY-030-401 and WY-040-408

**Description** Adobe Town is proposed by the conservation community for wilderness designation. The area proposed for wilderness includes all of the Adobe Town Wilderness Study Area, plus additional lands of wilderness quality in The Haystacks, along Willow Creek and the Willow Creek Rim, and south of the WSA to the Powder Rim and just beyond it. All of these areas possess the full complement of required characteristics for wilderness in abundance: outstanding opportunities for both solitude *and* primitive and unconfined recreation, wilderness-quality naturalness, size (at over 180,000 acres, the citizens proposed Adobe Town wilderness is well above the 5,000-acre minimum), and in addition has outstanding supplemental values such as abundant wildlife, wild horse herds, unique geology, and abundant archaeological and paleontological resources.

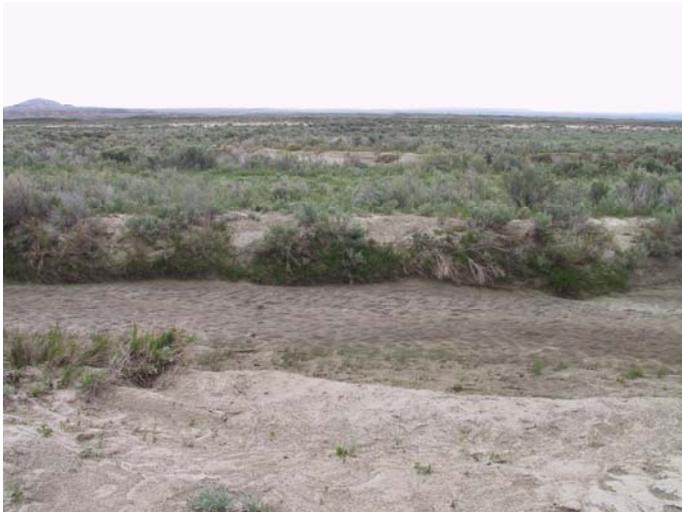
Photo #EMM41-16

Route AT-78  
UTM 0744274 4571795  
5/19/01

Route peters out beside wash.

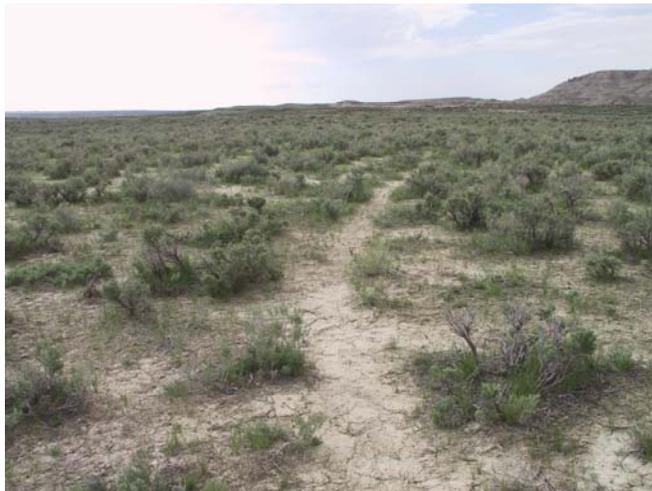
Photo #EMM41-15

Route AT-78  
UTM 0742924 4572299  
5/18/01

Old wash crossing is now  
abandoned and impassable.

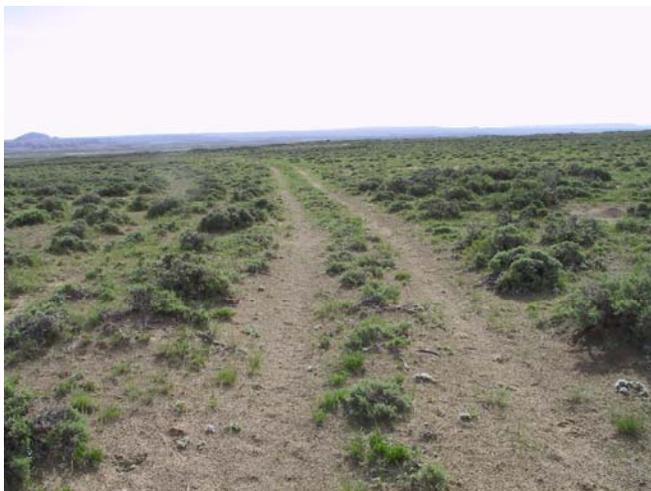
Photo #EMM41-14

Route AT-78  
UTM 0743020 4572214  
5/18/01

Western leg of AT-78 ends near  
Willow Creek wash.

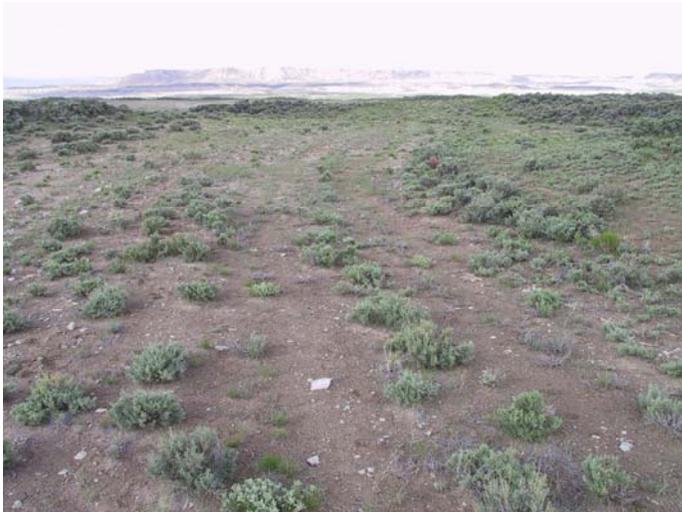
Photo #EMM41-13

Route AT-78  
UTM 0741995 45718561  
5/18/01

Route in its best condition.

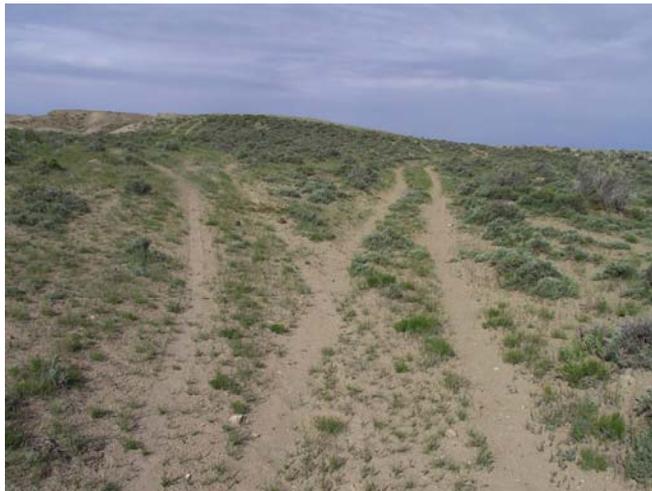
Photo #EMM41-12

Route AT-78  
UTM 0741415 4571548  
5/18/01

Main route gullied 18 inches deep.

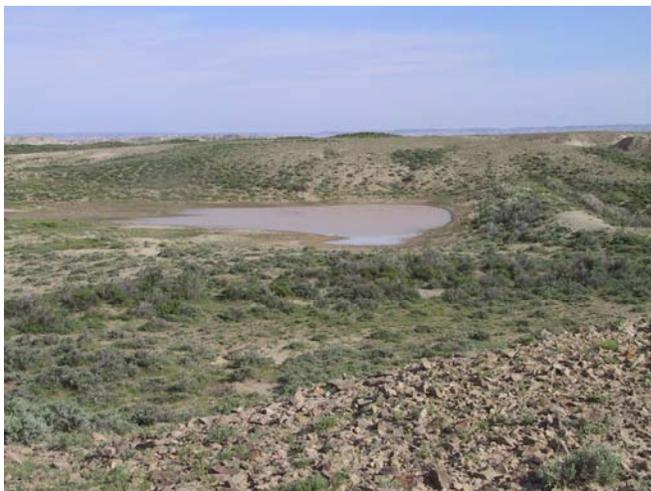
Photo #EMM41-11

Route AT-78  
UTM 0741291 4571498  
5/18/01

Junction: AT-78 is at left; short spur route to reservoir is at right.

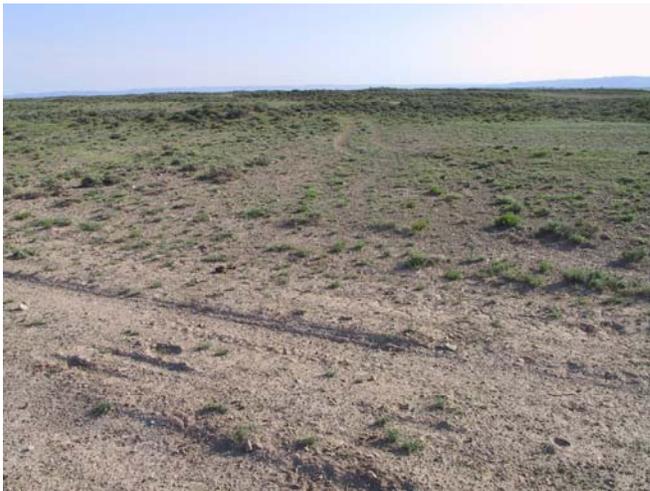
Photo #EMM40-80

Route AT-78  
UTM 0741019 4571253  
5/17/01

Route AT-78 rather weak at its junction with AT-23; view northeast.

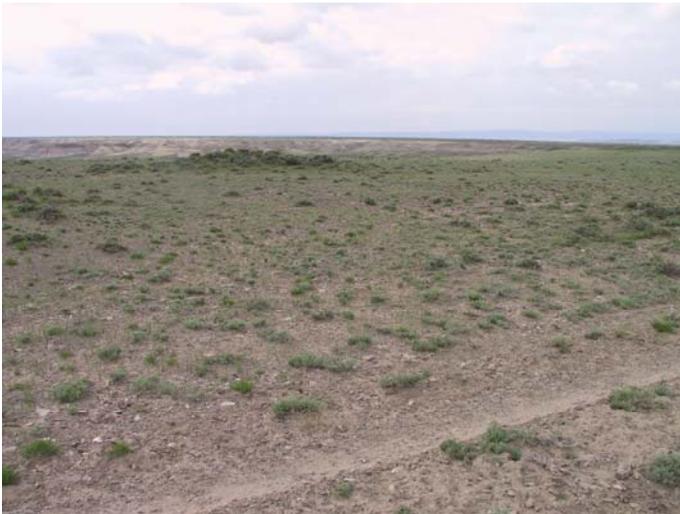
Photo #EMM41-24

This abandoned route accesses the reservoir at its end. It has been abandoned and is no longer passable.

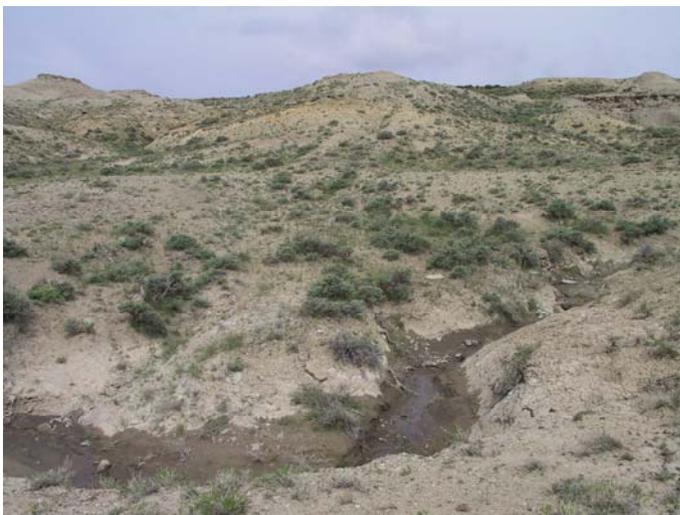
Photo #EMM41-23

Route AT-79  
UTM 0741307 4573088  
5/18/01

There is no sign of Route AT-79 at its junction with AT-23 (right foreground).

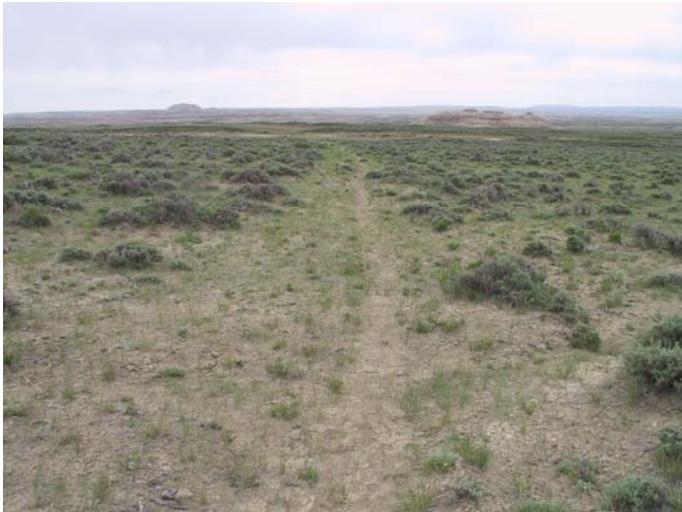
Photo #EMM41-21

Route AT-79  
UTM 0741510 4572877  
5/18/01

This was the old grade down from the Willow Creek Rim.

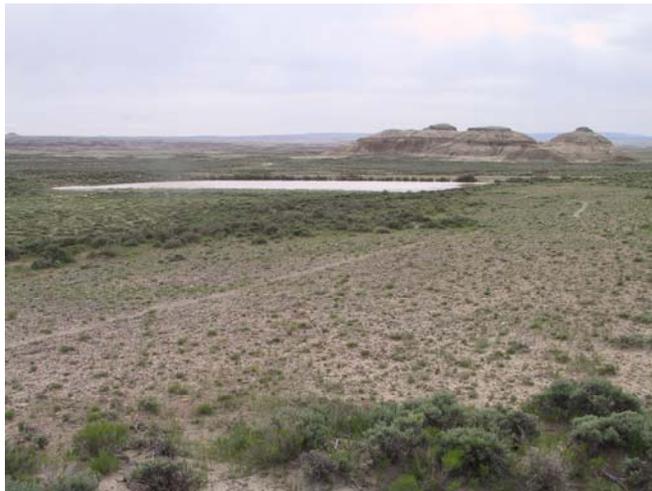
Photo #EMM41-22

Route in its best condition. It is now a wild horse trail.

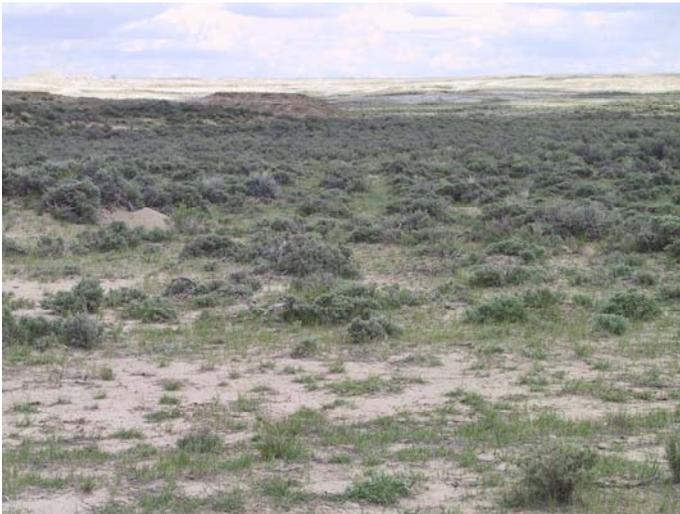
Photo #EMM42-57

This route no longer exists in places.

This old jeep trail has been abandoned and is now being reclaimed by the forces of natural degradation. There is an abandoned wild horse trap along the way.

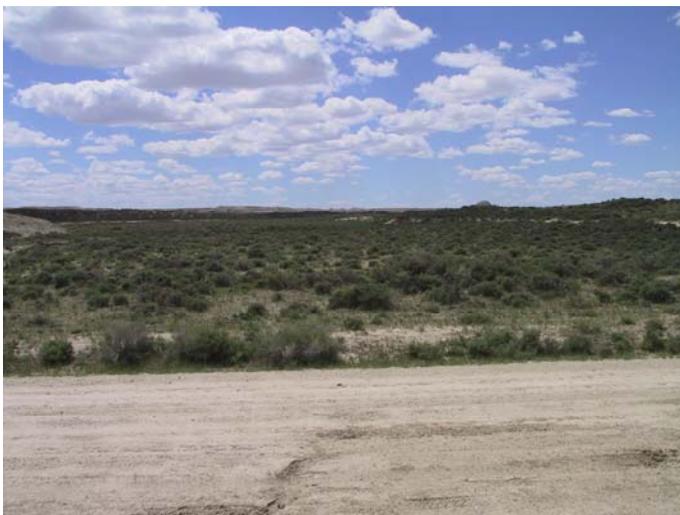
Photo #EMM42-58

Reclaimed jeep trail AT-83 is visible to the east of its junction with AT-82.

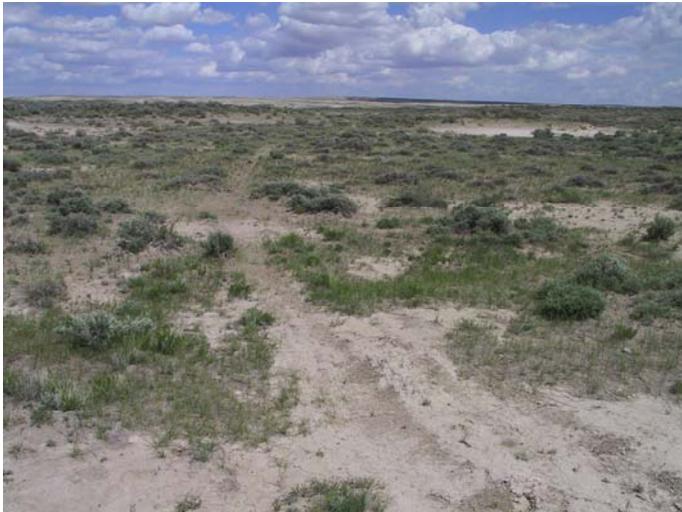
Photo #EMM42-65

Route AT-83 is invisible/does not exist west of its junction with AT-82.

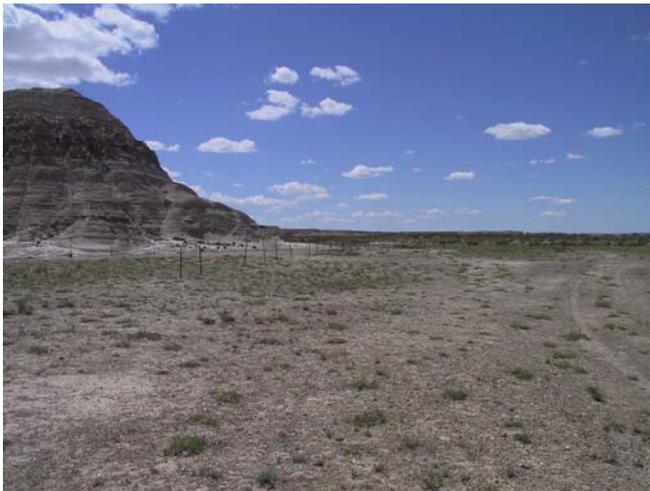
Photo #EMM42-64

Route AT-83  
UTM 0742099 4577010  
5/19/01

Route devolves into a wild horse trail.

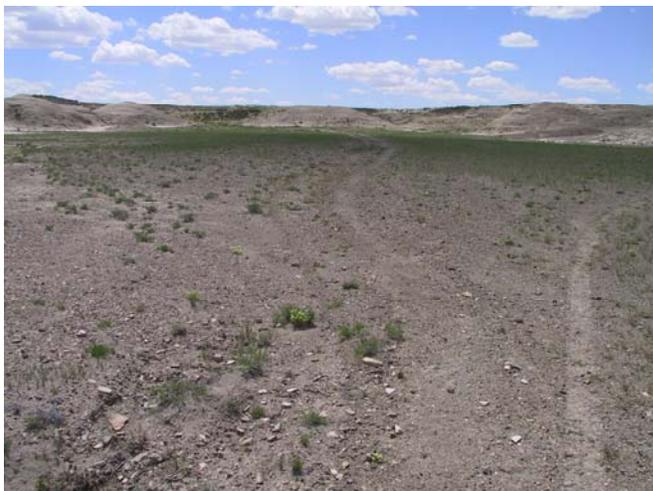
Photo #EMM42-63

Route AT-83  
UTM 0741668 4576892  
5/19/01

Abandoned wild horse trap with wing fences at base of butte.

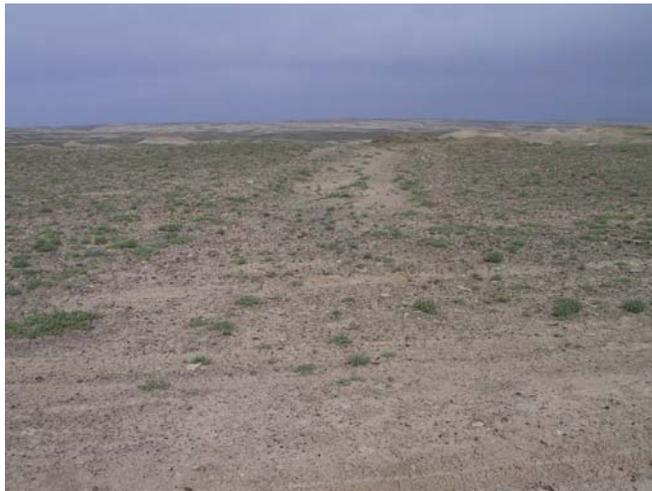
Photo #EMM40-63

Bladed route AT-83 descends from rim. No use here.

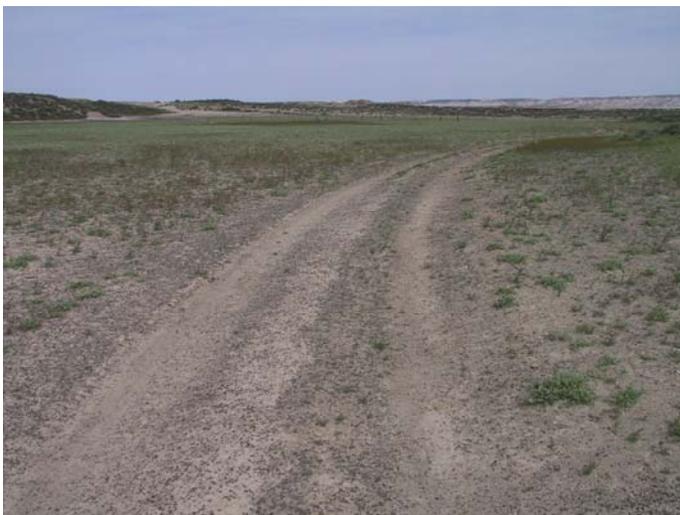
Photo #EMM40-11

Route AT-84  
UTM 0740354 4578215  
5/17/01

Jeep trail AT-84 runs south from  
its junction with AT-27. Note  
corrals.

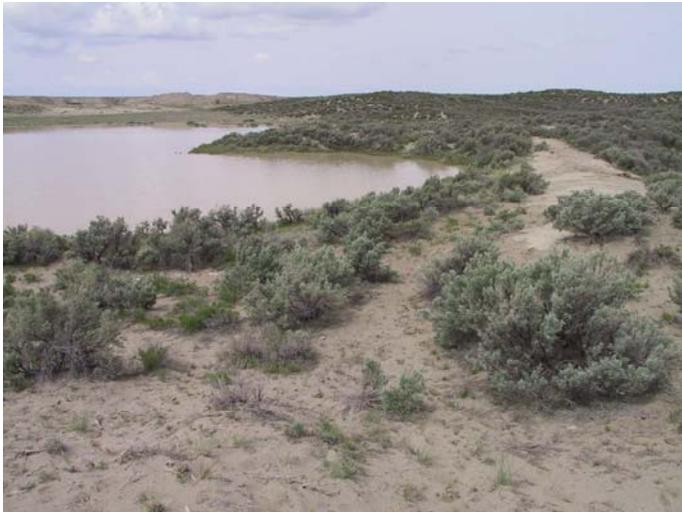
Photo #EMM40-12

Route AT-84  
UTM 0740396 4578033  
5/17/01

Route AT-84 in its best condition.

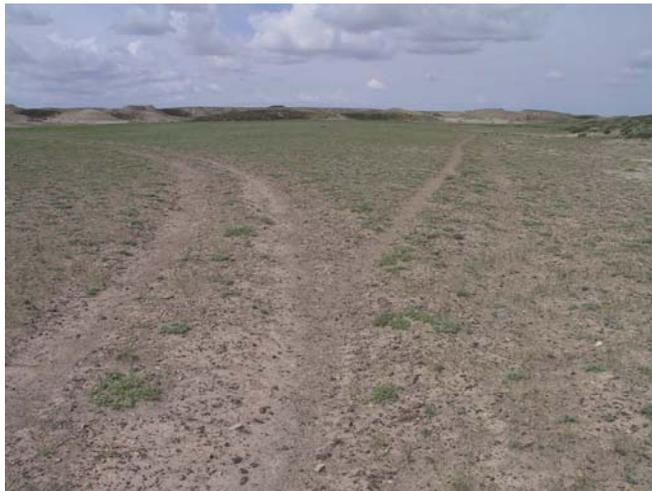
Photo #EMM40-13

Route AT-84  
UTM 0740459 4577966  
5/17/01

Reservoir: sound, holds water.  
Dam is 300 feet across,  
revegetated.

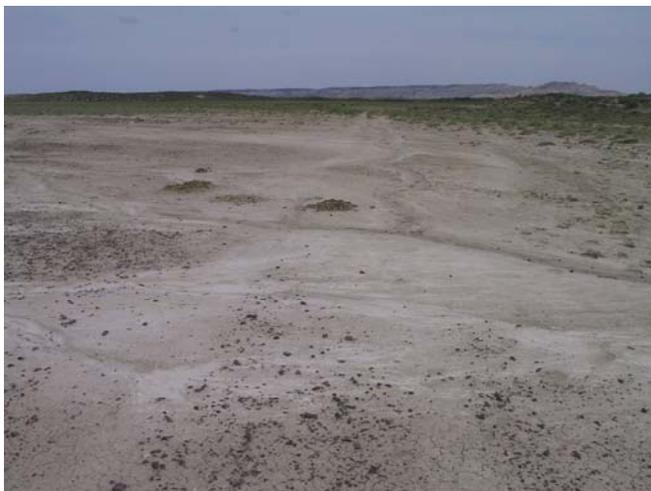
Photo #EMM40-15

Route AT-84  
UTM 0740559 4577890  
5/17/01

Route at right is an abandoned  
spur jeep trail that once ran to the  
reservoir. Now it is a wild horse  
trail.

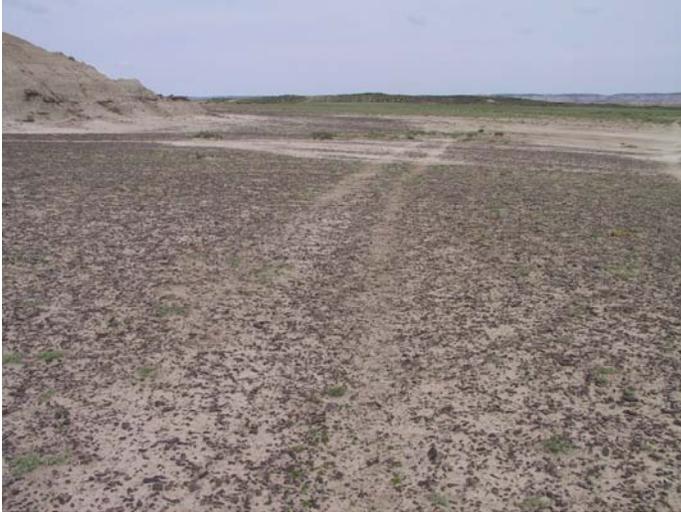
Photo #EMM40-16

Route AT-84  
UTM 0740564 4577570  
5/17/01

Route AT-84 is very primitive  
here.

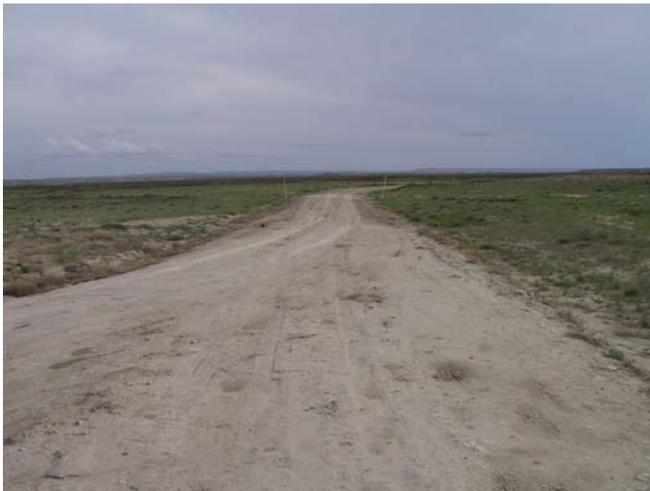
Photo #EMM39-101

View north on AT-85 from its  
junction with AT-27.

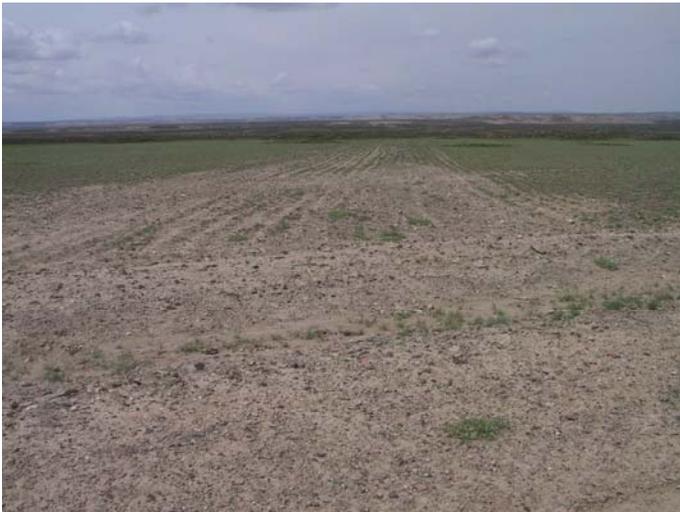
Photo #EMM40-22

Abandoned well site at the end of AT-86A. It has been obliterated mechanically and reseeded, but has yet to return to a natural condition. Having only been 7 years since its abandonment, it can be expected to reclaim significantly in the coming years.

This abandoned spur route to a plugged and abandoned well has been mechanically obliterated and reseeded

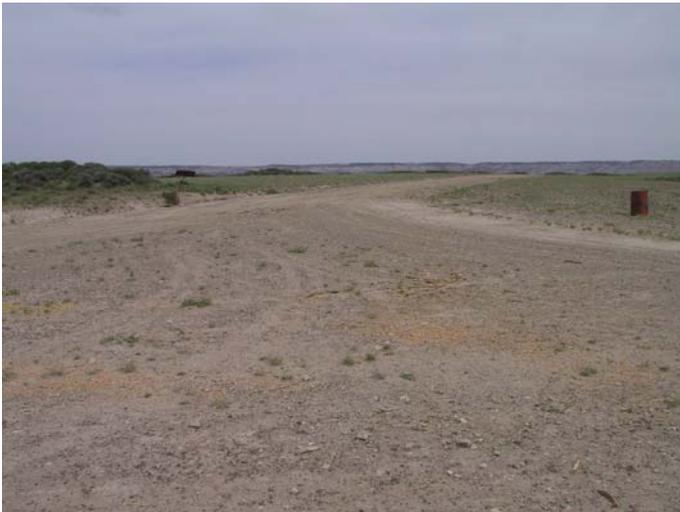
Photo #EMM40-20

Route AT-86 in its best condition. This former gas field access road has been abandoned and is now a useless dead-end route. It is a “temporary intrusion” that requires obliteration, much like Routes AT-1 and AT-3 within Adobe Town WSA.

This improved gravel road accessed now-abandoned wells. It should have been obliterated and revegetated by the lessees upon the abandonment of their wells, but these obligations were not fulfilled. The route currently serves no purpose.

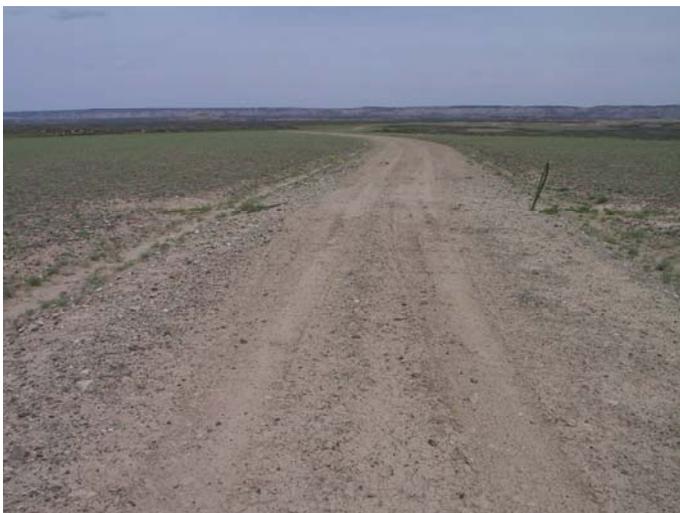
Photo #EMM40-23

Route AT-86 runs north from its junction with AT-27.

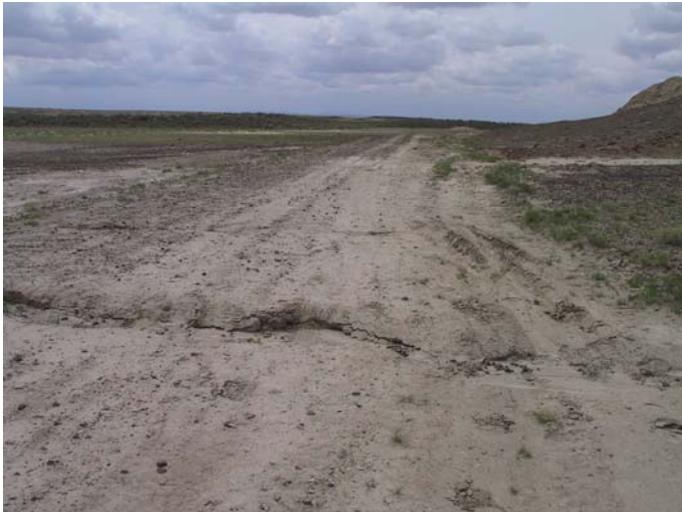
Photo #EMM40-25

View of AT-86 northward from its junction with AT-86A. This view is typical of the early stretches of the route.

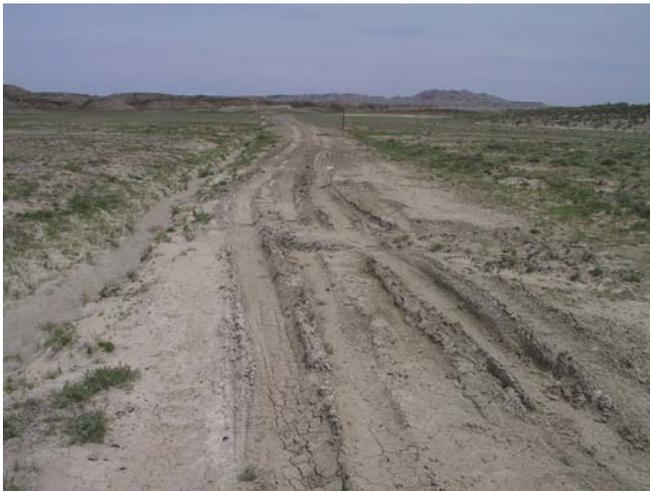
Photo #EMM40-26

Route is in rough condition here.  
4 wheel drive required beyond  
this point.

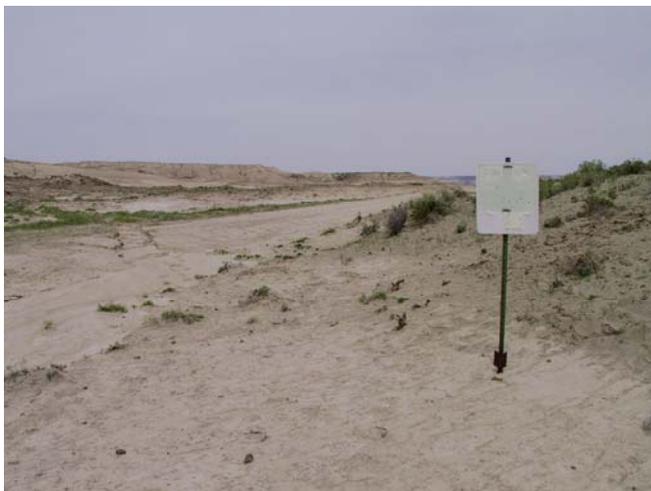
Photo #EMM40-27

Route is now rutted and in poor  
condition.

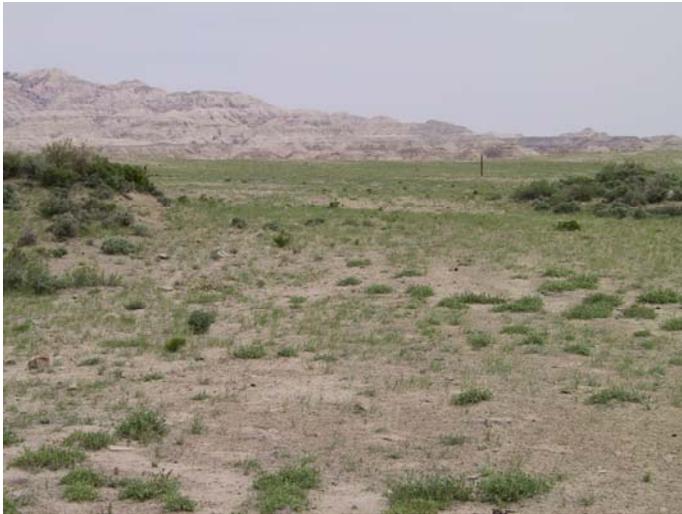
Photo #EMM40-28

Faded sign: "Limited Use Area -  
Vehicles Limited to Designated  
Roads and Trails." Note - without  
identification of which roads and  
trails are "designated," this sign is  
meaningless.

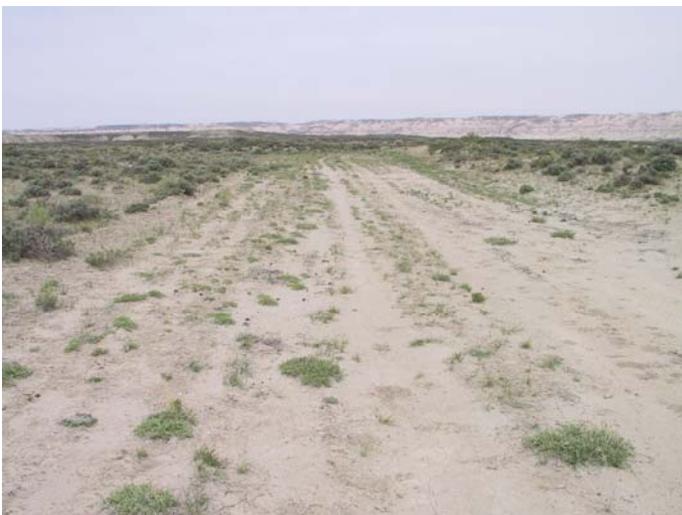
Photo #EMM40-29

This gravel trunk road once served two wells, since plugged and abandoned. The road itself was mechanically obliterated and revegetated, and now is abandoned.

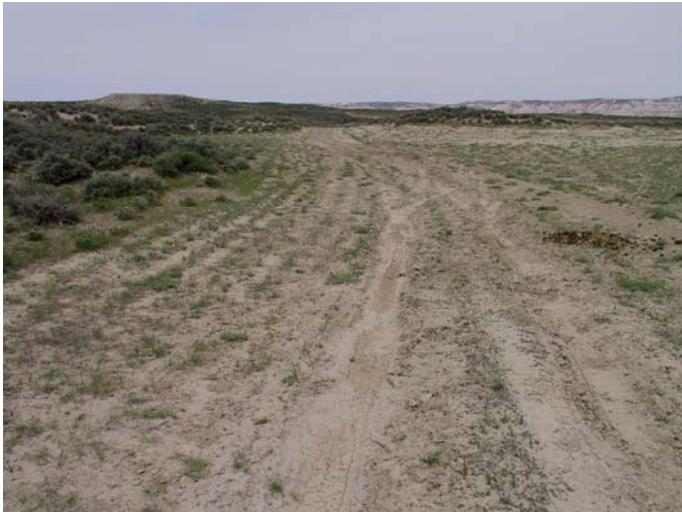
Photo #EMM40-30

Route AT-87 runs northwest from its beginning at the Amoco Willow Reservoir Unit #5.

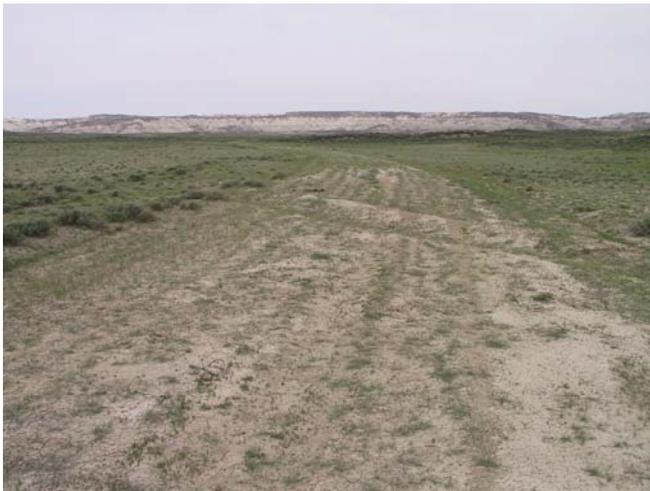
Photo #EMM40-33

Route is very primitive; this is its typical condition beyond Willow Reservoir Unit #5. Very light use.

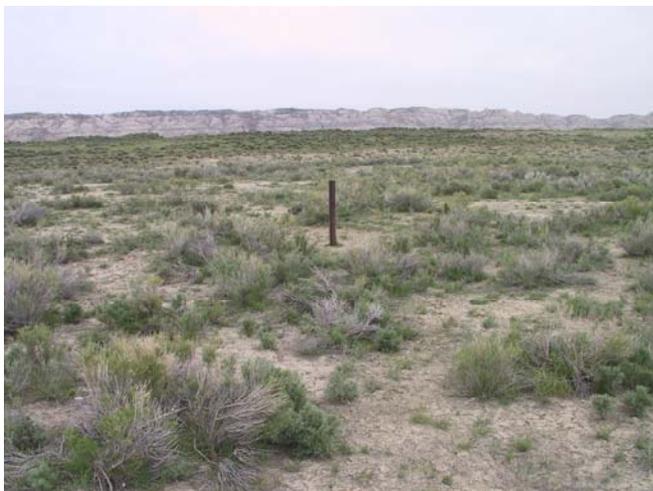
Photo #EMM40-34

Route AT-87, the obliterated and reseeded segment of AT-86, in typical condition. This is a "minor intrusion" rather than a "way."

Typical condition of revegetated route; no use here.

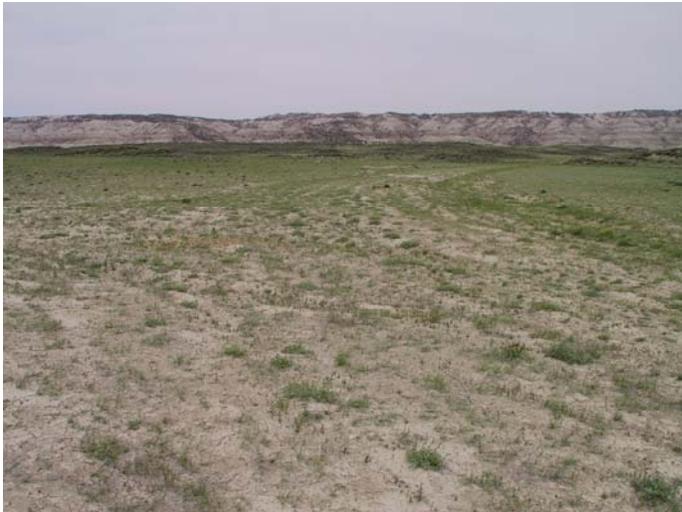
Photo #EMM40-35

Dry hole: Ladd Petroleum, Total Depth 10,040 ft.

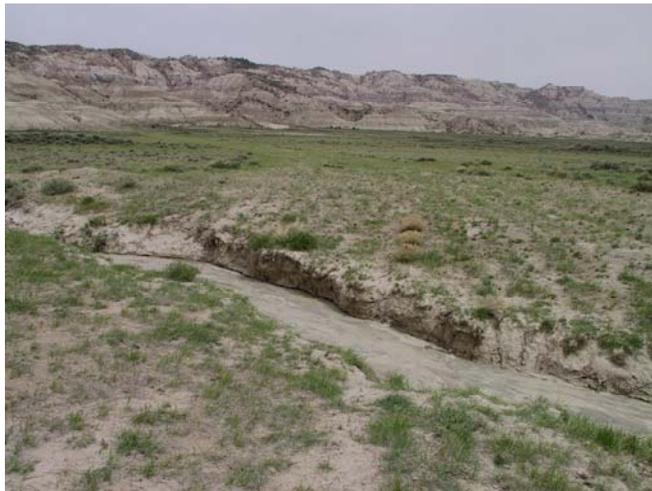
Photo #EMM40-37

Route AT-87 runs north from its junction with revegetation strip AT-90.

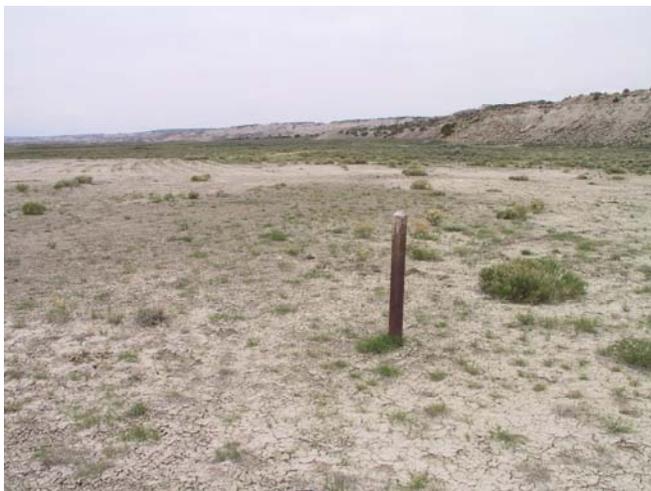
Photo #EMM40-38

Wash crosses route, a vehicular impasse.

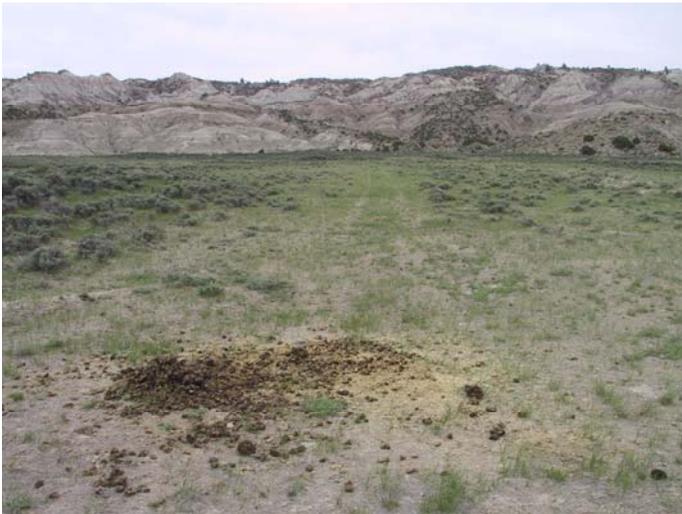
Photo #EMM40-41

This abandoned spur route once accessed a camping spot, now isolated due to the obliteration of AT-87.

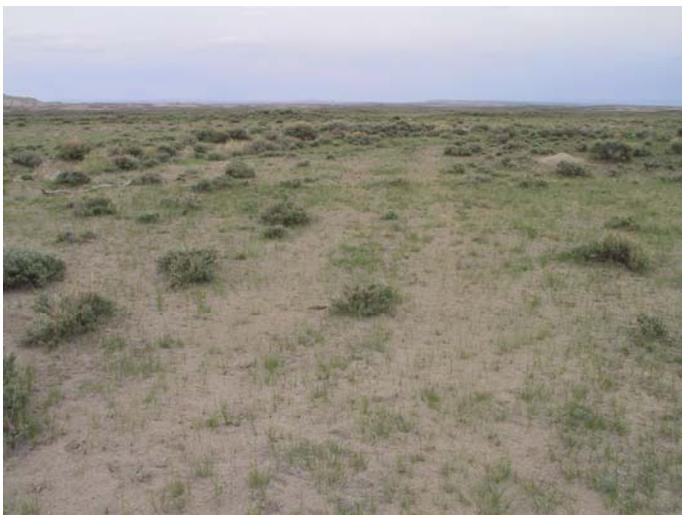
Photo #EMM40-40

Route AT-87A runs north from its  
junction with AT-87.

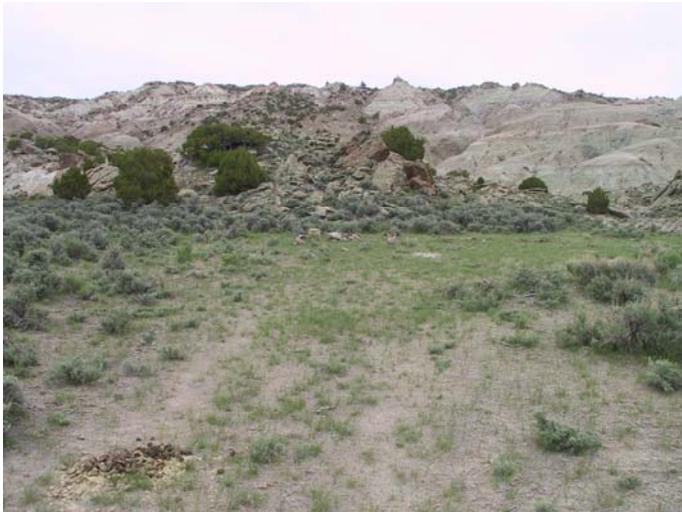
Photo #EMM40-39

Typical view of route.

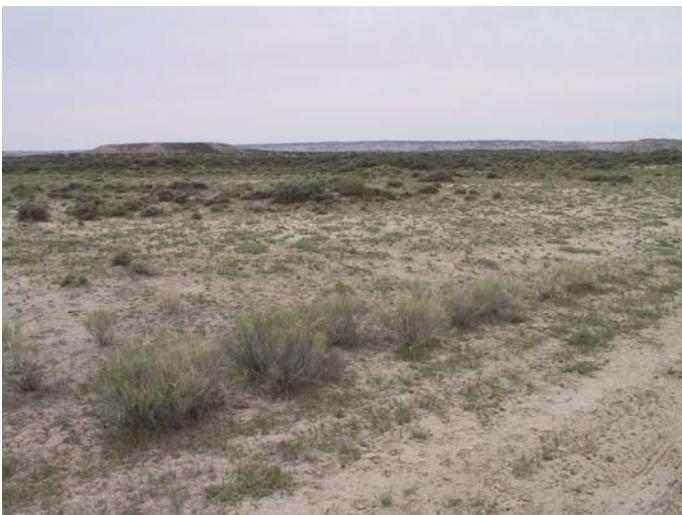
Photo #EMM40-45

This former jeep trail, although shown on the USGS Barrel Springs SW quad, no longer exists on the ground.

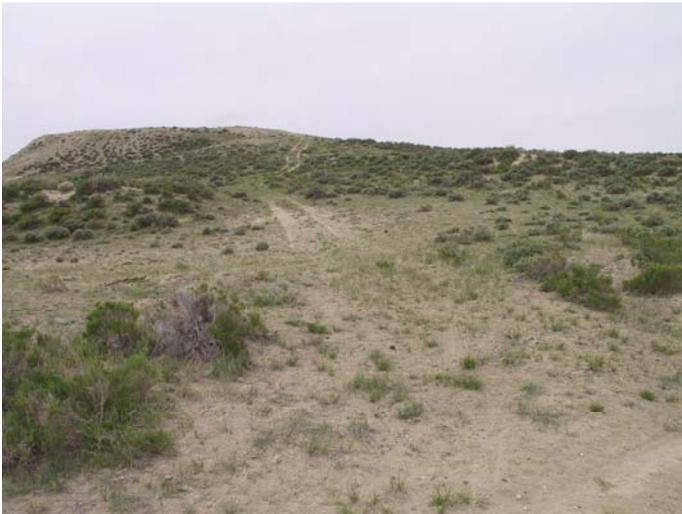
Photo #EMM40-31

This jeep trail climbs over a rise from AT-87.

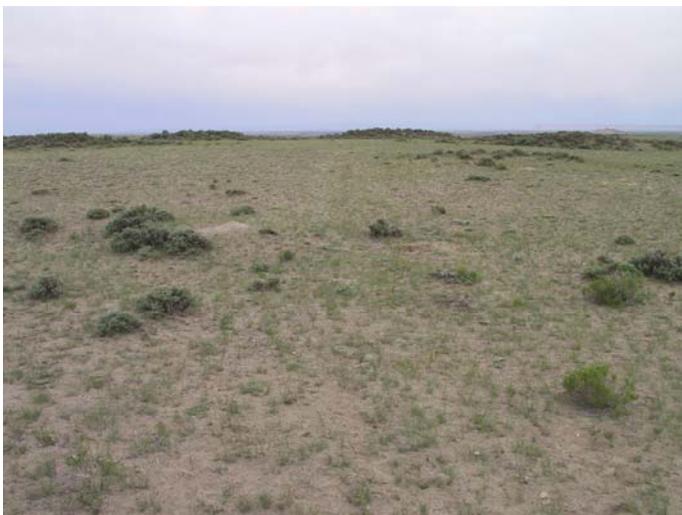
Photo #EMM40-43

Jeep trail AT-89 departs from  
AT-87.

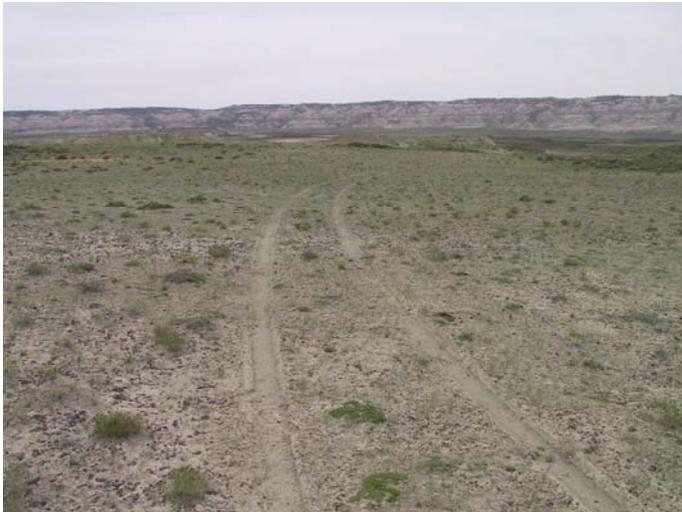
Photo #EMM40-44

Route fades out southbound.

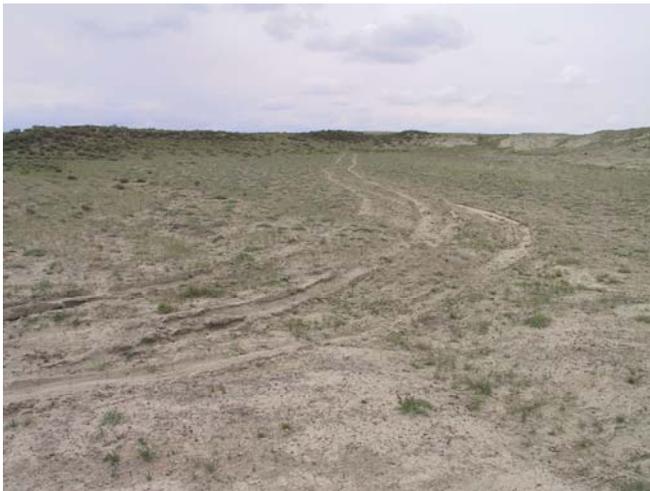
Photo #EMM40-32

Route in its best condition atop  
hill.

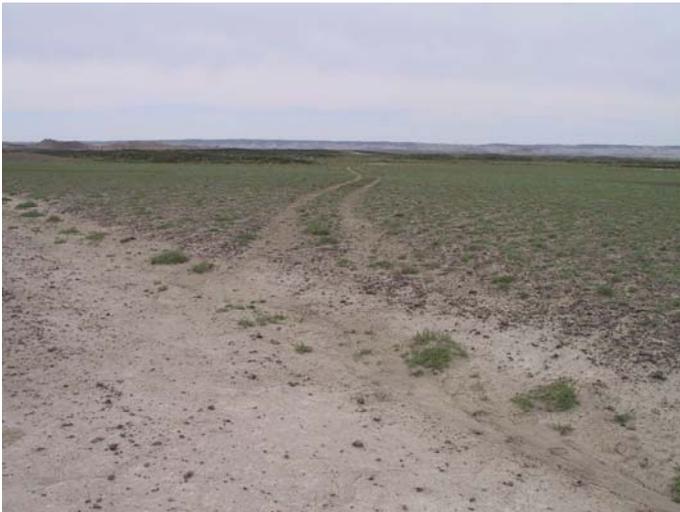
Photo #EMM40-51

This dead-end two-track appears to have no purpose.

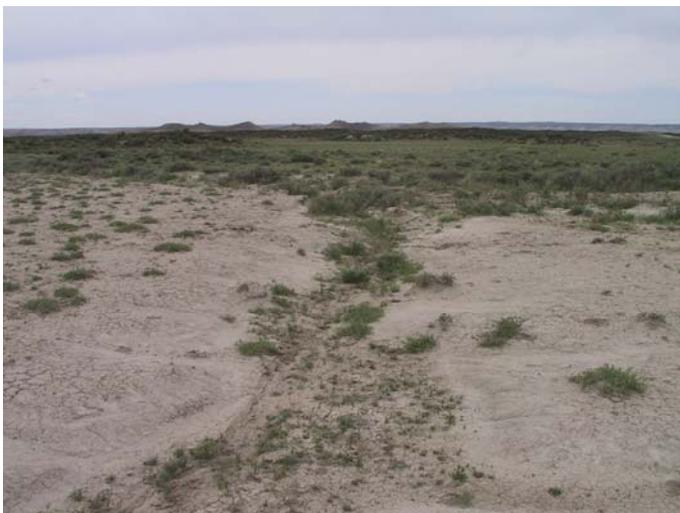
Photo #EMM40-52

Two-track departs northward from  
AT-27.

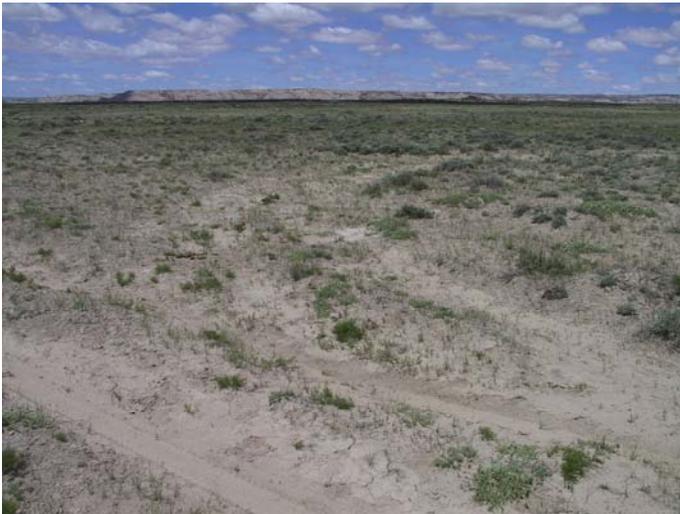
Photo #EMM44-16

This jeep trail, according to the USGS Barrel Springs SW quad, makes a semi-loop around upper West Haystack Creek to rejoin AT-30 east of Manuel Gap. In fact, the route dead ends farther north in the basin. It visits N-T Reservoir early on.

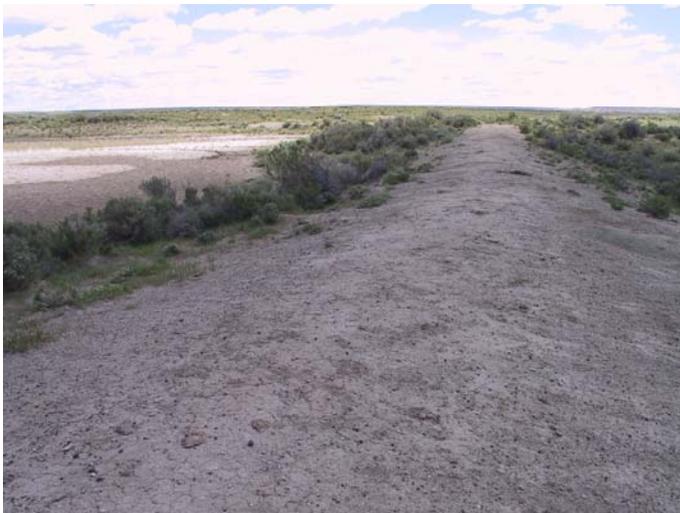
Photo #EMM44-17

Route AT-89B departs northward from AT-30 at the east end of the route. Route is well-reclaimed here.

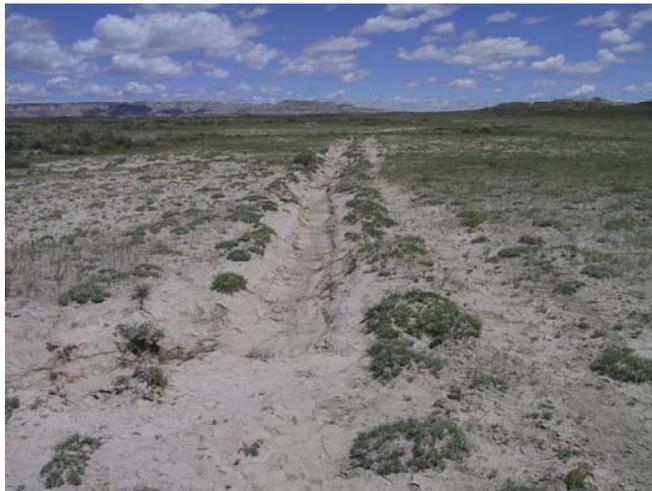
Photo #EMM44-19

Route departs westward from  
N-T Reservoir.

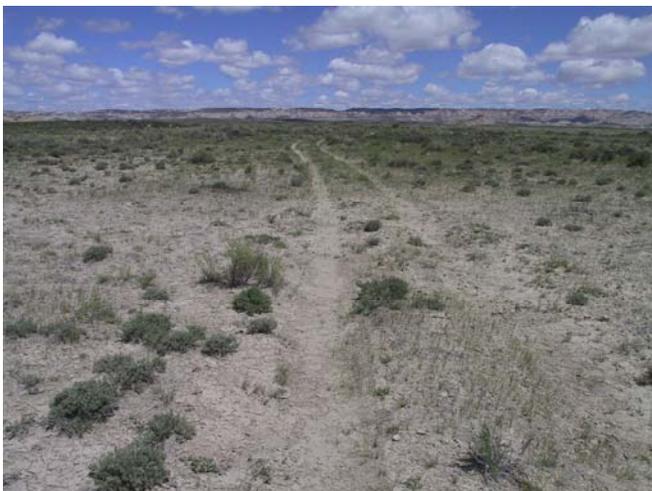
Photo #EMM44-20

Erosion 1½ to 2 feet deep in one  
track.

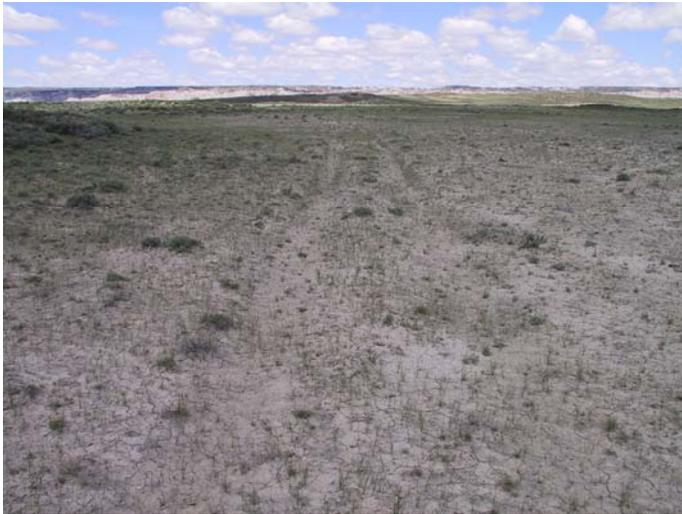
Photo #EMM44-21

Typical view of AT-89B. This two-track was never constructed or maintained, and receives no use beyond N-T Reservoir. It is a “way” that is rapidly deteriorating.

Typical condition of Route  
AT-89B.

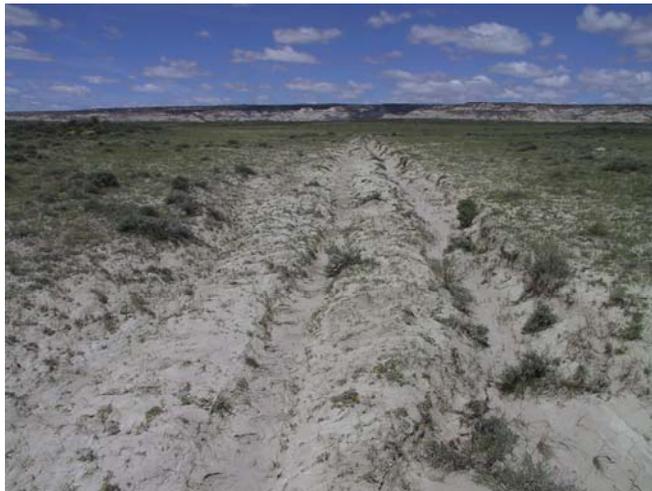
Photo #EMM44-22

Route is well-reclaimed. This view is ear the abandoned mapped route that loops back to AT-30 (no wash crossing is available to reach it). No use.

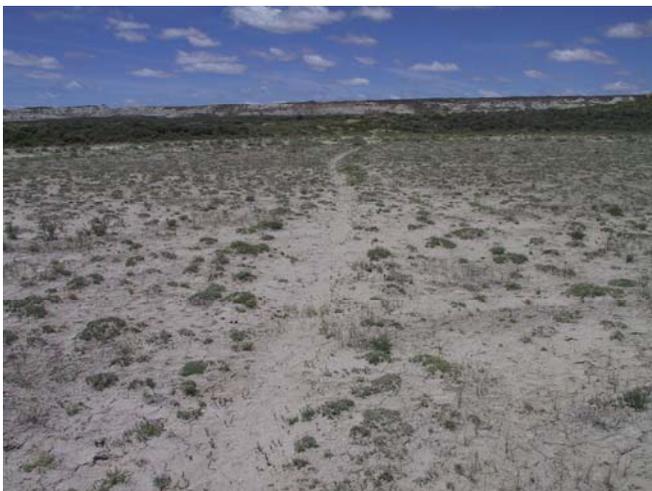
Photo #EMM44-23

Route is deeply eroded here.

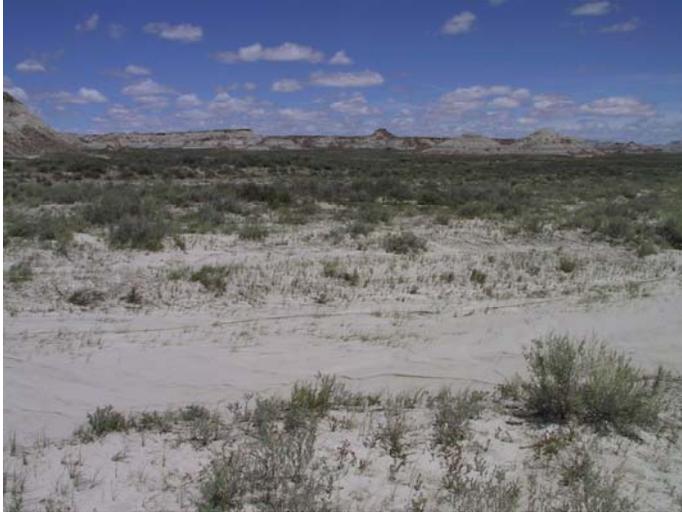
Photo #EMM44-24

Route fades out and becomes a wild horse trail.

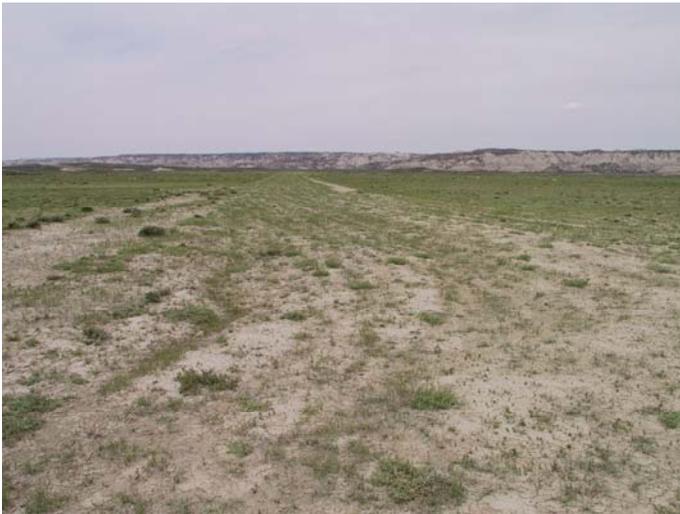
Photo #EMM40-36

This abandoned and reclaimed road served a plugged and abandoned well.

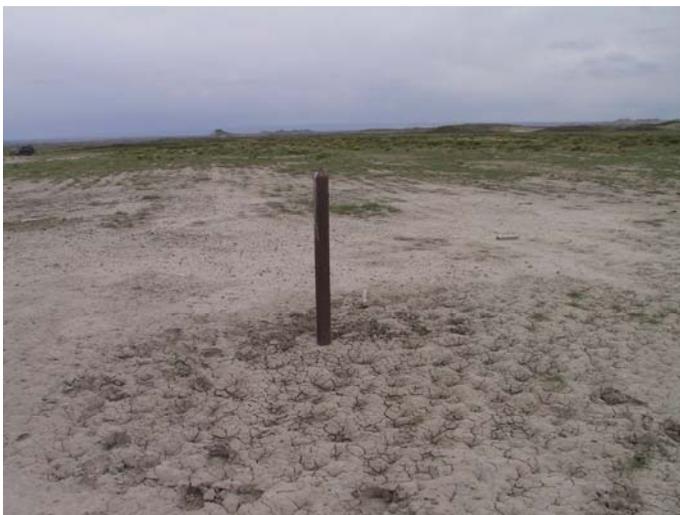
Photo #EMM40-42

Revegetation strip AT-90 runs  
west from its junction with  
AT-87.

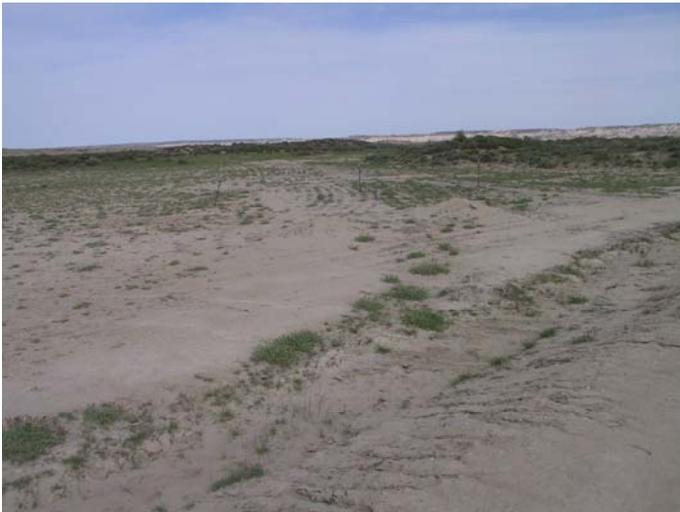
Photo #EMM40-1

Revegetated Route AT-91 departs from AT-85. Sign reads, "No Unauthorized personnel Construction in Progress."

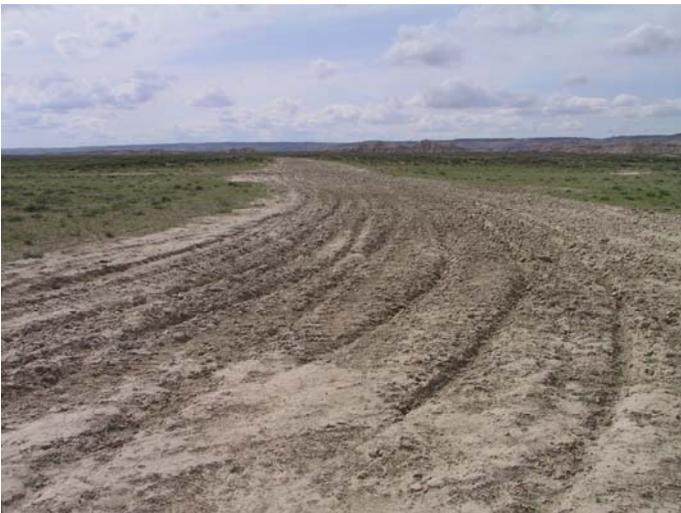
Photo #EMM39-88

Reclaimed route runs west from  
AT-85.

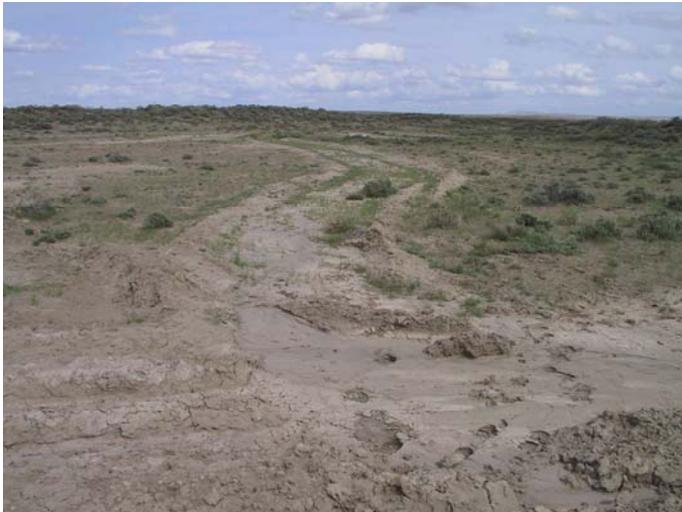
Photo #EMM39-91

Water-control blading to east approximately 10m long.

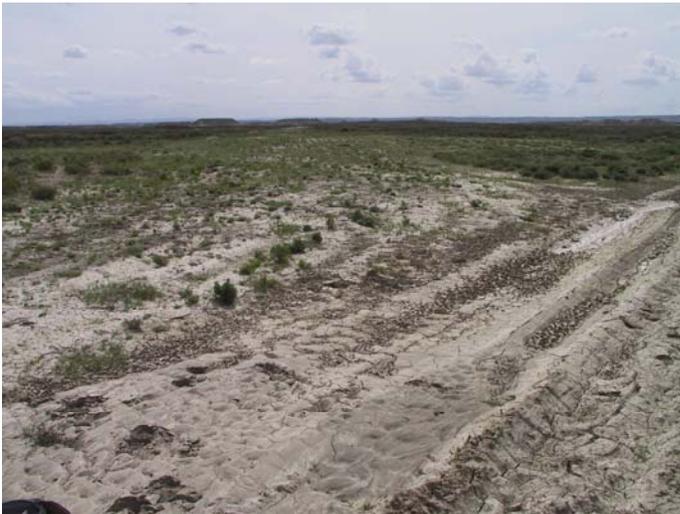
Photo #EMM39-90

Older revegetation strip, predating  
AT-92, departs to the southwest.

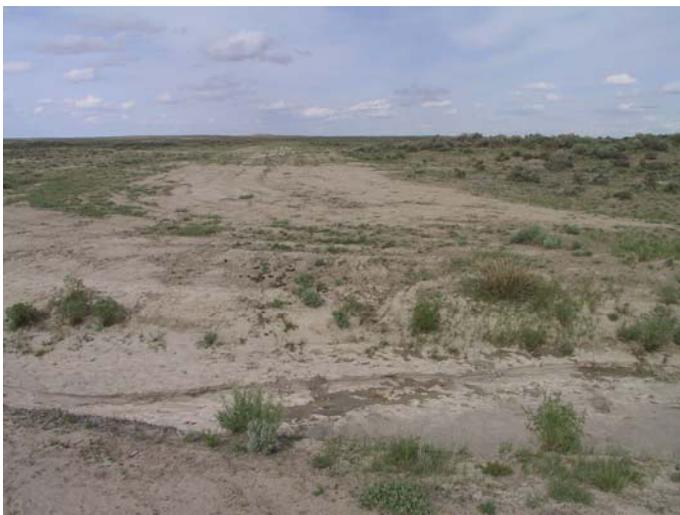
Photo #EMM39-99

Wash crossing. Difficult or  
impassable for vehicles.
