**BLM Unit Identification:** Adobe Town WY-030-401 and WY-040-408

**Description** Adobe Town is proposed by the conservation community for wilderness designation. The area proposed for wilderness includes all of the Adobe Town Wilderness Study Area, plus additional lands of wilderness quality in The Haystacks, along Willow Creek and the Willow Creek Rim, and south of the WSA to the Powder Rim and just beyond it. All of these areas possess the full complement of required characteristics for wilderness in abundance: outstanding opportunities for both solitude *and* primitive and unconfined recreation, wilderness-quality naturalness, size (at over 180,000 acres, the citizens proposed Adobe Town wilderness is well above the 5,000-acre minimum), and in addition has outstanding supplemental values such as abundant wildlife, wild horse herds, unique geology, and abundant archaeological and paleontological resources.

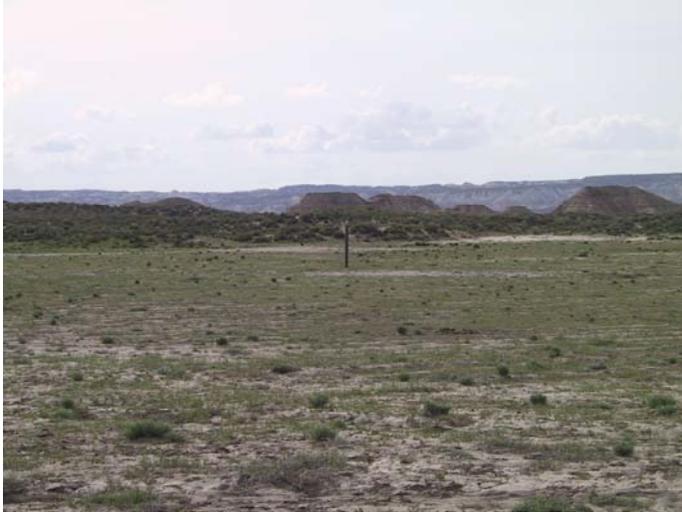
Photo #EMM39-98

Looking back along reclaimed route from the well pad at its end.

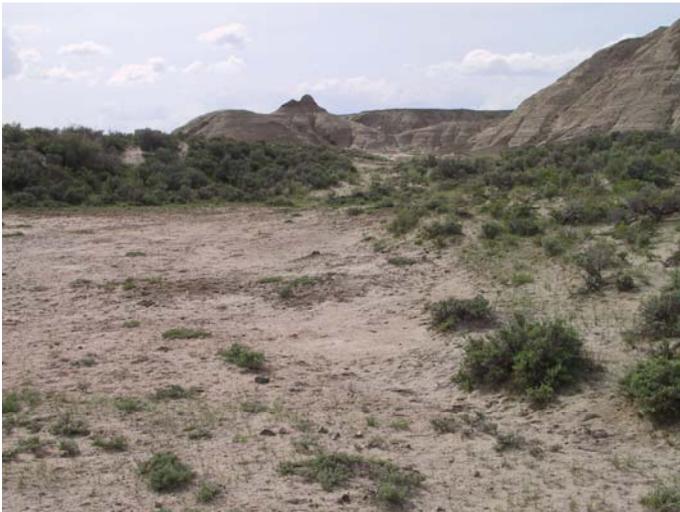
Photo #EMM39-93

Old jeep trail departs westward  
from AT-92.

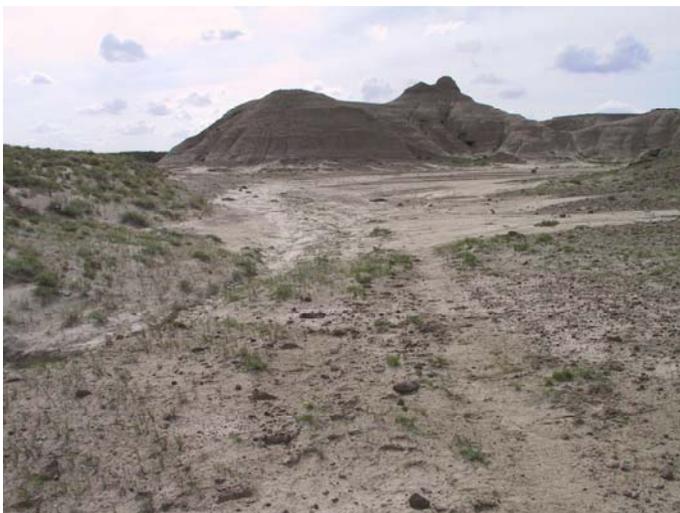
Photo #EMM39-94

View typical of route.

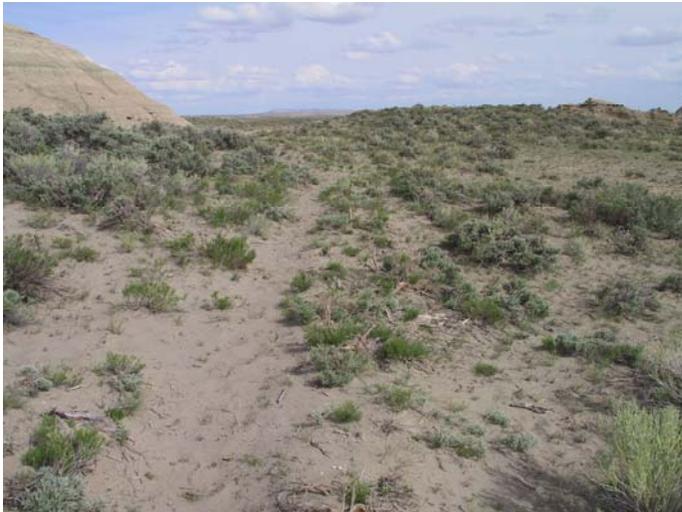
Photo #EMM39-95

Occasional traces remain of the route. View east from its end.

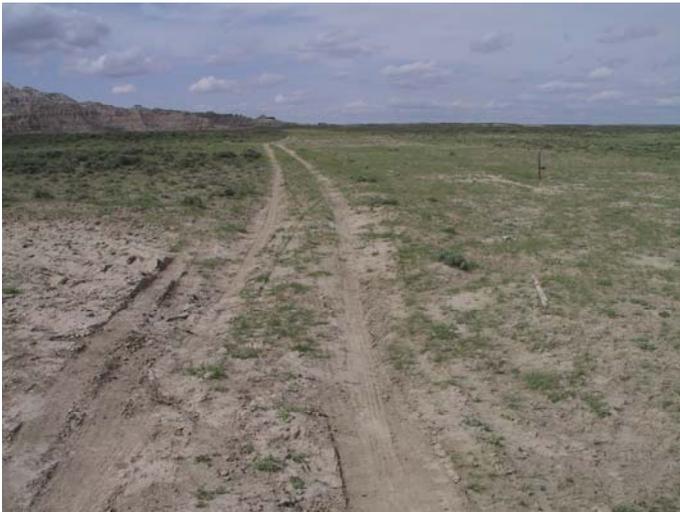
Photo #EMM39-87

Unimproved route and pipeline AT-95 run north from the end of AT-85.

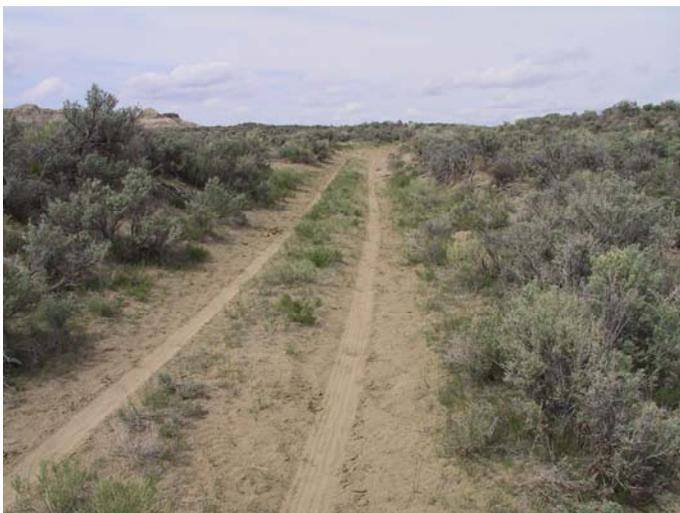
Photo #EMM39-83

View north from junction with AT-95A. This view is typical for the route; pipeline is just to the east.

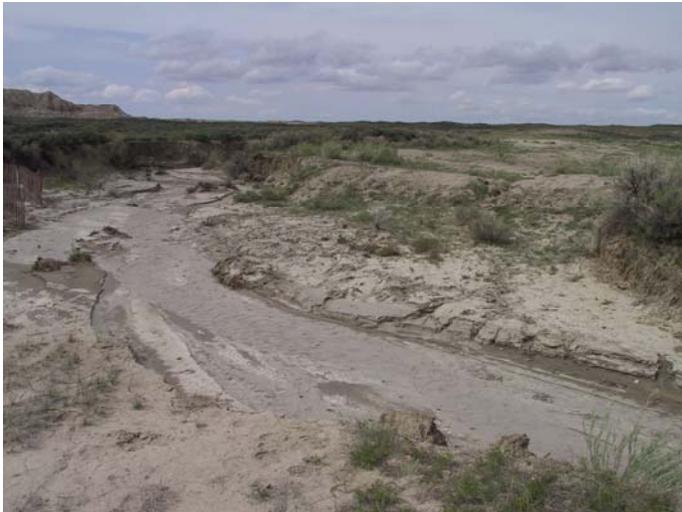
Photo #EMM39-82

Pipeline right of way crosses wash; no sign of pipe.

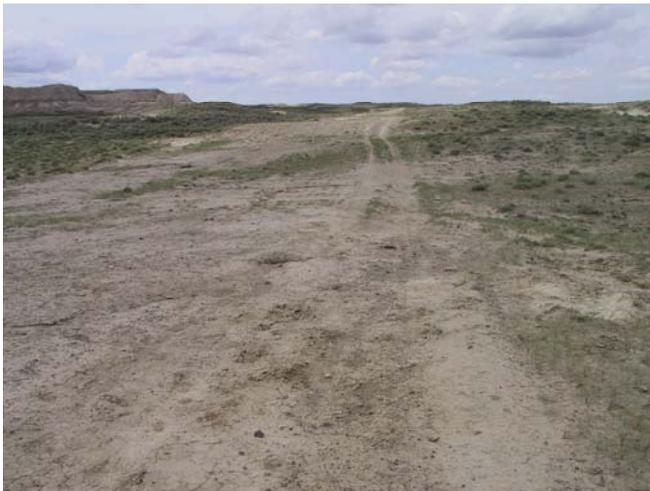
Photo #EMM39-81

Typical condition of route and pipeline along this stretch.

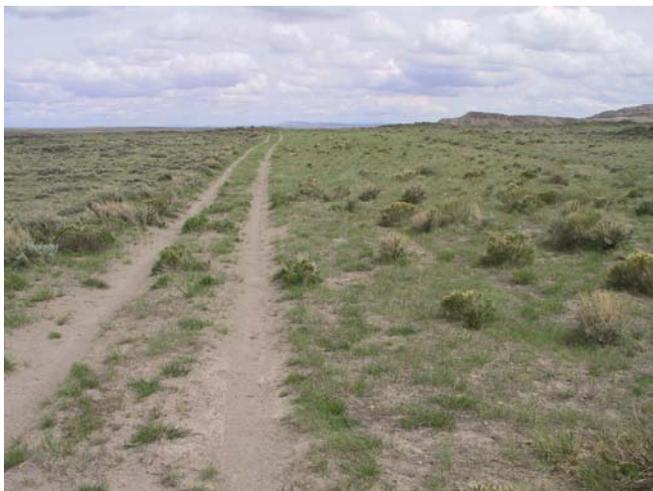
Photo #EMM39-78

Route and pipeline in typical condition.

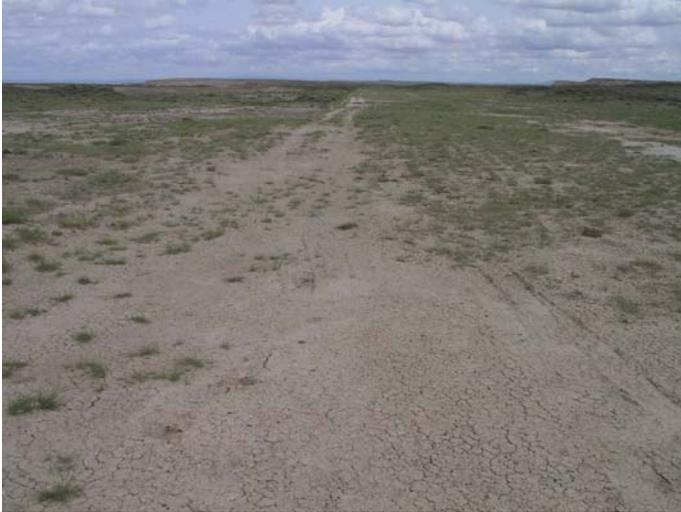
Photo #EMM39-77

Route AT-95 runs southeast from  
its junction with Pipeline AT-97.

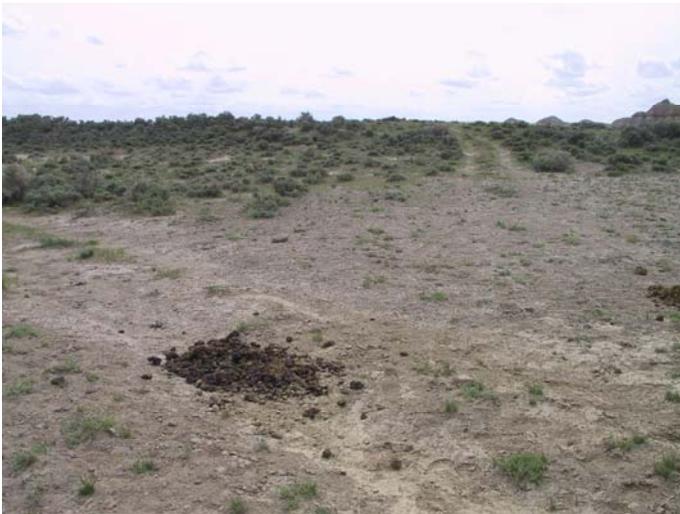
Photo #EMM39-84

Unimproved route runs southwest  
from AT-95.

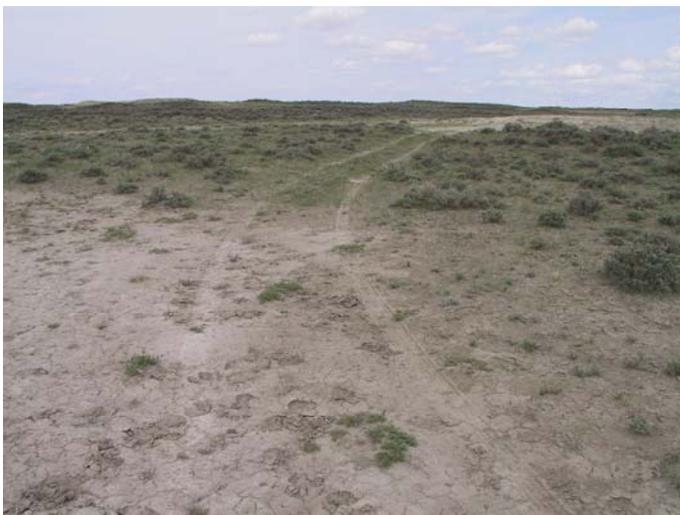
Photo #EMM39-86

View northeast along AT-95A  
from the end of the route.

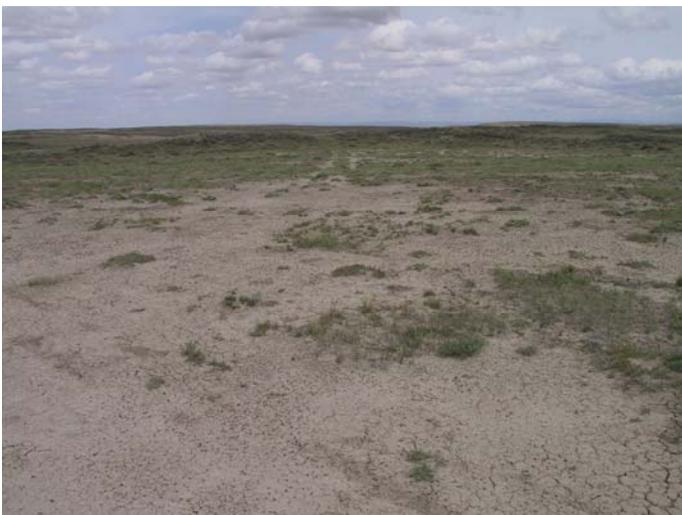
Photo #EMM39-72

View east from the cutoff to  
AT-96.

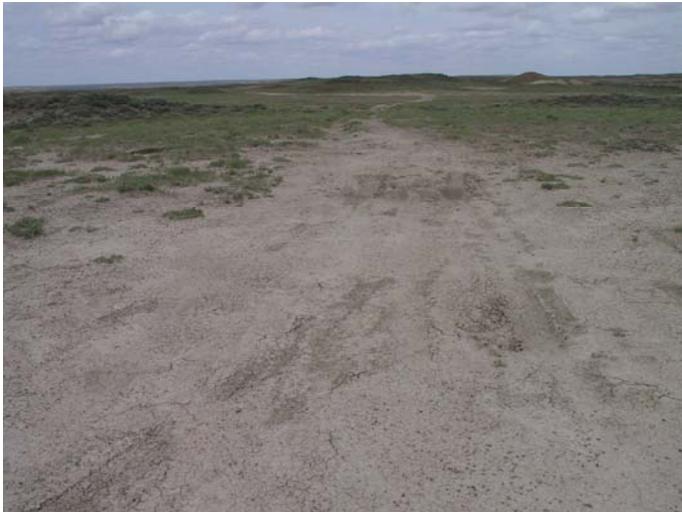
Photo #EMM39-71

Cutoff route runs north from  
AT-96 to AT-95.

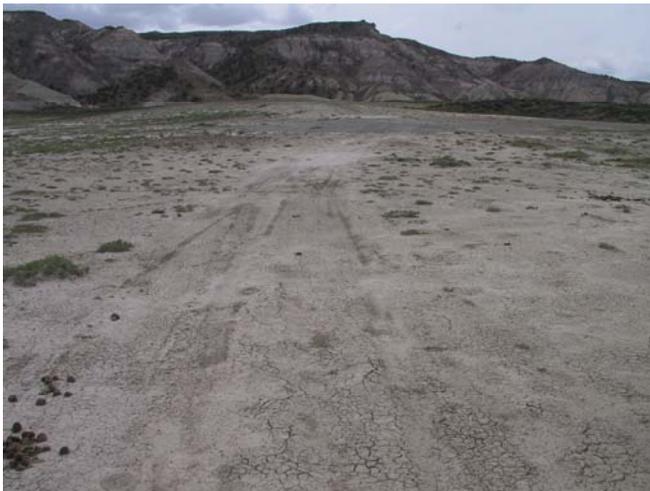
Photo #EMM39-73

Illegal user-created trail on bad-  
lands near junction.

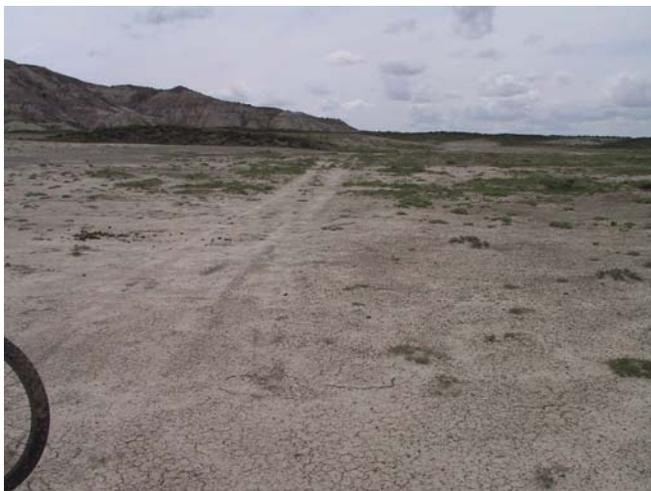
Photo #EMM39-74

Route runs west from cutoff to  
AT-95.

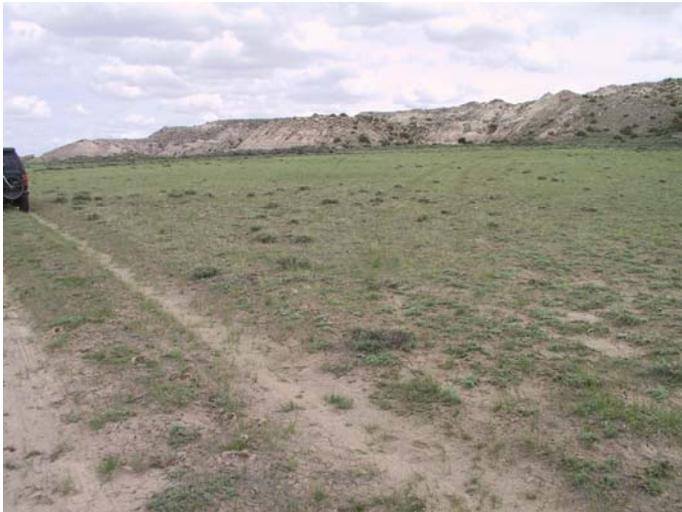
Photo #EMM39-70

Long-reclaimed two-track (at right) runs southeast from AT-96.

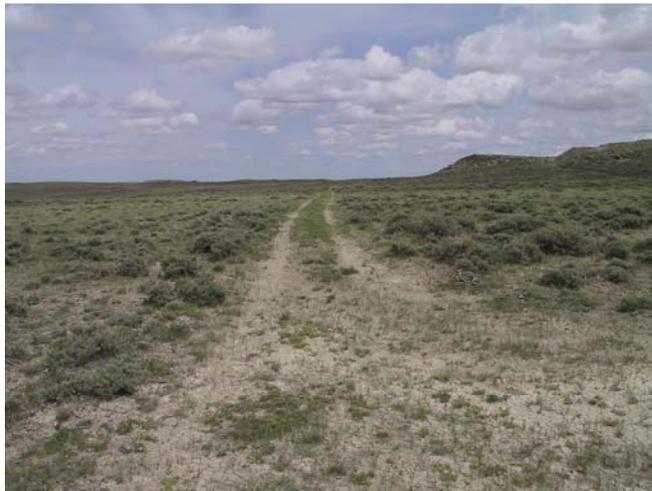
Photo #EMM39-69

Typical view of this segment of the route.

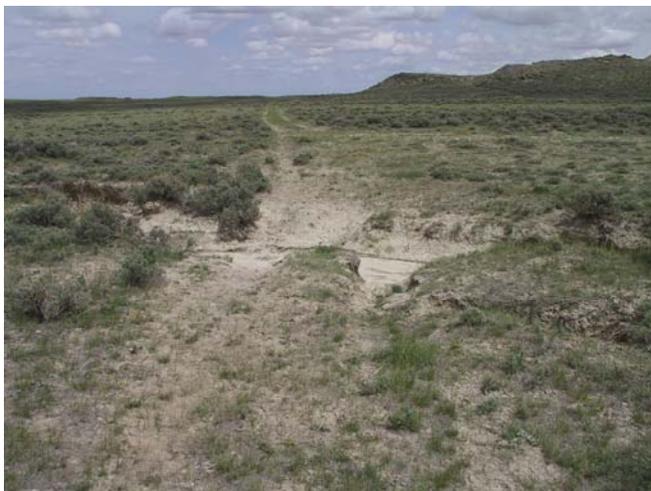
Photo #EMM39-68

Impasse at wash crossing.

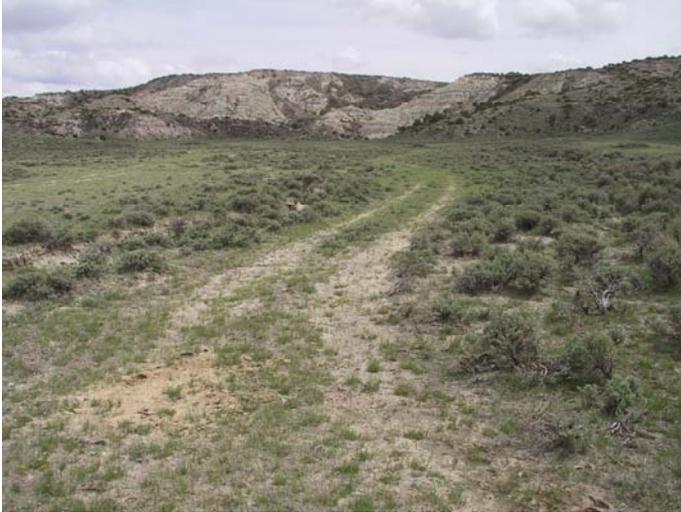
Photo #EMM39-67

Long drive-around runs south to the base of the Haystacks to avoid impassable wash.

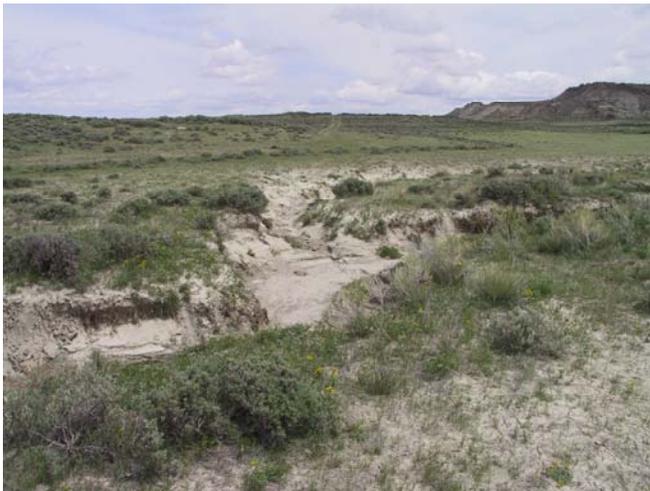
Photo #EMM39-50

Impasse at wash crossing. Bypass route is farther north.

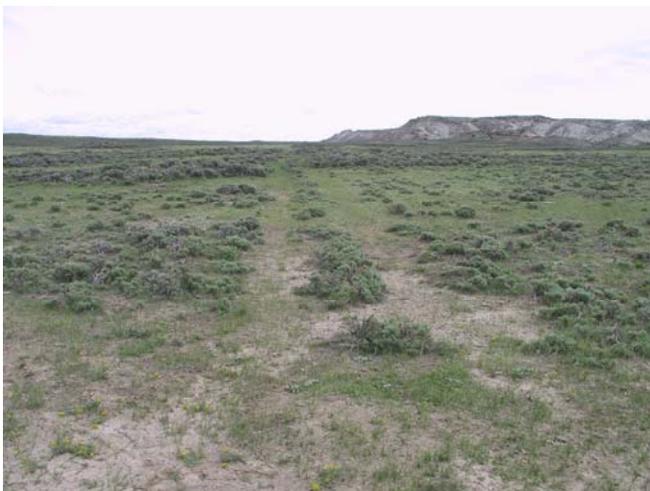
Photo #EMM39-37

Old AT-96 runs east from junction with AT-102 toward impassable wash crossing. It receives no use.

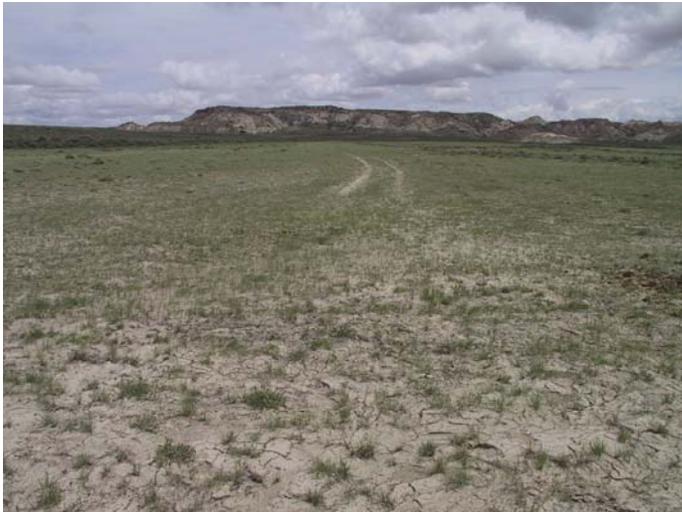
Photo #EMM39-52

AT-96 bypass route runs east  
from AT-102.

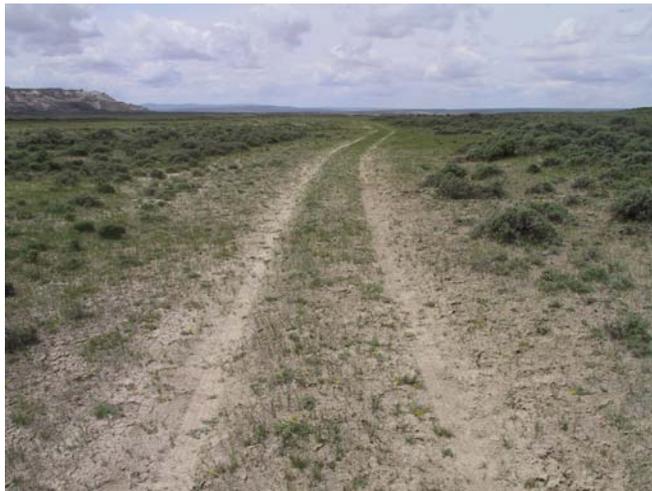
Photo #EMM39-53

View west on AT-96 bypass from  
junction with original AT-96  
route.

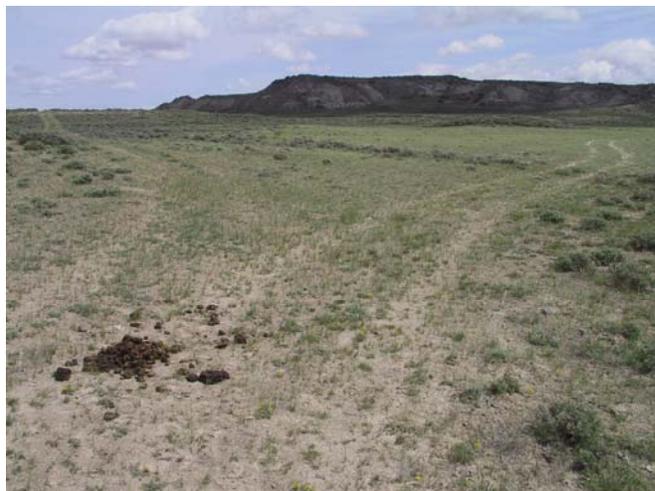
Photo #EMM39-54

Junction of AT-96 (at left) with  
AT-99.

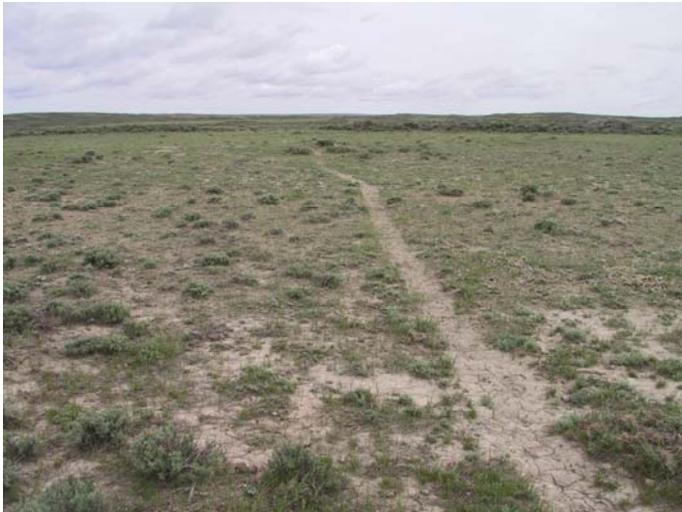
Photo #EMM39-16

Route ahead disappears, becoming a wild horse trail.

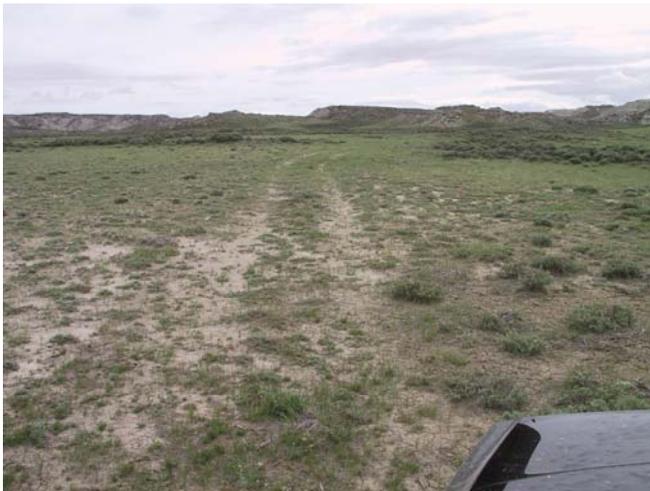
Photo #EMM39-17

Bypass route to east becomes main AT-96 track.

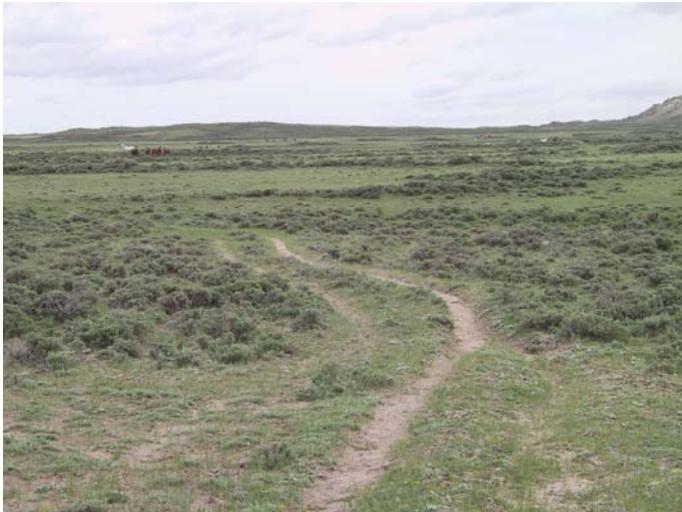
Photo #EMM39-14

Route AT-96  
UTM 0729557 4587310  
5/17/01

Abandoned jeep trail joins from the west. It receives no use. Possibly an old seismograph trail.

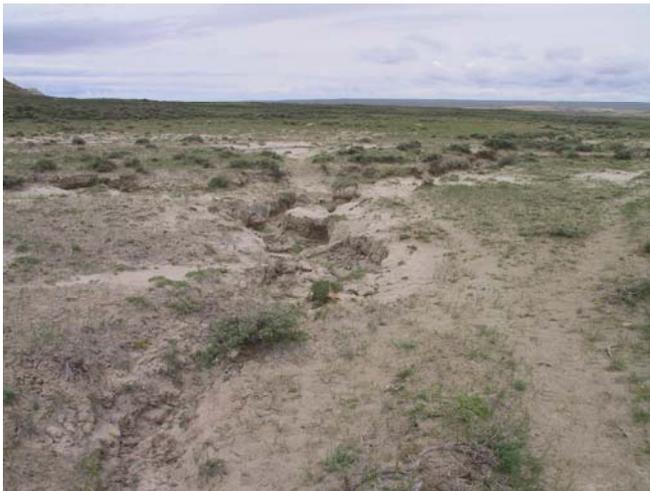
Photo #EMM39-12

Route AT-96  
UTM 0729481 4587225  
5/16/01

View east on AT-96 from its  
junction with AT-104.

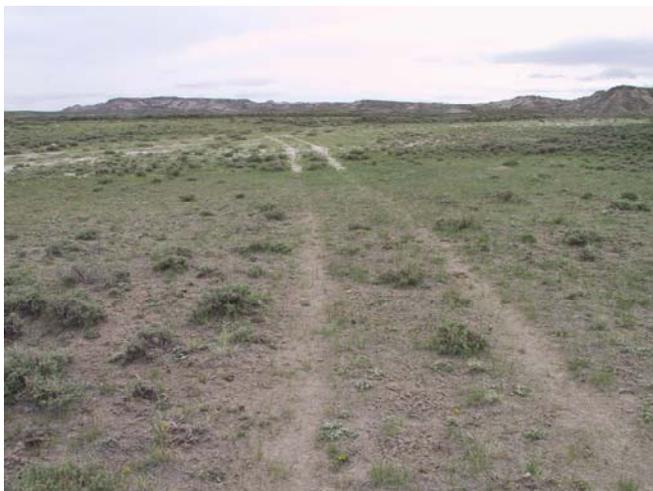
Photo #EMM39-11

Route AT-96  
UTM 0728799 4587315  
5/16/01

Impasse with long drive-around to  
the south.

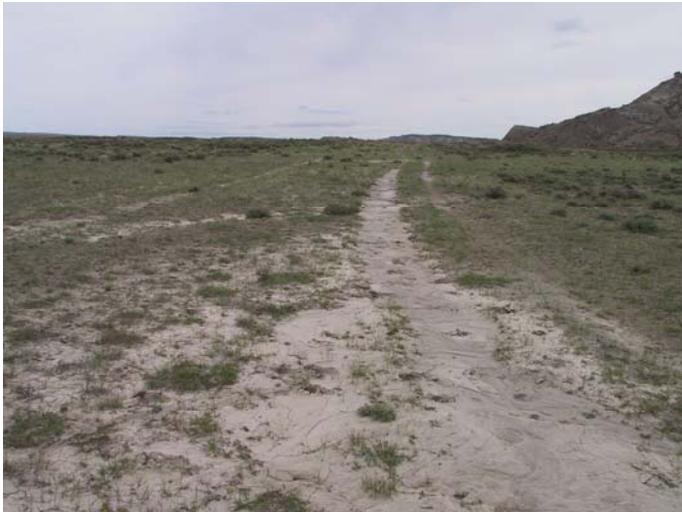
Photo #EMM39-10

Route AT-96  
UTM 0728585 4587361  
5/17/01

Route typical for this segment.

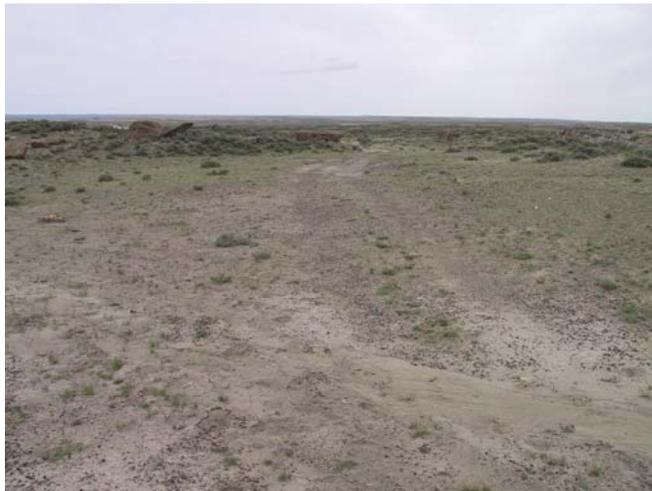
Photo #EMM39-6

Route AT-96  
UTM 0726700 4587188  
5/16/01

Route AT-96 joins Pipeline  
AT-97 right of way briefly.

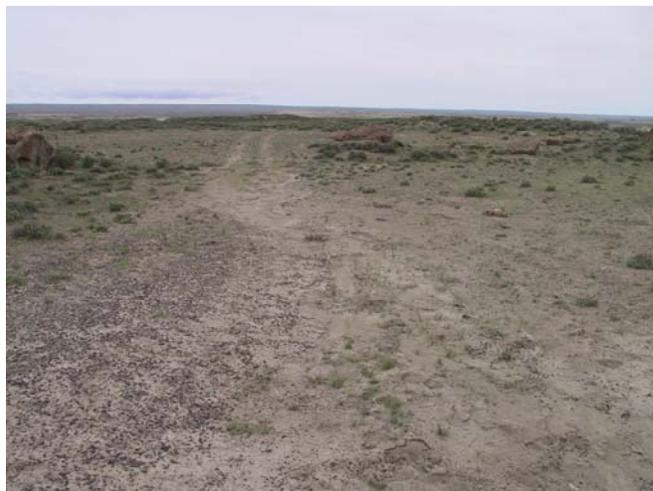
Photo #EMM39-7

Route AT-96  
UTM 0726060 4586769  
5/16/01

Route splits near pipeline, view  
northeast on main leg of AT-96.

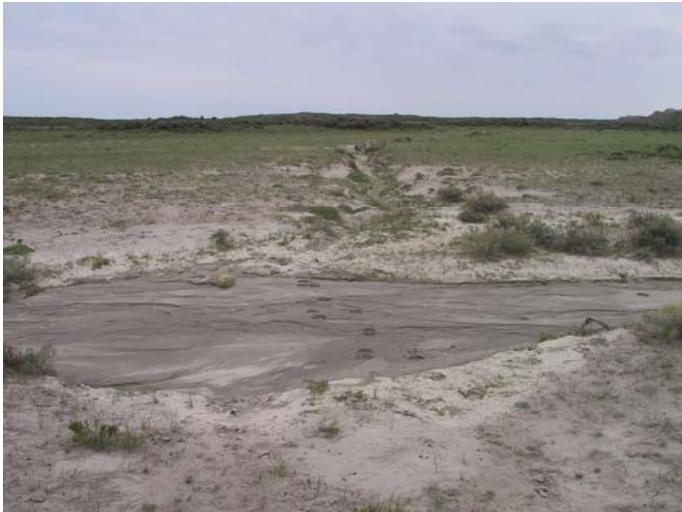
Photo #EMM39-3

Route AT-96  
UTM 0726060 4586769  
5/16/01

Cutoff route to pipeline AT-97.  
Very light use.

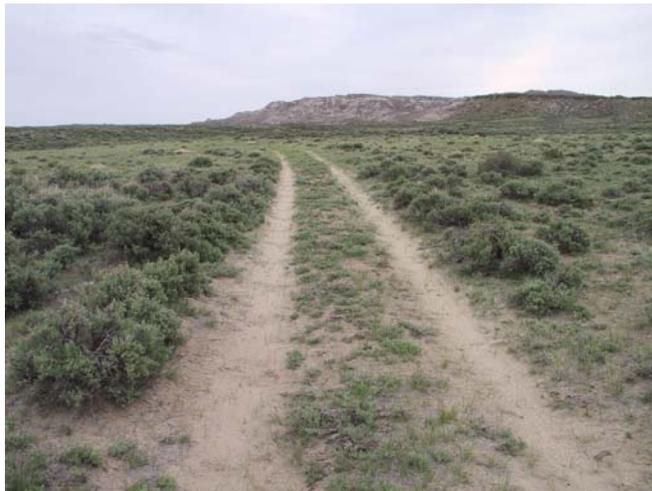
Photo #EMM39-2

Route AT-96  
UTM 0725421 4585252  
5/16/01

Difficult crossing due to erosion  
beyond wash.

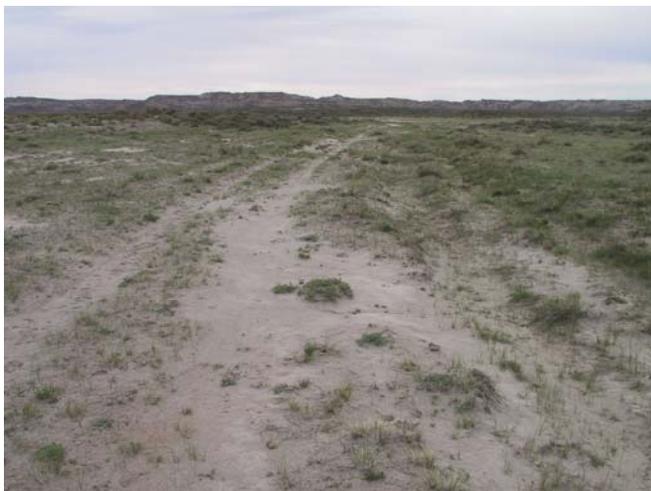
Photo #EMM39-1

Route AT-96  
UTM 0724636 4584087  
5/16/01

Route in its best condition.

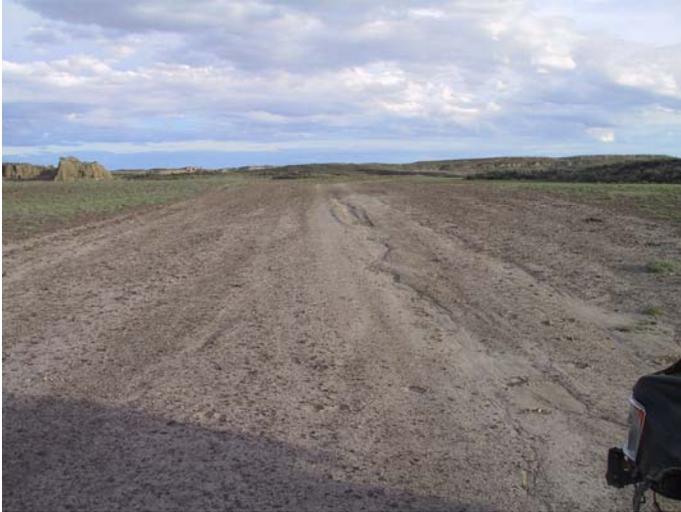
Photo #EMM38-51

Route AT-96  
UTM 0721824 4582602  
5/16/01

Erosion with drive-around route  
now follows Pipeline AT-97.

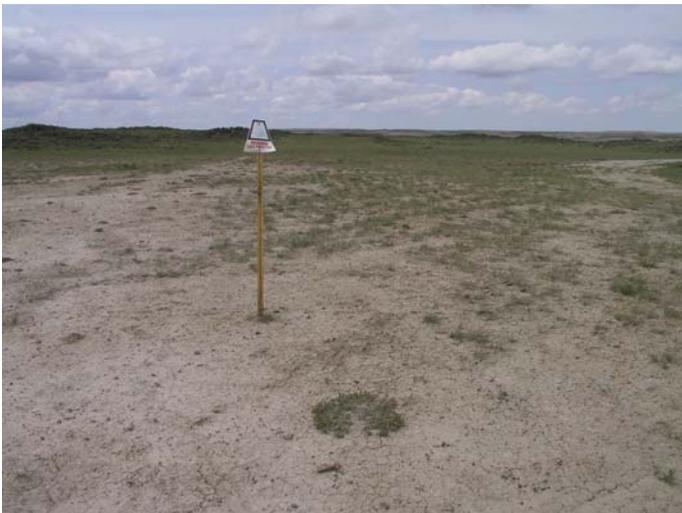
Photo #EMM39-75

Constructed.  
Not maintained.  
50 feet wide right-of-way.  
Not driveable.  
In use.

This pipeline arcs north of The Haystacks. It forms the north boundary of the proposed Adobe Town WSA expansion..

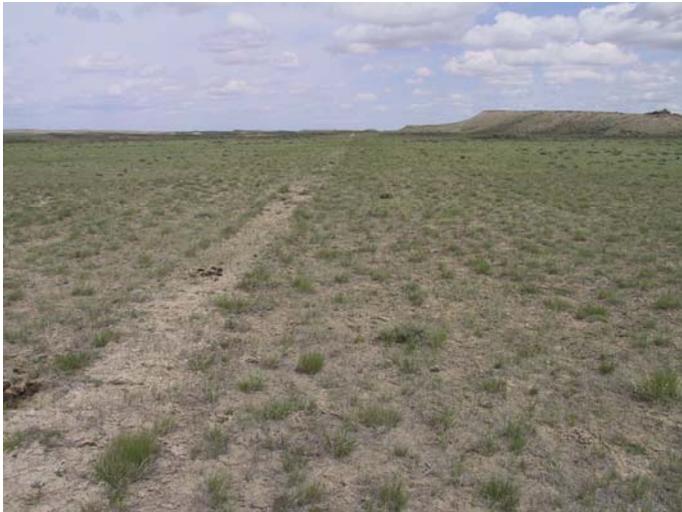
Photo #EMM39-65

Rt. AT-97  
UTM 0737067 4589931  
5/16/01

View west along pipeline from its  
junction with Route AT-95.

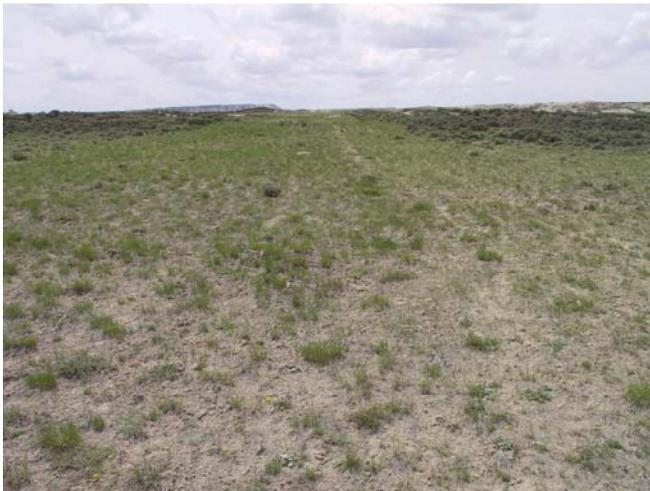
Photo #EMM39-66

Route AT-97  
UTM 0733066 4590193  
5/16/01

Pipeline runs east from its  
junction with AT-98.

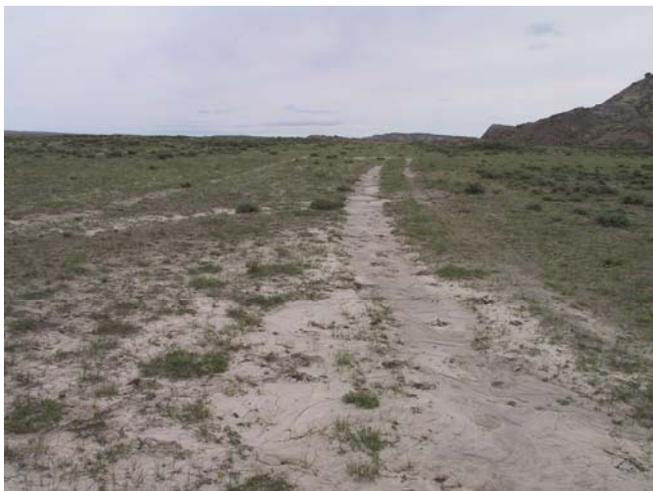
Photo #EMM39-10

Route AT-97  
UTM 0733066 4590193  
5/16/01

Pipeline runs west from its  
junction with AT-98.

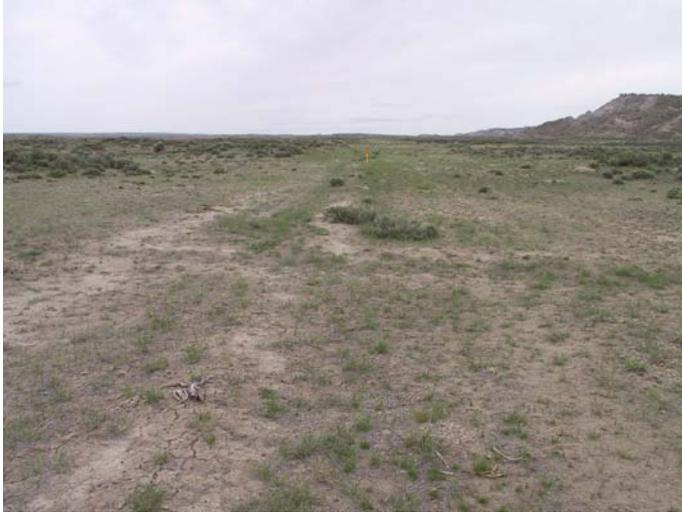
Photo #EMM39-9

Route AT-97  
UTM 0726700 4587188  
5/17/01

Pipeline runs in tandem with route  
AT-96.

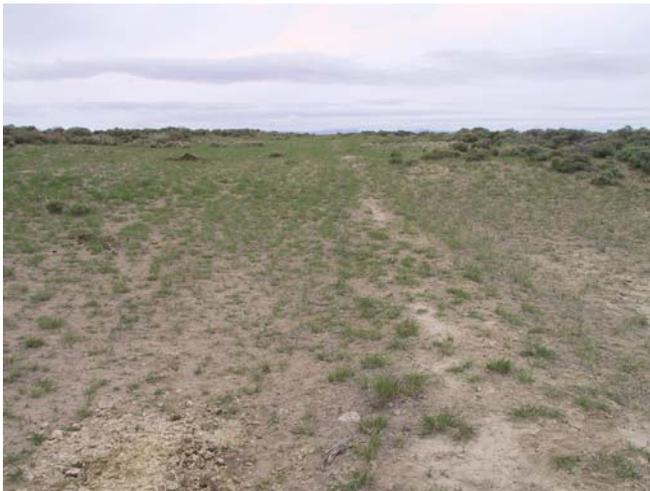
Photo #EMM39-8

Route AT-97

Pipeline runs east in tandem with  
Route AT-96.

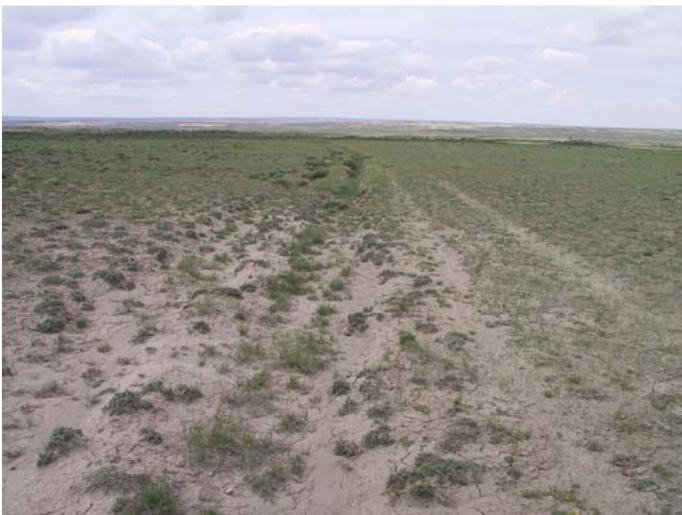
Photo #EMM39-64

Not constructed.  
Not maintained.  
6 feet wide.  
4 wheel drive.  
Very light use.

This jeep trail runs south to a camping site at the base of the Haystacks.

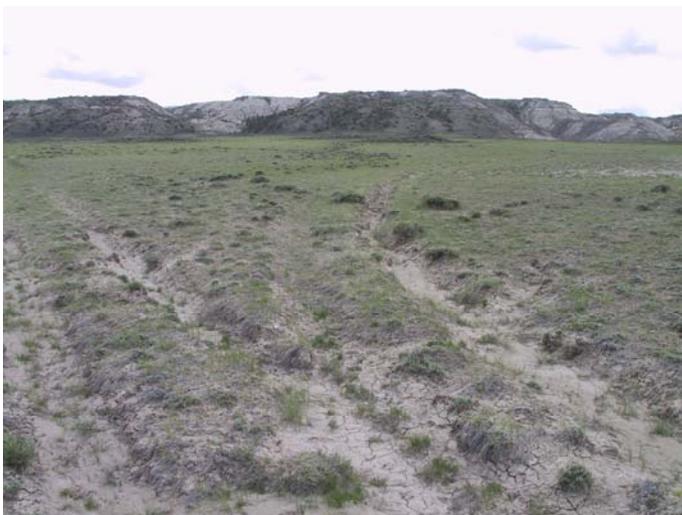
Photo #EMM39-63

Route AT-98  
UTM 0733253 4589742  
5/16/01

Route is eroded and deeply rutted.  
Double trailing.

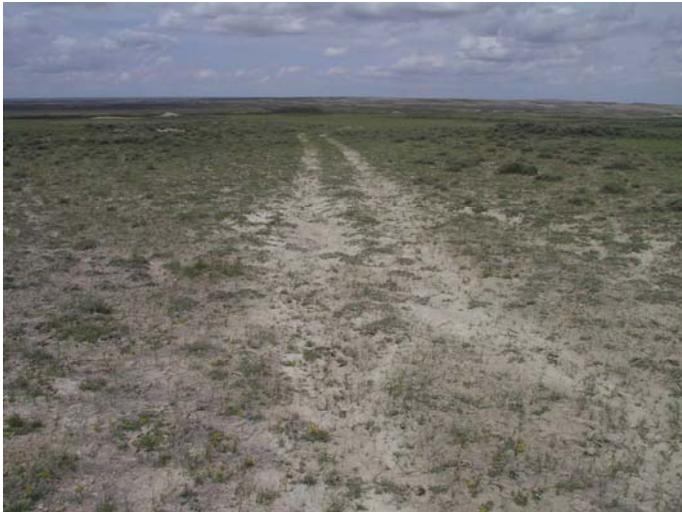
Photo #EMM39-60

Route AT-98  
UTM 0733253 4589742  
5/16/01

Abandoned and eroded route  
swings west. No use.

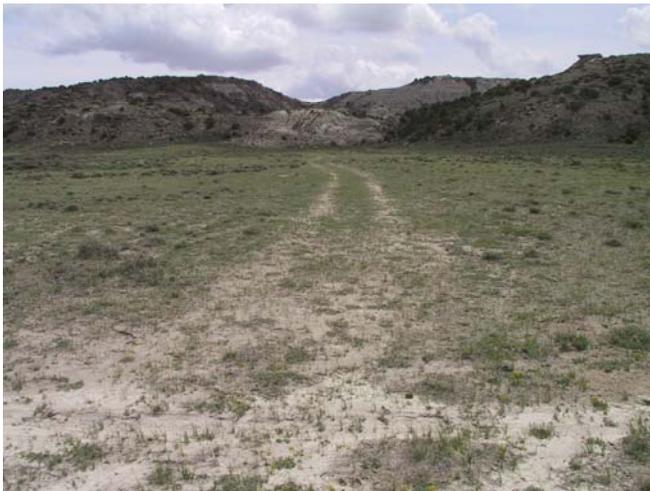
Photo #EMM39-61

Route AT-98  
UTM 0733248 4589122  
5/16/01

View north along AT-98 from its junction with AT-96.

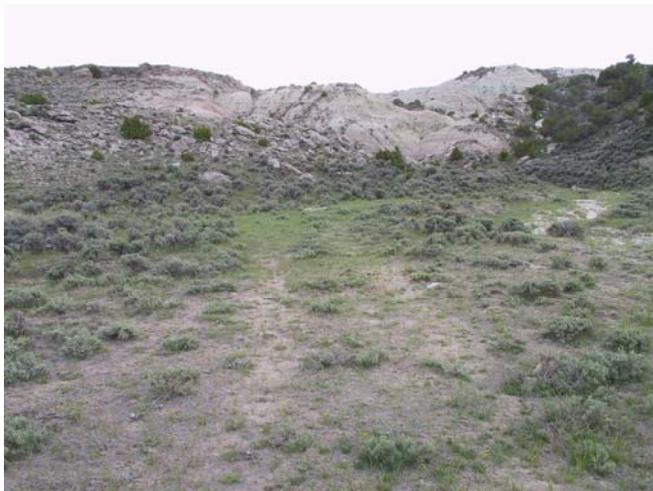
Photo #EMM39-62

Route AT-98  
UTM 0733248 4589122  
5/16/01

View south along AT-98 from its junction with AT-96.

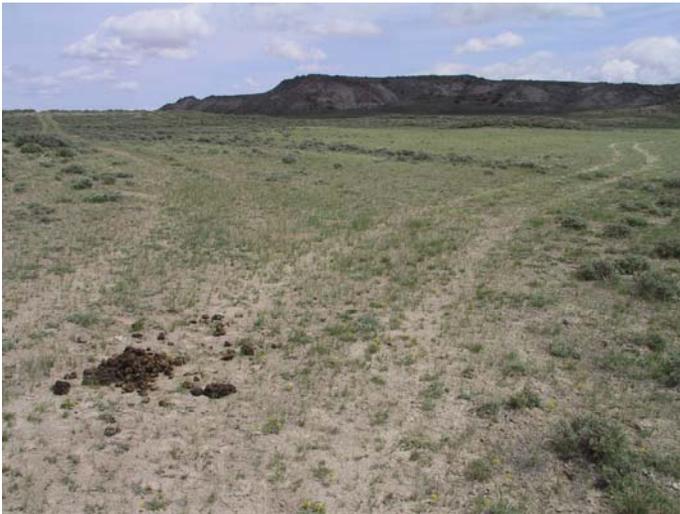
Photo #EMM39-54

Not constructed.  
Not maintained.  
6 feet wide.  
4 wheel drive.  
Very light use.

This jeep trail runs southeast from AT-96 to a camping site at the base of the Haystacks.

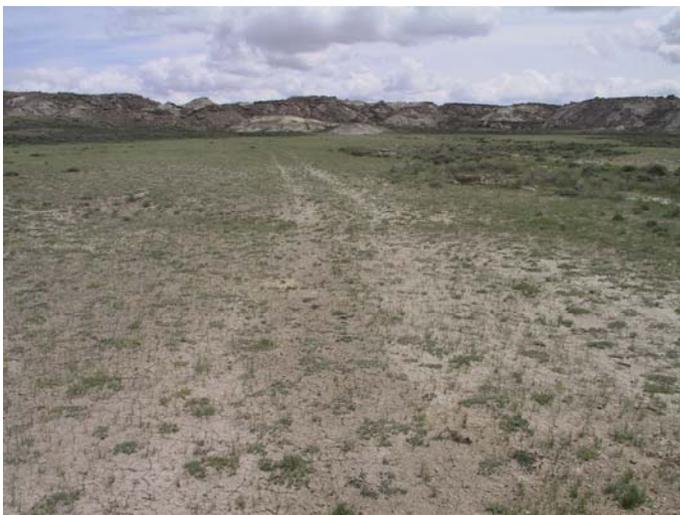
Photo #EMM39-55

Route AT-99  
UTM 0730849 4558051  
5/16/01

Route AT-99 (at right) splits away  
from AT-96.

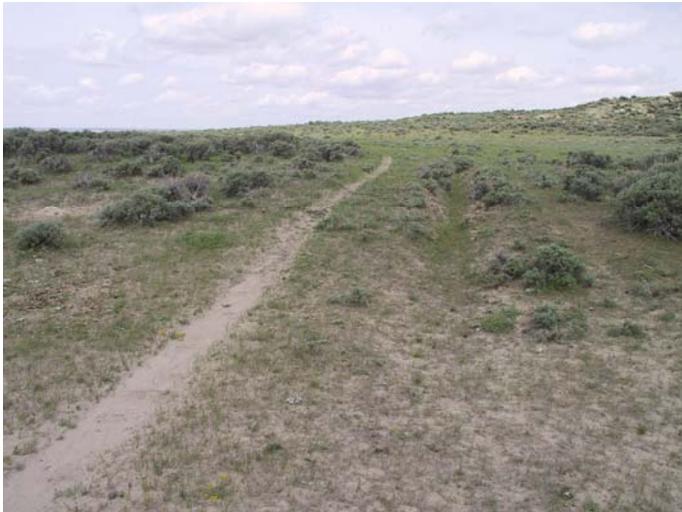
Photo #EMM39-59

Route AT-99  
UTM 0730929 4588024  
5/16/01

View southeast along AT-99 from  
its junction with AT-101.

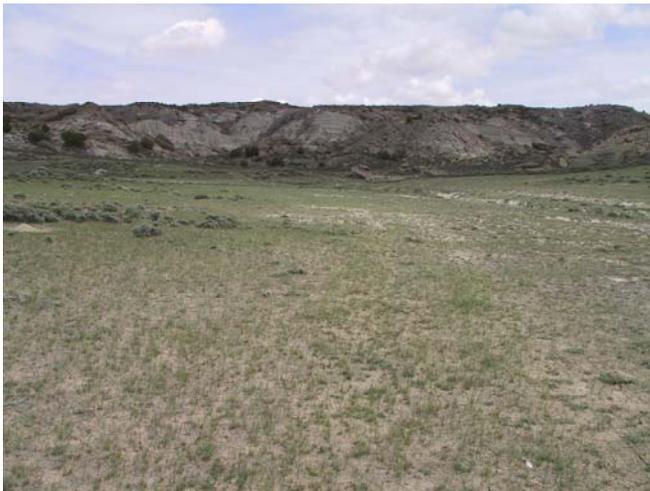
Photo #EMM39-58

Route AT-99

Perhaps once a vehicle route, this way is now a wild horse trail.

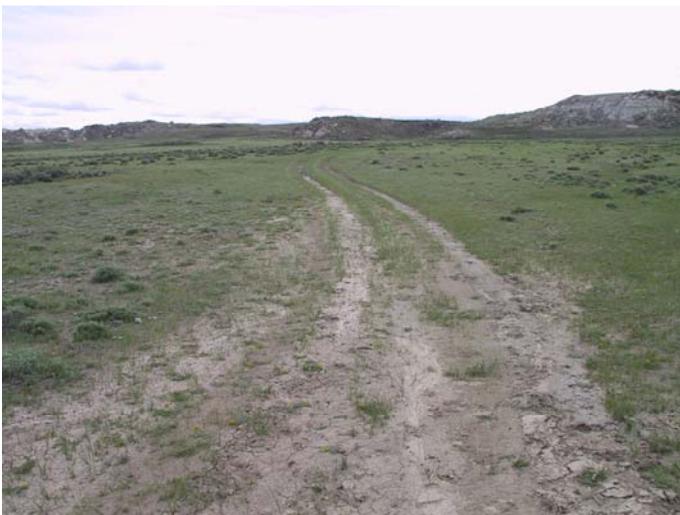
Photo #EMM39-36

Not constructed.  
Not maintained.  
6 feet wide.  
4 wheel drive.  
Very light use.

This jeep trail runs to the top of the Haystacks, ending at a campsite.

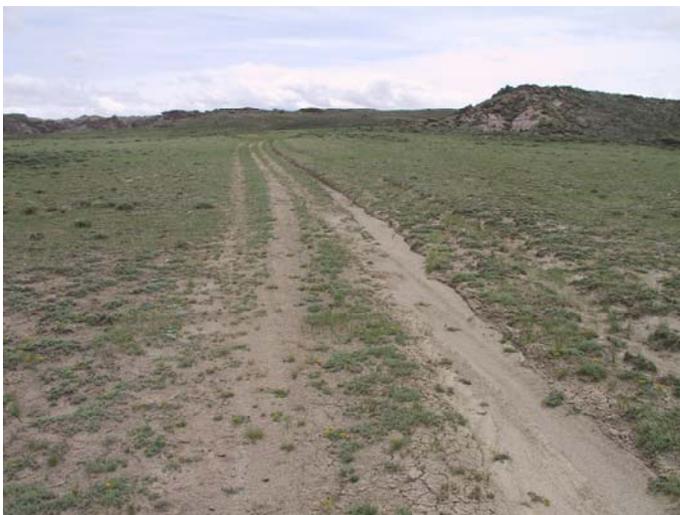
Photo #EMM39-38

Route AT-100  
UTM 0730366 4587762  
5/16/01

Route AT-100 departs southeast  
from its junction with AT-96 and  
AT-102.

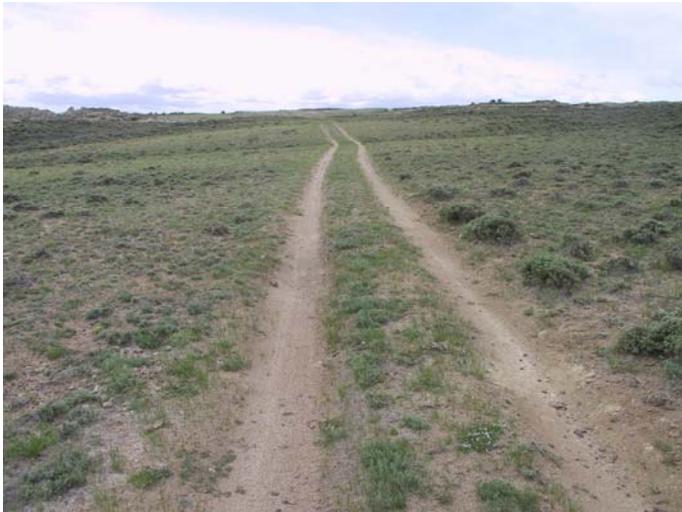
Photo #EMM39-39

Route AT-100  
UTM 0730534 4587648  
5/16/01

Double trailing as seen here is  
typical for Route AT-100.

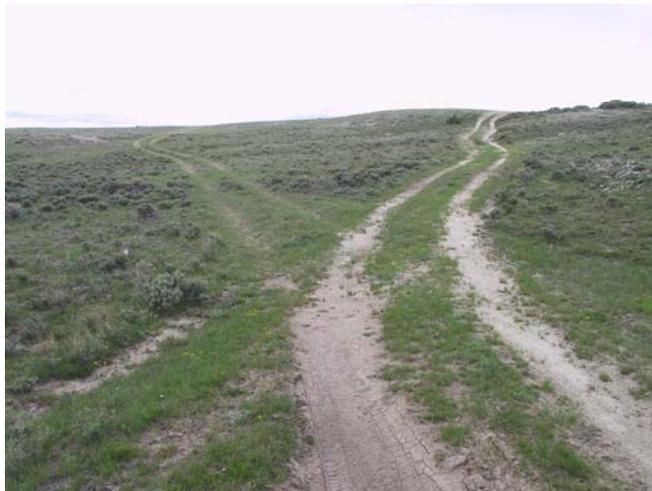
Photo #EMM39-40

Route AT-100  
UTM 0730882 4587040  
5/16/01

Route in its best shape.

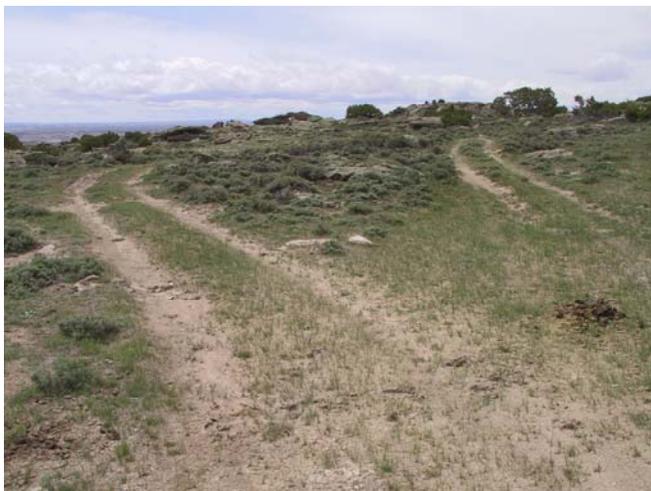
Photo #EMM39-41

Route AT-100  
UTM 0730763 4586661  
5/16/01

Route AT-100A (at left) splits  
away from AT-100.

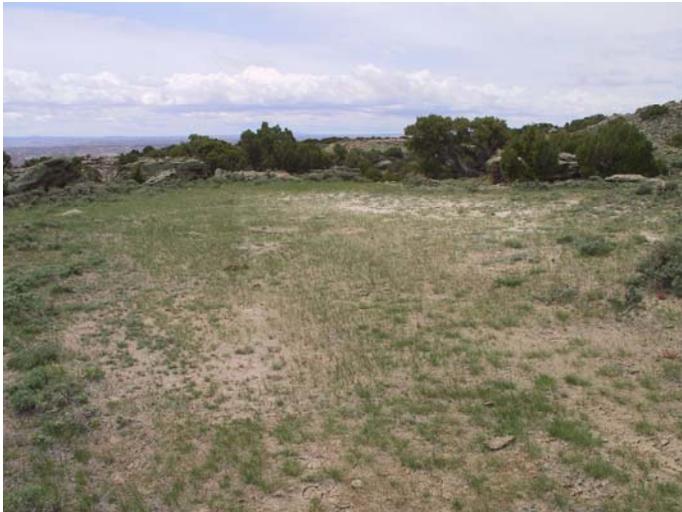
Photo #EMM39-42

Route AT-100  
UTM 0730326 4586219  
5/17/01

Double trailing. Route is very  
rocky here.

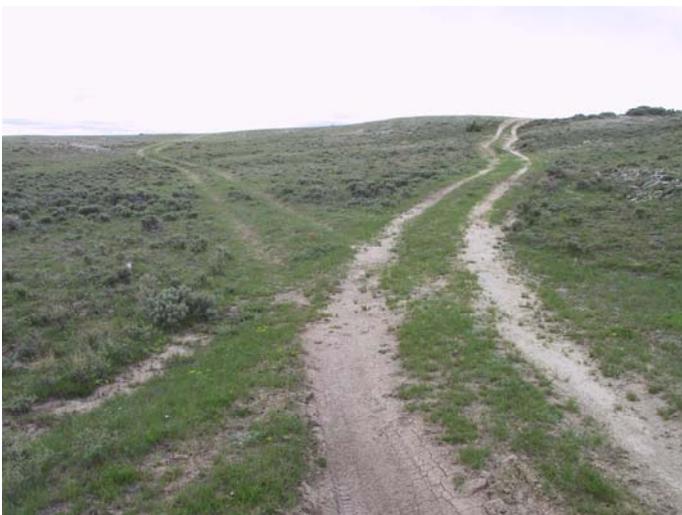
Photo #EMM39-40

Not constructed.  
Not maintained.  
6 feet wide.  
4 wheel drive.  
Very light use.

This spur route runs from AT-100 to a more easterly camp spot atop The Haystacks.

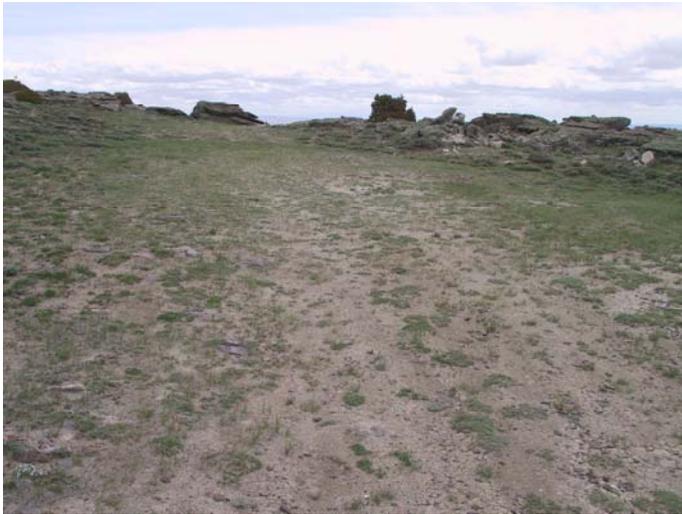
Photo #EMM39-43

Rt. AT-100A  
UTM 0730763 4586661  
5/16/01

Route AT-100A (at left) splits  
away from AT-100.

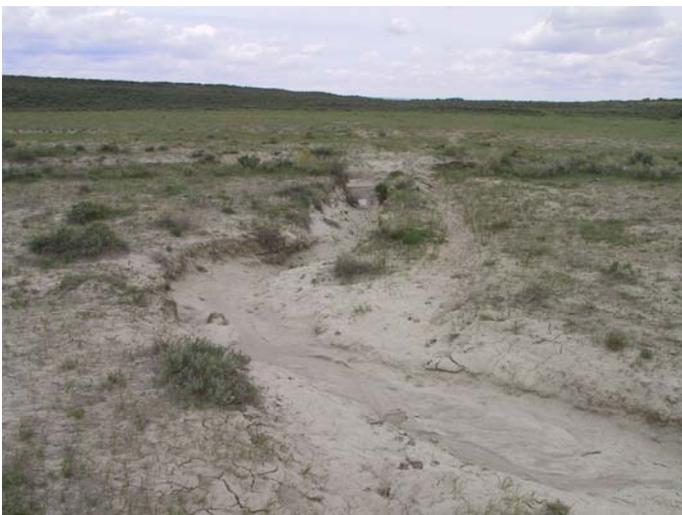
Photo #EMM39-49

Not constructed.  
Not maintained.  
6 feet wide.  
4 wheel drive.  
No use.

This abandoned jeep trail was once a cutoff to AT-100, but gullying at its beginning has rendered it impassable.

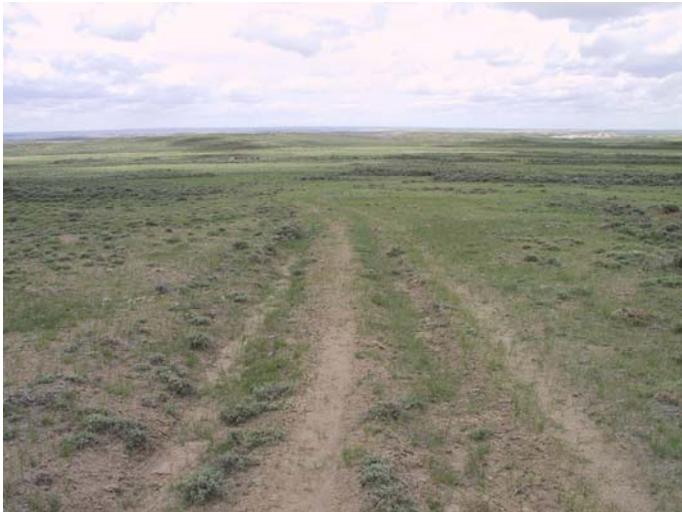
Photo #EMM39-48

Rt. AT-100A  
UTM 0730932 4587984  
5/16/01

Impassable wash crossing leads  
AT-101 south from its junction  
with AT-99.
