**BLM Unit Identification:** Adobe Town WY-030-401 and WY-040-408

**Description** Adobe Town is proposed by the conservation community for wilderness designation. The area proposed for wilderness includes all of the Adobe Town Wilderness Study Area, plus additional lands of wilderness quality in The Haystacks, along Willow Creek and the Willow Creek Rim, and south of the WSA to the Powder Rim and just beyond it. All of these areas possess the full complement of required characteristics for wilderness in abundance: outstanding opportunities for both solitude *and* primitive and unconfined recreation, wilderness-quality naturalness, size (at over 180,000 acres, the citizens proposed Adobe Town wilderness is well above the 5,000-acre minimum), and in addition has outstanding supplemental values such as abundant wildlife, wild horse herds, unique geology, and abundant archaeological and paleontological resources.

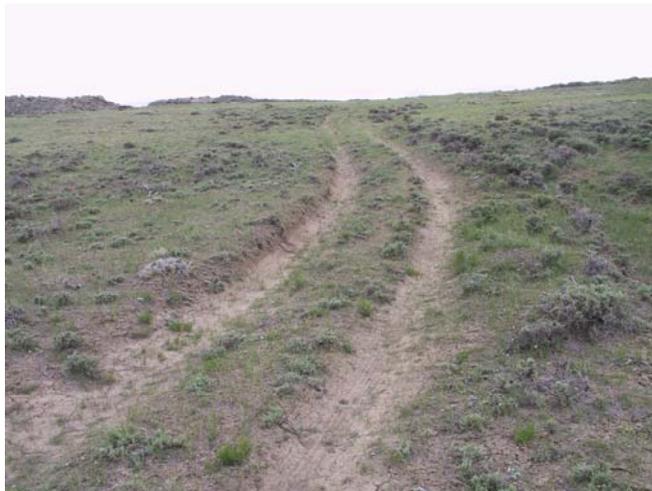
Photo #EMM39-47

Route AT-101  
UTM 0730899 4587569  
5/16/01

Cutoff trail hardly evident.

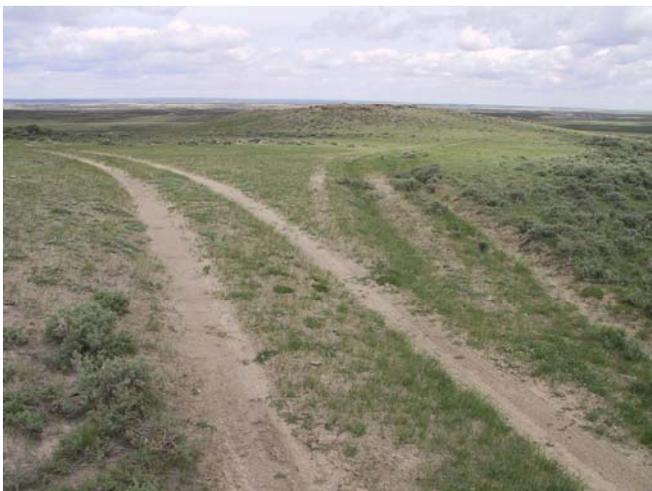
Photo #EMM39-46

Route AT-101  
UTM 0730899 4587569  
5/16/01

Cutoff trail deeply worn.

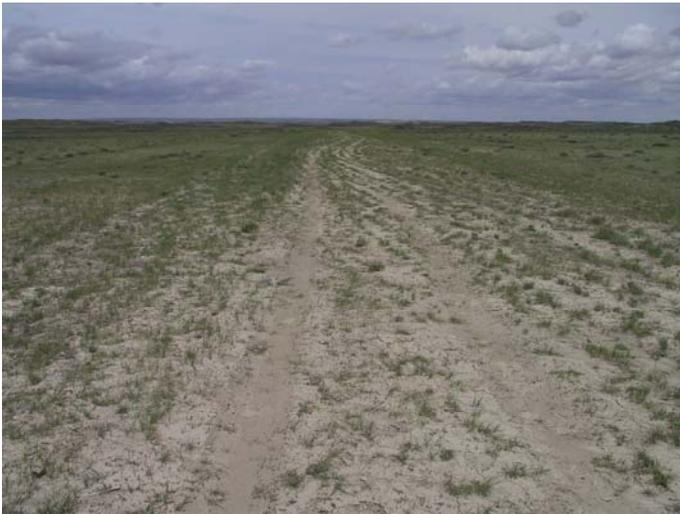
Photo #EMM39-51

Route AT-102, formerly an improved road to an abandoned drilling pad. It was obliterated and re-seeded, by sporadic use has continued, wearing a two-track “way” into part of it.

Originally constructed, but obliterated and revegetated.  
Not maintained.  
6 feet wide (revegetation strip is 30 feet wide).  
4 wheel drive.  
Very light use.

This abandoned and reclaimed route runs to a plugged well site.

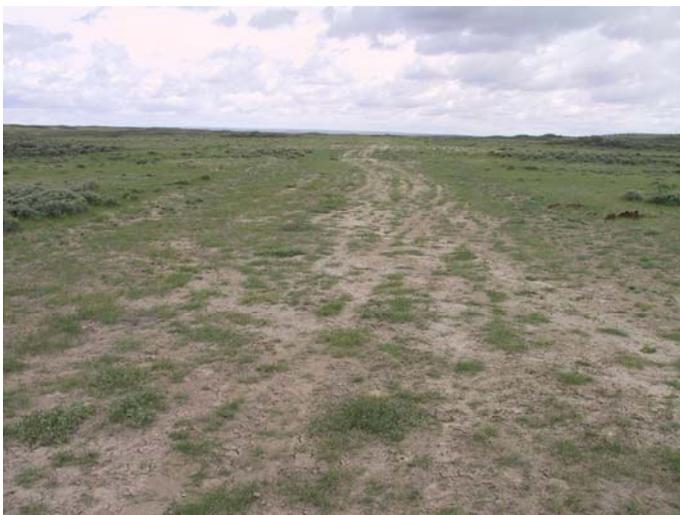
Photo #EMM39-34

Route AT-102  
UTM 0730384 4588046  
5/16/01

View north on reclaimed drill pad  
route AT-102 from its junction  
with the bypass route of AT-96.

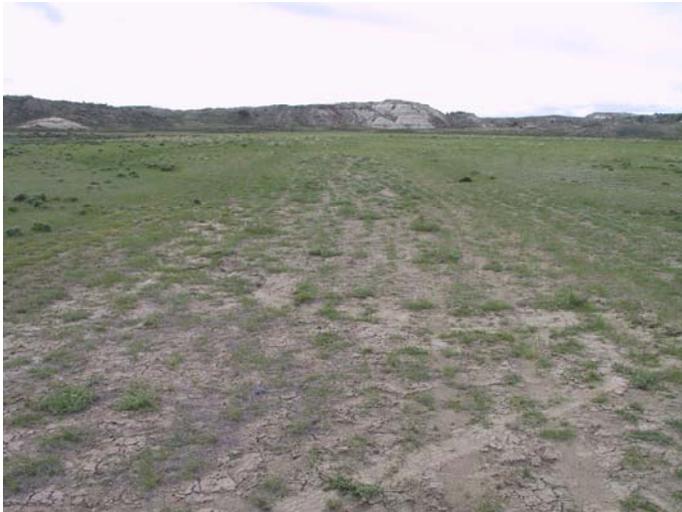
Photo #EMM39-35

Route AT-102  
UTM 0730364 4587760  
5/16/01

View south on AT-102 from AT-  
96; route is well-revegetated.

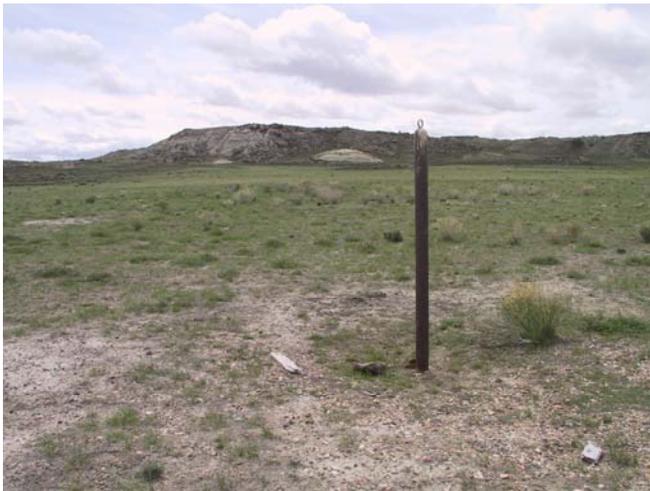
Photo #EMM39-33

Route AT-102 runs south from its junction with AT-96. It is fully reclaimed.

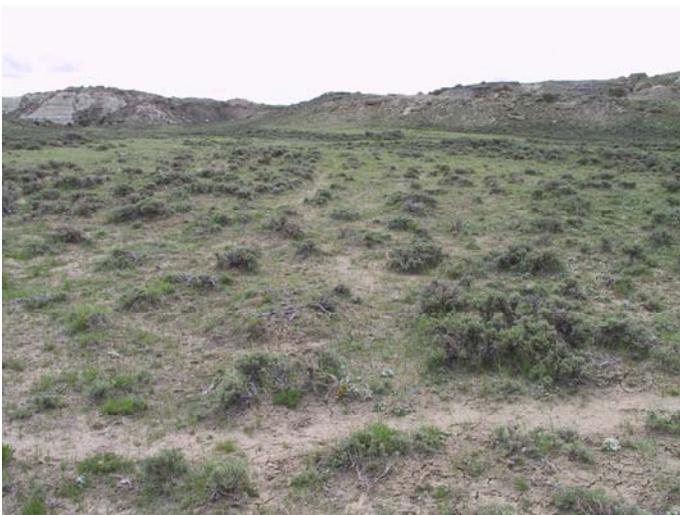
Photo #EMM39-30

This jeep trail runs to a cove among The Haystacks.

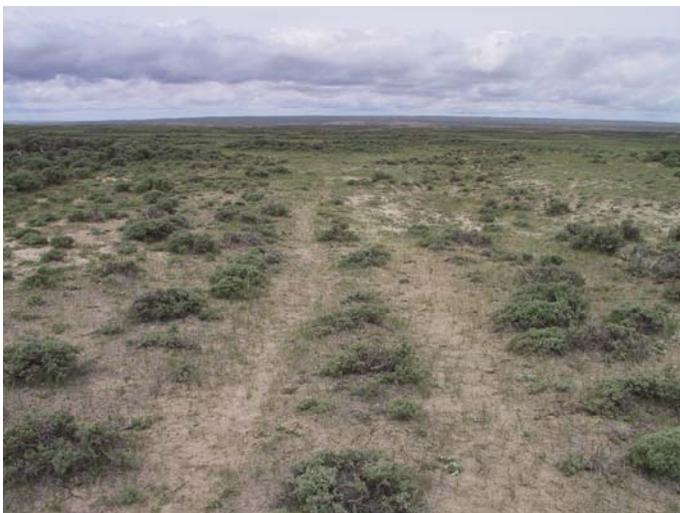
Photo #EMM39-25

Origins of Route AT-103 are  
invisible at its junction with  
AT-96.

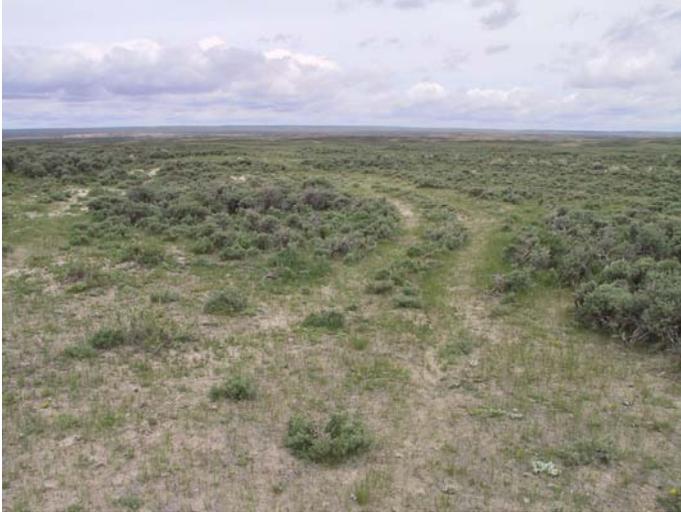
Photo #EMM39-24

Typical condition of AT-103.

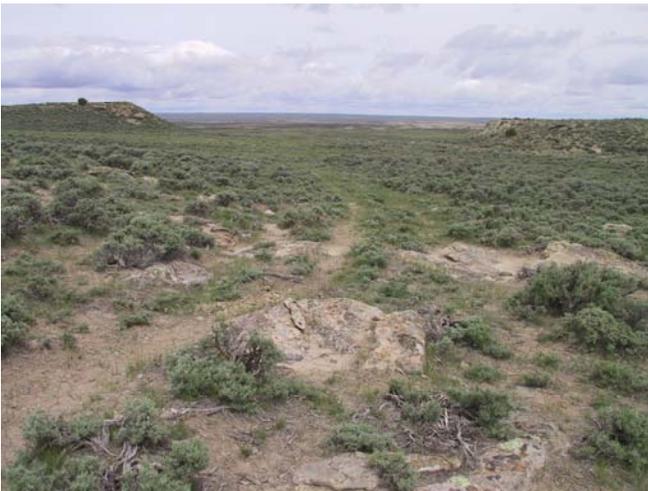
Photo #EMM39-23

Cutoff route runs north from  
AT-103.

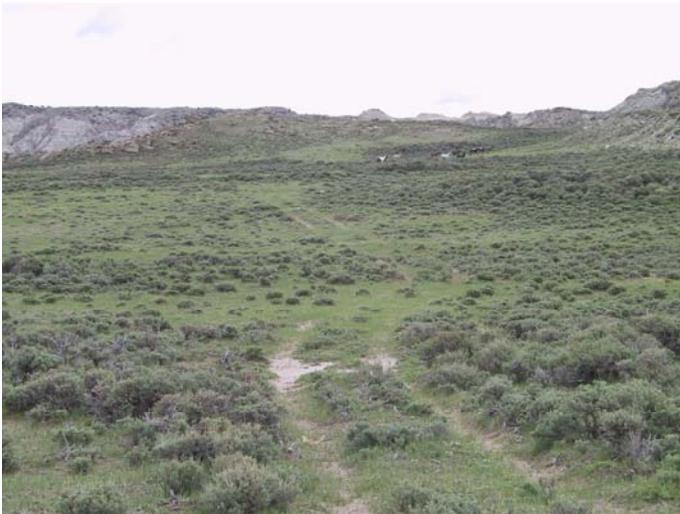
Photo #EMM39-13

This jeep trail runs to the base of the Haystacks, then devolves into single-track trails.

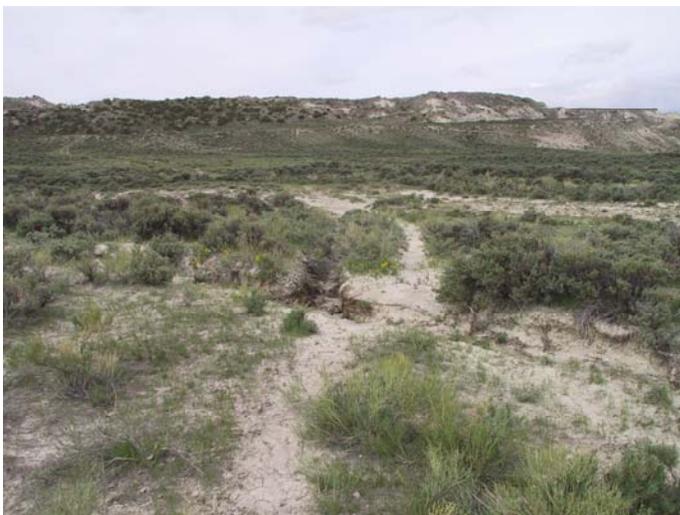
Photo #EMM39-18

Route AT-104 departs southeast  
from its junction with AT-96.

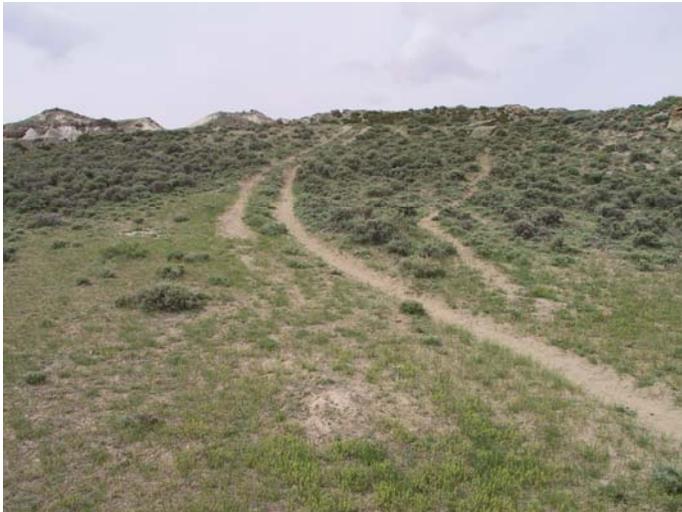
Photo #EMM39-19

Impasse along route.

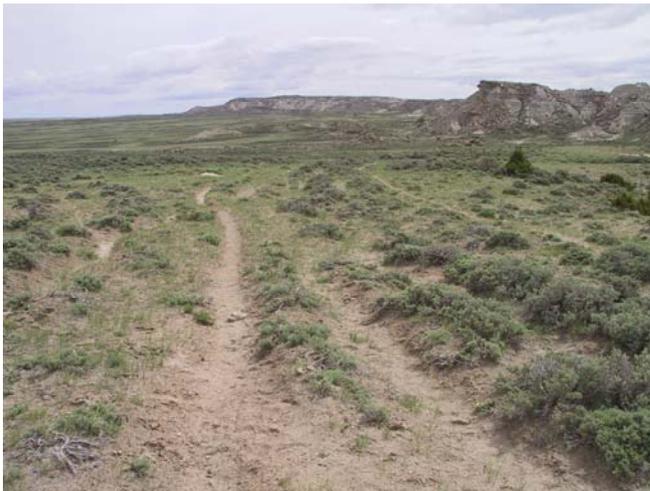
Photo #EMM39-21

Route is most evident at hill climb.

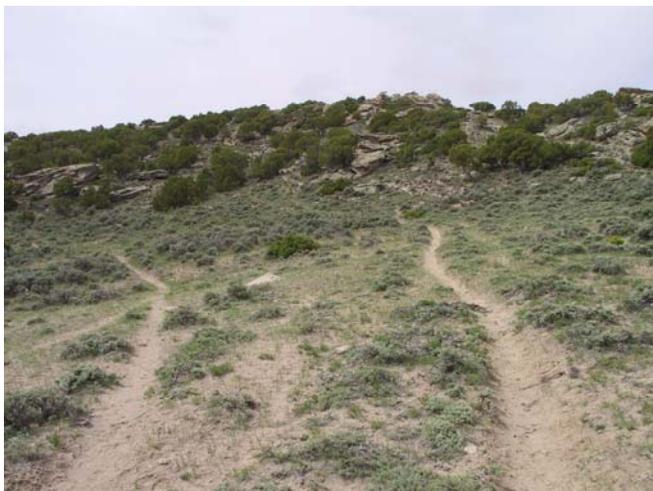
Photo #EMM39-20

View northeast from the end of AT-104.

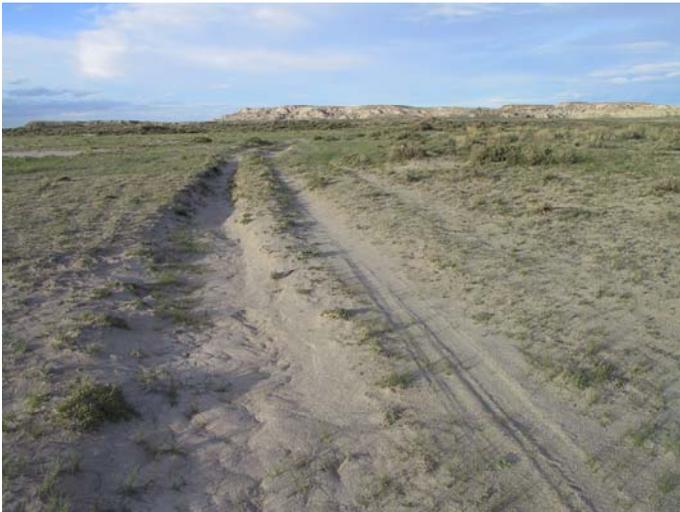
Photo #EMM39-1

This pipeline forms part of the north boundary of the proposed Adobe Town WSA expansion.

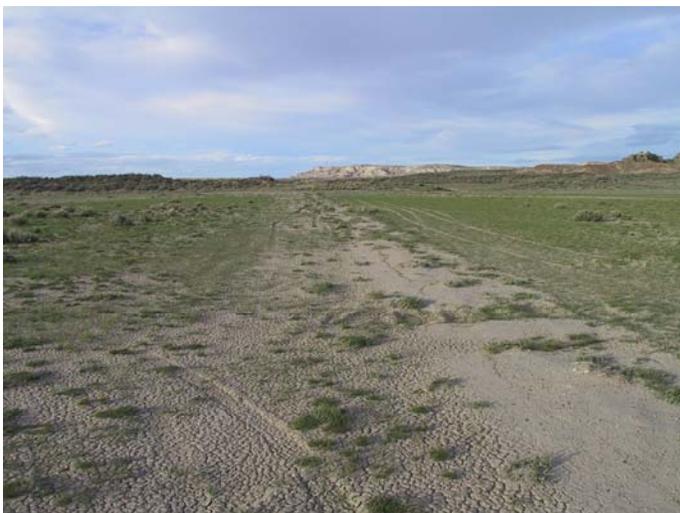
Photo #EMM38-47

Pipeline crosses Route AT-96.

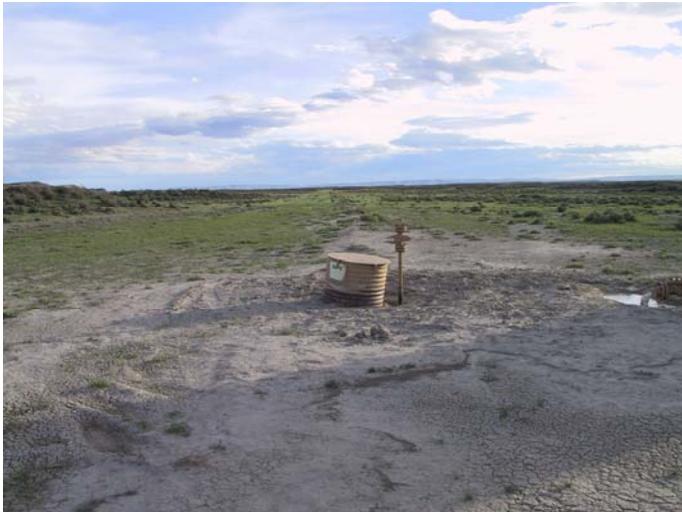
Photo #EMM38-48

Natural gas pipeline runs north-east from its junction with AT-30.

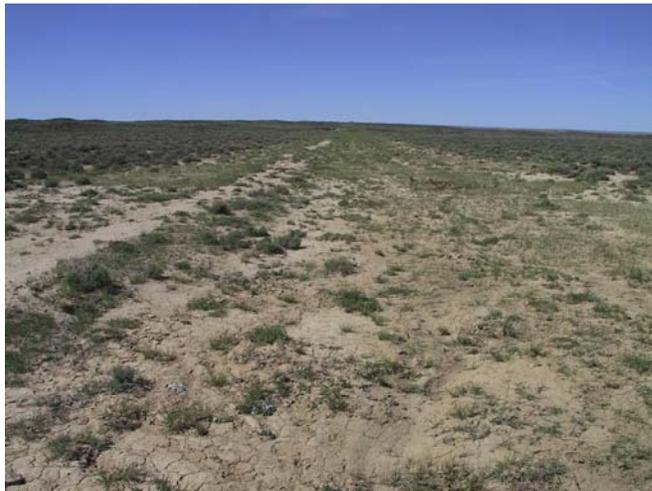
Photo #EMM44-33

Pipeline runs west from its junction with AT-30.

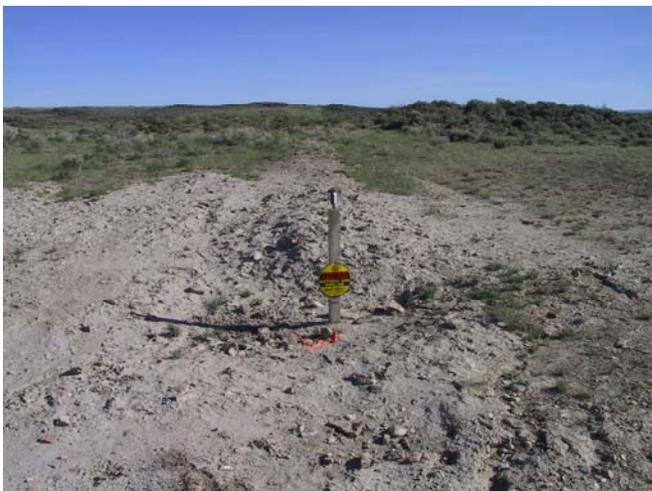
Photo #EMM44-56

View north at pipeline crossing of AT-109.

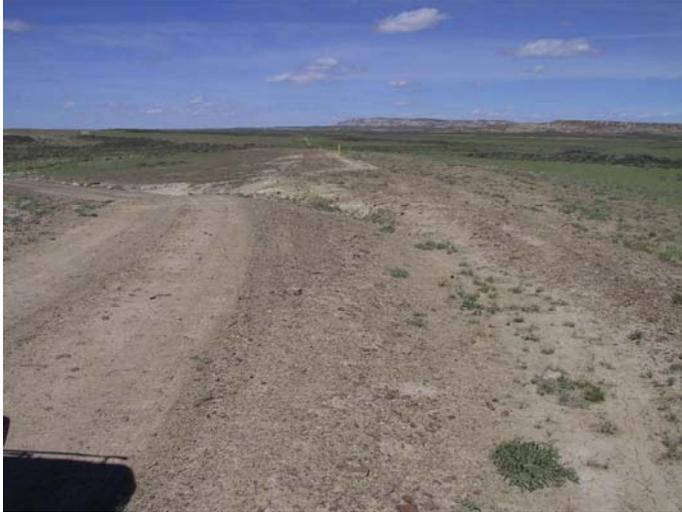
Photo #EMM44-26

Pipeline crossing of Route AT-108. View south.

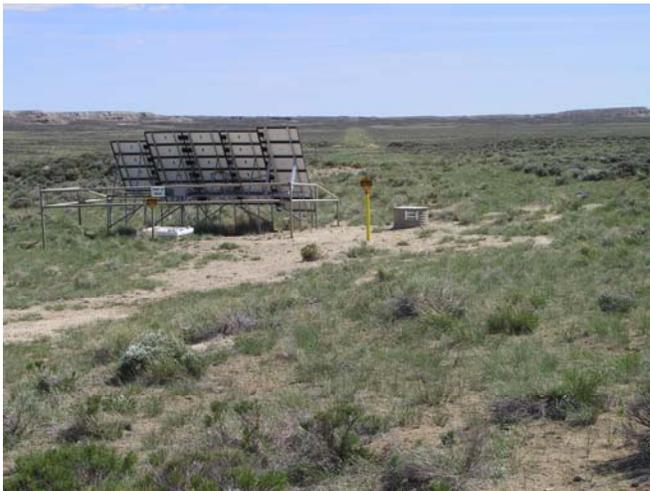
Photo #EMM44-27

Pipeline meets Route AT-110.

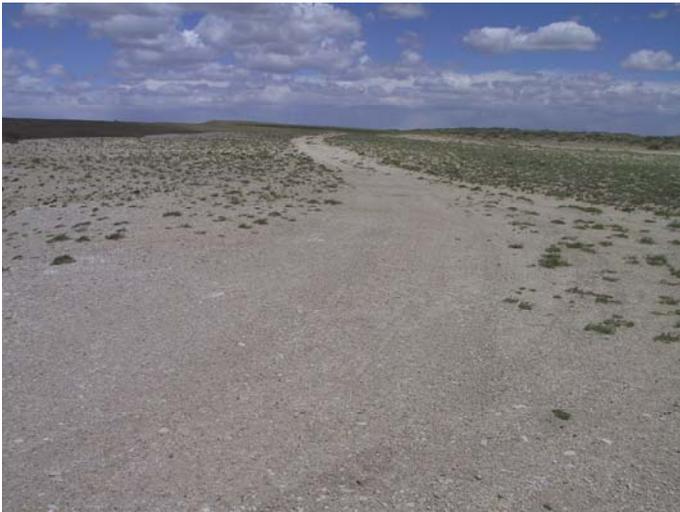
Photo #EMM43-5

This dead-end jeep trail runs north from AT-30 for ½ mile to reach an overlook.

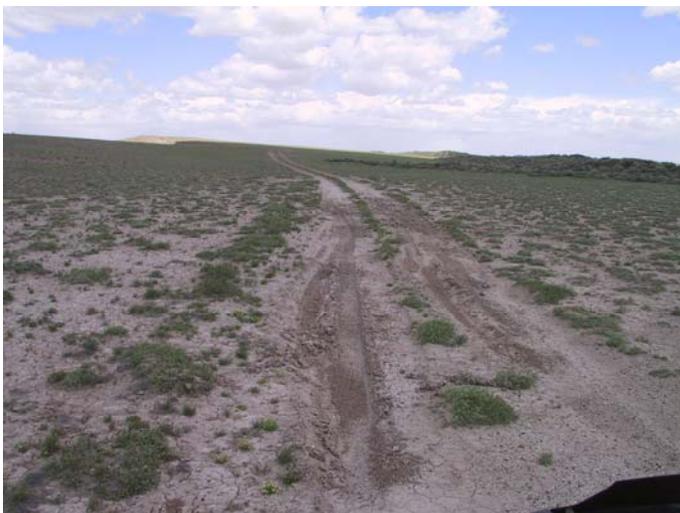
Photo #EMM43-7

Route AT-107 departs northeast  
from its junction with AT-30.

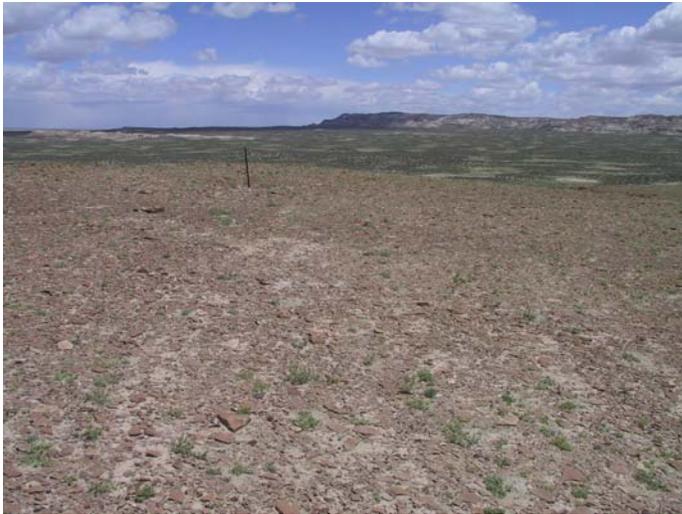
Photo #EMM43-8

Route is badly gouged out here.

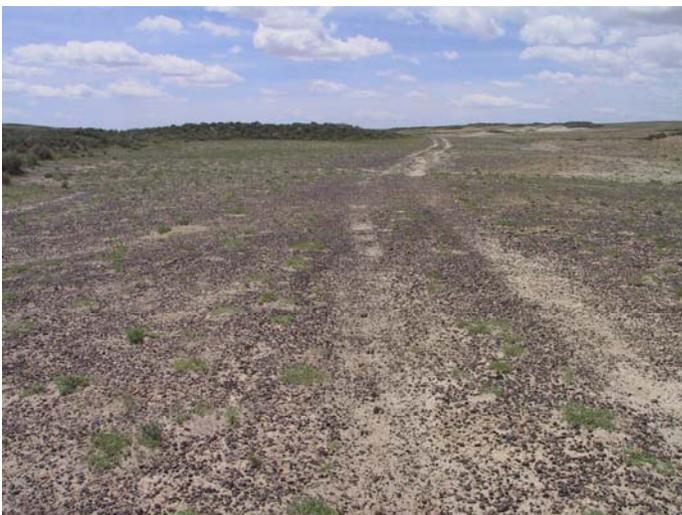
Photo #EMM43-10

This jeep trail follows the ridgetops southwest from AT-30.

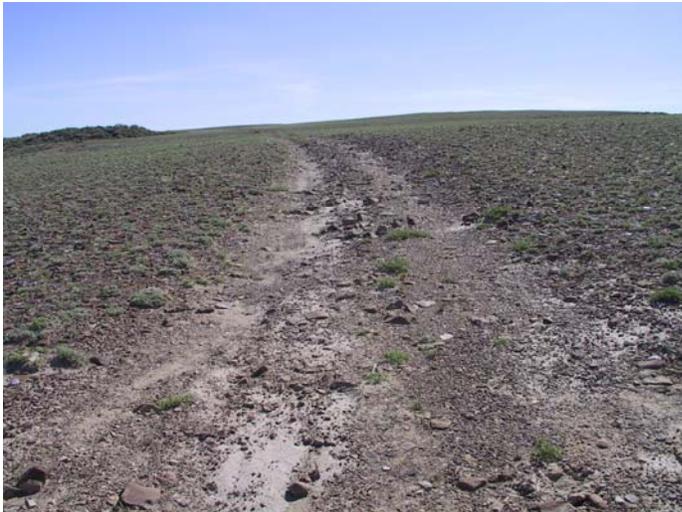
Photo #EMM44-47

Route AT-108 runs southwest  
from its junction with AT-30.

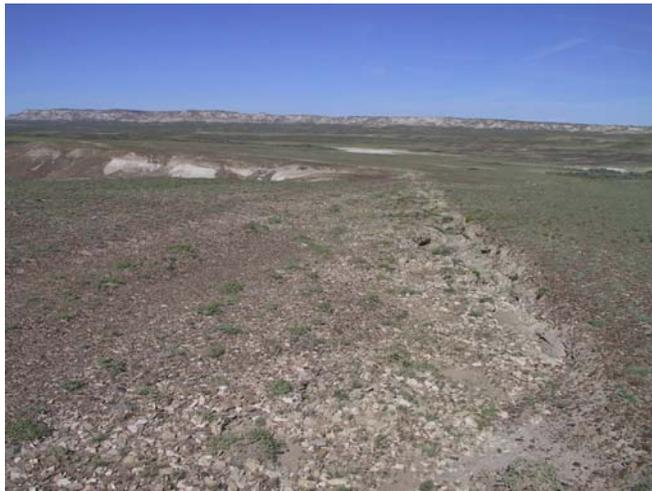
Photo #EMM44-48

Route is rocky and rough here.

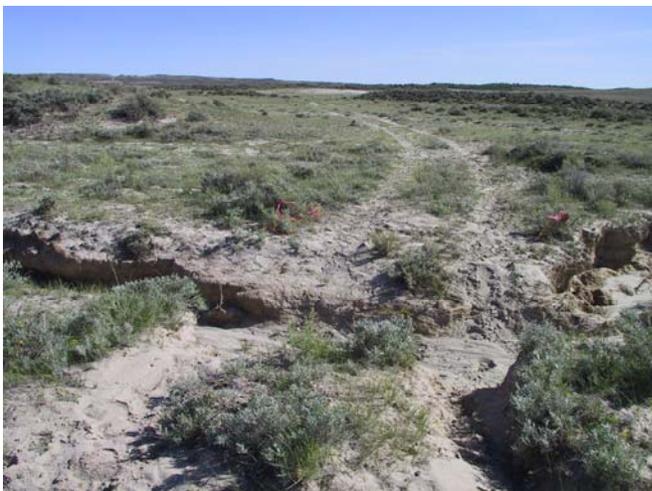
Photo #EMM44-49

The original route is eroded here;  
note drive-around at left.

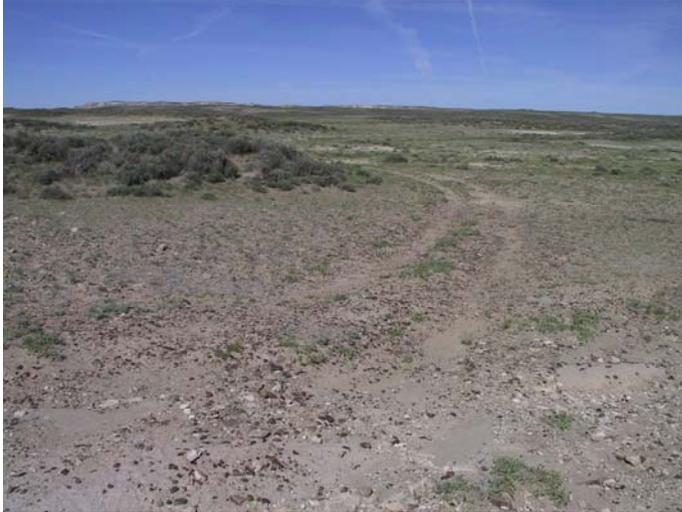
Photo #EMM44-40

2 ½ foot dropoff at wash crossing;  
impasse, drive-around to south-  
east.

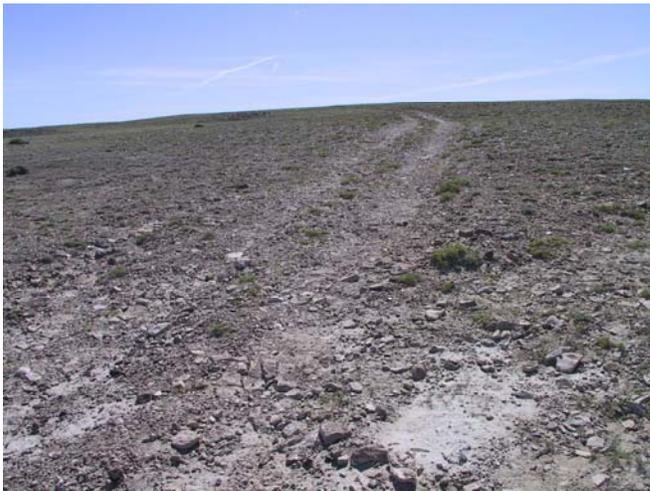
Photo #EMM44-41

Route AT-108 runs northeast  
from its junction with AT-109.

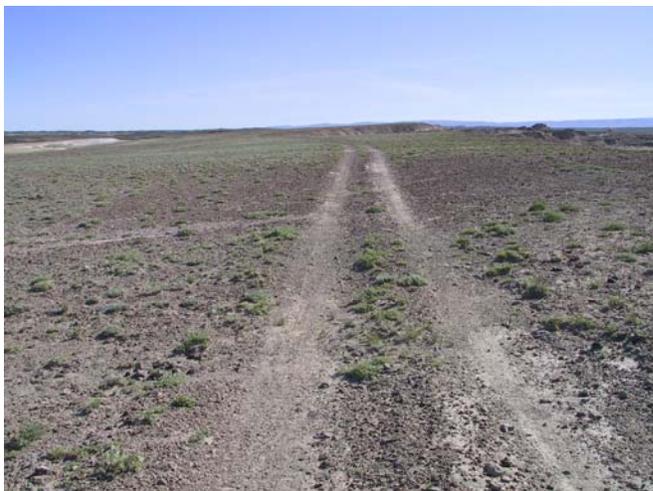
Photo #EMM44-50

Route AT-108 runs southwest  
from its junction with AT-109.

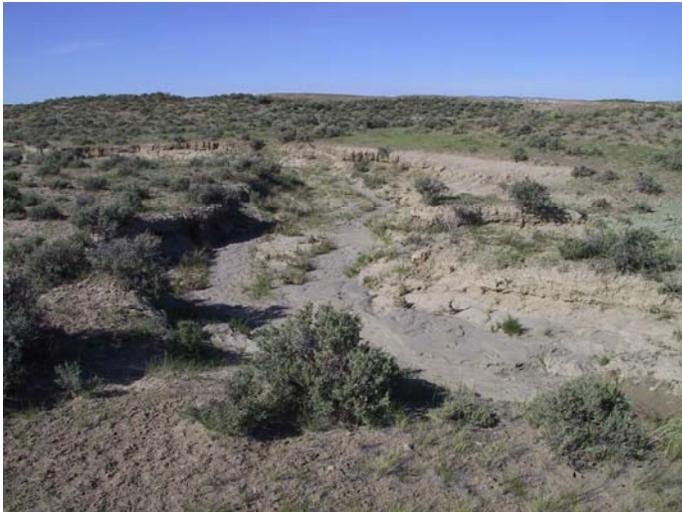
Photo #EMM44-54

Route AT-108 in its best condition. Never constructed or maintained, this is a classic “way.”

Route AT-108 in its best  
condition.

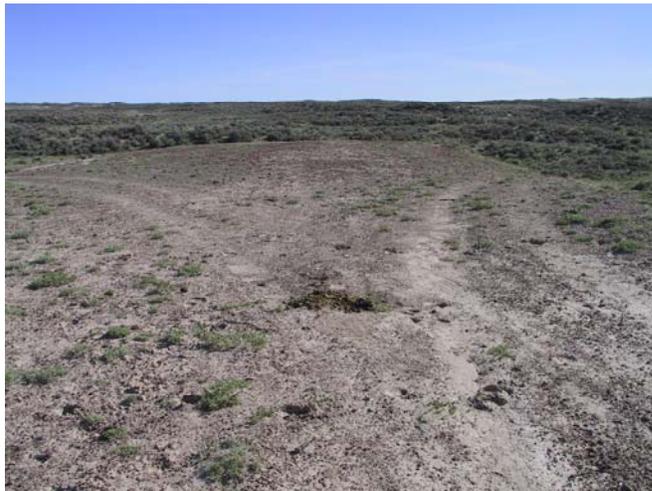
Photo #EMM44-51

Impasse at wash crossing; drive-arounds to southeast.

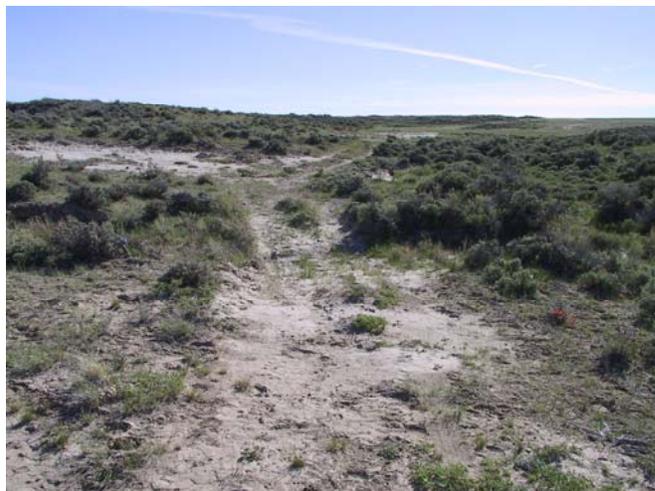
Photo #EMM44-52

Northeast leg of drive-around (at left) splits away from former route.

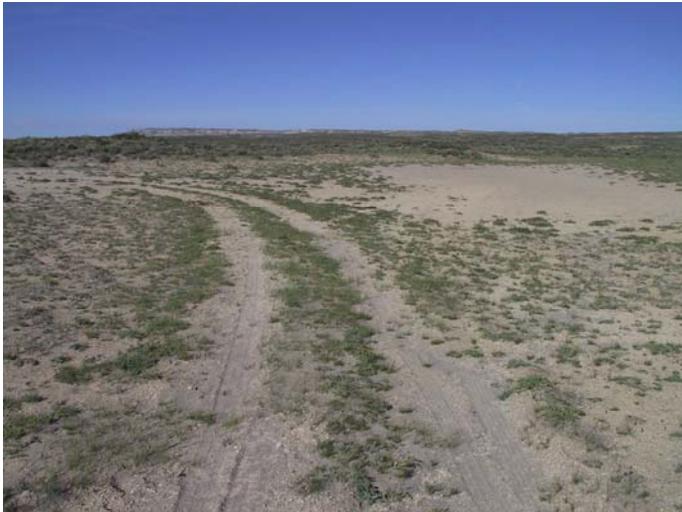
Photo #EMM44-53

Bypass route in its typical poor condition.

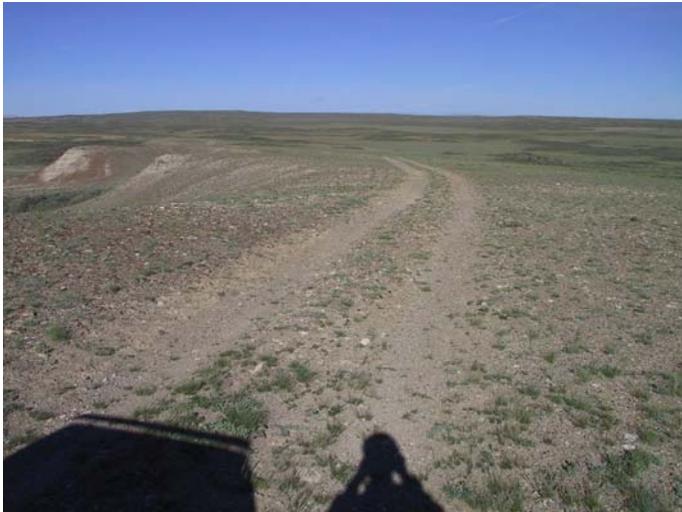
Photo #EMM44-58

Route AT-108 runs southwest  
from the crossing of Pipeline  
AT-106.

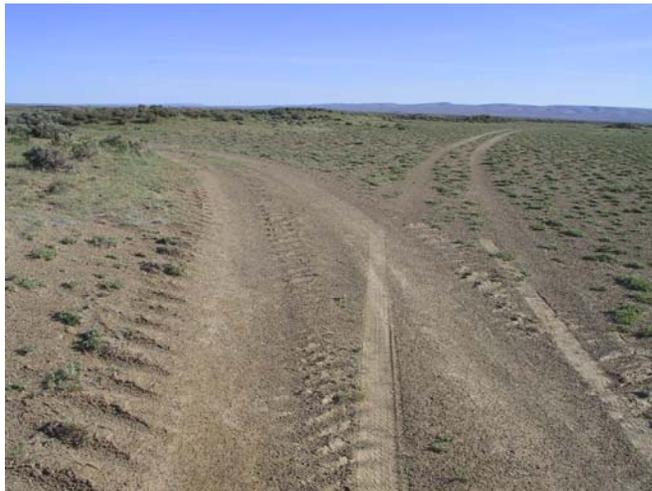
Photo #EMM44-59

Typical view of this stretch of AT-108. Note evidence of heavy equipment traffic.

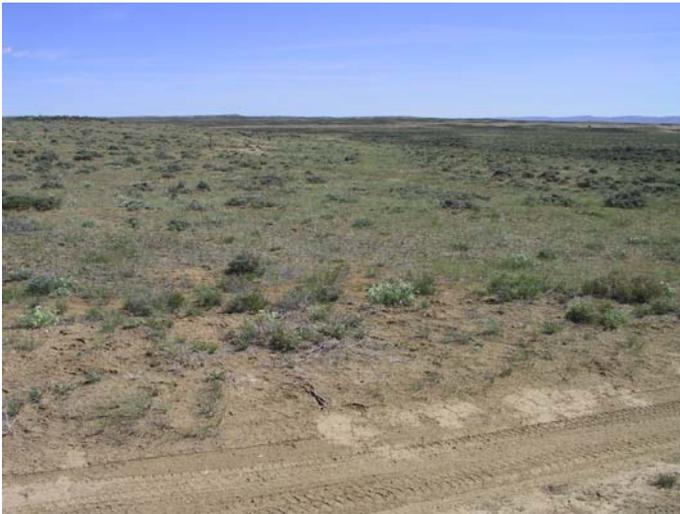
Photo #EMM44-29

This jeep trail offers a linkage between AT-110 and AT-30. It receives very little use.

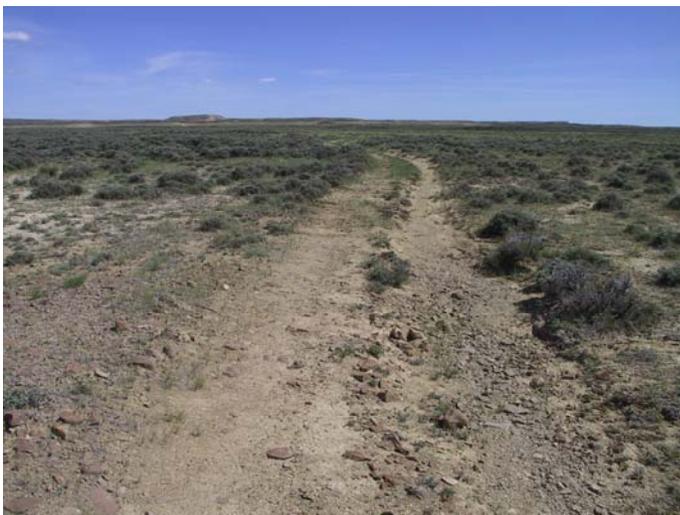
Photo #EMM44-32

Very faint origins of AT-109, departing south from AT-110.

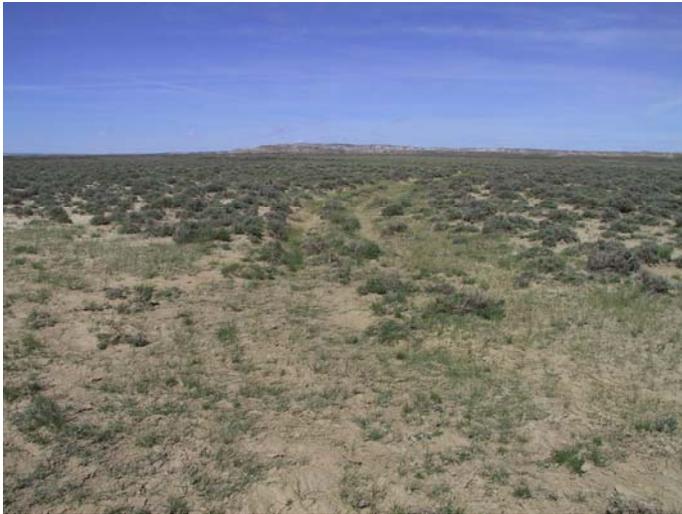
Photo #EMM44-34

Erosion and stream wash following track is characteristic of this segment.

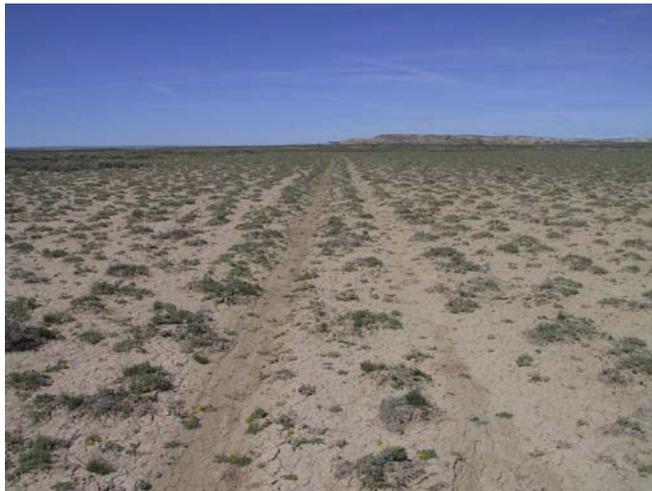
Photo #EMM44-36

Route AT-109 runs northeast  
from the crossing of Pipeline  
AT-106.

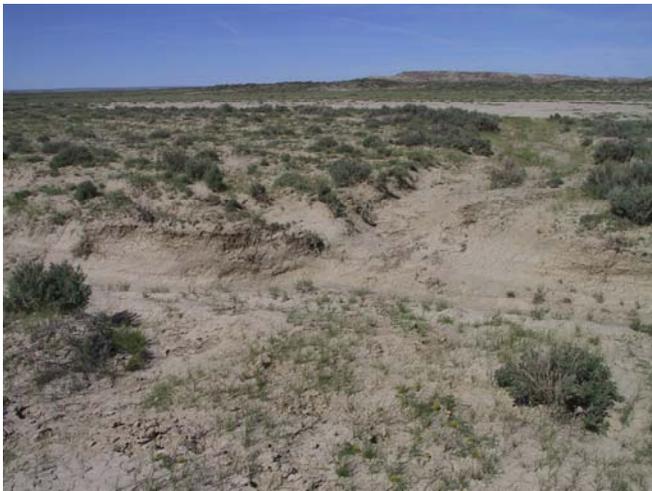
Photo #EMM44-37

Route AT-109 in its best  
condition for this stretch.

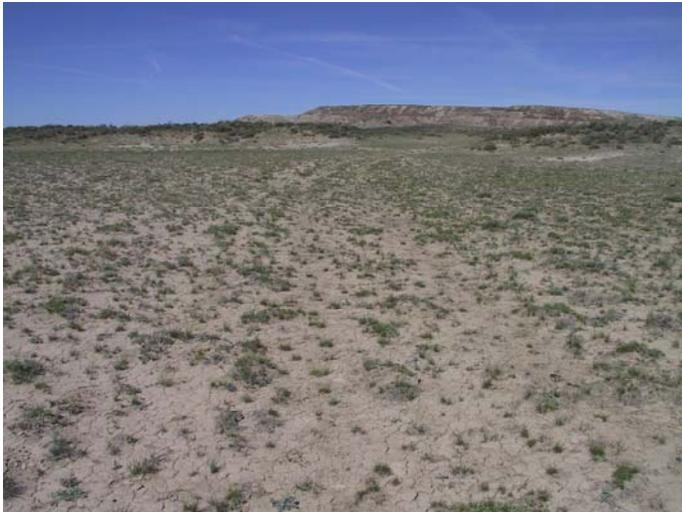
Photo #EMM44-38

Difficult wash crossing.

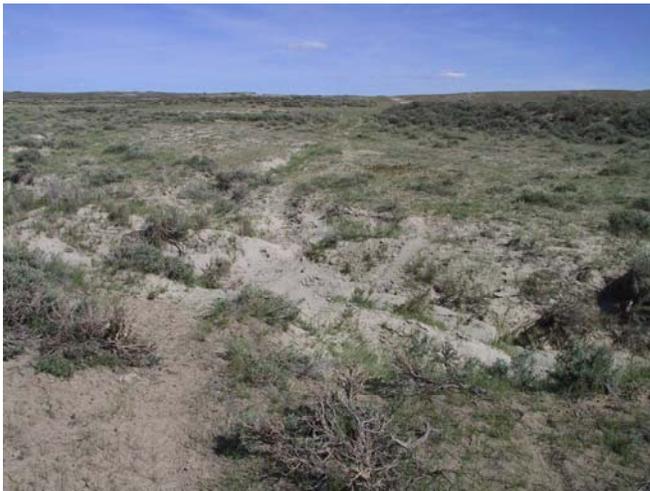
Photo #EMM44-39

Route is well-reclaimed at this point.

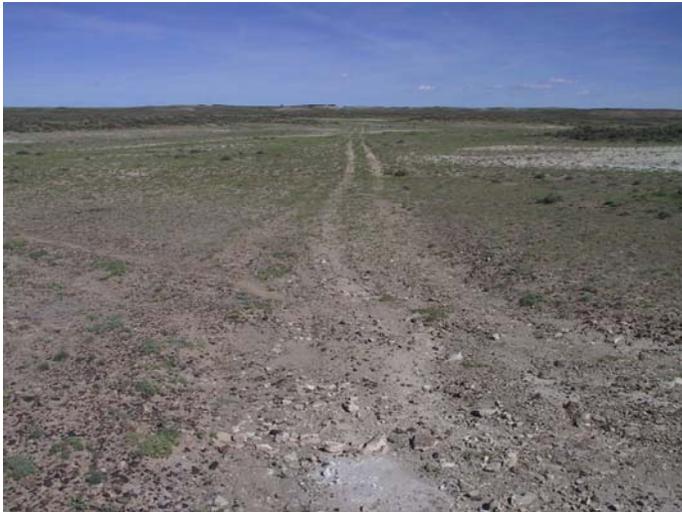
Photo #EMM44-42

View west on AT-109 from its junction with AT-108.

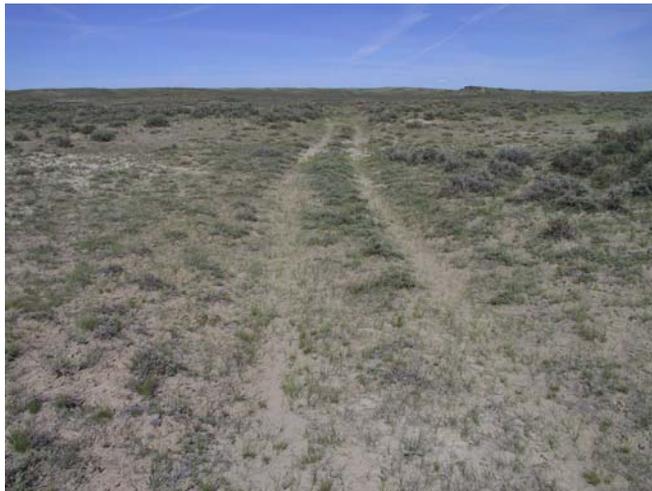
Photo #EMM44-44

View east on AT-109 from its  
junction with AT-108.

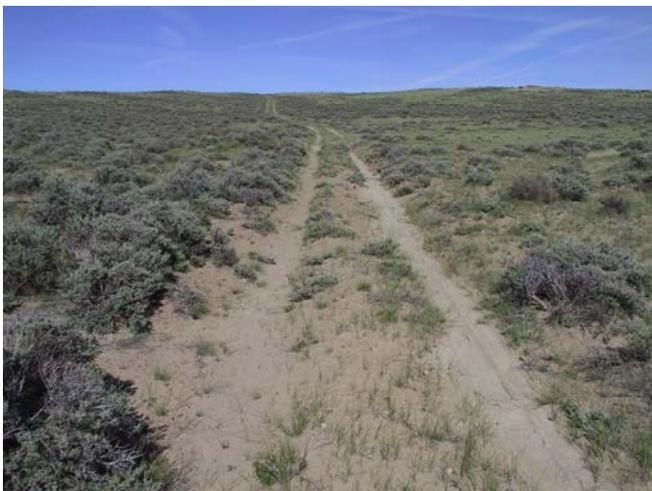
Photo #EMM44-45

Typical view of this stretch of  
AT-109.

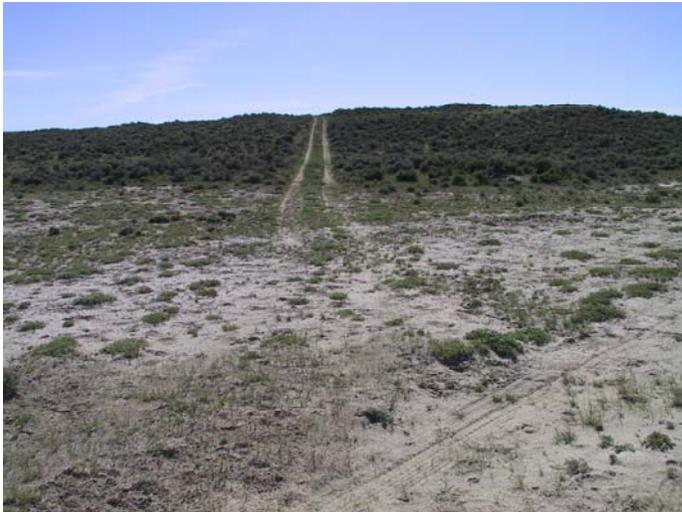
Photo #EMM44-46

Route AT-109 in its best  
condition.

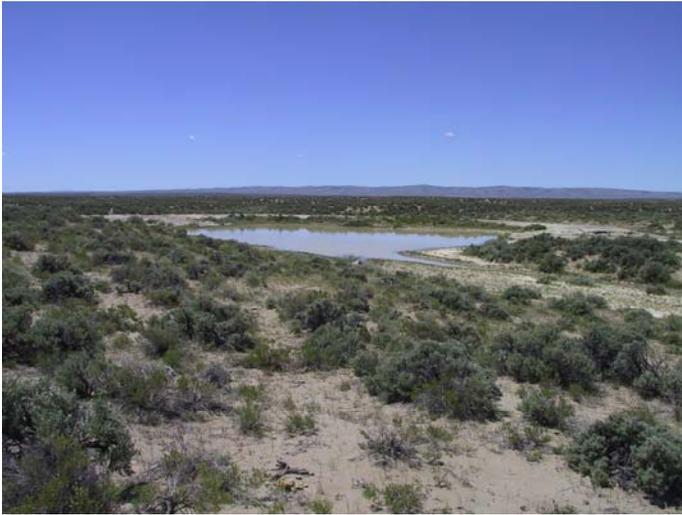
Photo #EMM45-44

Constructed  
No maintenance  
150 foot dam.  
Not driveable.  
In use

Sand Hill Reservoir, sound and holds water. Erosion is beginning around north corner.

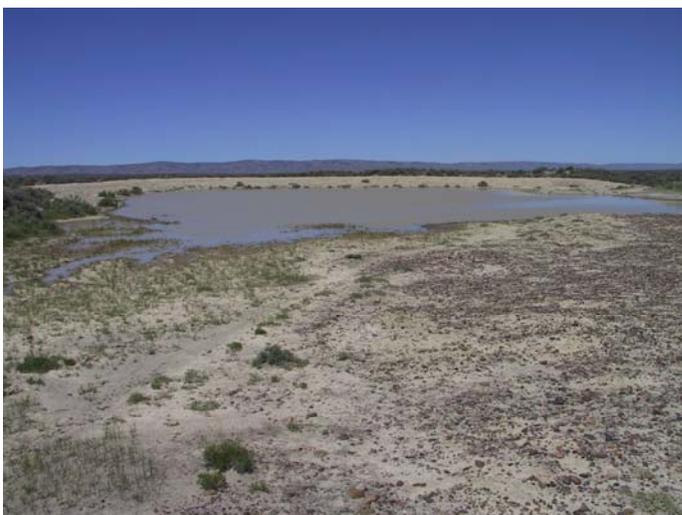
Photo #EMM45-22

Constructed  
Not maintained  
200 foot dam.  
Not driveable.  
In use

East Cow Creek Reservoir, sound and holds water. Gullying out on north corner.

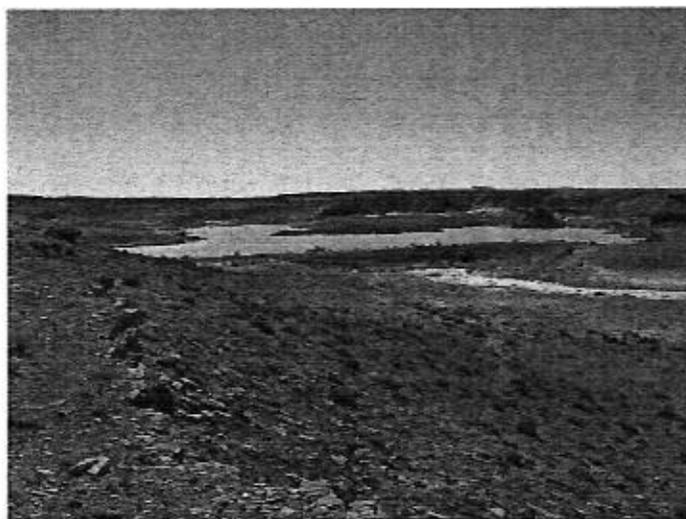
Photo #EMM46-9

Constructed.  
 Not maintained.  
 150 foot dam.  
 Not driveable.  
 In use.

No Name Reservoir (T13N R97W S7 NE1/4), sound and holds water. Within the WSA.

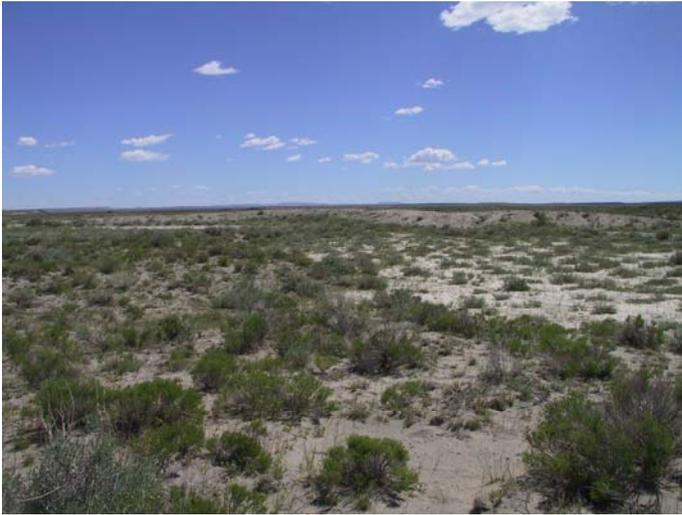
Photo #EMM46-28

Reservoir AT-2035  
Constructed  
No maintenance  
200 foot dam.  
Not driveable.  
No use

Adobe Butte Reservoir. Inoperable, holds no water. Within WSA.

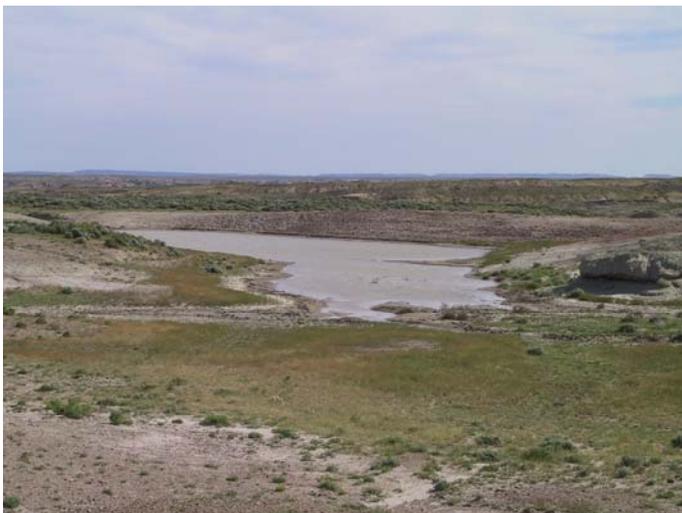
Photo #EMM56-10

Constructed  
Not maintained  
200 foot dam.  
Not driveable.  
In use

East Cow Creek Reservoir, sound and holds water. Gullying out on north corner.

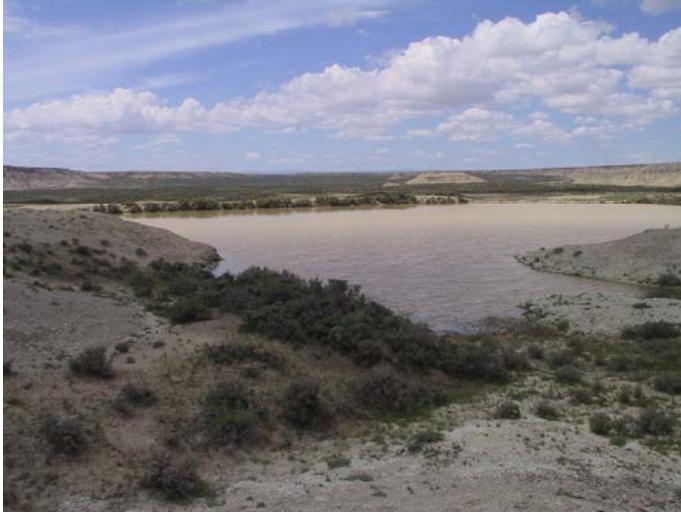
Photo #EMM42-46

Constructed.  
Not maintained.  
100 foot dam.  
Not driveable.  
In use.

Salazar Reservoir southeast of Salazar Butte. Sound, holds water.
